HERITAGE
WATCH.AI

ARMENIAN CULTURAL HERITAGE SITES
CONDITIONAL REPORT

2 0 2 0

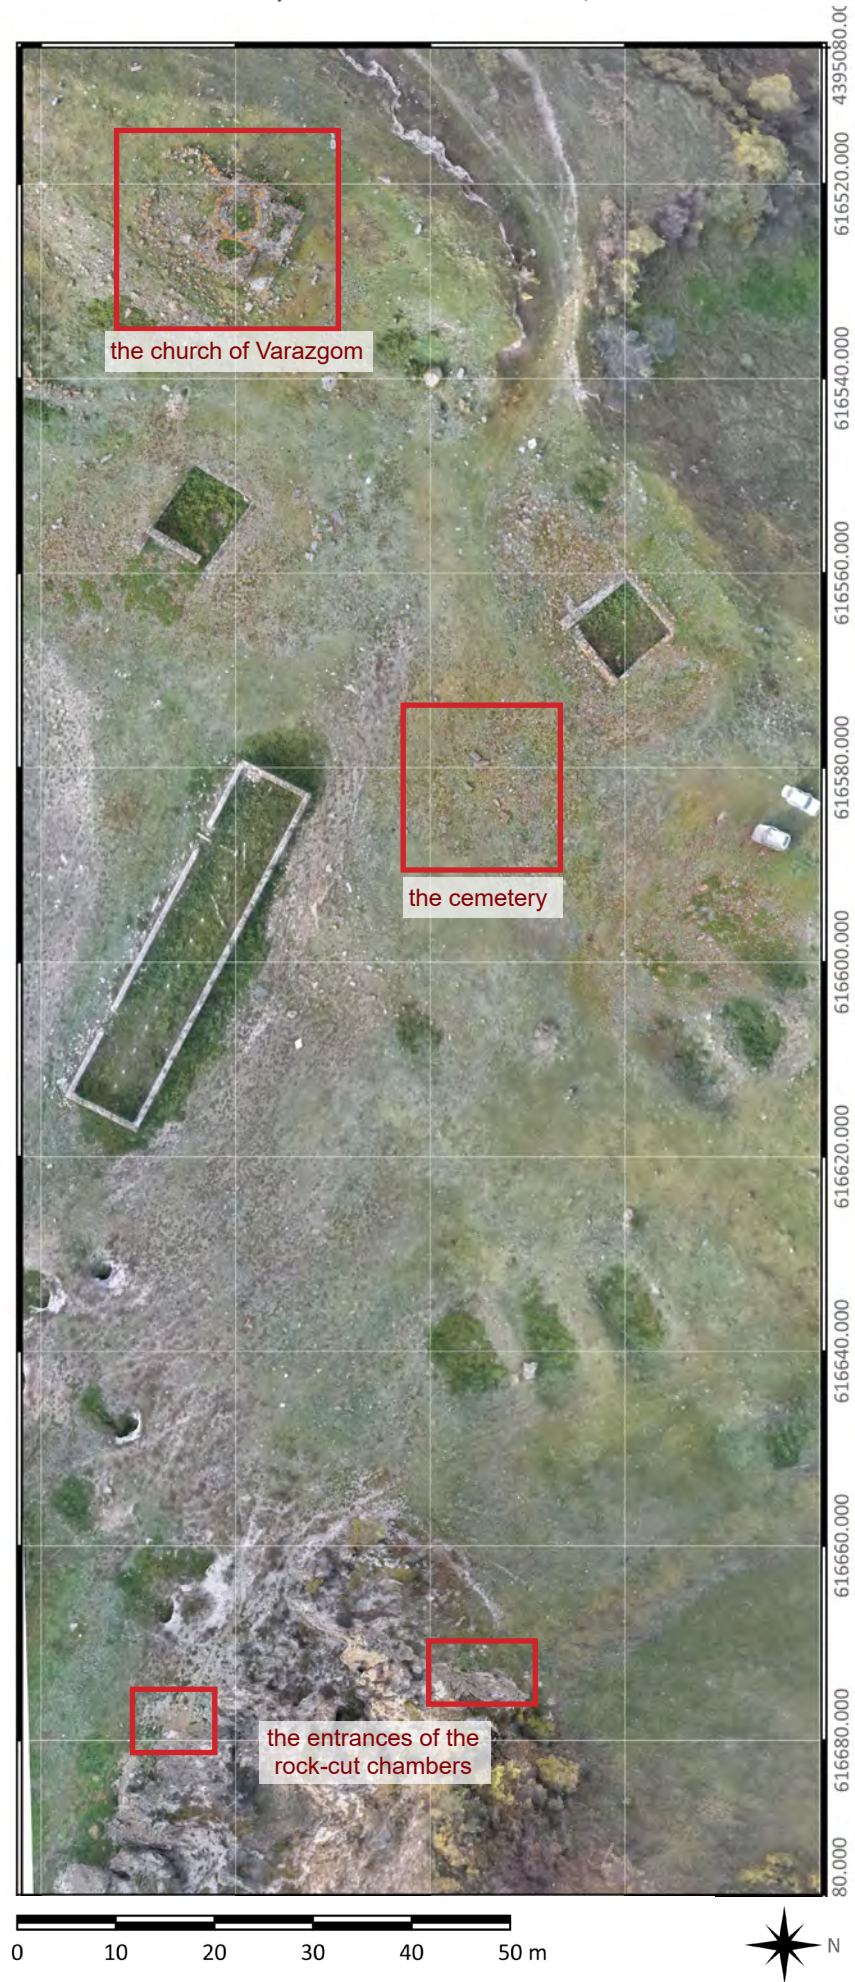
Fig. 1. Georeferenced ortho-image of Varazgom extracted from the textured 3D scan (Iconem 2021)

A medieval cemetery is located 55 meters from the church, on its north-eastern side, and seems to develop on another 40 meters (fig. 1). A few *khachkars* (cross-carved stele) and tombstones were found, most of them fragmentary (fig. 12). The tombstones are carved with stylised representations of the deceased on their upper surface and the *khachkars* are ornamented with the symbol of the cross along other motifs such as grape vines.

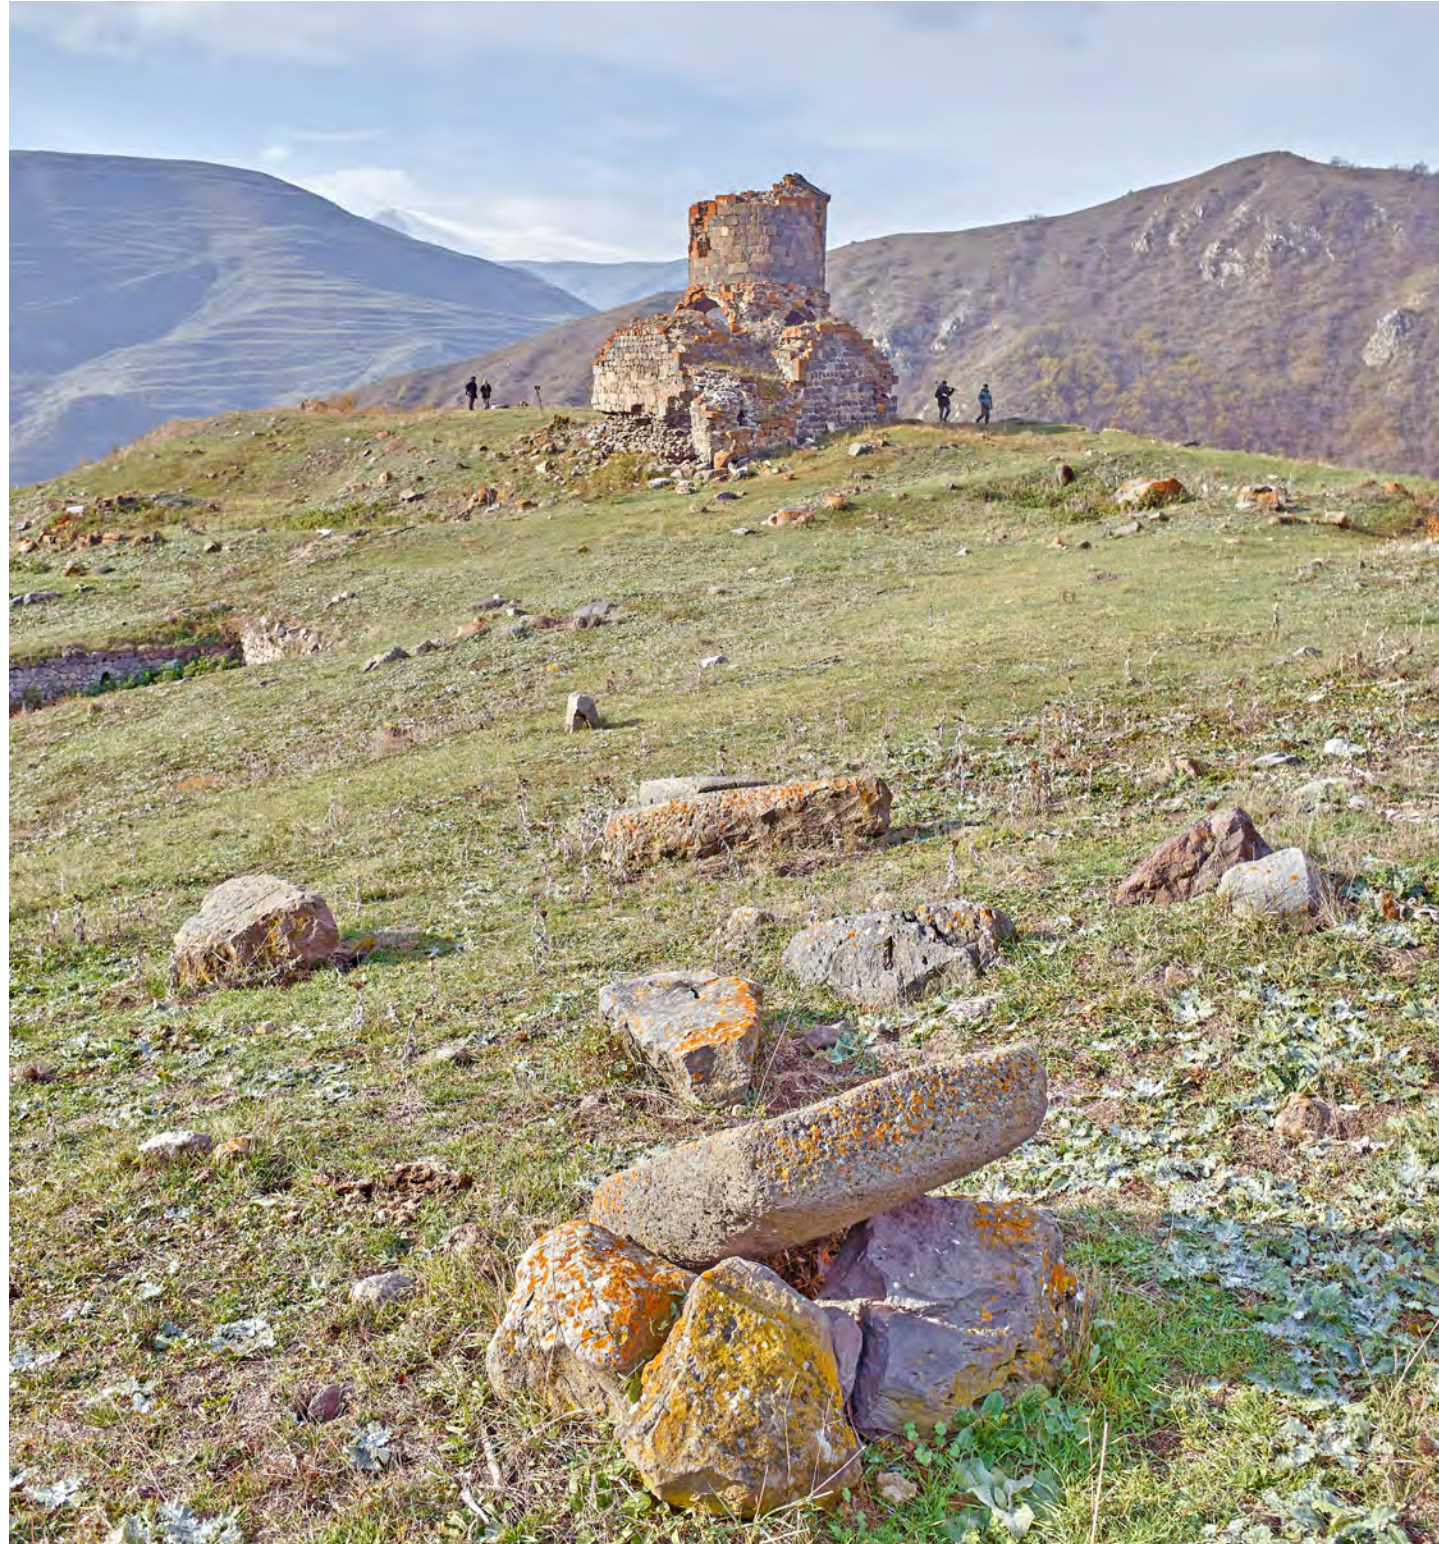
Fig. 3. The church seen from the northeastern cemetery (Iconem 2020)

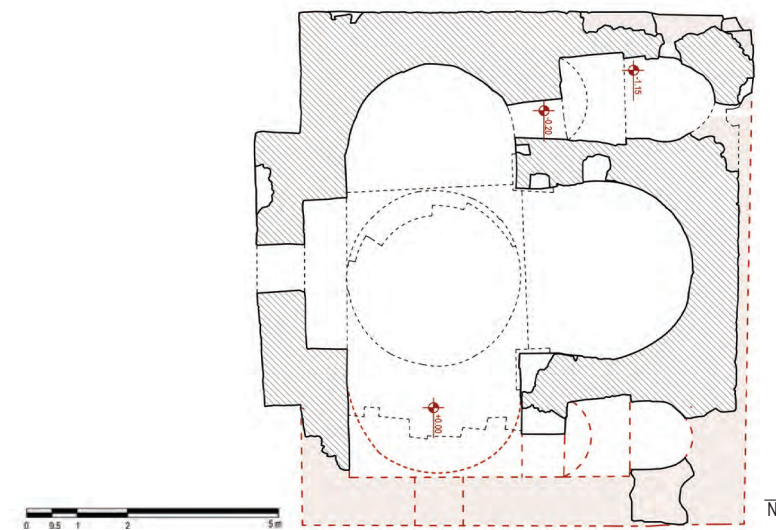
Fig. 6. Restitution hypothesis of the church's plan (Iconem 2021)

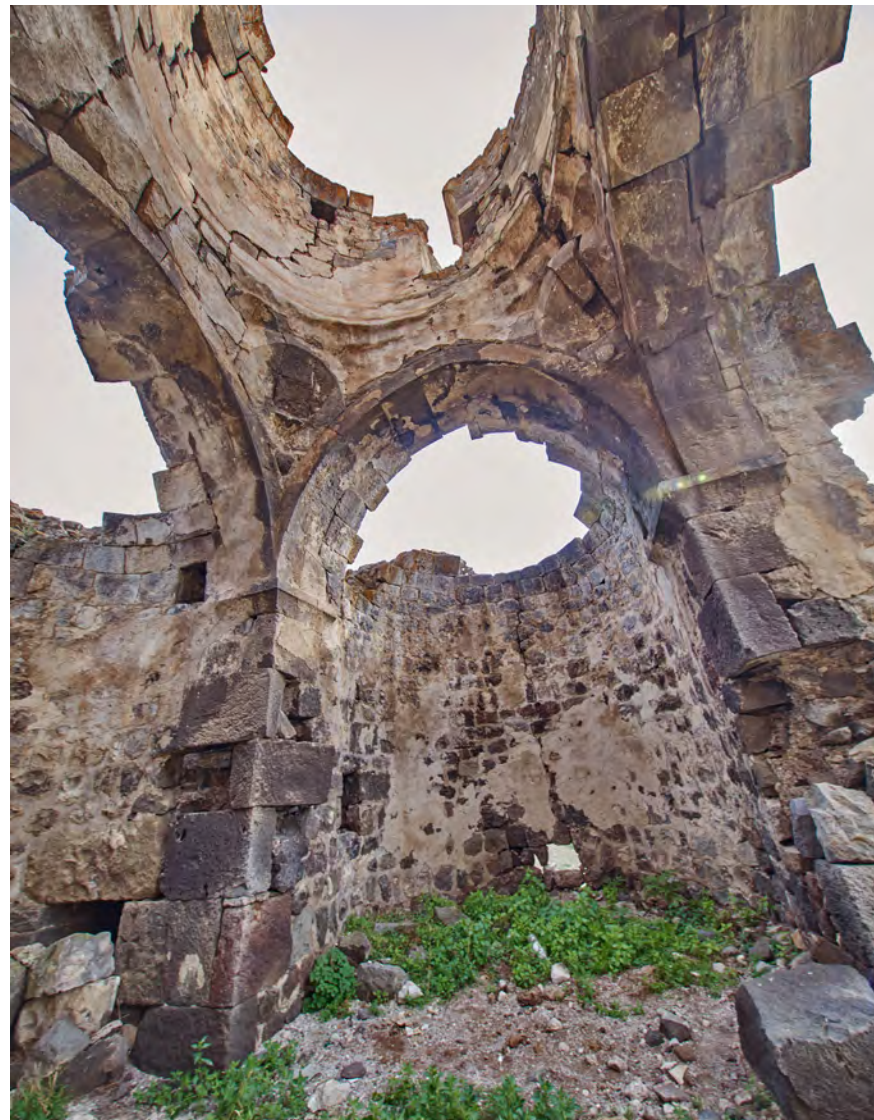
Fig. 7. The church's elevation from inside facing the eastern apse (Iconem 2020)

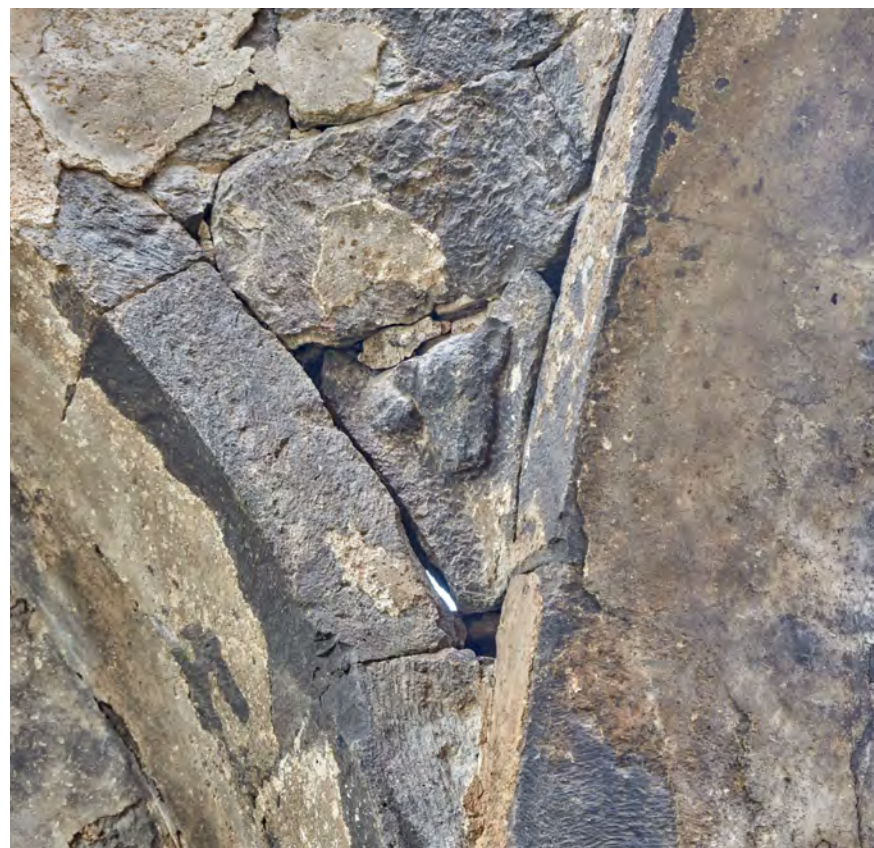
Fig. 8. An ox or a lion, north-western pendentive (Iconem 2020)

The church does not seem to have been decorated with frescoes or carved relief, except on the inside: the dome's pendentives are carved with the symbols of the four evangelists, each one represented by the head of the Animal (fig. 8)⁸. The interior of the church was covered with lime. An inscription was found by J.-M. Thierry on the western wall, which read: " In the name of God, I, Hekaz, gave my belongings [...]"⁹.

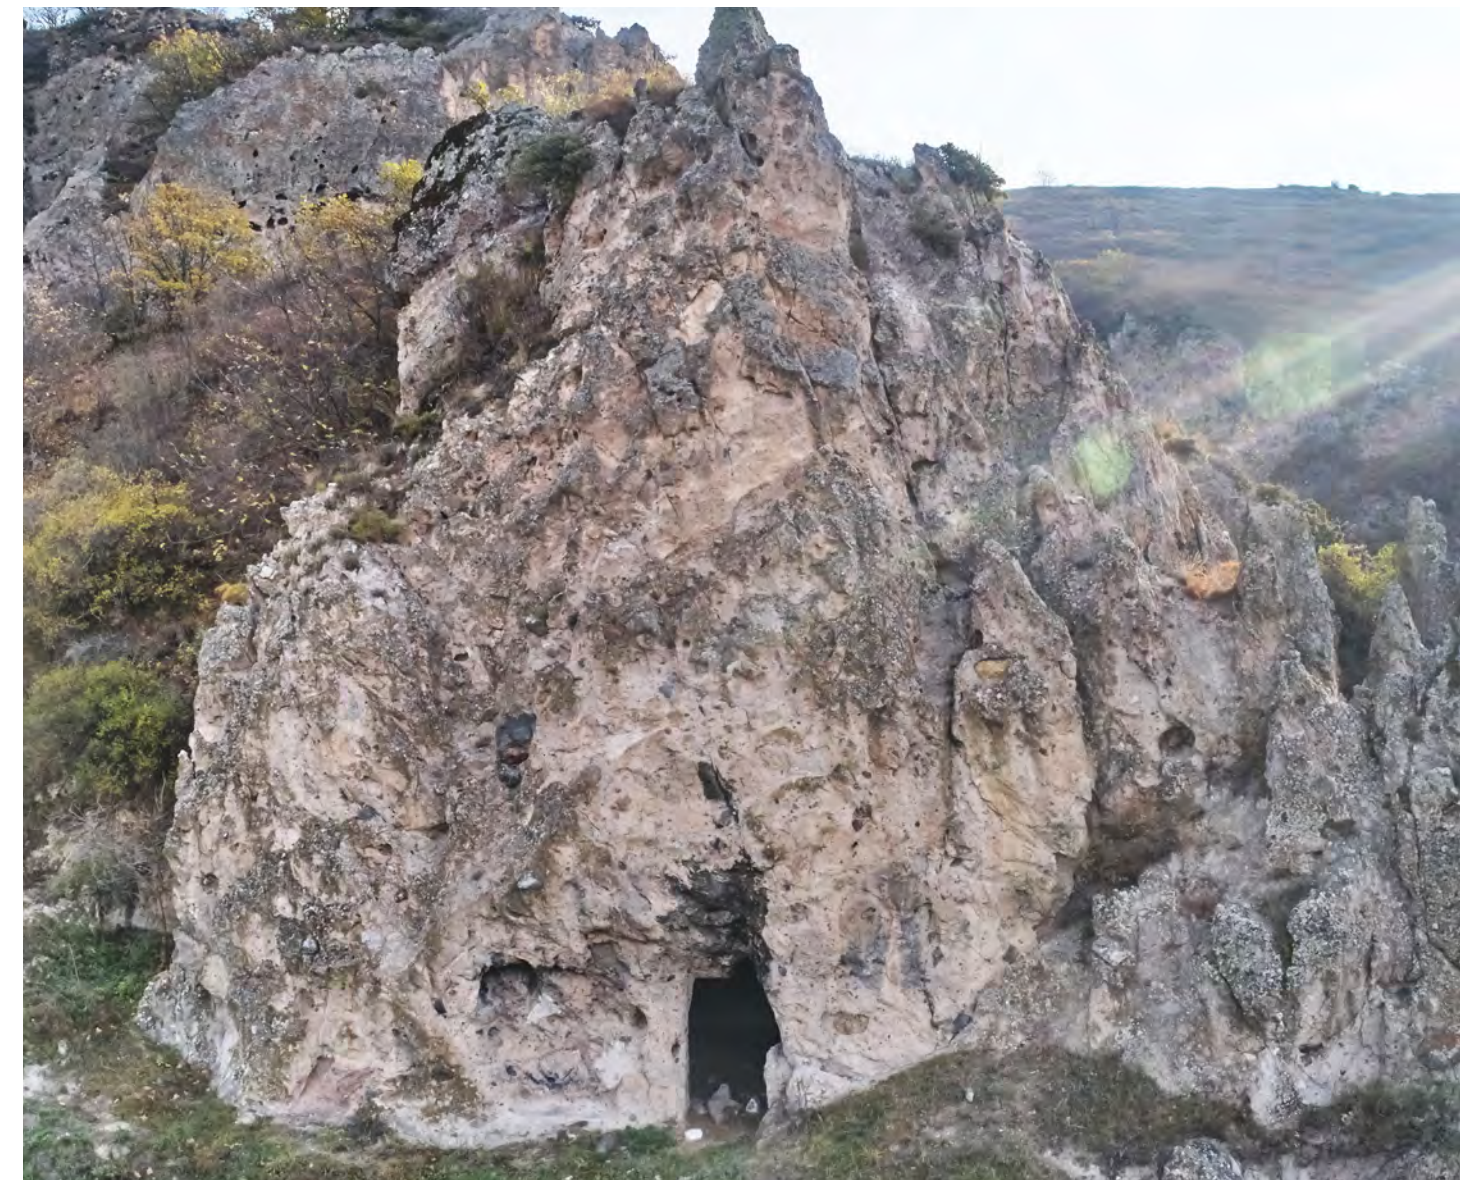
Fig. 9. The entrance of one of the rock-cut chambers (Iconem 2020)

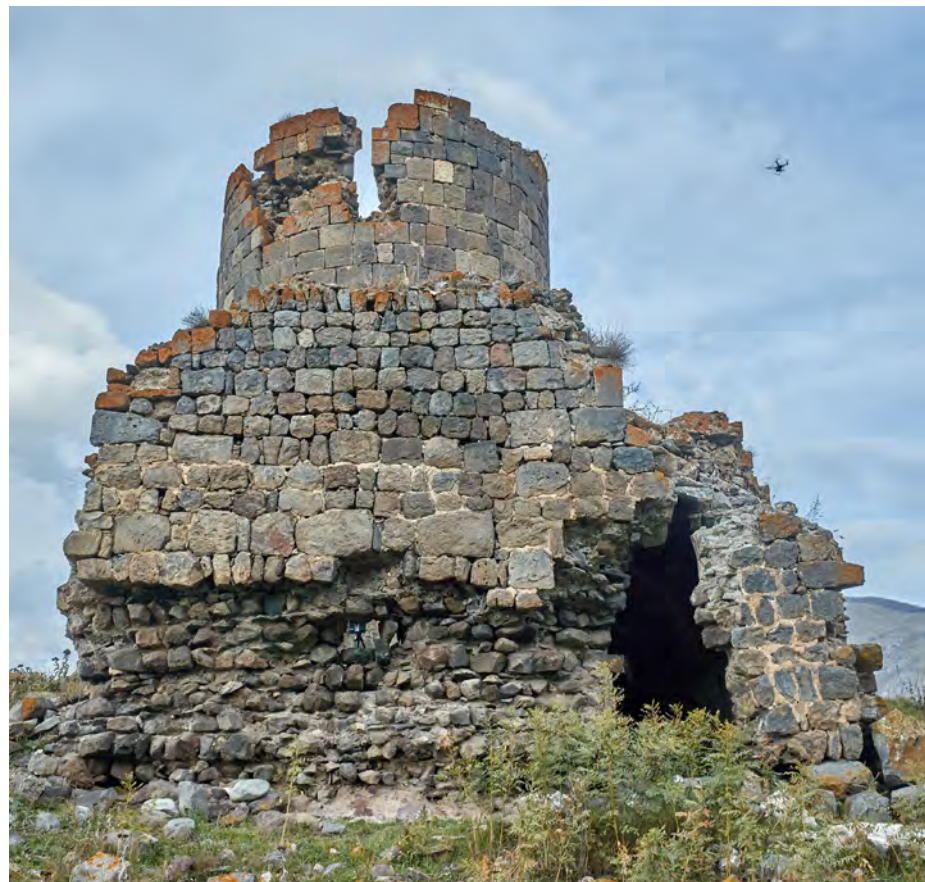
Fig. 11. Eastern façade (Iconem 2020)

The church is extremely damaged (fig. 10). The dome and the top of the two apses have collapsed. The dome's drum is cracked on several places, particularly on its southern side. The southern arm of the church and the southern sacristy are entirely destroyed. The exterior of the eastern wall is also damaged, especially on its lower rows where the cut stones have been extracted, probably for being reemployed (fig. 11)¹¹. The same deteriorations can be observed in the previous publications, although the southern small apse flanking the large eastern apse was better preserved.

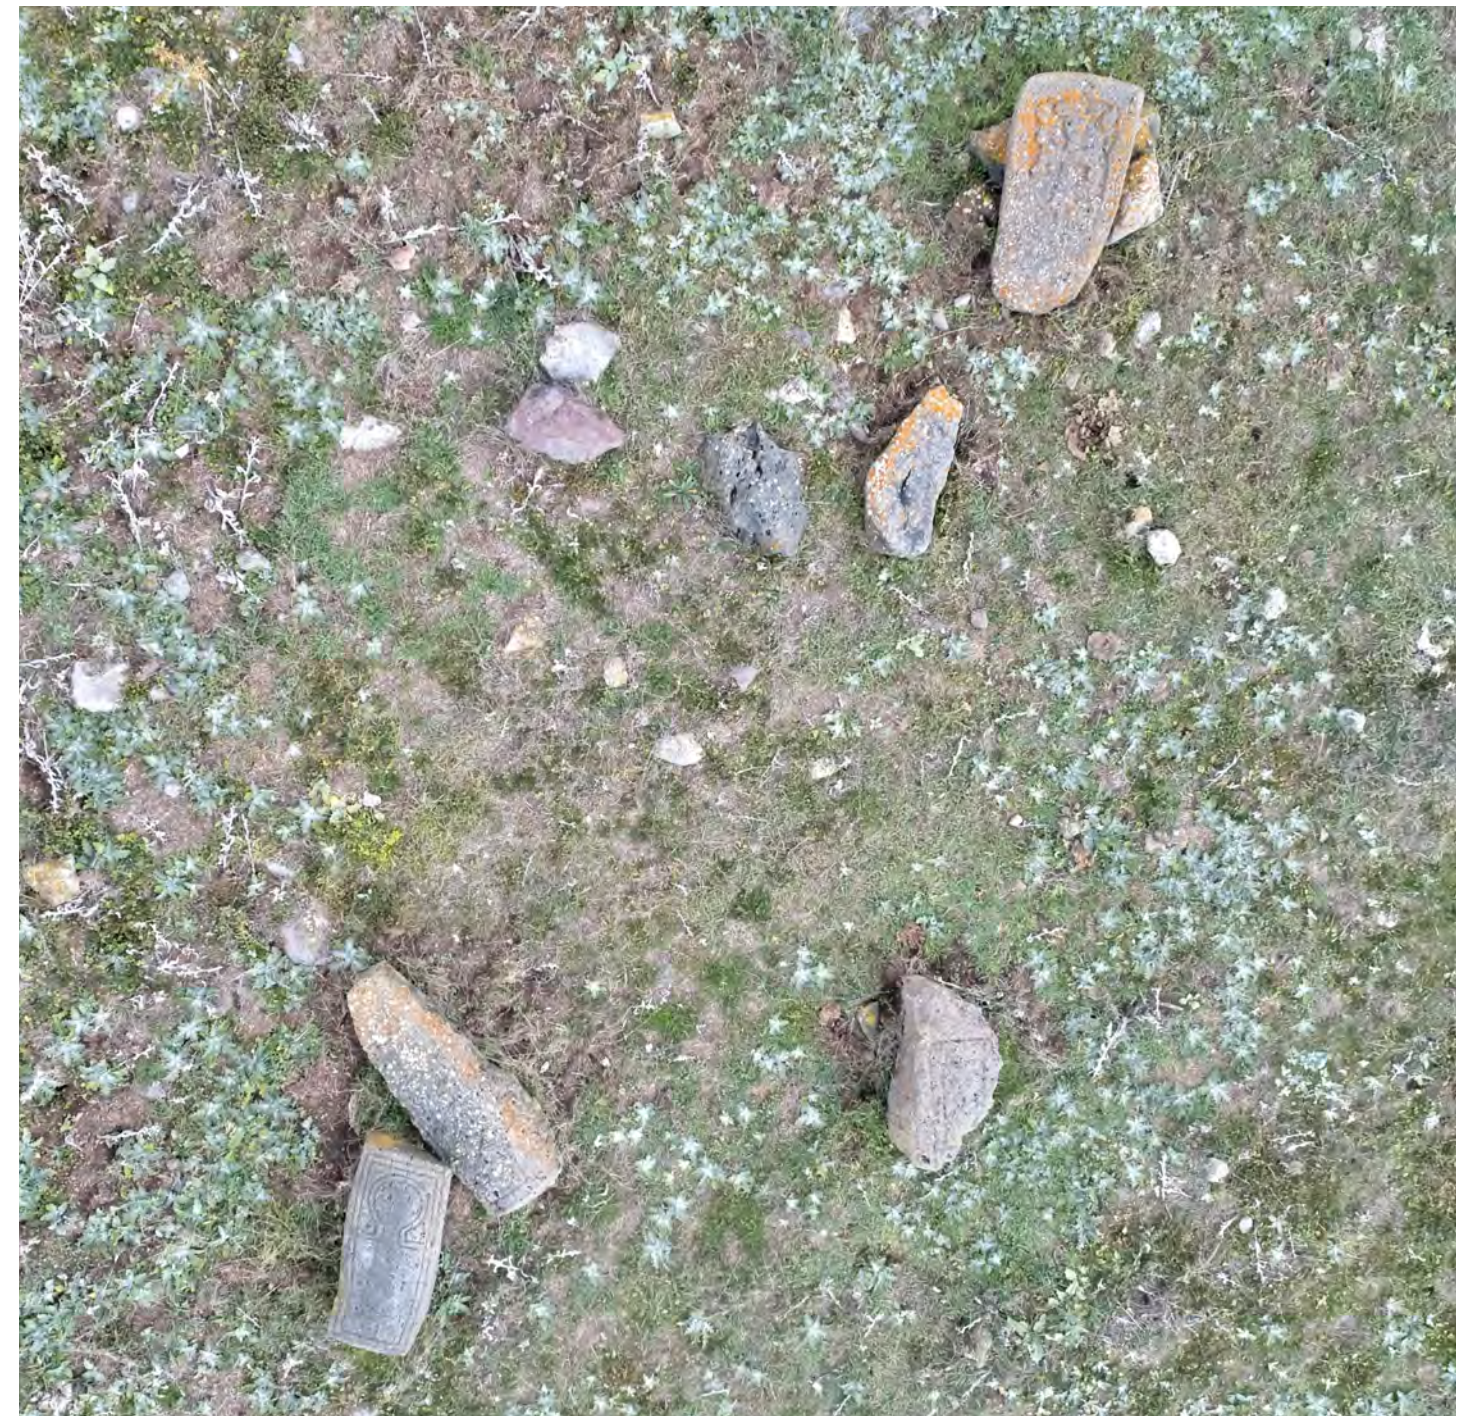
The *khachkars* and tombstones documented around the church and in the funerary areas are quite damaged due to the stone erosion, some of them even fragmented. It seems like the cemetery has been severely disturbed (fig. 12): as a rule, the tombstones are horizontally inserted in the ground, showing only their upper surface, and the *khachkars* stand vertically, inserted in a base on the eastern end of the tombstone. However, in Varazgom they are scattered and laid above ground, which has probably aggravated the phenomenon of erosion.

Fig. 12 View overlooking a part of the cemetery (Iconem 2020)

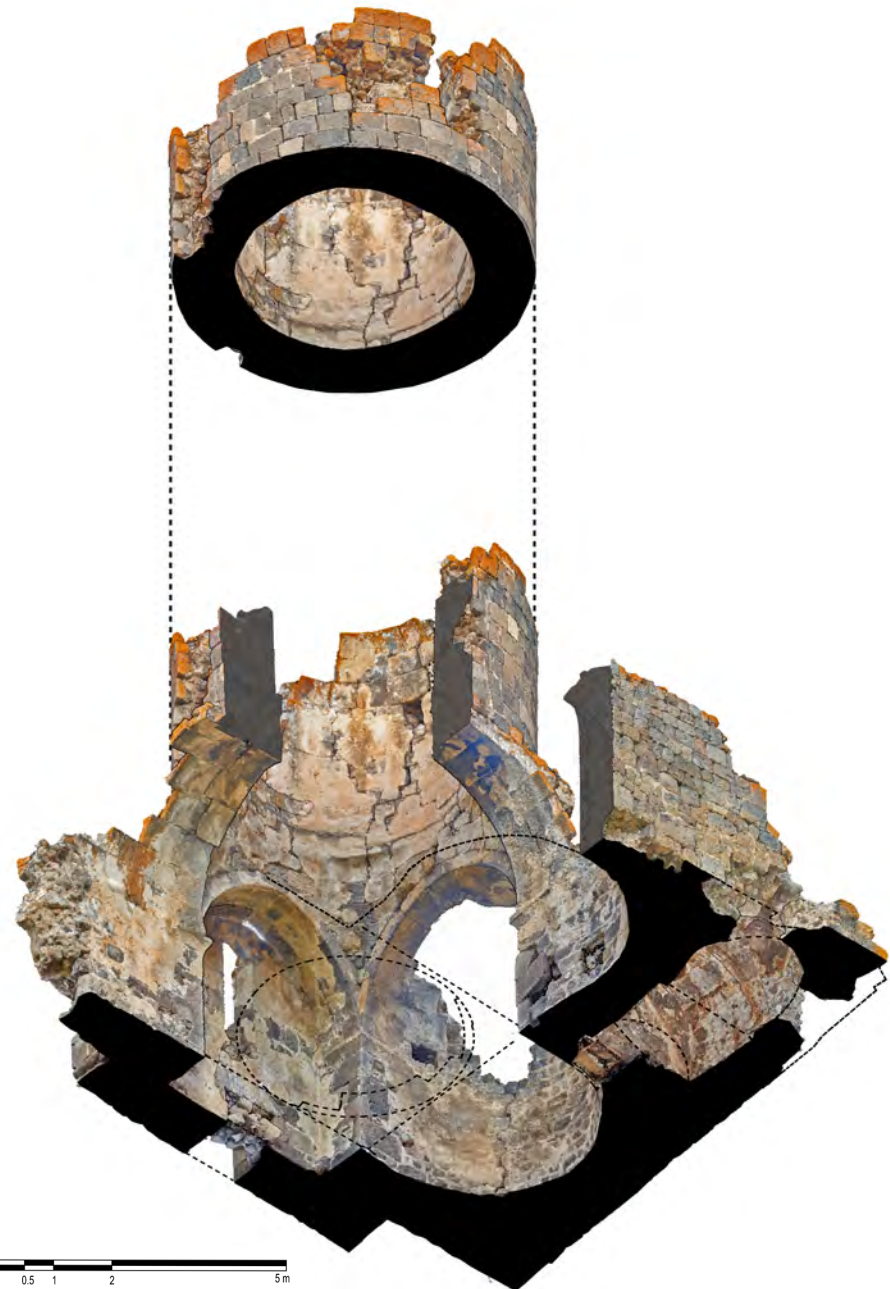
Fig. 13. Axonometry « Choisy » type extracted from the textured 3D scan (Iconem 2021)

Emergency recommendations: There is a need to prop the four arches carrying the base of the cylinder with a wooden framing. The installation of a crackmeter will allow to monitor the evolution of the structure's deformation.

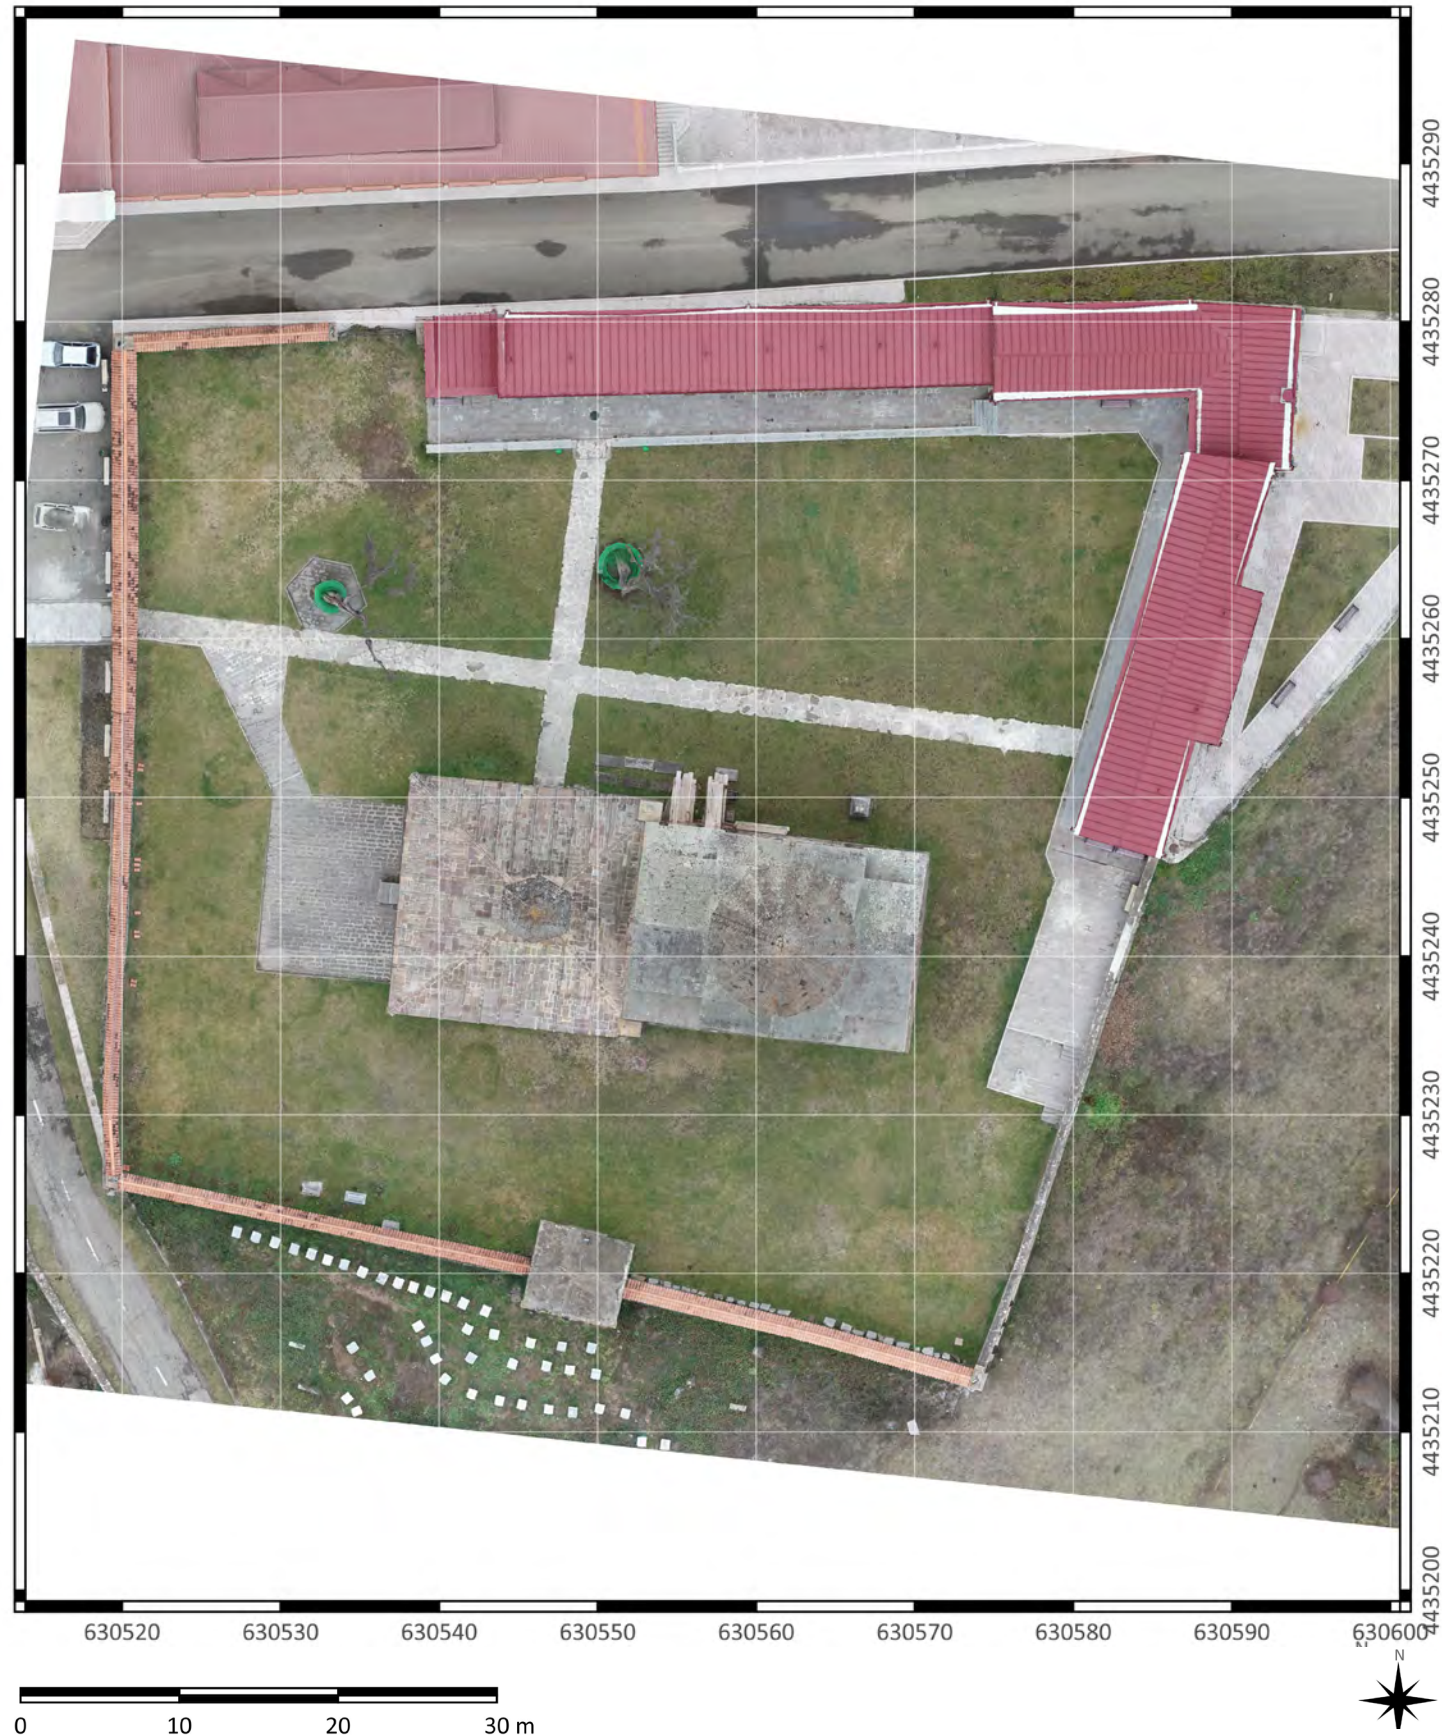
Fig. 1. Georeferenced ortho-image of Gandzasar extracted from the textured 3D scan (Iconem 2021)

The monastic complex consists of several buildings, that is the church, its *jamatun* (narthex) and the monastic buildings, all within an enclosure (fig. 1).

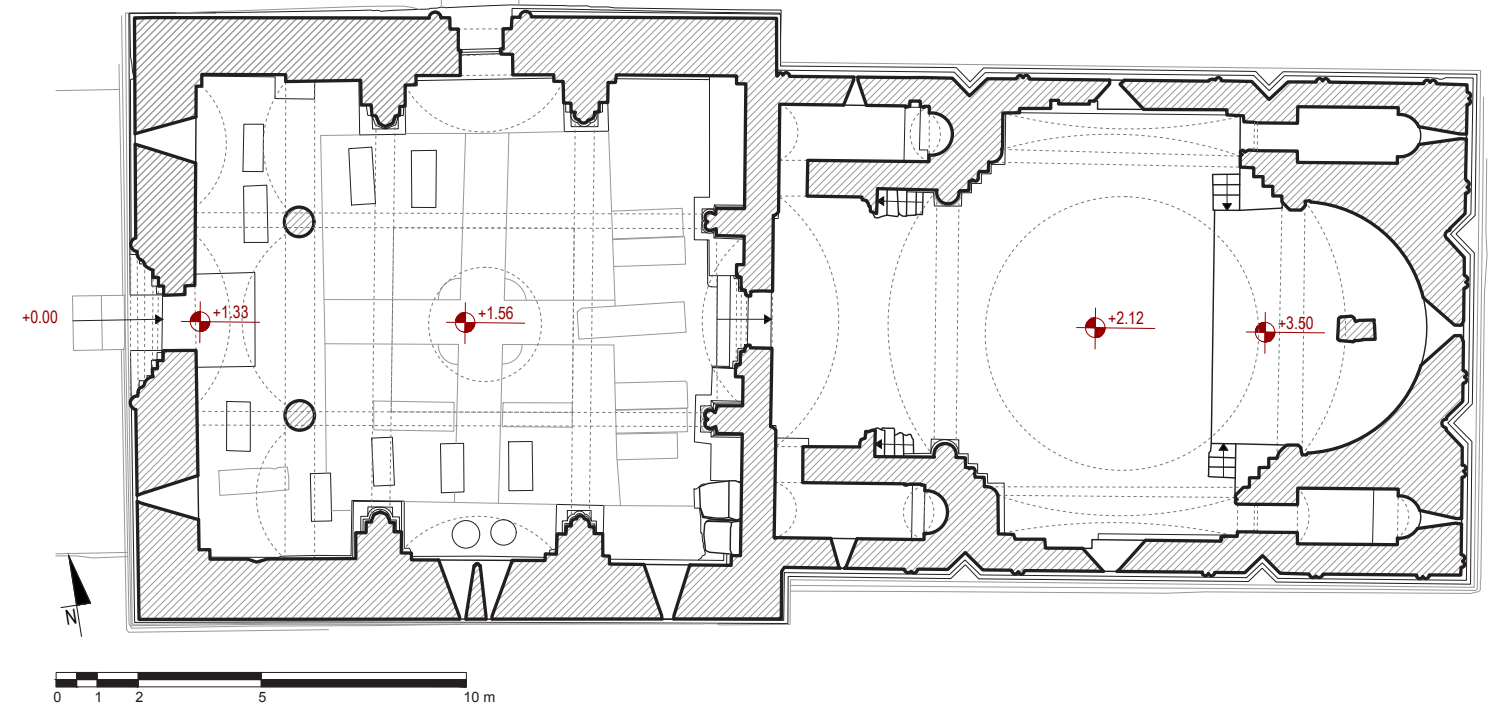
Fig. 2. Plan of the church and its *jamatun* (Iconem 2021)

The main church of the monastery, dedicated to Saint-John-the-Baptist, has a rectangular-cruciform plan elevated on a five-degree stylobate and four two-storey corner chambers (fig. 2). This architectural type was widely used in the Armenian monastic architecture from the 10th to the 14th century⁵. It is topped with a dome on a polygonal drum. Attached to the western entrance of the church, the *jamatun* has a large and rectangular plan with intercrossed rib arches resting on free-standing piers at the west (fig. 2 and 3)⁶, which is comparable to contemporary *jamatuns*⁷. Its central dome has a skylight carved with stalactites, also referred to as *muqarnas* (fig. 4)⁸.

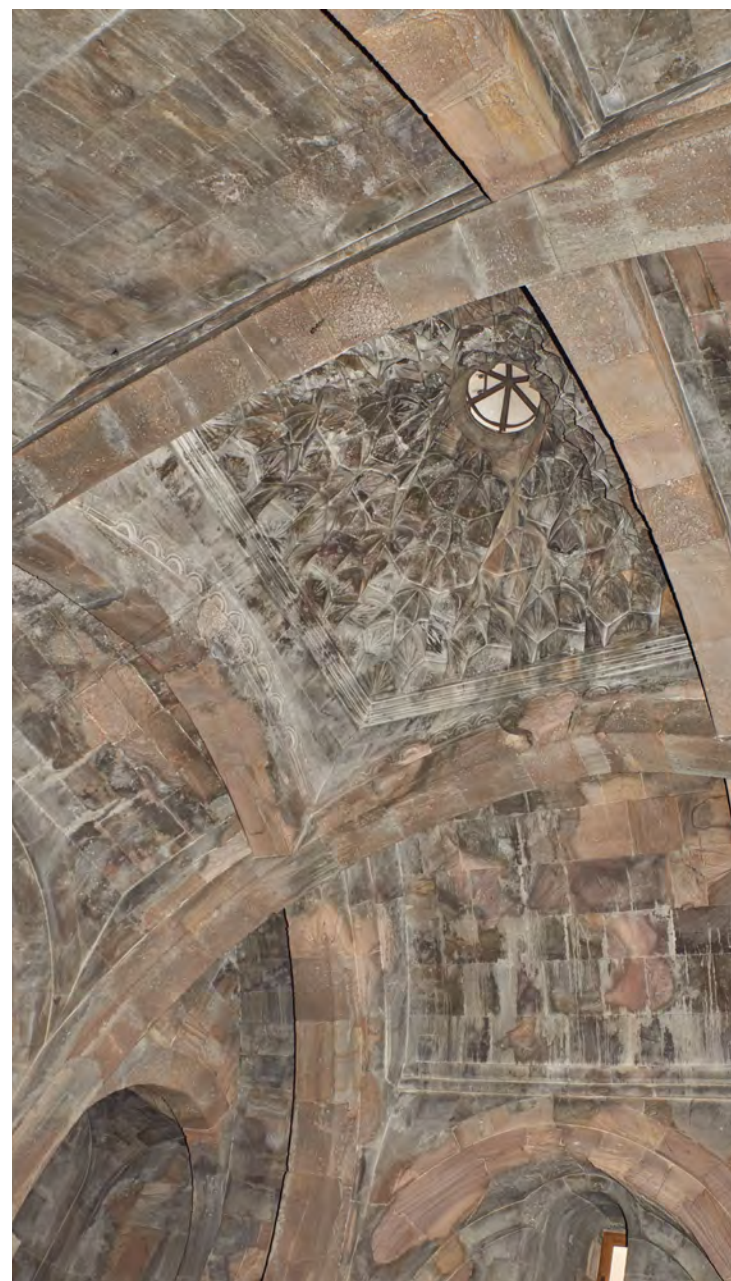
Fig. 4. The *jamatun*'s dome (Iconem 2020)

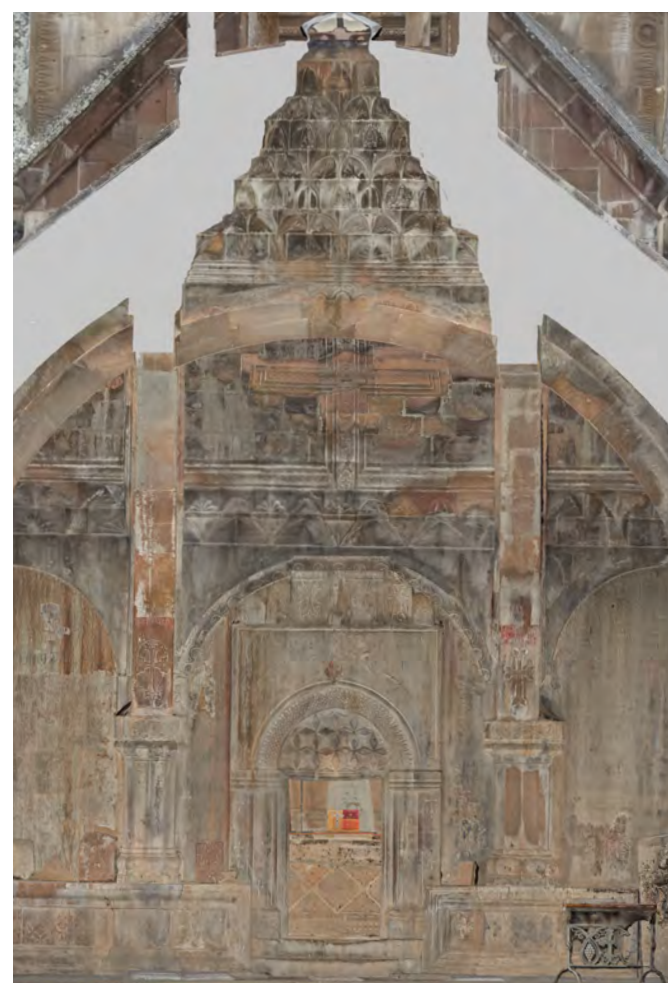
Fig. 5. The church's western *tympa-num* extracted from the ortho-image of the textured 3D scan (Iconem 2021)

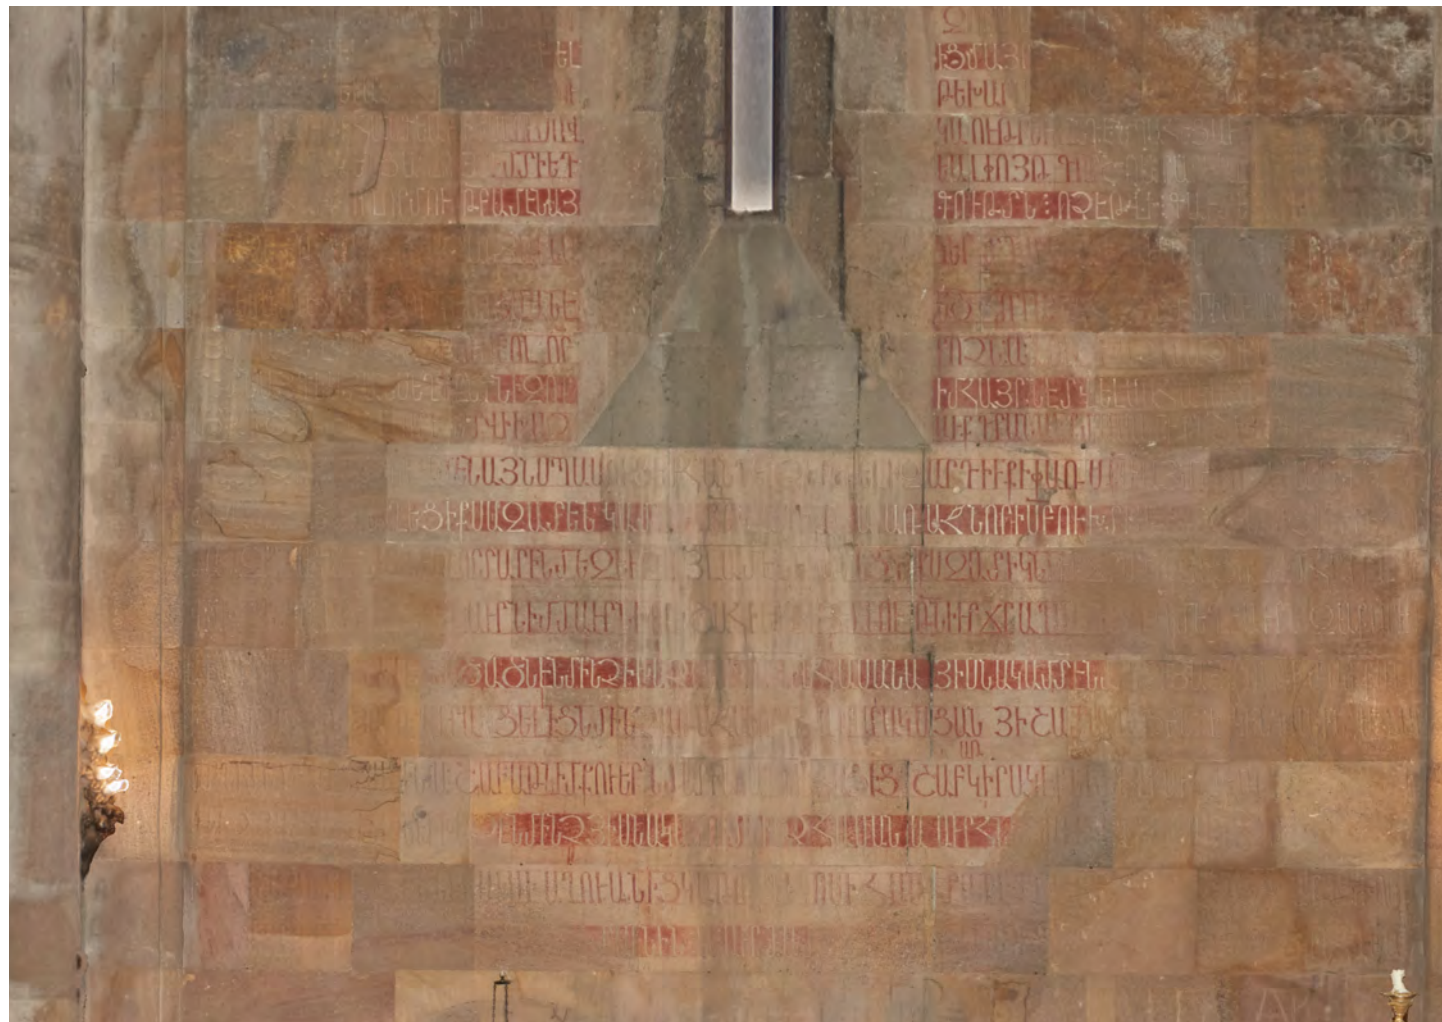
Fig. 8. The dedicatory inscription on the northern wall of the church. Ortho-image extracted from the textured 3D scan (Iconem 2021)

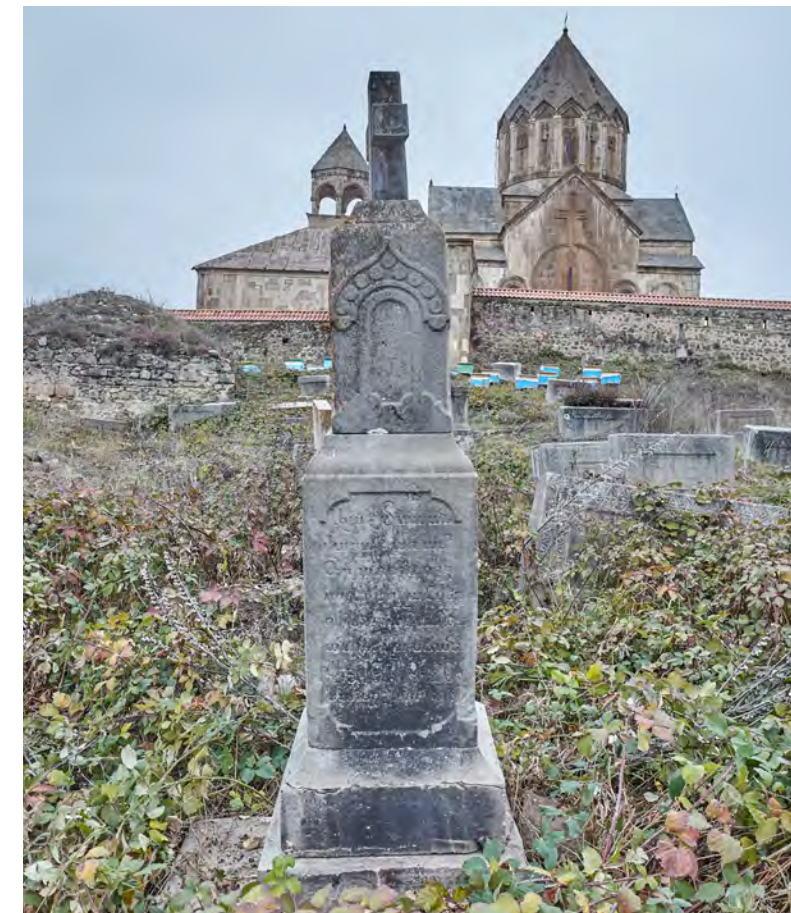
The monastery has been restored on several occasions from the 16th to the 20th centuries¹¹. Partially destroyed during the first war in Nagorno-Karabakh (1991-1993), it was restored in the end of the 20th century until 2002¹². If the buildings are in good condition, the *khachkars* and tombstones in the medieval cemetery are quite damaged.

Fig. 10. The cemetery on the south of the monastery (Iconem 2020)

A cemetery is spread on the West and North of the monastic complex, outside the enclosure, with *khachkars* (cross-stones) dating mainly from the 9th-13th centuries (some dated precisely with inscriptions) and modern gravestones (fig. 10). A few *khachkars* are placed inside the *jamatun* and in front of the church, along the southern wall.

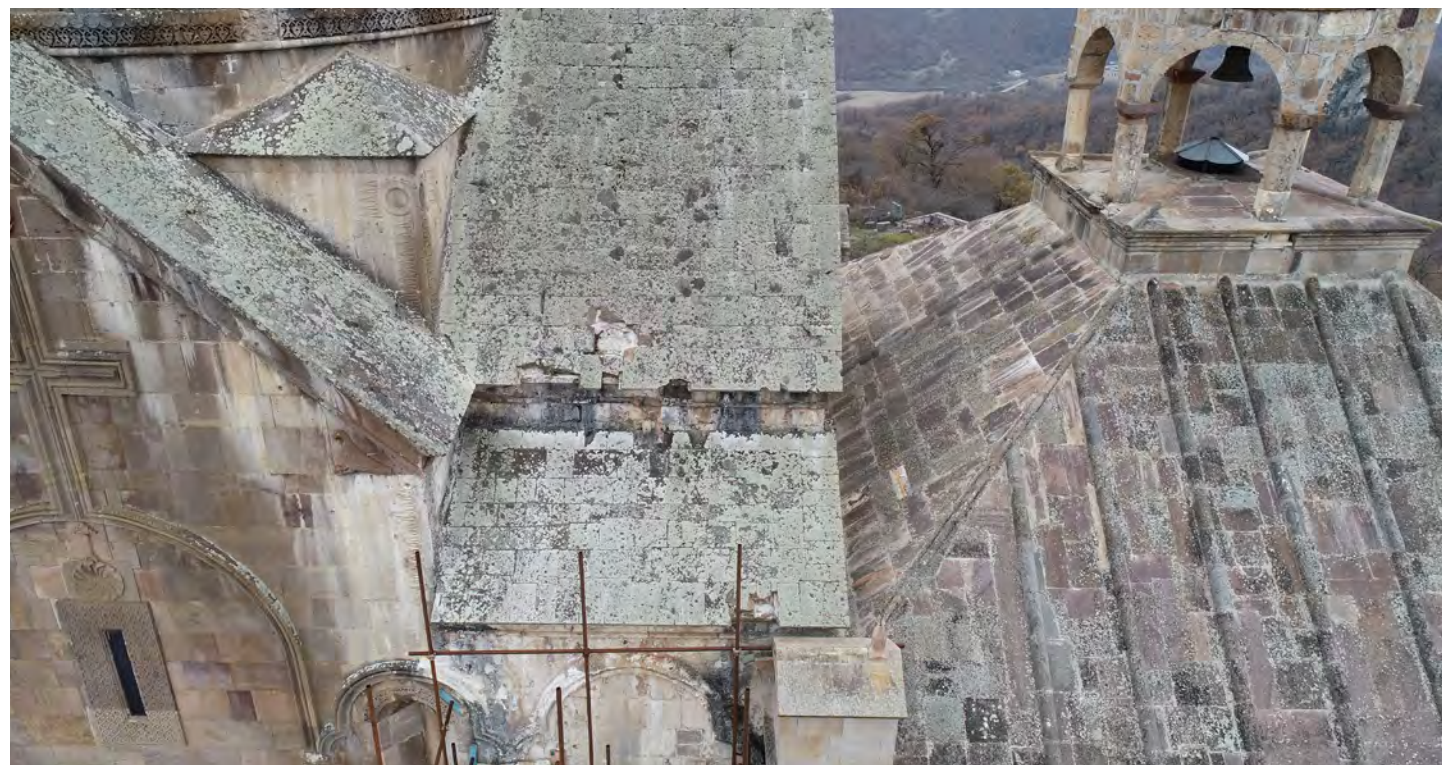
The roofing, made of layered stone slabs, does not present any weak points and appears to be in good general condition. However, the north ramp covering the western arm of the nave shows damage, particularly on the side.

Traces of moisture infiltration appear on the right of the sunken gutter, located at the junction of the western gable of the church and of the *jamatun*.

Fig. 11. Deteriorations on the northern roof's pitch on the church's western arm (Iconem 2020)

Emergency requirements: The joints of the roof slabs must be pointed again with hybrid mortar: it is a standard routine maintenance. However, it is necessary to restore a certain number of broken slabs on the north pitch of the church's western arm. The gutter between the west gable of the nave and the *jamatun* should be maintained well.
