HERITAGE
WATCH.AI

ARMENIAN CULTURAL HERITAGE SITES
CONDITIONAL REPORT

2 0 2 0

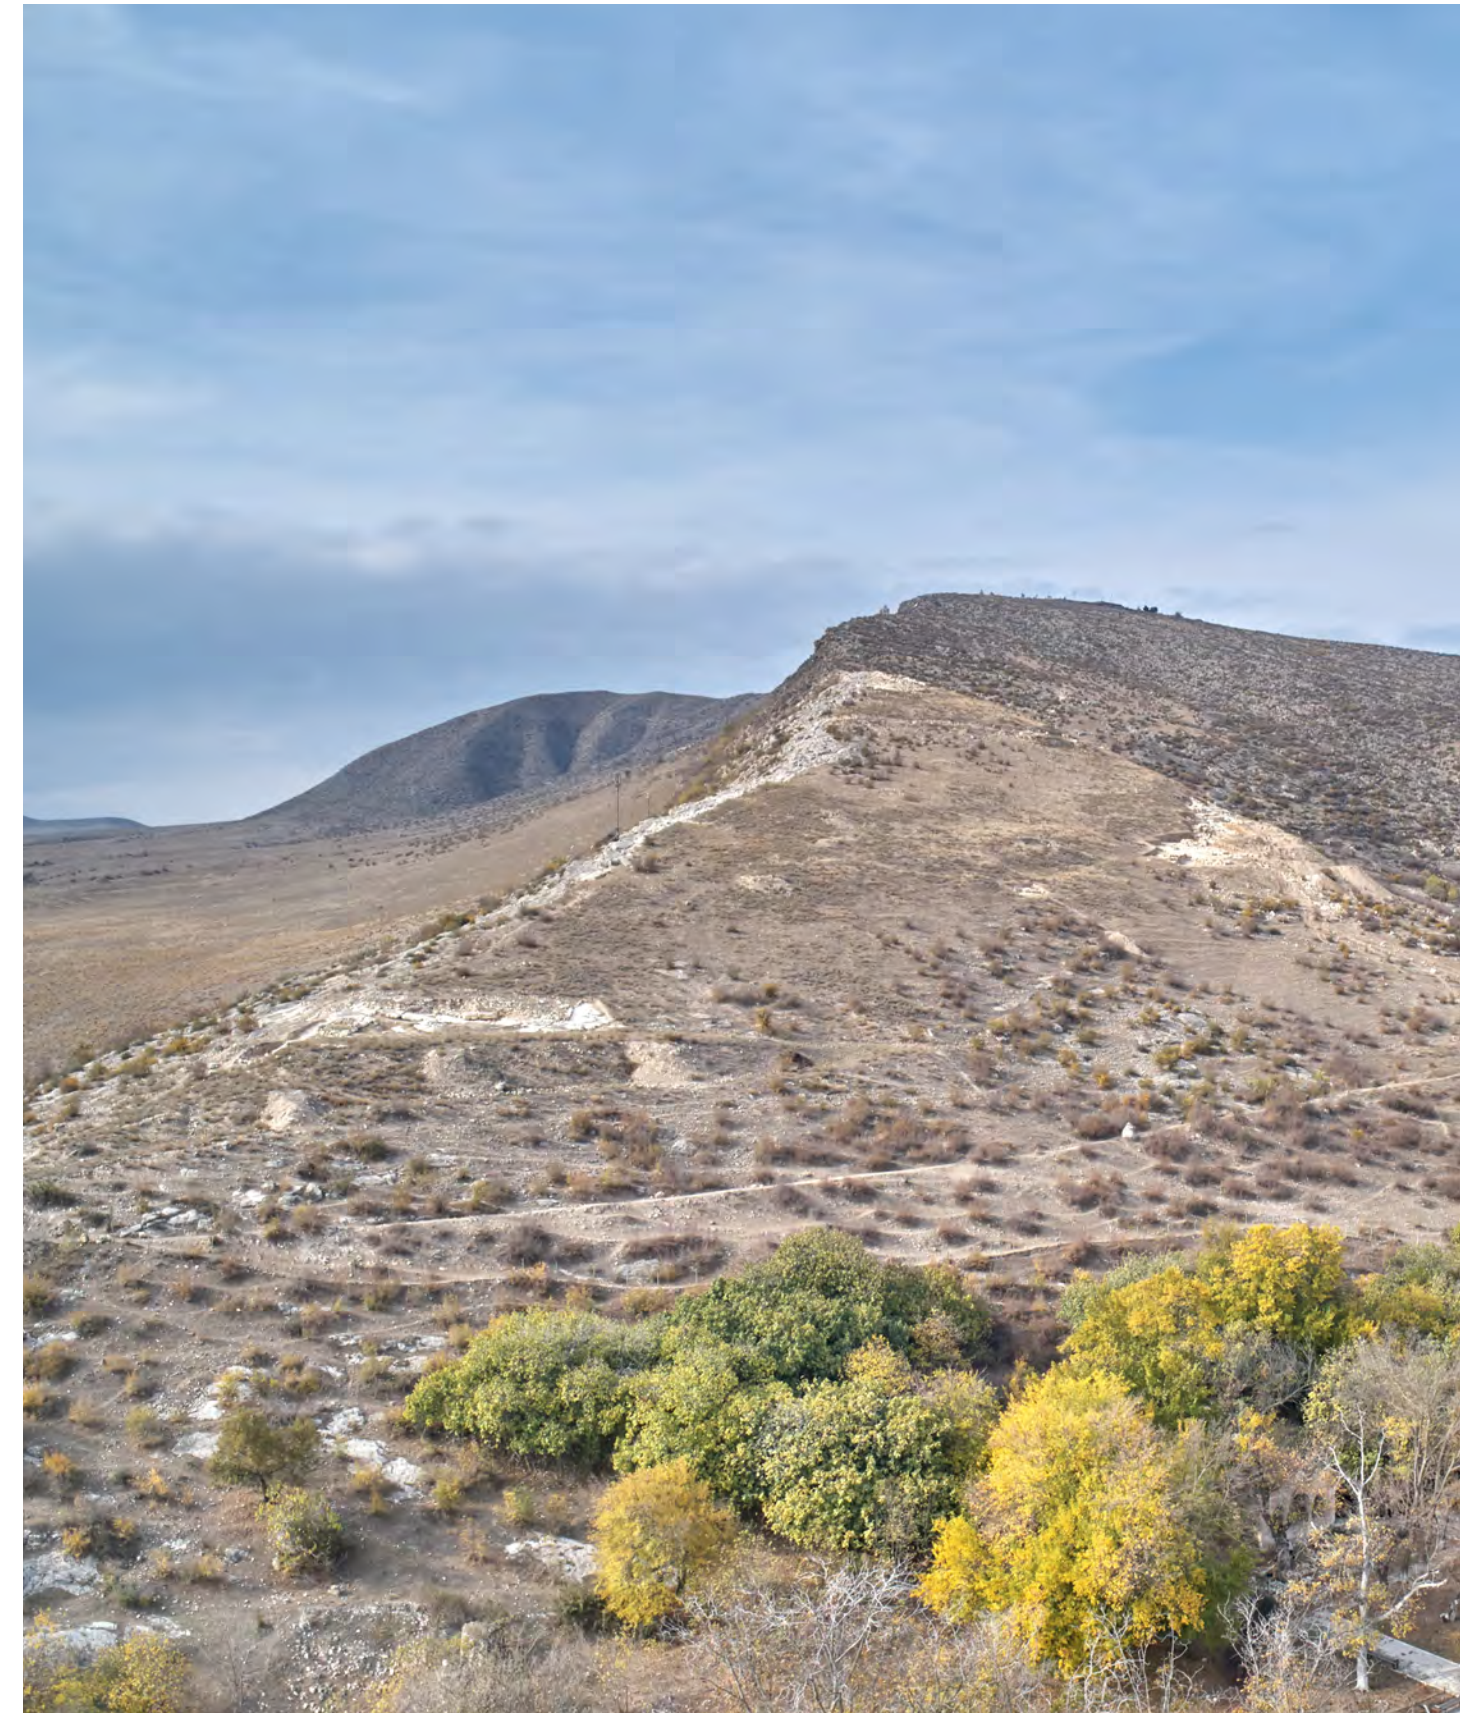
Fig. 2. General view of the fortified district from the east (Iconem 2020)

The fortification of Tigran the Great consists in a succession of round and rectangular towers connected by zigzag-shaped walls on a surface of 6 ha (fig. 2). It has a triangular plan, which aligns with the natural triangle-shaped limestone outcropping of the mountain's slope, not far from the water springs. The walls' stone blocks were assembled with the technique of dovetail junctions - also called swallowtails, a building technique widely used in Antic east-Mediterranean cities (fig. 3). The lowest row's blocks were directly inserted into carved out mortises into the ground, which were interpreted by the 20th century scholars as scales leading to the top of the mount where stands the Vankasar church⁵. A mortar made of lime and limestone was also used to strengthen the junction of the blocks and to avoid the infiltration of rainwater into the rock-cut bases.

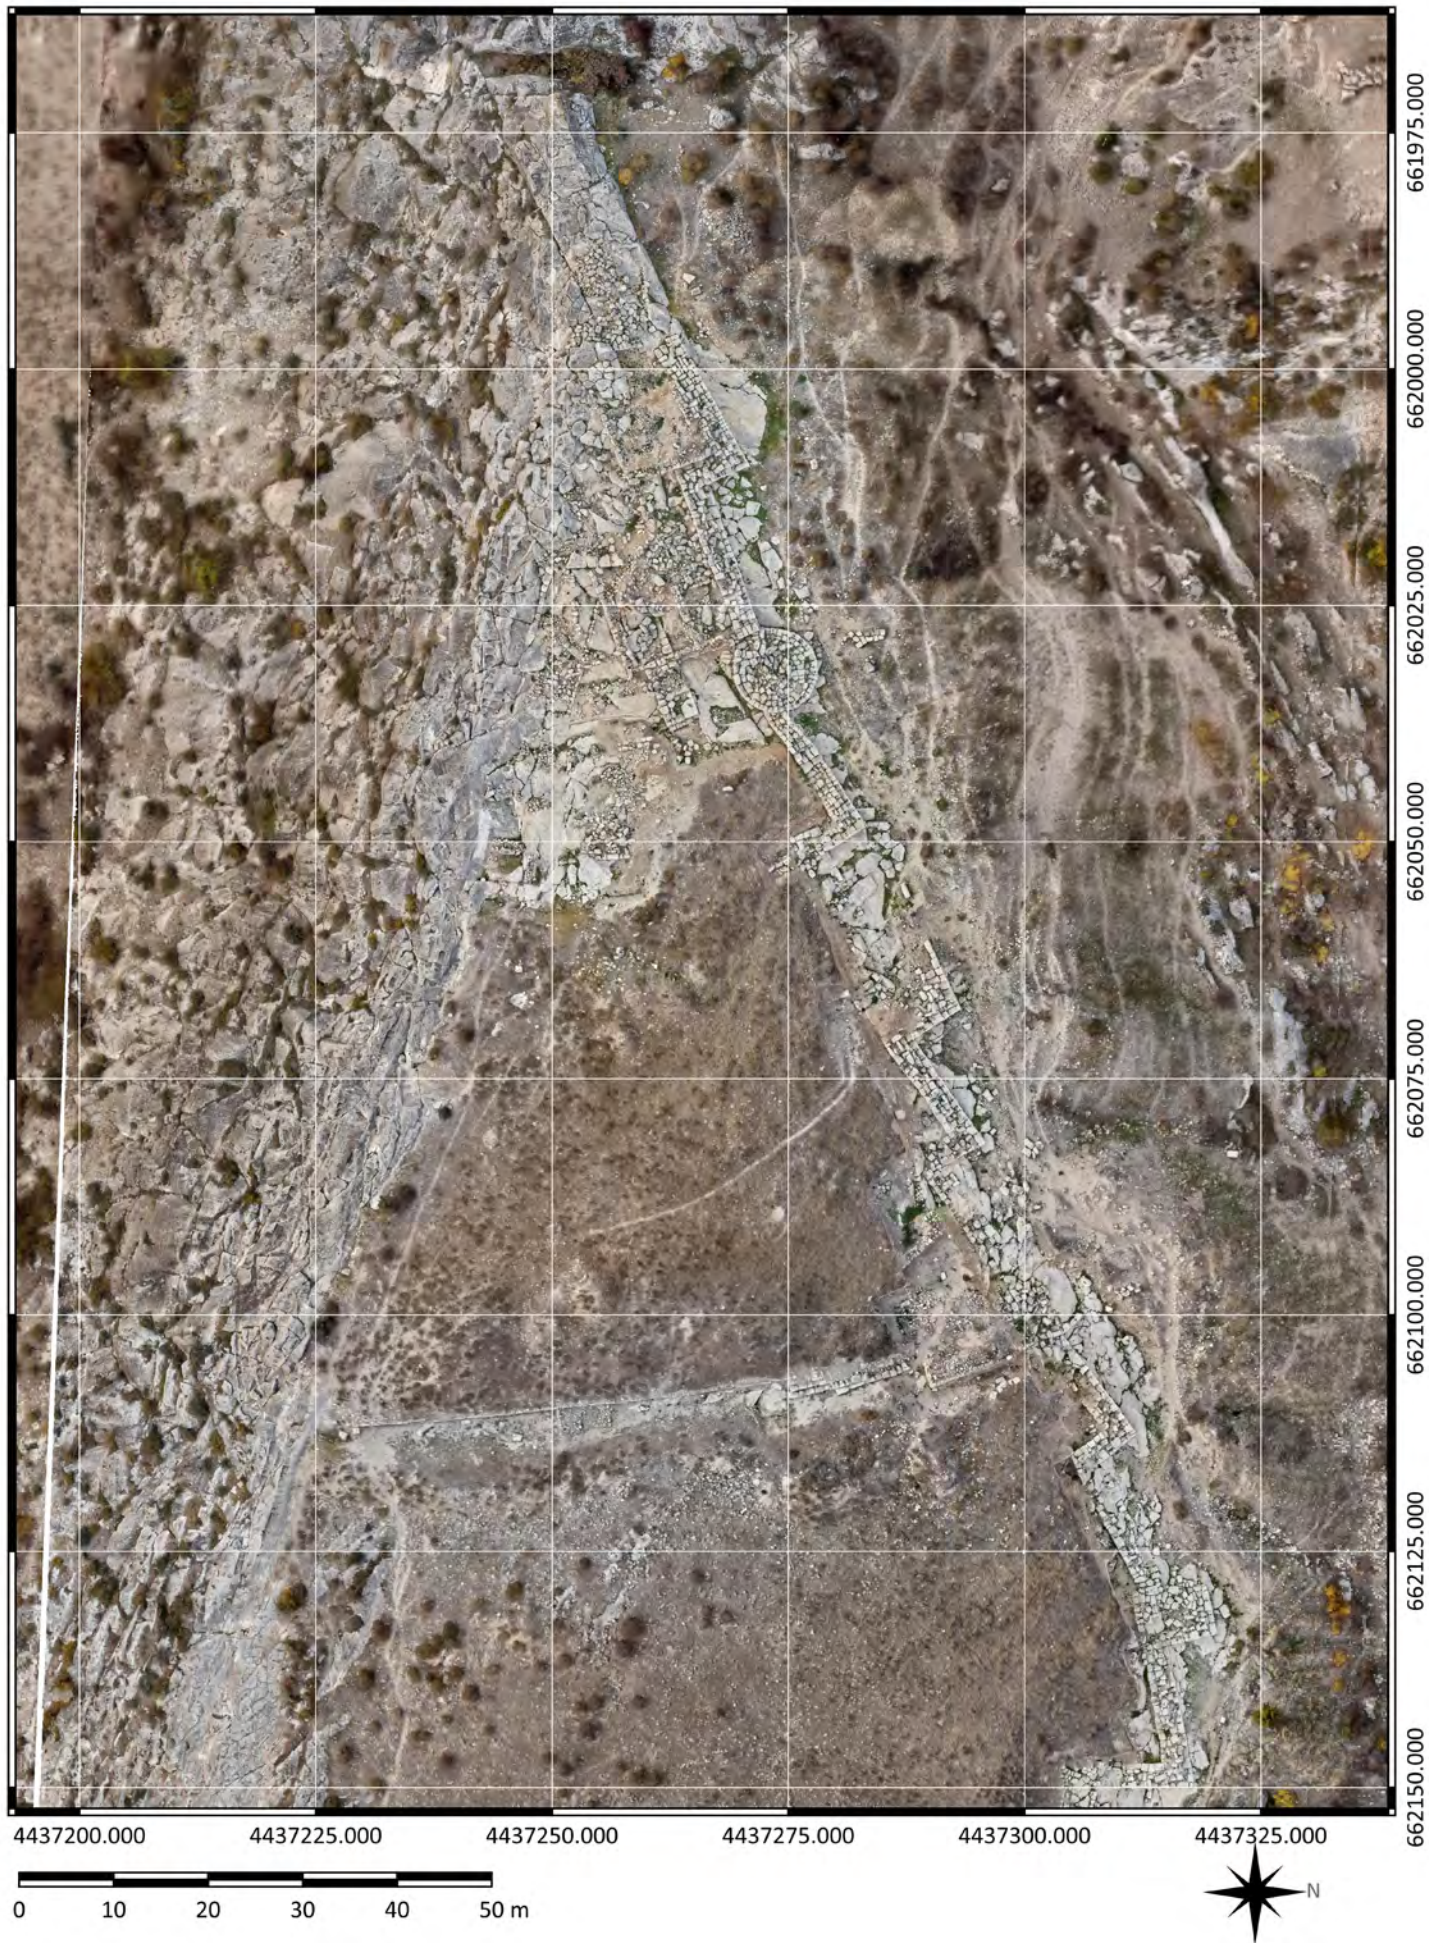
Fig. 5. Georeferenced ortho-image of the citadel of Tigranakert's fortified district extracted from the textured 3D scan (Iconem 2020)

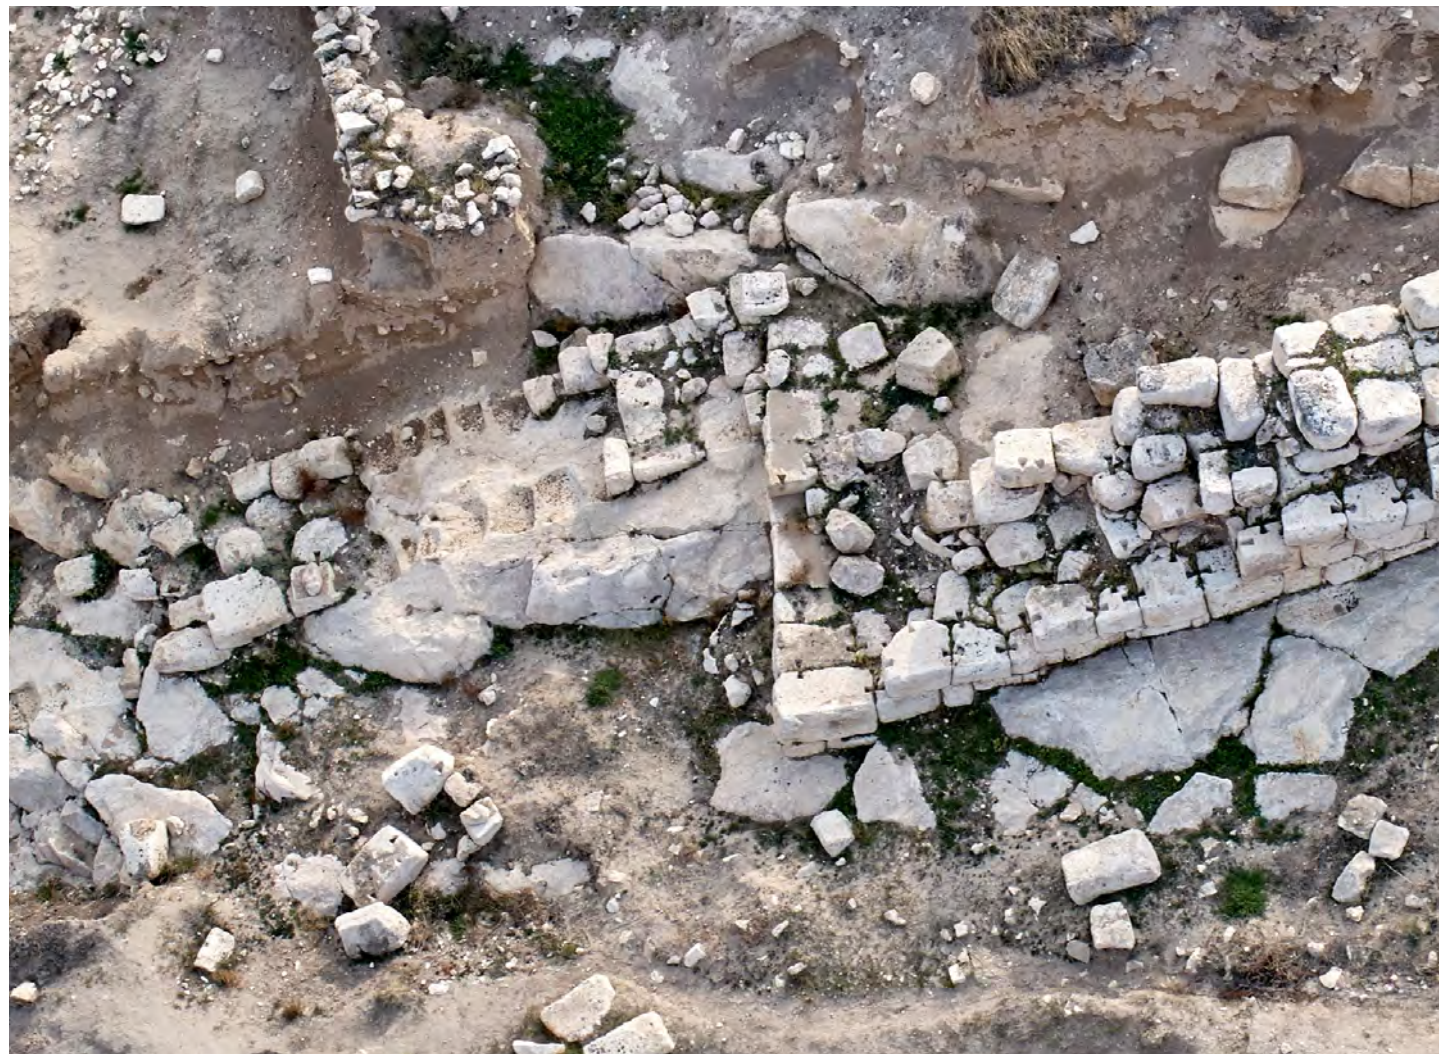
Fig. 7. Details of one of the towers of the fortification's northern wall (Iconem 2020)

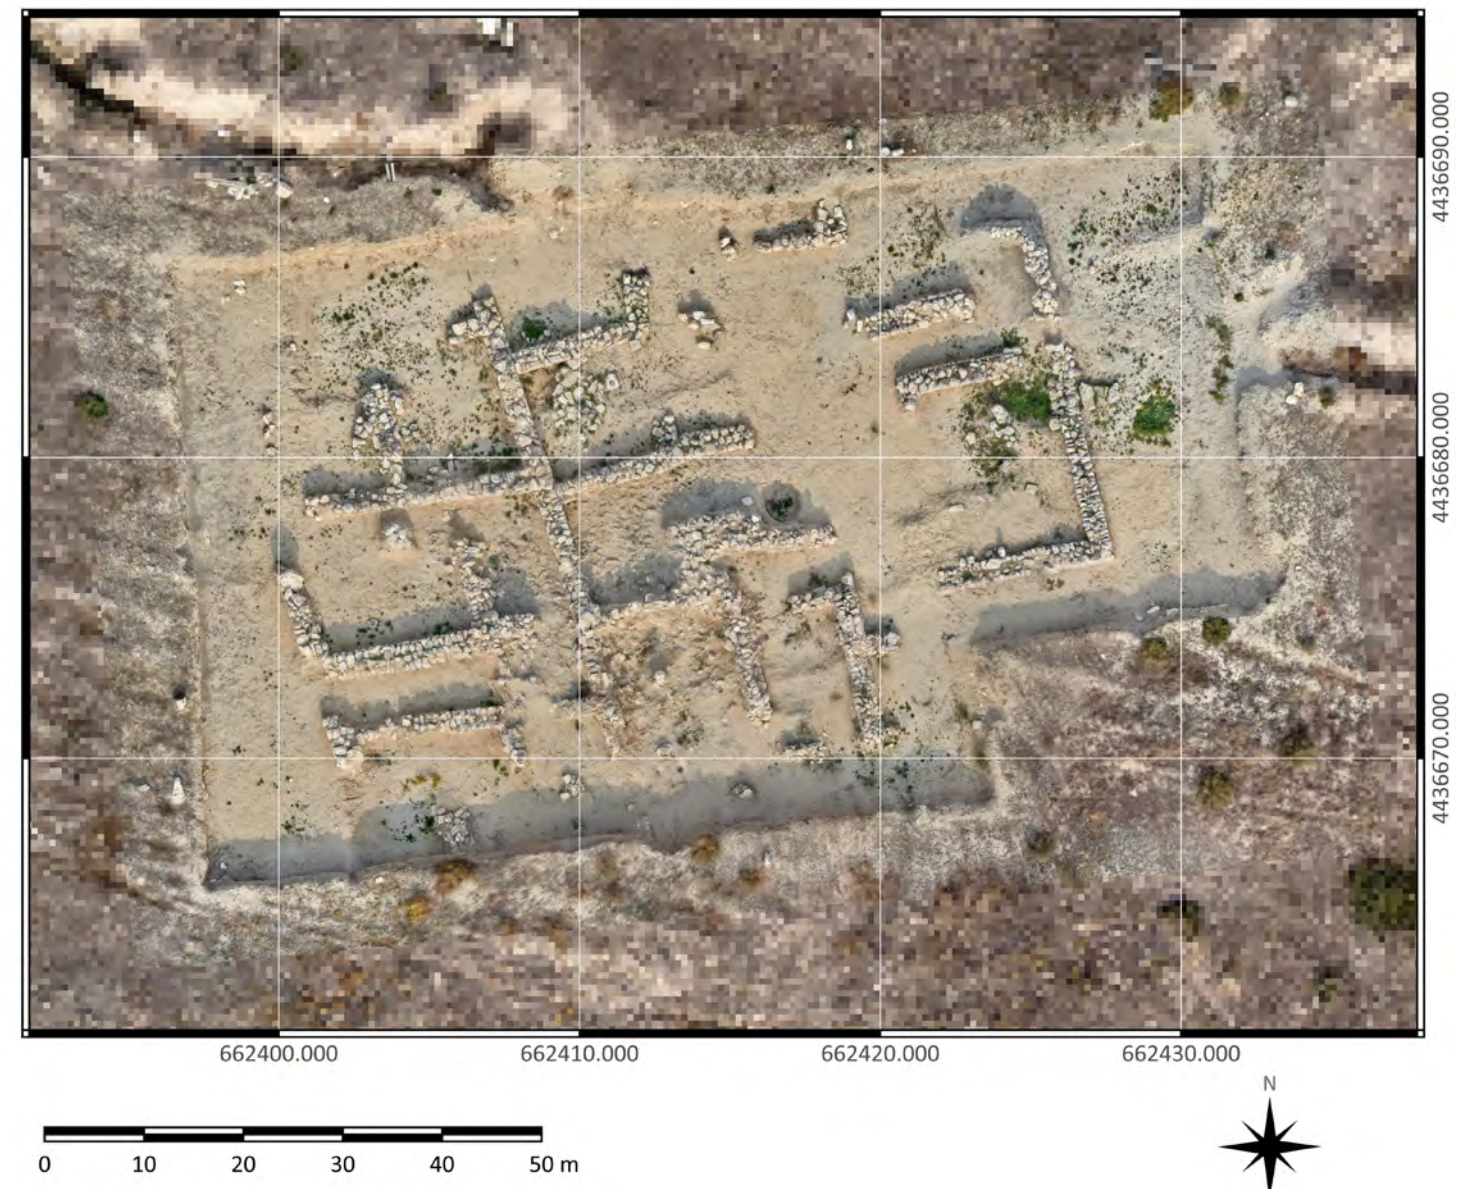
Fig. 8. Georeferenced ortho-image of the first late Hellenistic district (Iconem 2021)

The late Hellenistic urban districts, such as the first district presented in this technical sheet, are those left in place after the excavation campaigns. Since they are in the open air, they are exposed to the elements and to vandalism. They consist of the foundations of the walls with a masonry made of stones and mortar.

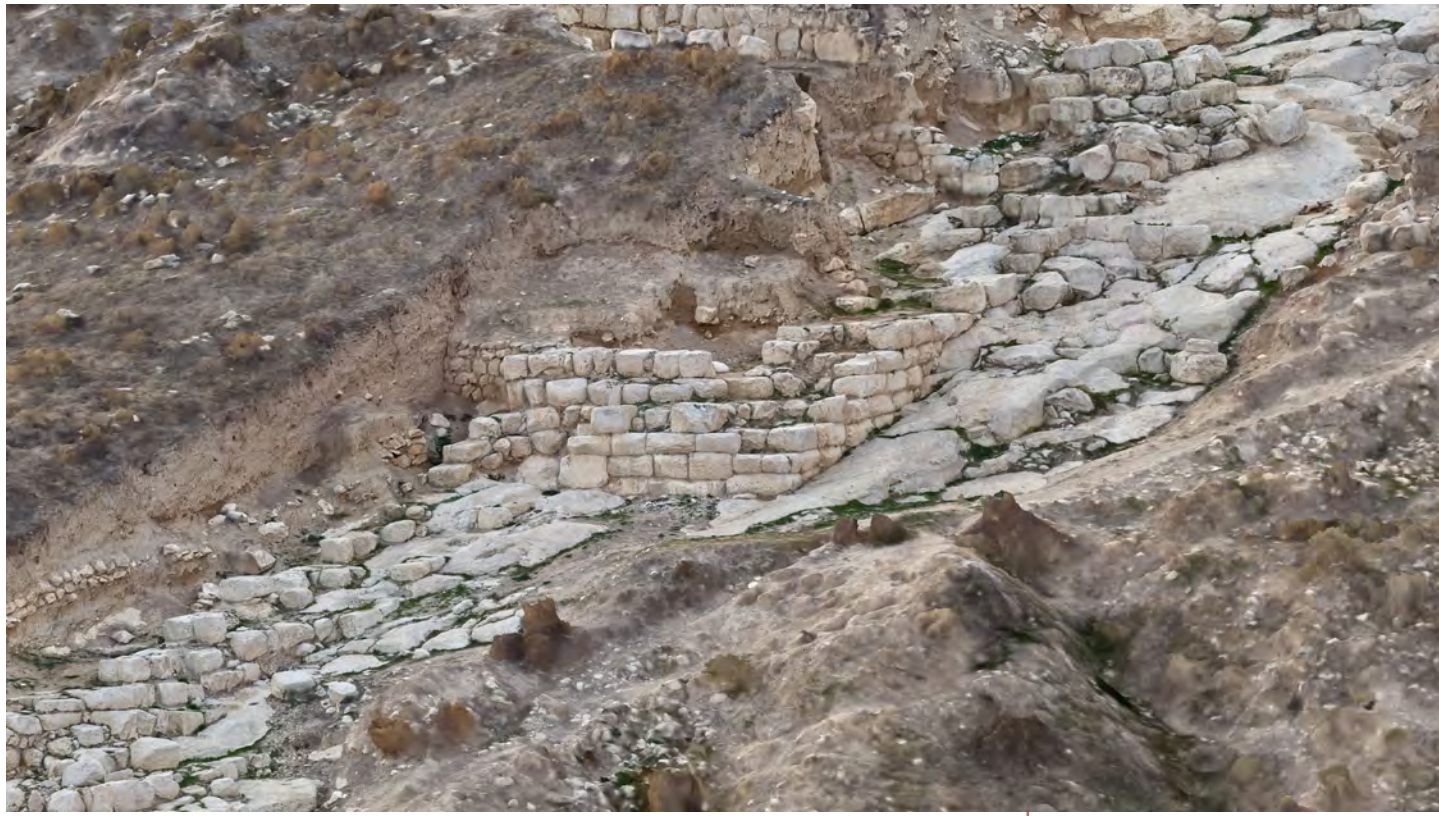
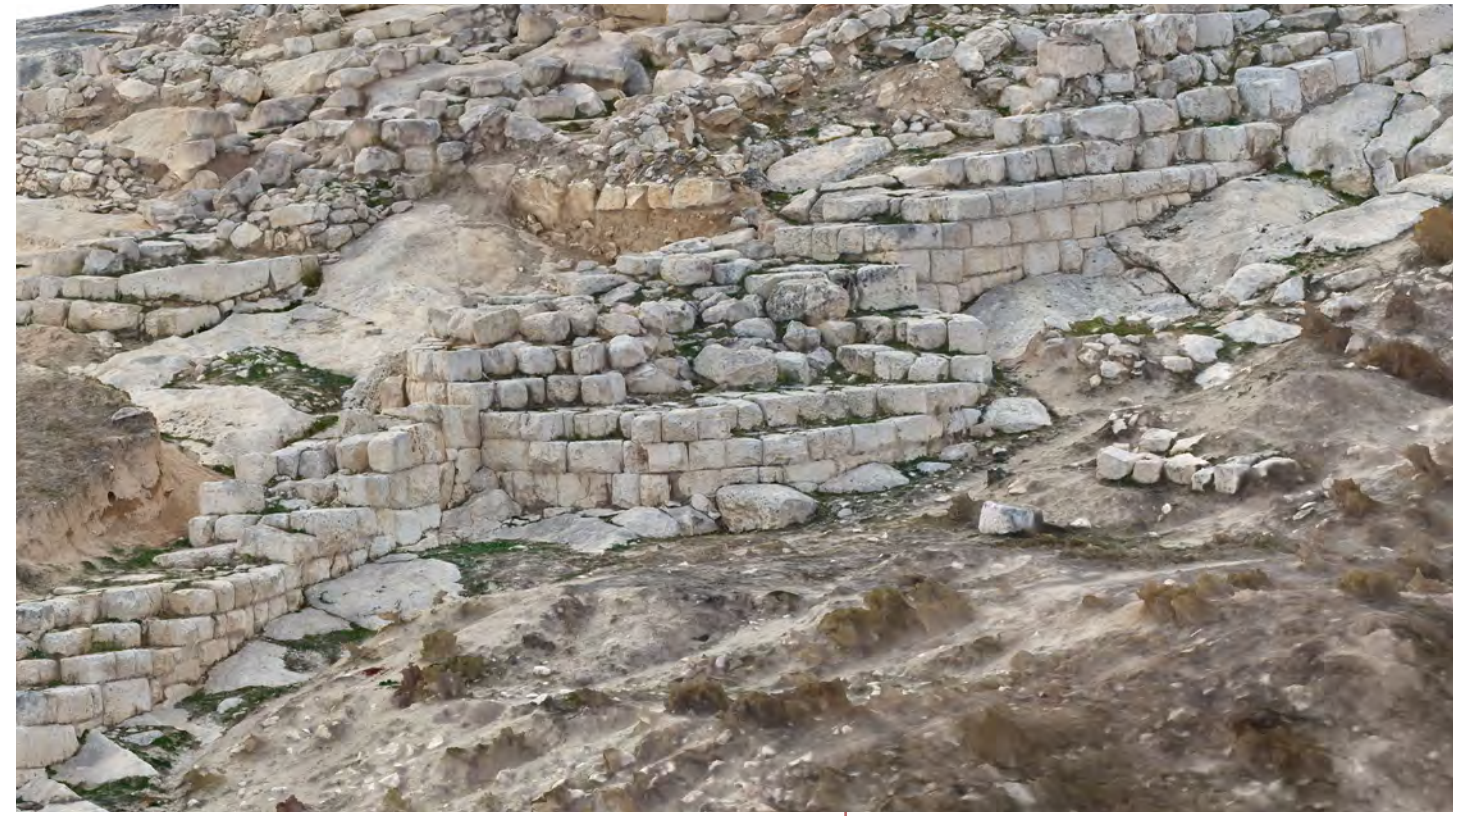
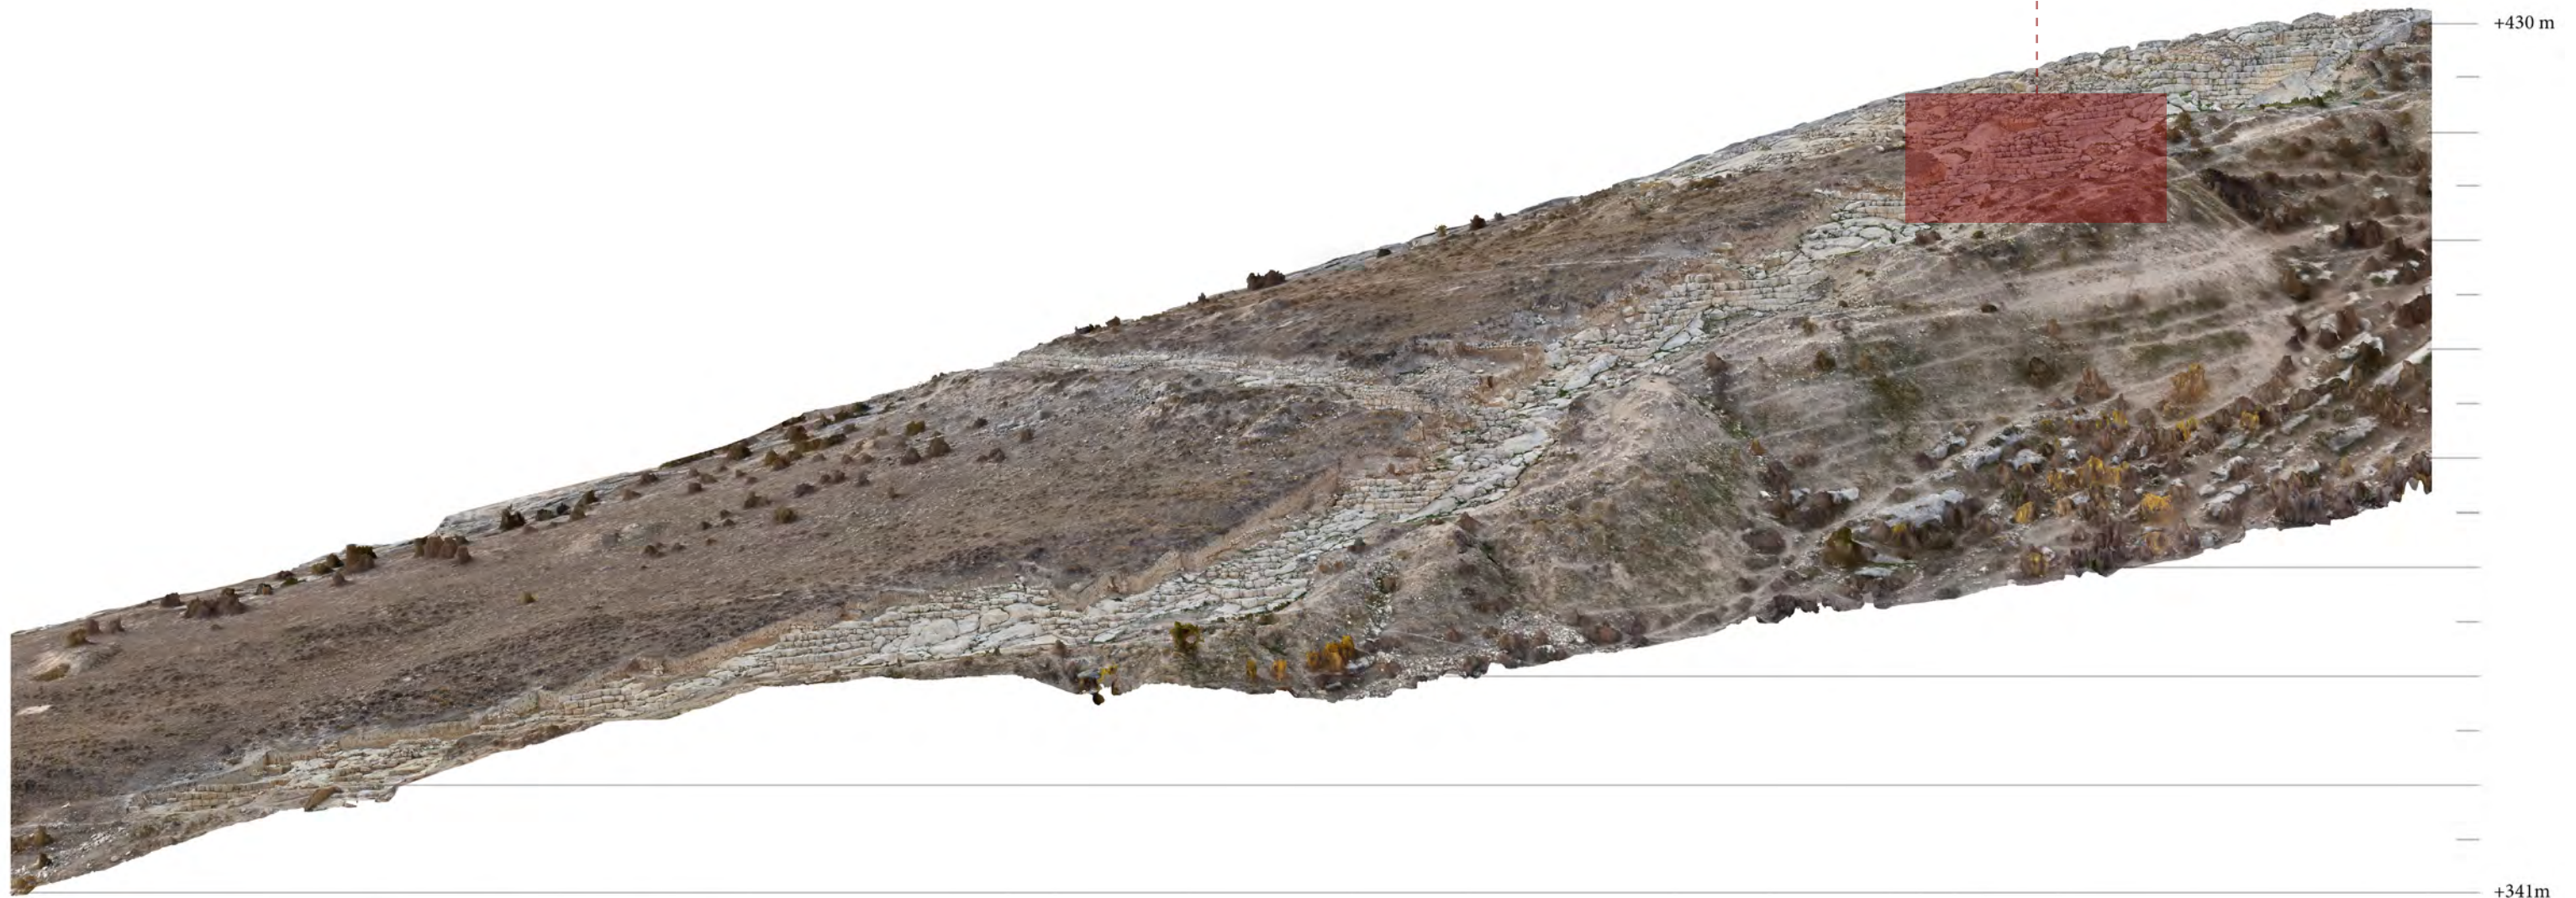
Fig. 9. Ortho-image of the northern facade extracted from the textured 3D scan of the fortified district (Iconem 2021)

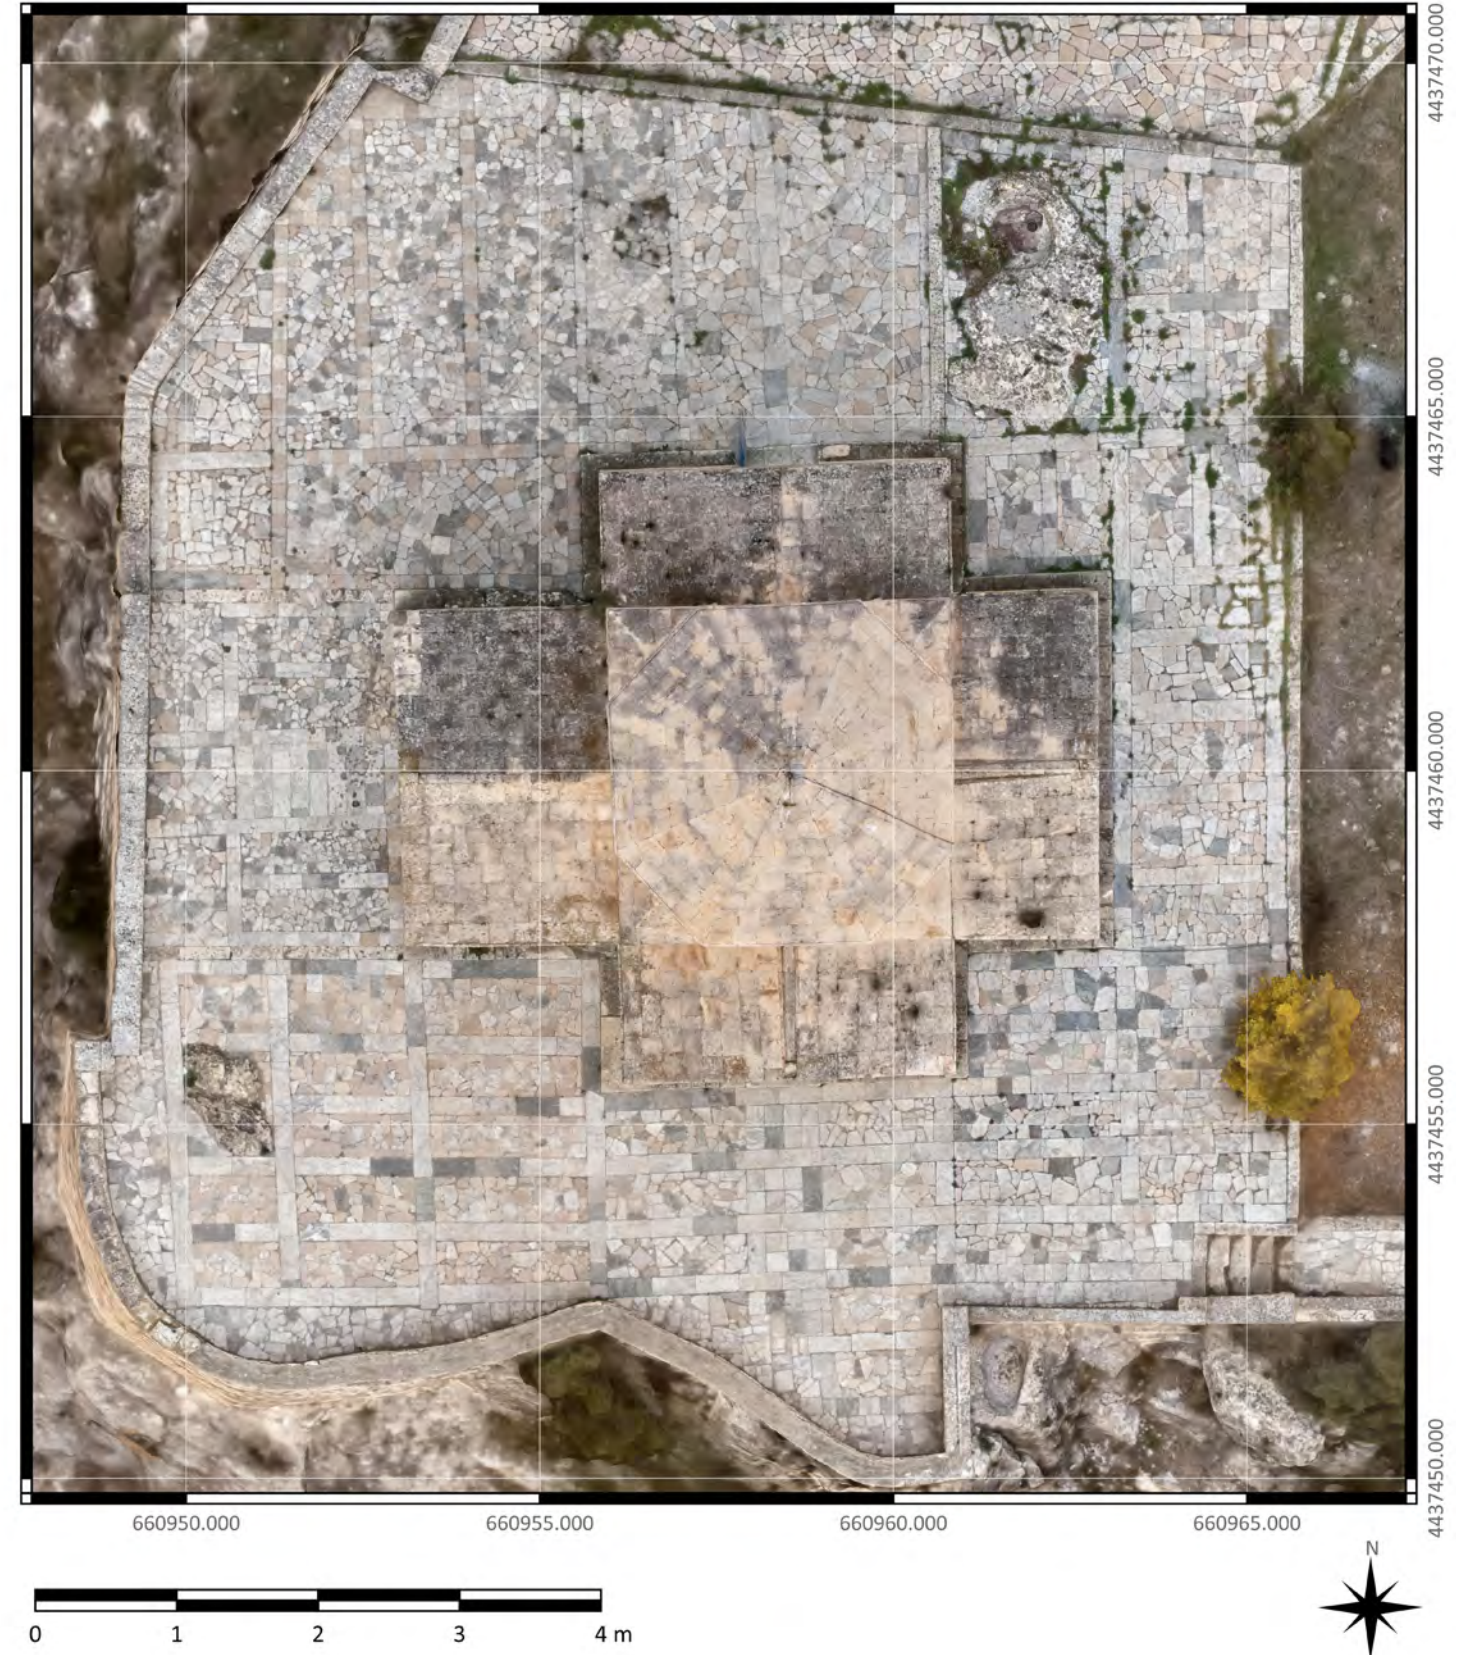
Fig. 2. Georeferenced ortho-image of Vankasar church extracted from the textured 3D scan (Iconem 2021)

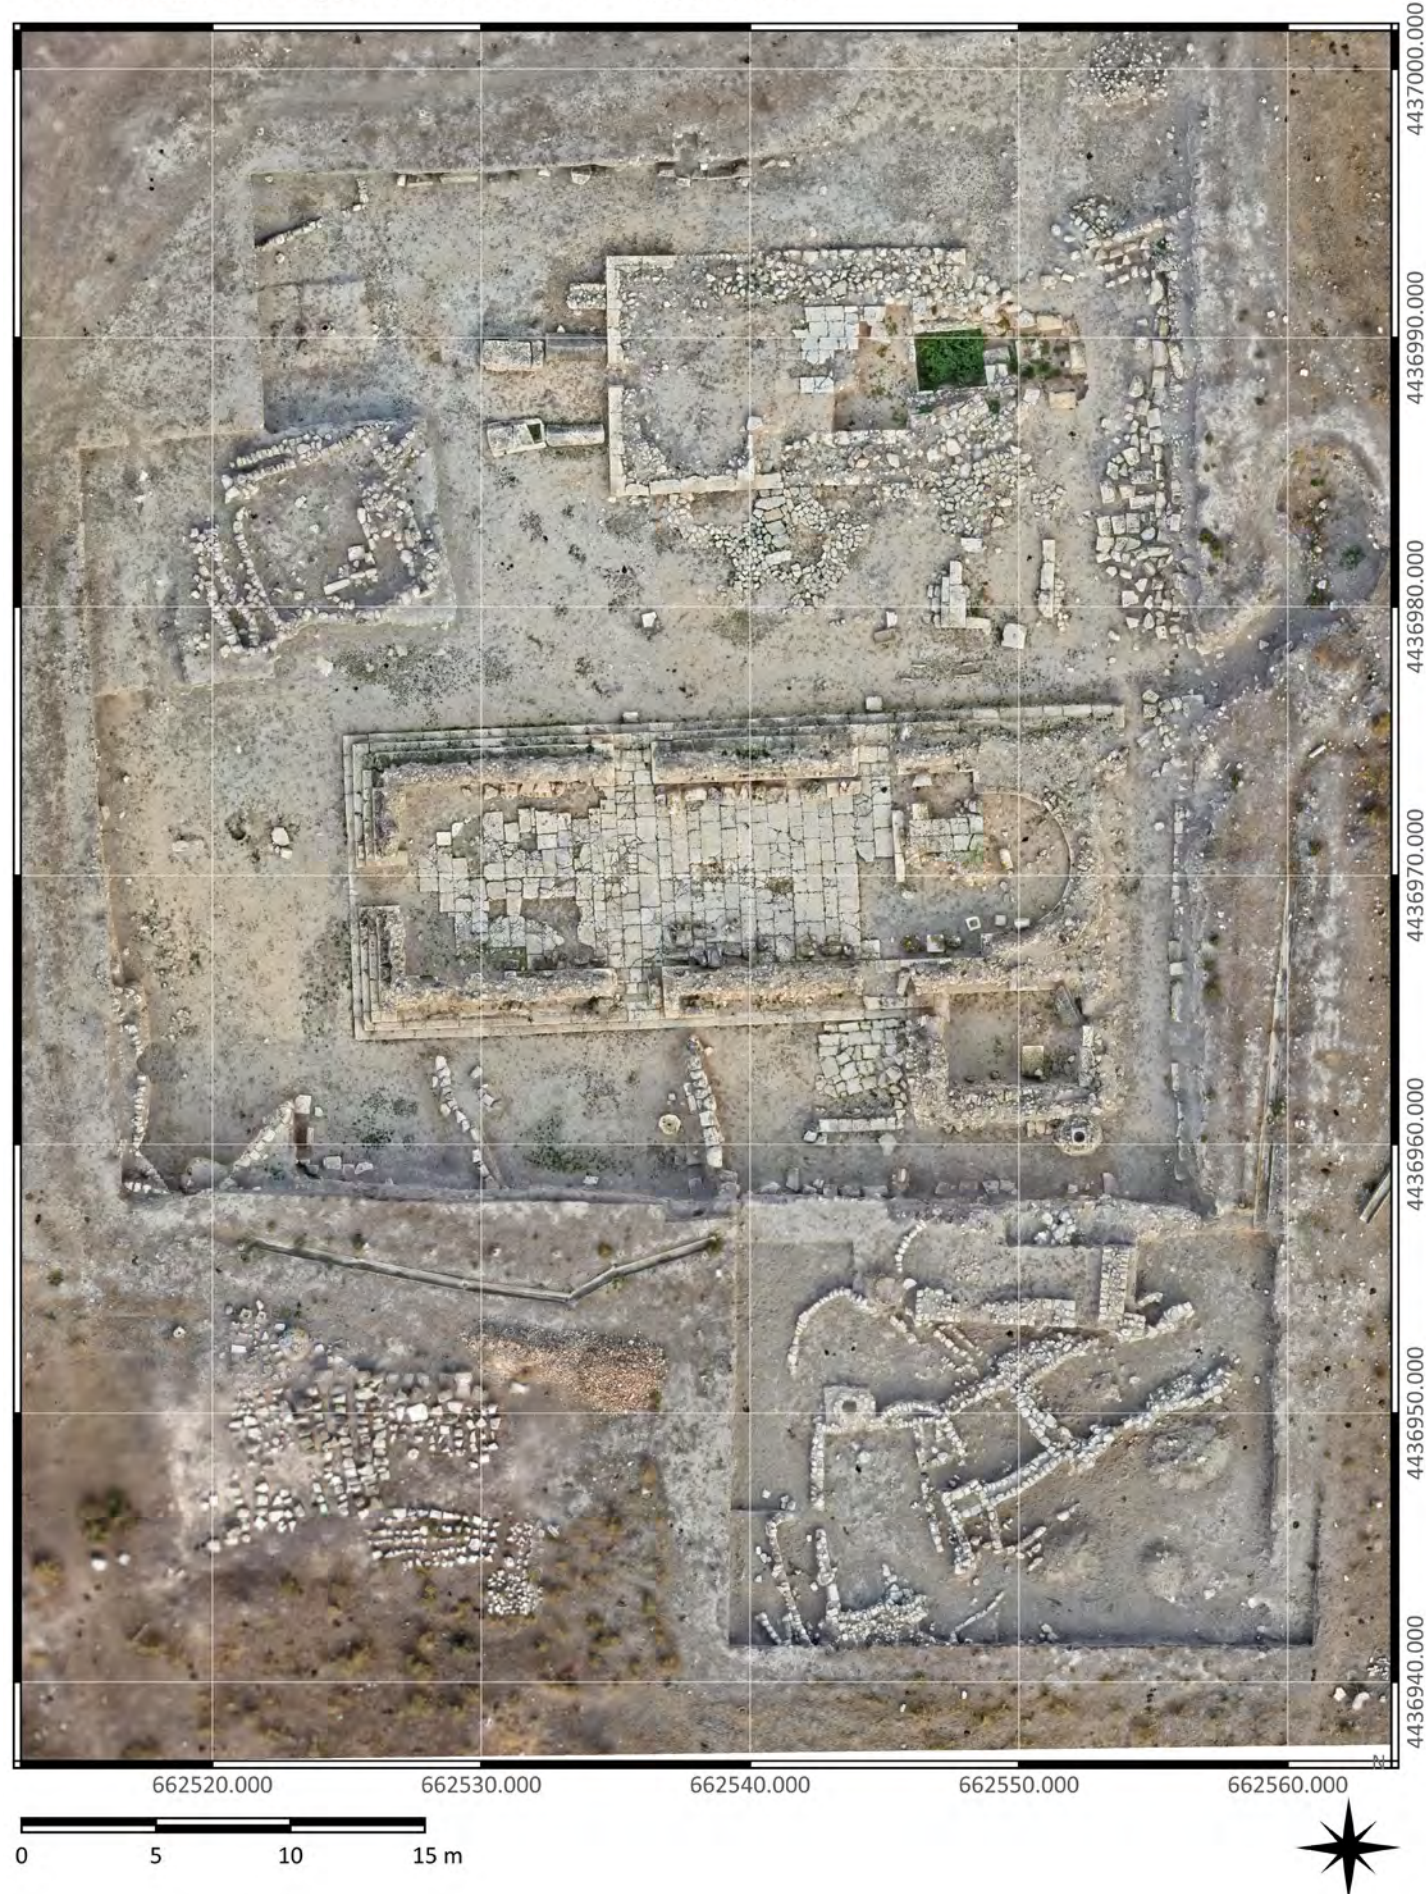
Fig. 3. Georeferenced ortho-image of the early Christian square extracted from the textured 3D scan (Iconem 2021)

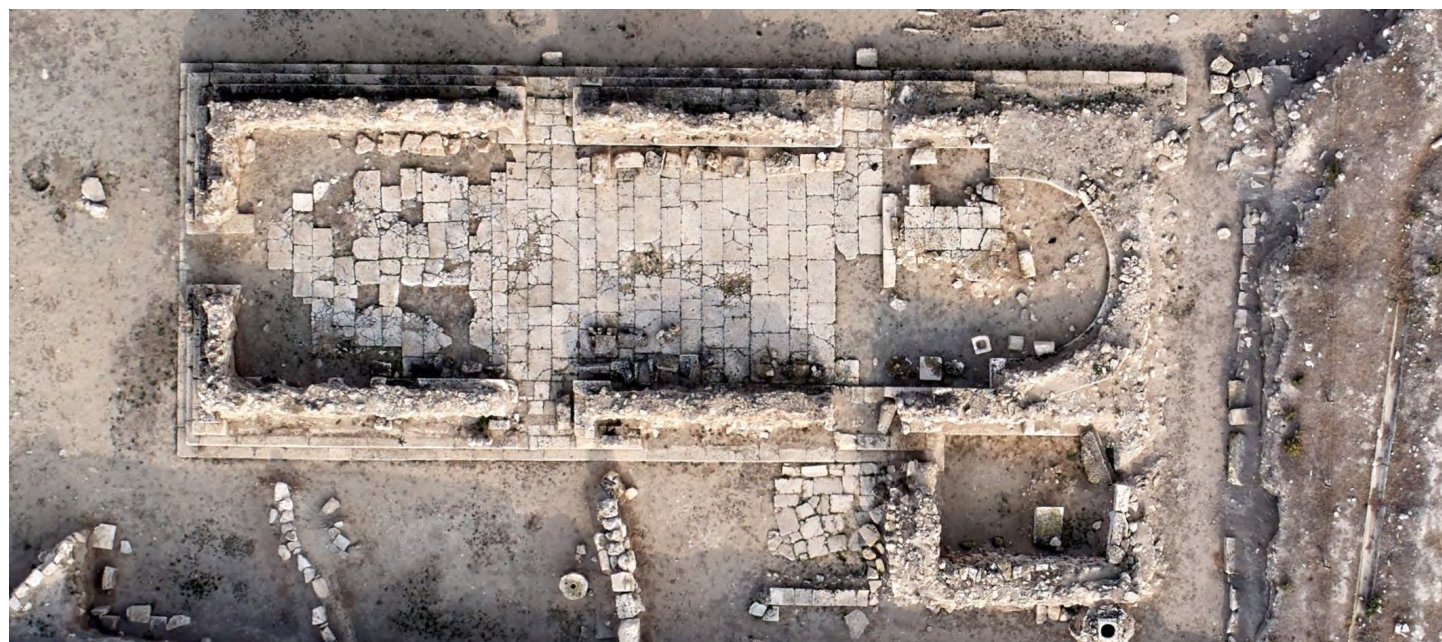
Fig. 4. Aerial view of the basilica (Iconem 2020)

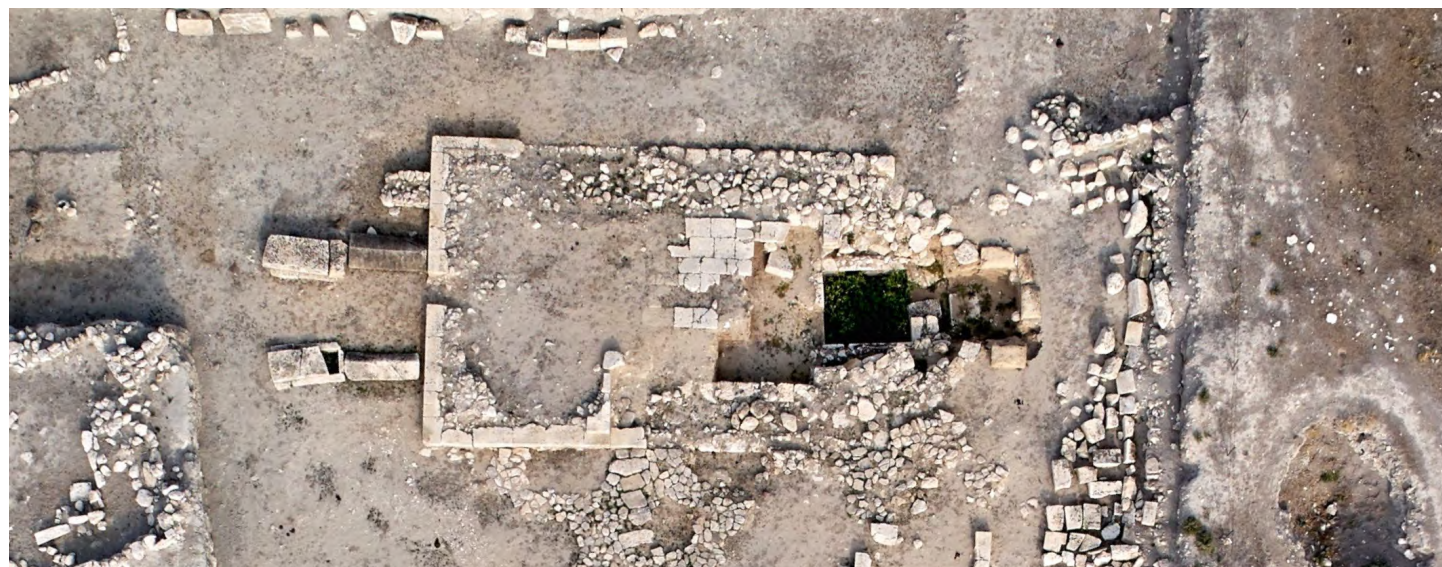
To the north, a second church has been excavated (fig. 5). It was probably a *martyrium*, as shown by the sepulchre-reliquary excavated under the eastern apse of the church. This function, together with its unique eastern entrance, makes it comparable to the funerary monuments of St-Grigoris of Amaras and St-Stepanos of Vachar⁷.

Fig. 5. Aerial view of the second church (Iconem 2020)
