HERITAGE
WATCH.AI

ARMENIAN CULTURAL HERITAGE SITES
CONDITIONAL REPORT

2 0 2 0

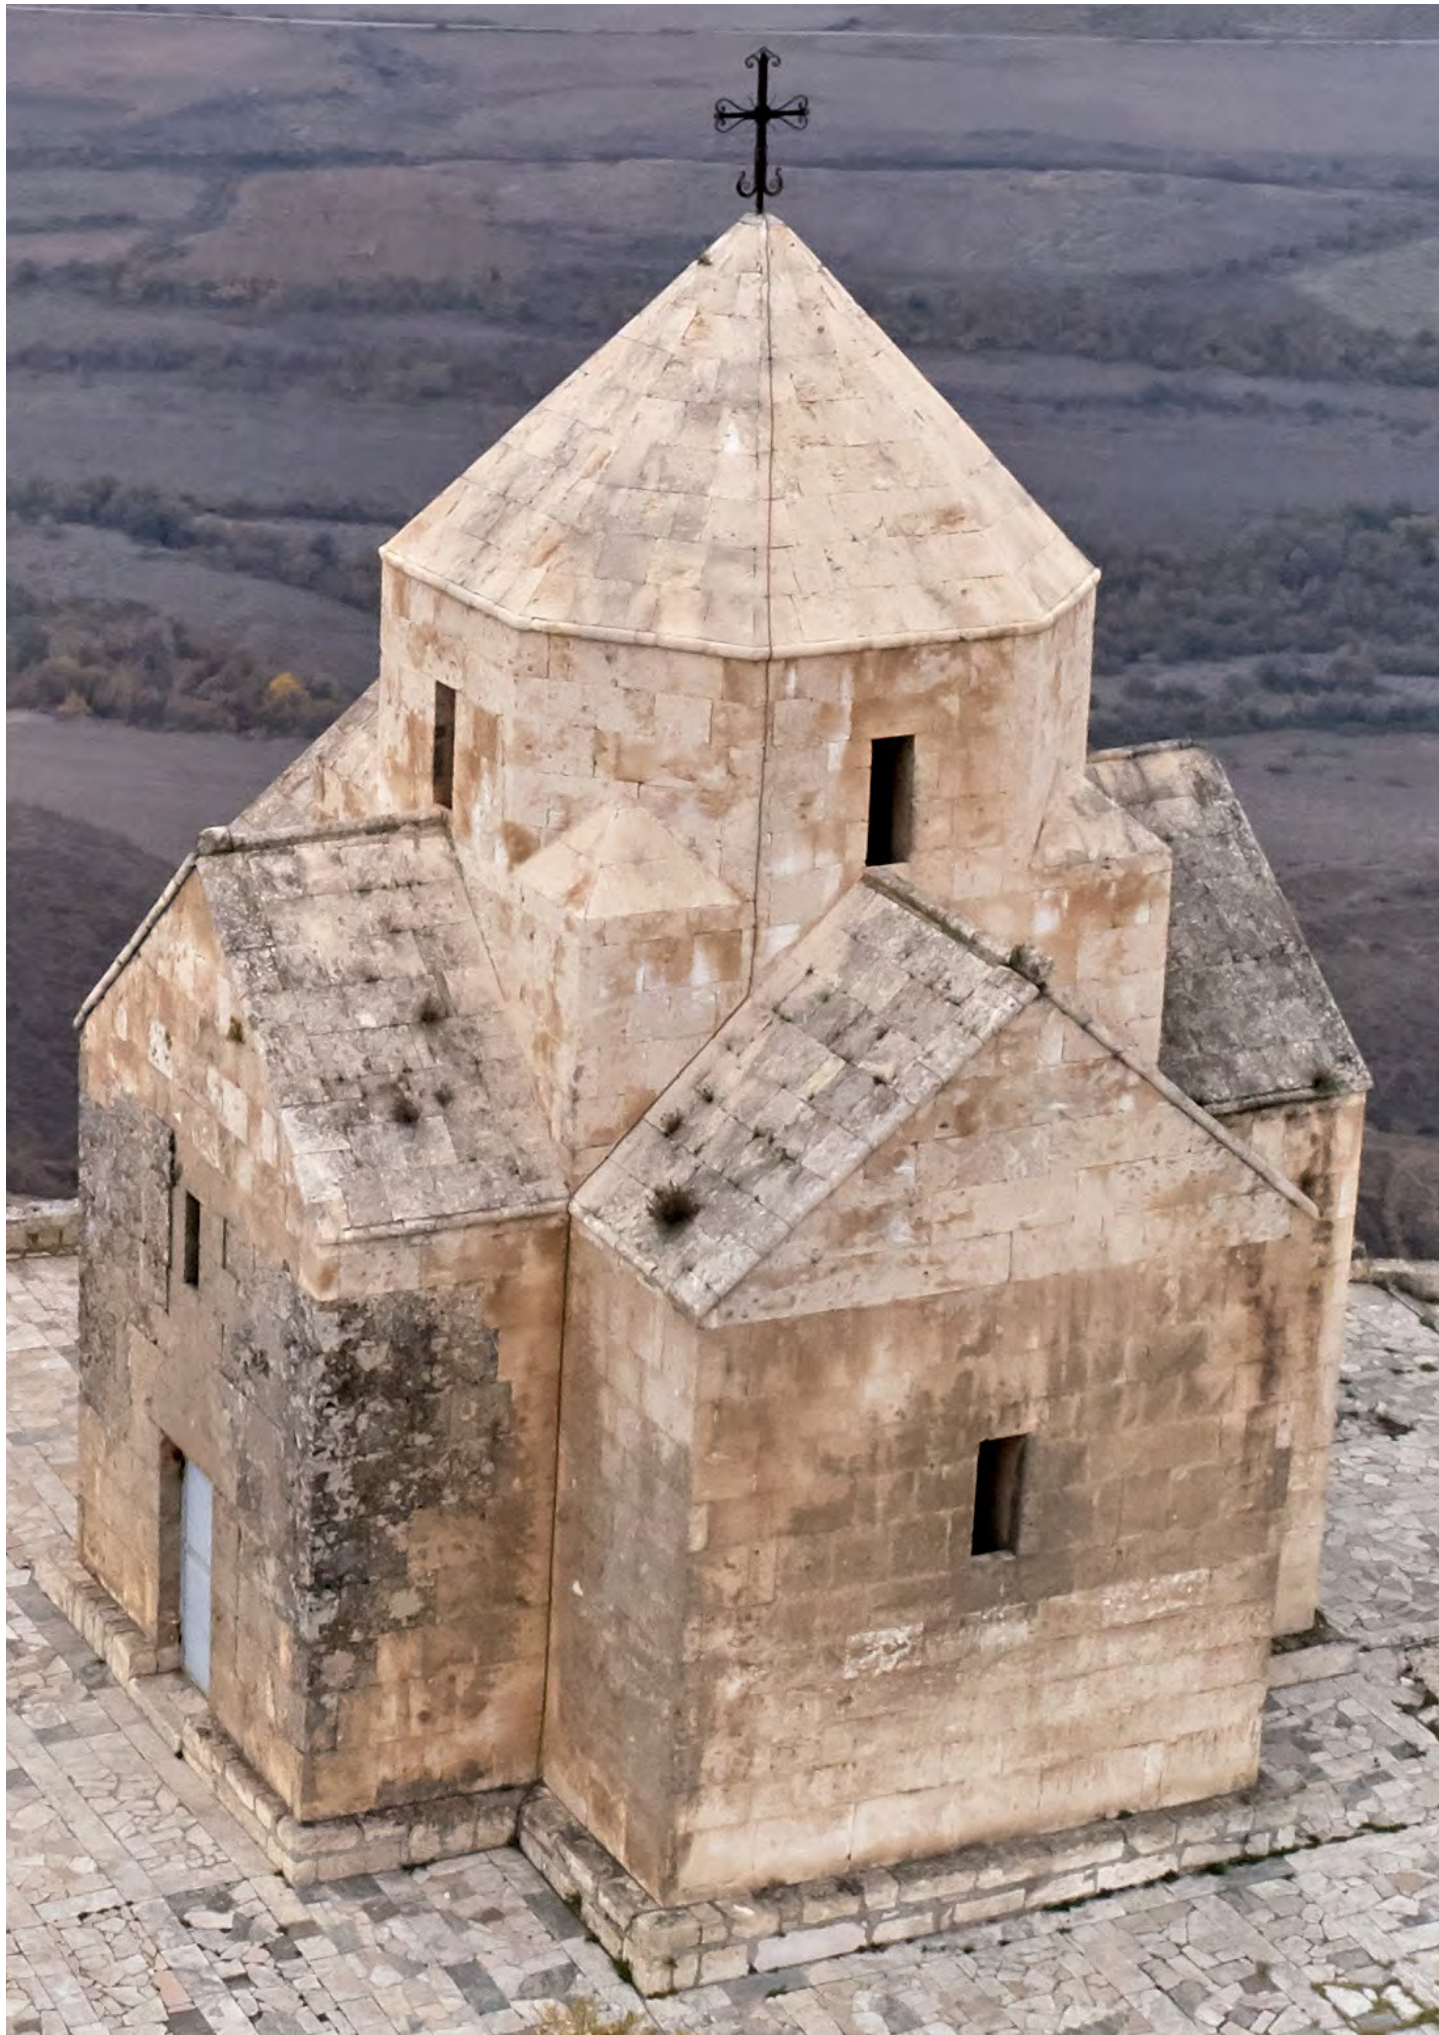
On the peak of the mountain, in the prolonging of the antic fortification of Tigran the Great, stands the 7th century church of Vankasar (fig. 7). It is a small triconch church with central plan and free arms inscribed in rectangles, built with limestone (fig. 6). The western arm is slightly longer than the other arms. There was originally a single entrance on the western arm of the cross (fig. 8), but after having been deeply renovated in the 1980's, entrances were added on the northern and southern arms⁸. Each entrance is topped with a window, as well as the altar of the eastern apse. The dome has a conical crown and rests on an octagonal drum, which also has four windows. The roofing of the church is made of stone tiles since the renovation, but the original elevation might have been different.

Fig. 7. South-eastern view of the church of Vankasar (Iconem 2020)

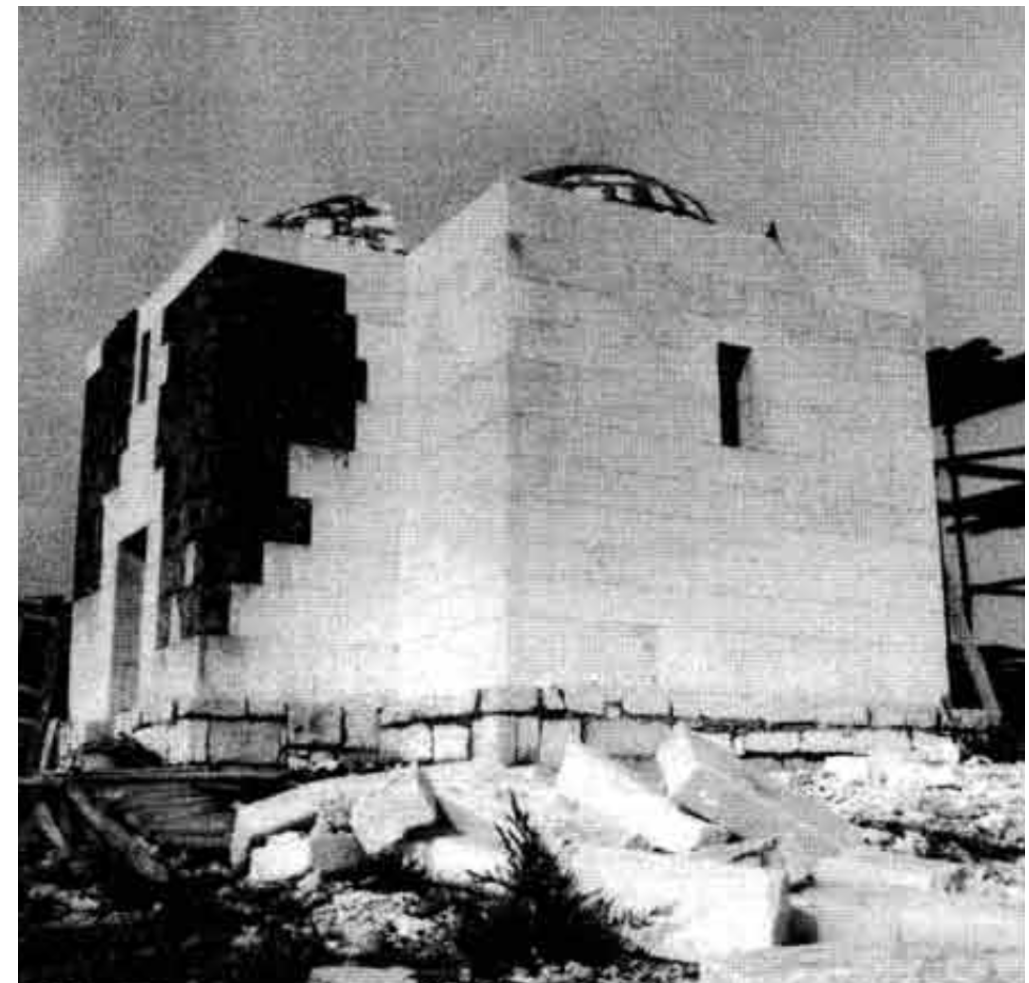
Fig. 10. The renovation of Vankasar's church in 1986 (Karapetyan 2001, p. 212)

The church of Vankasar was very deteriorated until the 1980's: according to M. Thierry, the eastern part was totally destroyed¹³. In the beginning of the 1980's, the Azerbaijan Soviet Republic took the initiative to renovate the church (fig. 10), therefore the church is architecturally very stable. However, specialists assert that the renovation altered the original aspect of the monument: white stone blocks replaced the original stone blocks with the inscriptions, two entrances were added on the northern and southern arm and several architectural elements have disappeared, such as the cornices, the original floor, the windows with arched endings (which are now rectangular), and the dome's original crown¹⁴.

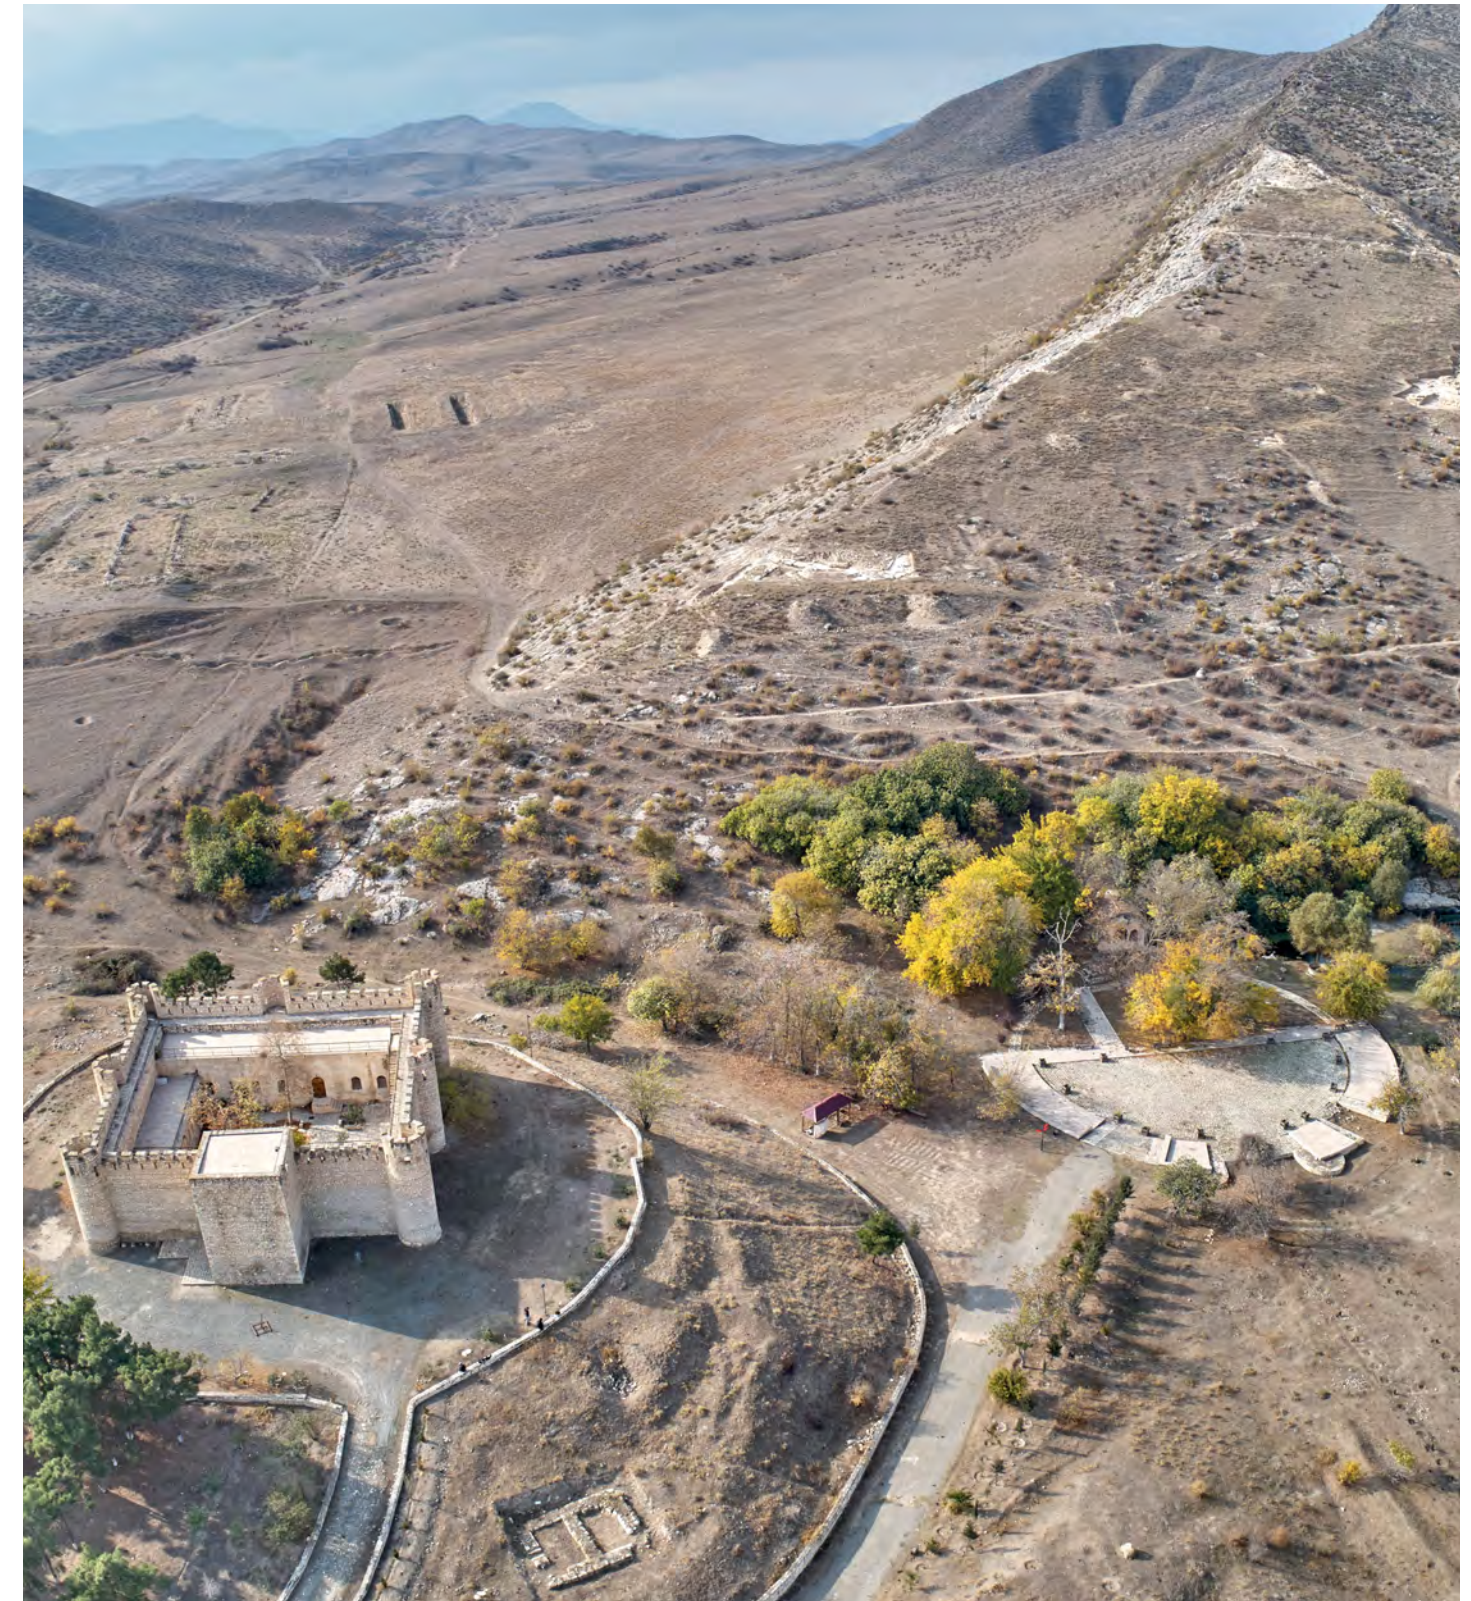
Fig. 2. General view of the castle, the mosque, the spring sources and the antic fortified district in the background (Iconem 2020)

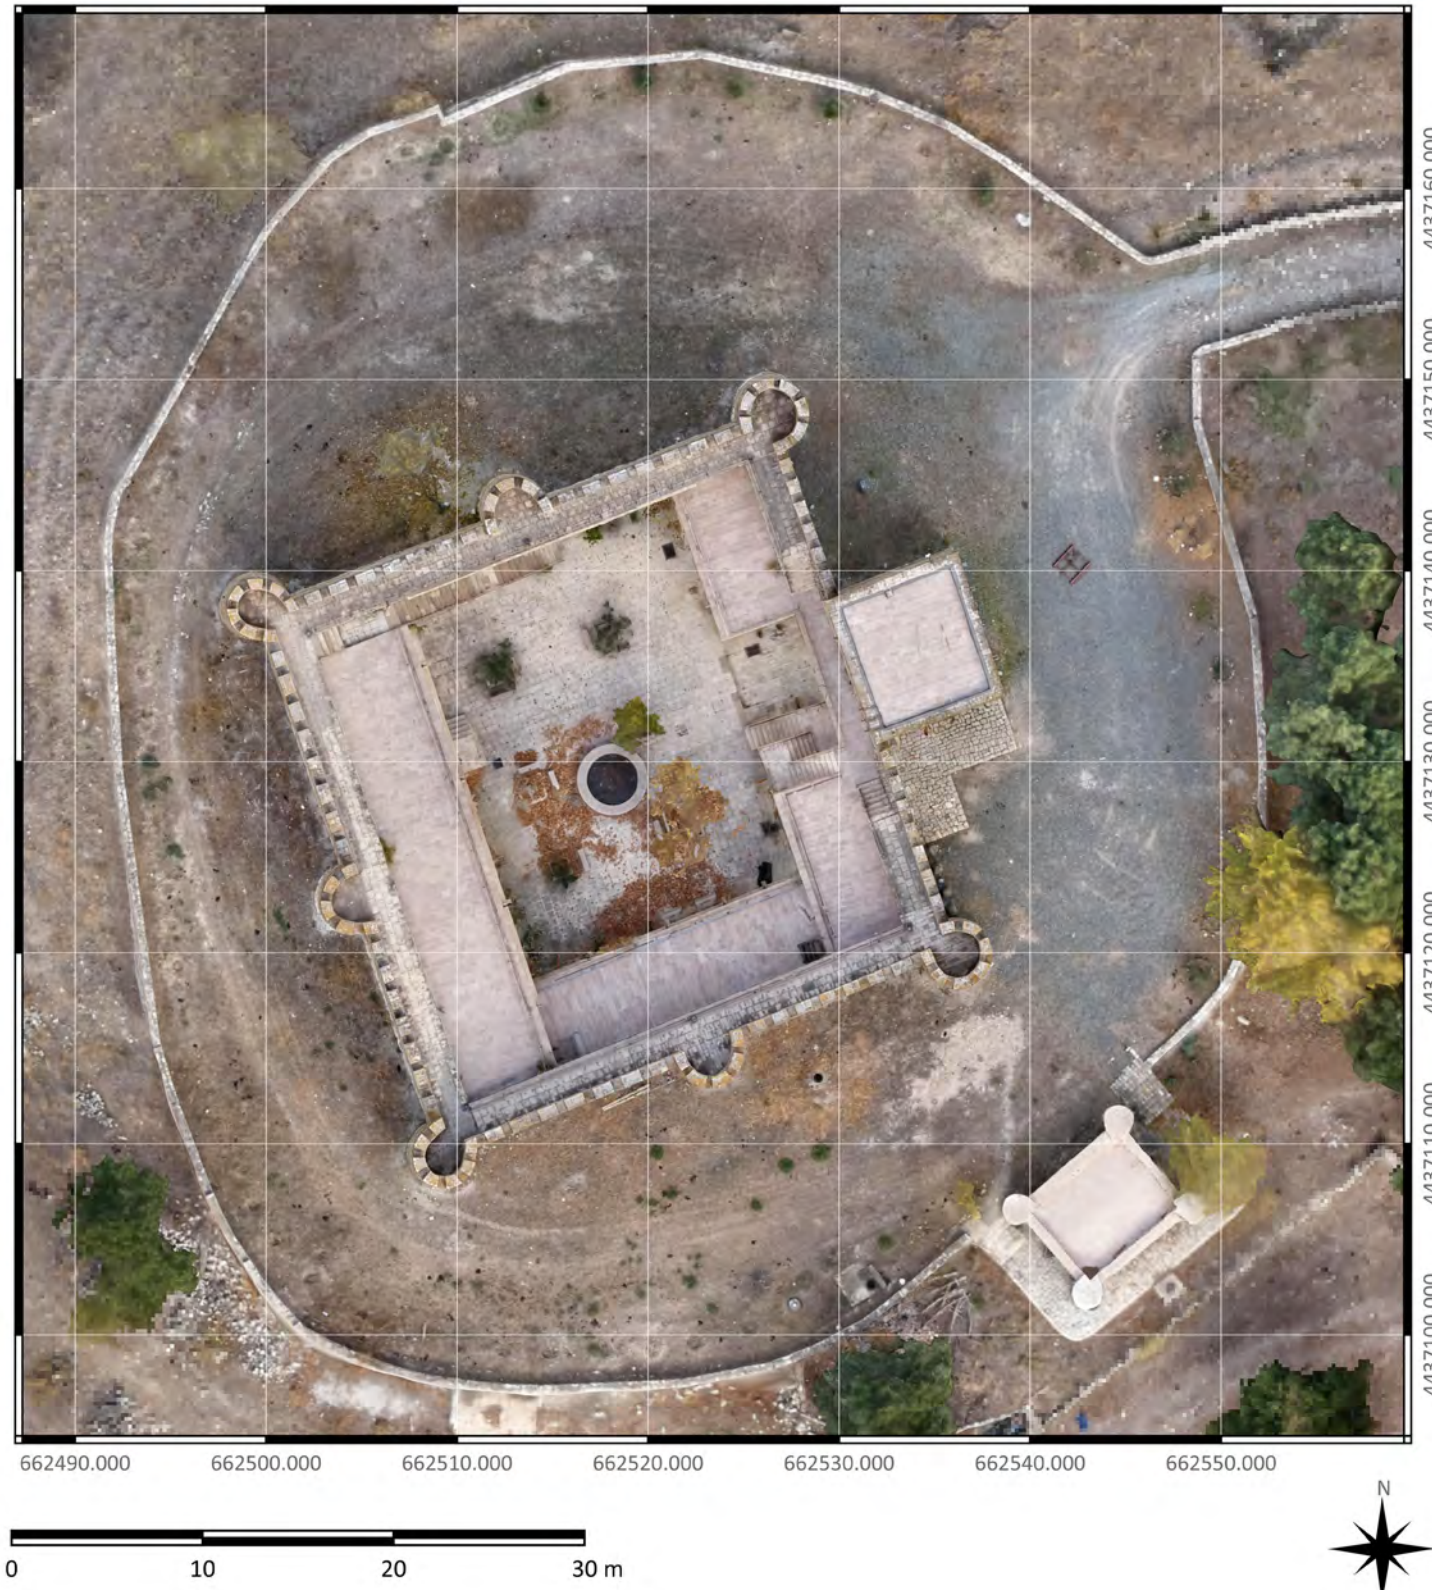
Fig. 3. Georeferenced ortho-image of Shahbulag castle extracted from the textured 3D scan (Iconem 2021)

The castle was rebuilt in 1980. Many molding elements seem to have disappeared. The building is entirely built of massive stone masonry. The claddings of the walls are made of dimension stones and the width of the walls is filled with rubble stones assembled with lime mortar. Given the recent restoration it has undergone, the castle's stability is good. The small mosque, however, is in poor condition.

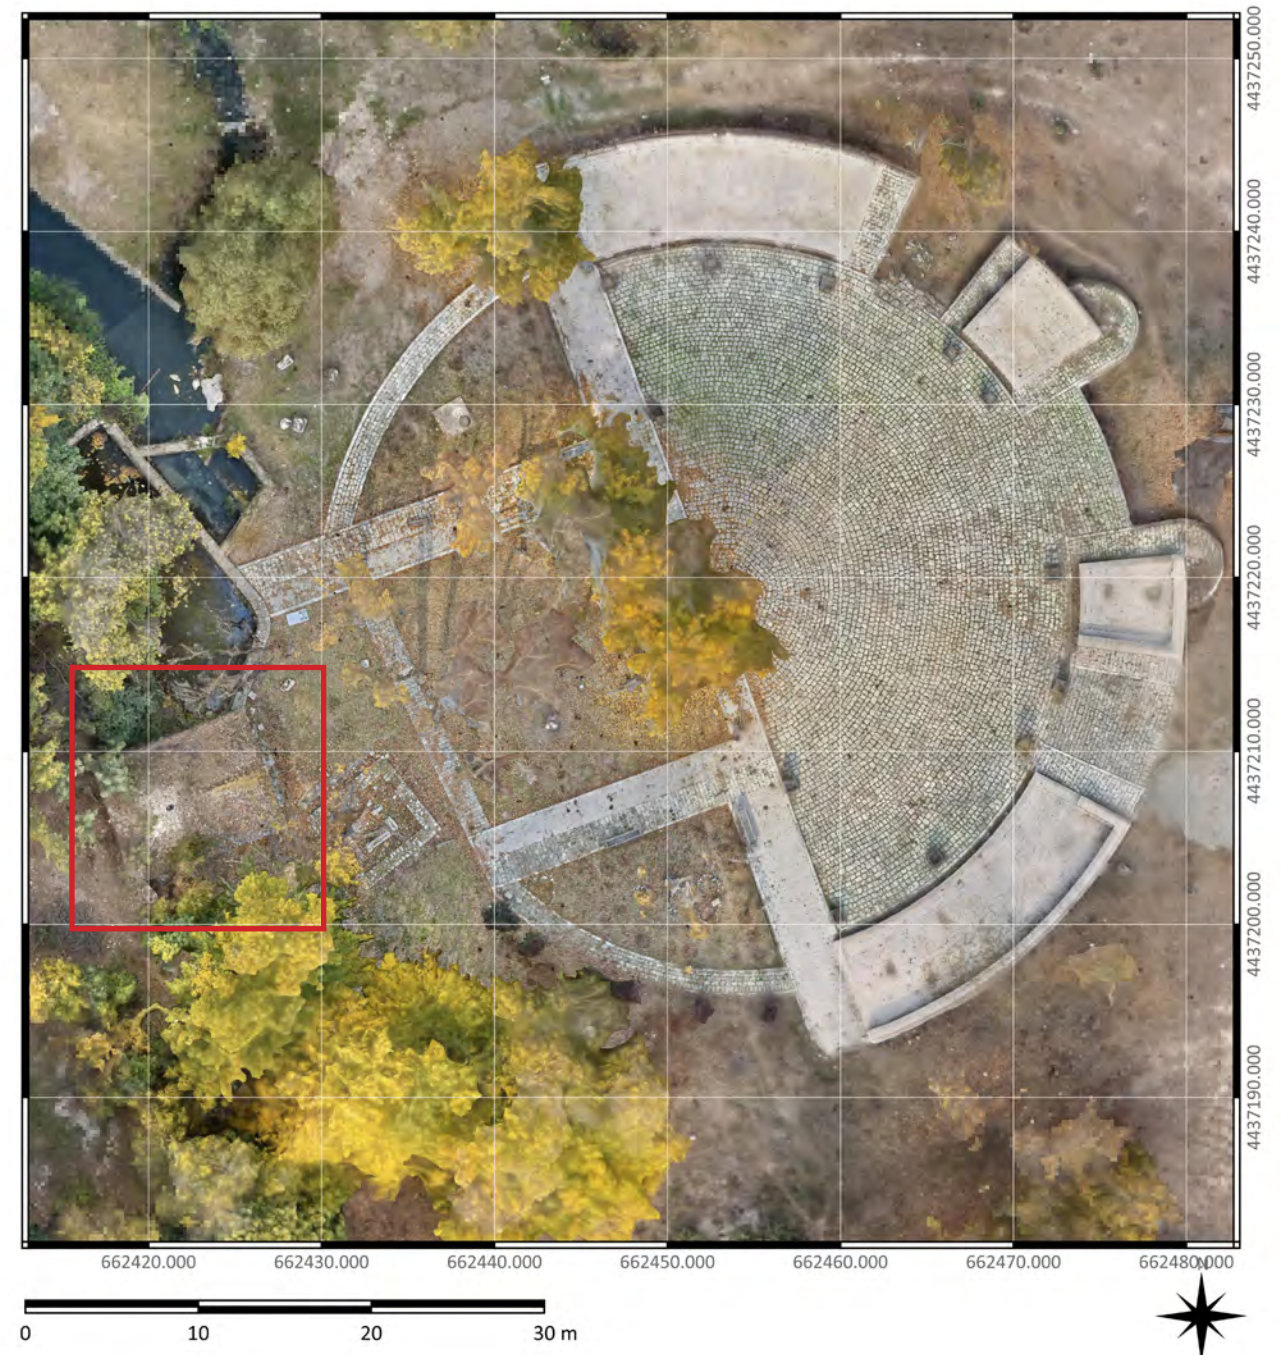
Fig. 4. Georeferenced ortho-image of the mosque and the spring sources extracted from the textured 3D scan (Iconem 2021)

The castle's terraces, made of fitted and adjoined stone slabs, do not present any weak points and appear to be in good overall condition. There are no traces of humidity infiltration. The castle being placed on a hillock, the risks of capillary rise through the ground are minimal. As for the small mosque, it is placed near a source, in a wet area.

Emergency prescriptions: No emergency prescriptions are to be taken for the castle, apart from the regular maintenance of the terraces, their weeding and the maintenance of the joints. As for the small mosque, heavy maintenance work is expected. The sanitation of the area could be analysed with the creation of a perimeter drain at the foot of the building's foundations. Furthermore, a renovation of the roof should be considered.

Since the castle was restored in 1980, it does not call for special measures. The lime repointing of the mosque's side walls should be considered as well as the repair of the roof.

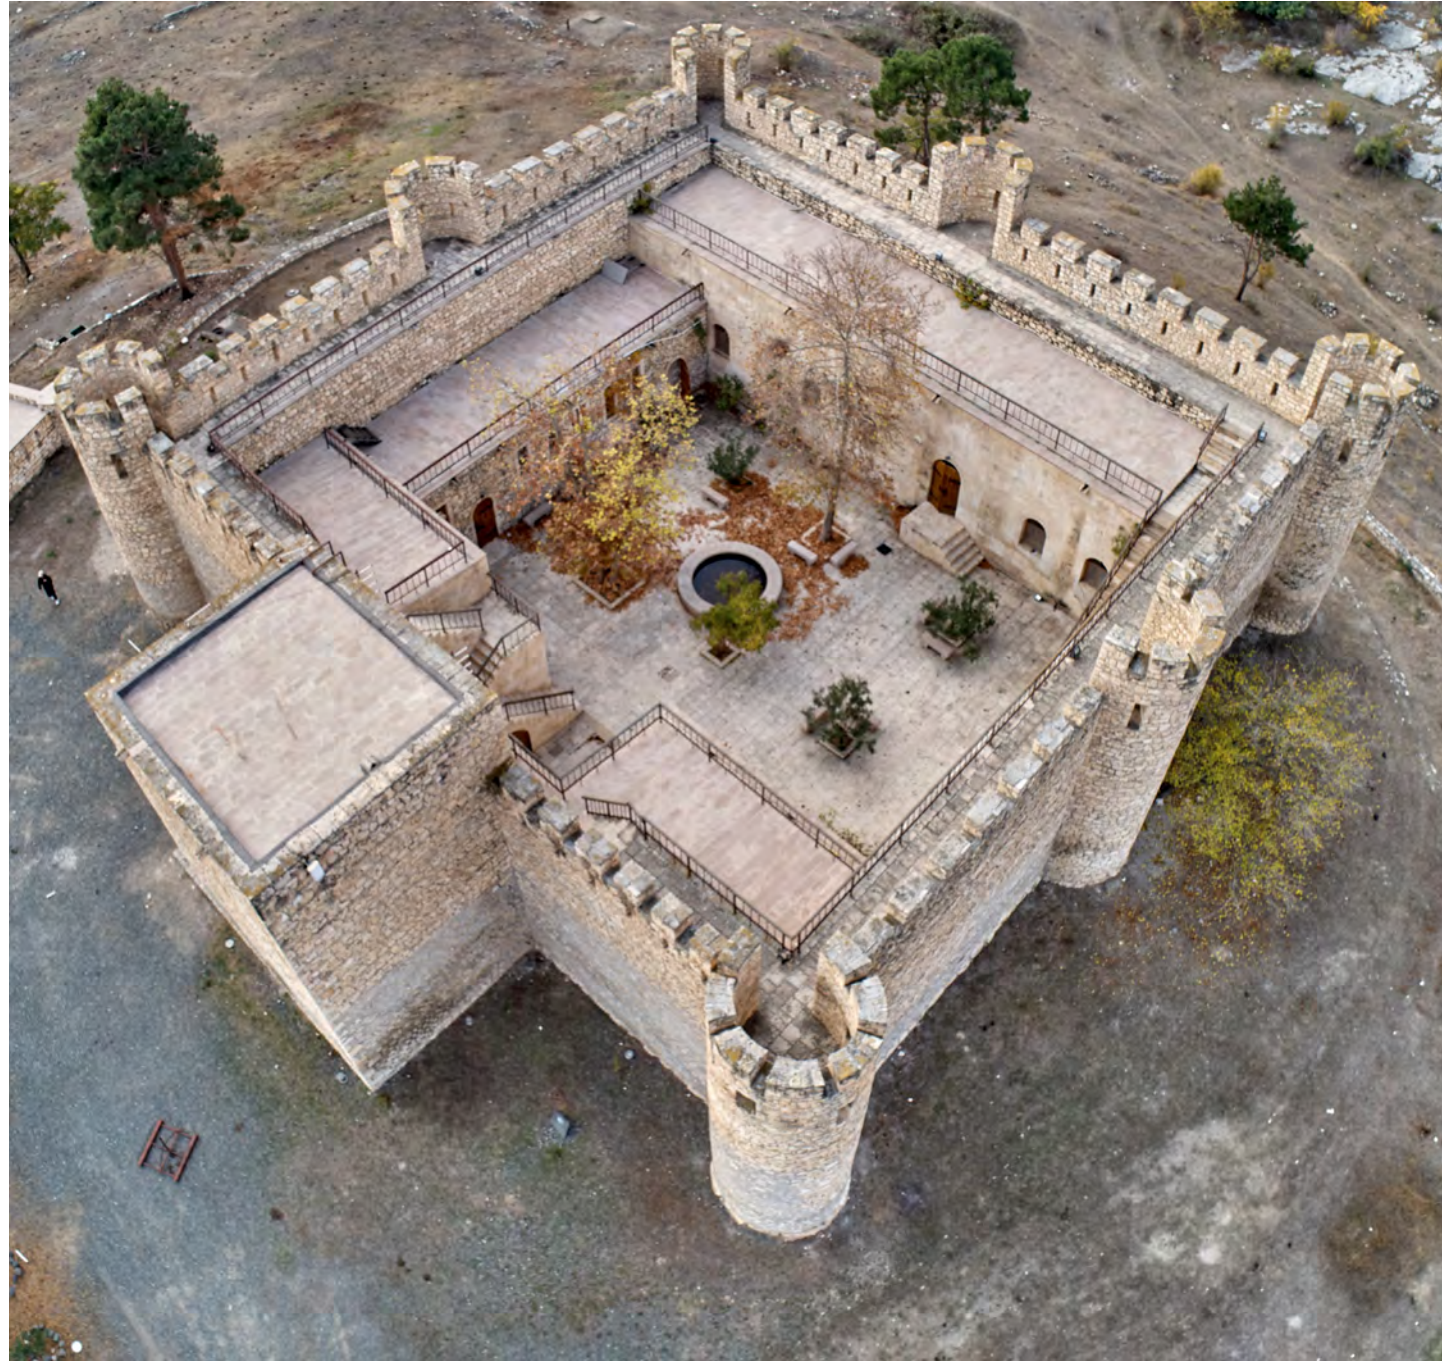
The Shahbulag castle is located on the plain, 150 meters east of the antic fortified district (fig. 2). It is a quadrangular fortified castle with semicircular towers in its corners and the middle of its curtain walls (fig. 5-6). Only the central tower of the northeastern curtain wall is square. The upper parts of the walls and the towers are pierced with arrowslits for defending purposes. Inside the fortress, facilities are attached to its eastern, southern and western walls. In the middle of the patio, a small circular basin is still visible.

Fig.5 . Aerial view of the Shahbulag castle, Iconem 2021

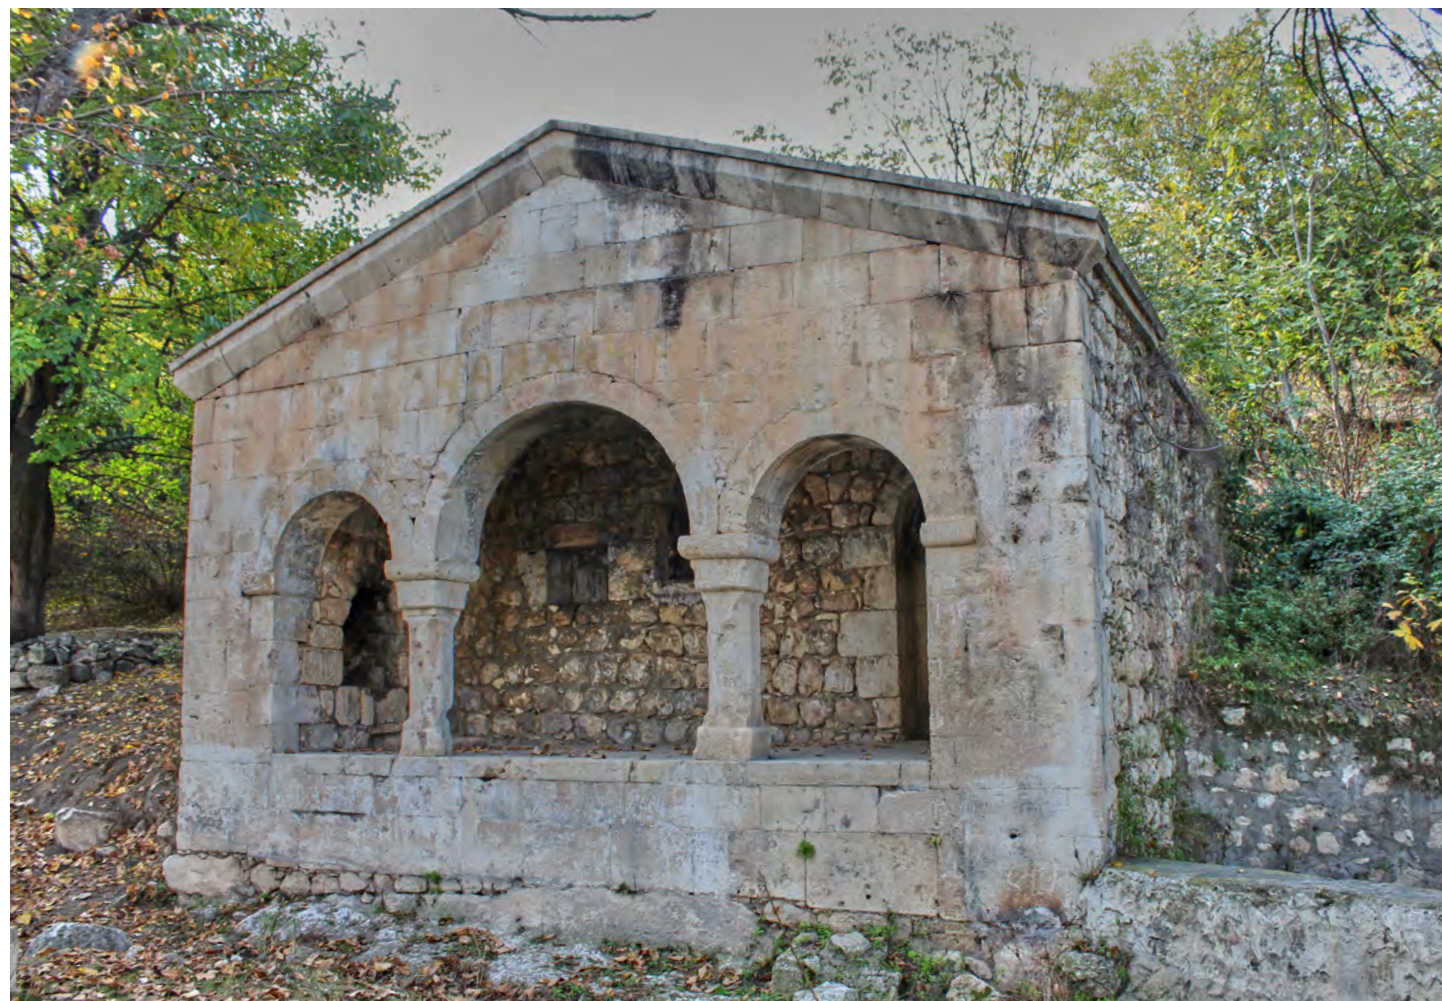
A mosque was built at the same time near the spring sources and the basins, about 100 meters northwest of the fortress (fig. 2-4). It is a small building with a series of three arches on its front façade, leaning on two octagonal pillars (fig. 7). A single entrance leads to a small room, which is the praying hall (fig. 8). A large niche is carved into the southern wall, and a smaller one on the western wall. The dome is pierced by an oculus.

Fig. 7. The mosque's façade (Iconem 2020)

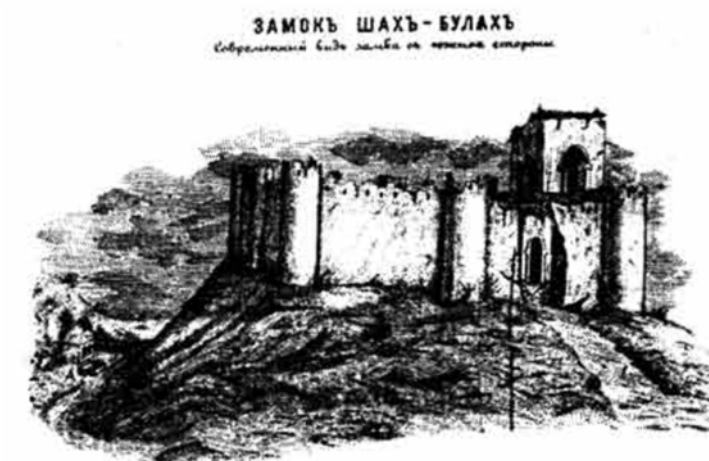
The fortress was renovated in the 1980's and is therefore stable⁶: however, based on representations dating from the beginning of the 19th century, it appears that the square tower was much higher (fig. 9). From 2010 to November 2020, it was used as the archaeological museum of the site.

Fig. 9. A representation of the fortress in the beginning of the 19th century (Karapetyan 2001, p. 213)

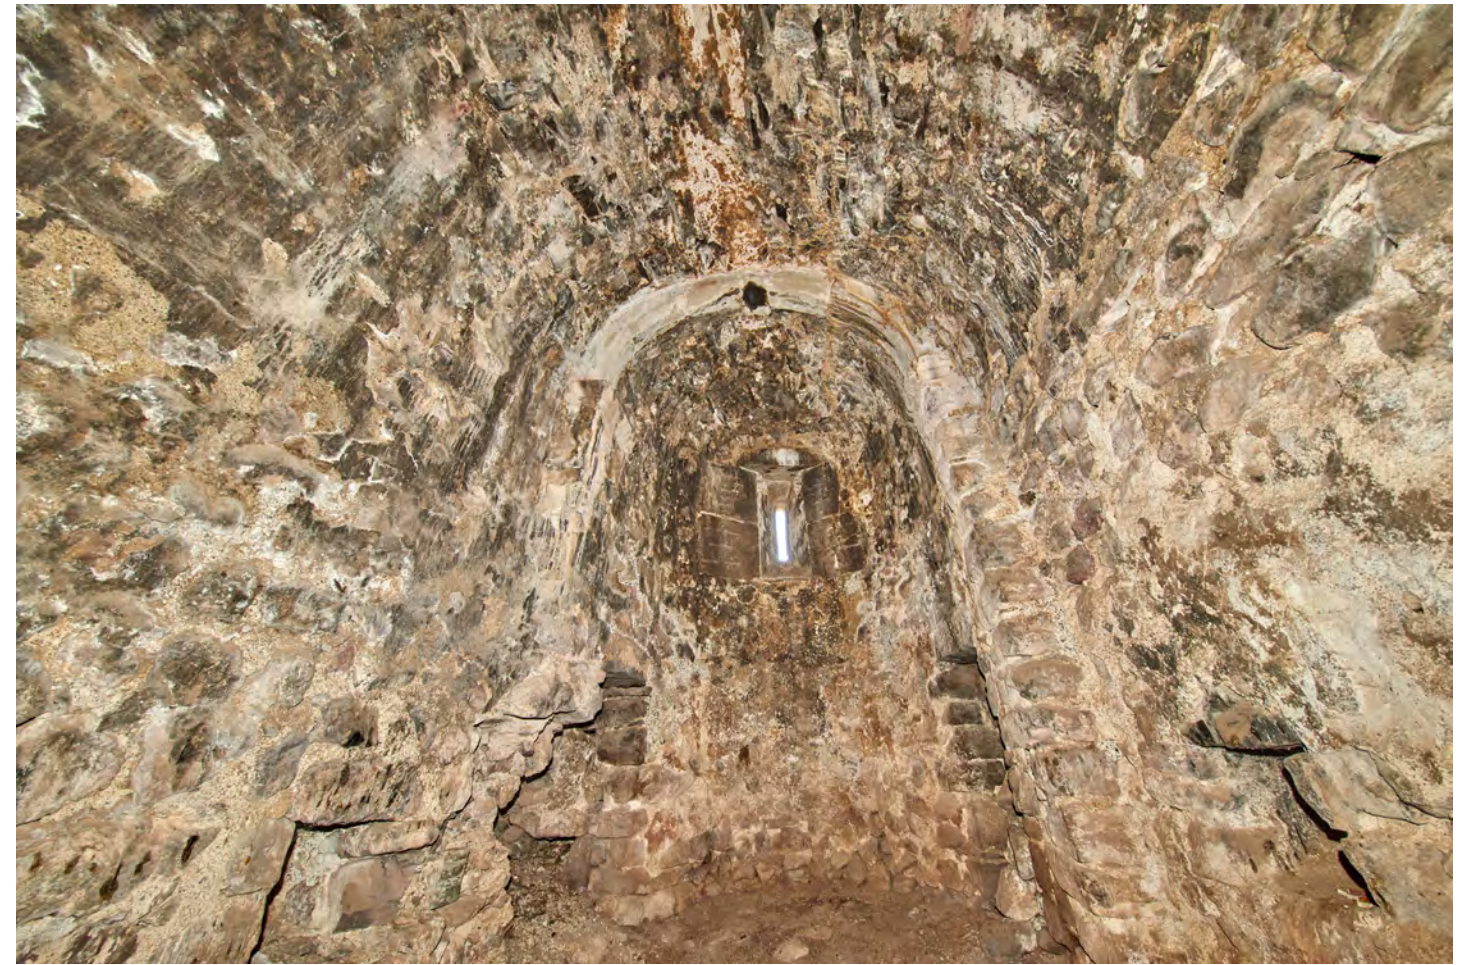
The church called Zorakhach is located around 3 km north-west of the village of Arakhish (fig. 1-2). It is a single nave basilica with an inscribed apse, which means it is rectangular from the outside but semi-circular on the inside. Two salient sacristies flank the apse on its southern and northern sides, which were directly connected to it through doors that have been filled by rocks. For this reason, it was not possible to document these rooms, however their dimensions appear in S. Karapetyan's plan (fig. 3-4). The roof is quite damaged on its exterior, but well preserved from the inside with a semi-circular vault (fig. 5-6).

Fig. 5. The church's apse (Iconem 2020)

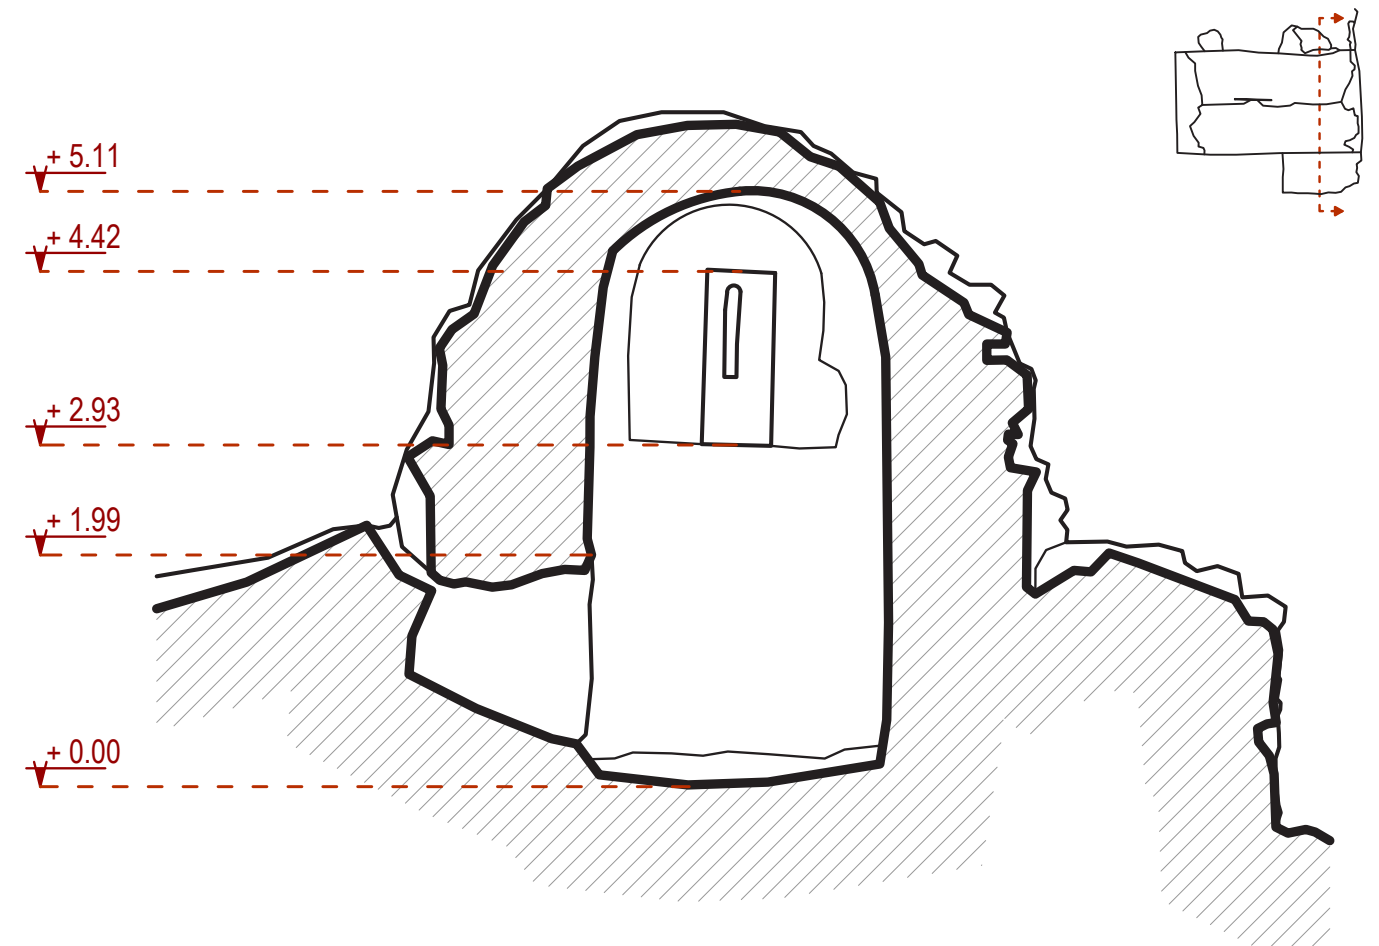
Fig. 6. Section of the church (Iconem 2021)

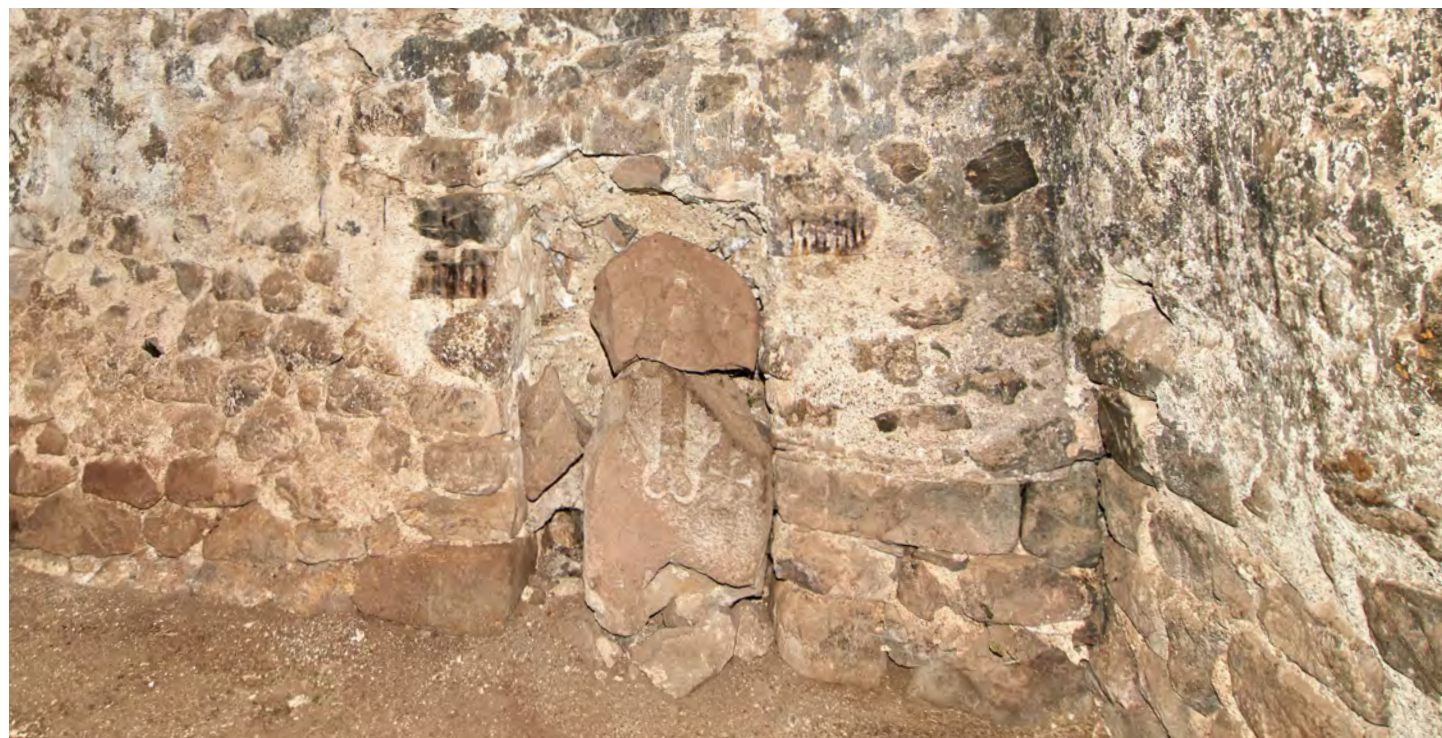
The church was built with coarse stones assembled with mortar. There is one entrance to the church on the northern façade, but another one would have been on the southern façade, which is now closed². A *khachkar* has been placed in front of the filled opening, on the interior (fig. 7). Inside the church, traces of plastering can be observed on the walls. The *bema* was elevated but the floor has not been well preserved.

Fig. 7. The southern entrance now closed (Iconem 2020)

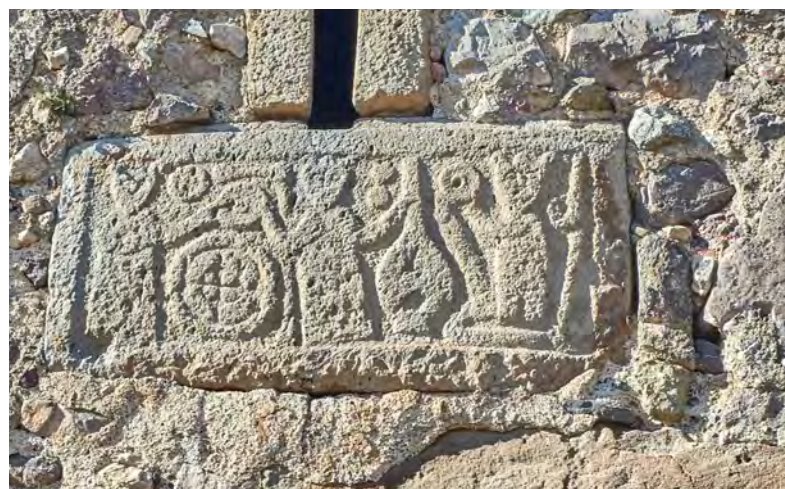
A couple of carved stone blocks have been reused on the eastern and western façades. The one on the eastern façade is a 16th-17th century tombstone with a figurative scene (fig. 8). Inside the church, a stone block placed over the window of the apse is carved with a dedicatory inscription dated from 1246³, which was used to date the church (fig. 9). However, architectural criteria allow dating it around the 17th century. According to S. Karapetyan, it was built in order to replace the previous ruined church of Arakhish⁴.

Fig. 8. A 16th-17th century tombstone (Iconem 2020)

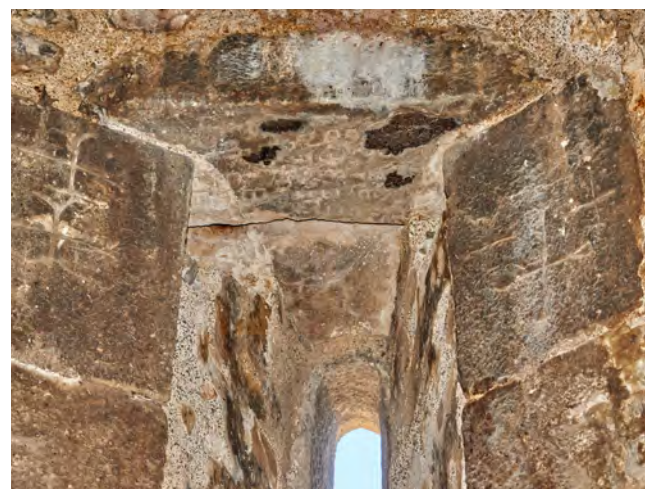
Fig. 9. A dedicatory inscription over the eastern window (Iconem 2020)

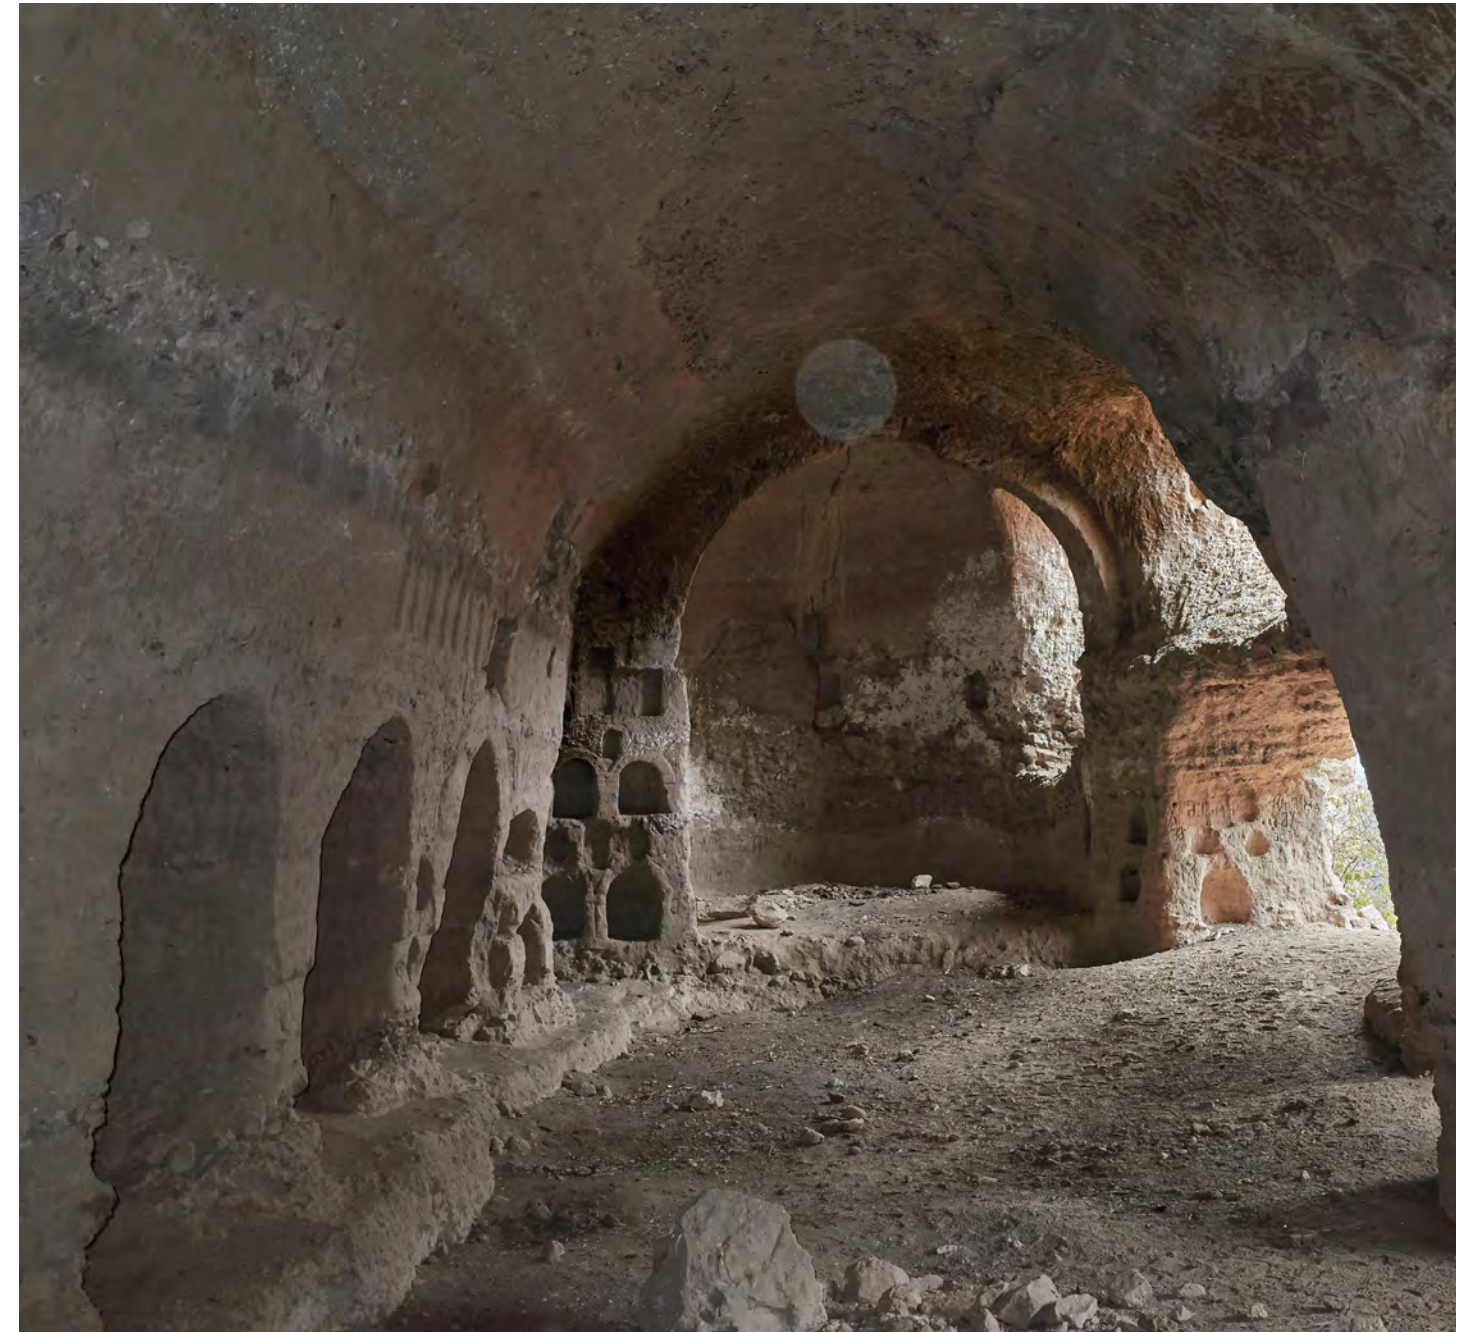
There are three entrances and two openings, one of them lightening the apse (fig. 4). Four arched niches are carved on the north-western wall, and one large niche is facing the apse, on the southwest (fig. 5). According to S. Shahinyan, the four arched niches were cut in the 17th century when the monastery turned into a priory⁶. A small room is cut on the northern side of the apse (fig. 6), identified with the number 4 (fig. 3). Also, a large number of smaller niches are carved inside the church (including blind arches) : these could have had a liturgical function as well as a decorative one.

Fig. 4. The church's apse (Iconem 2020)

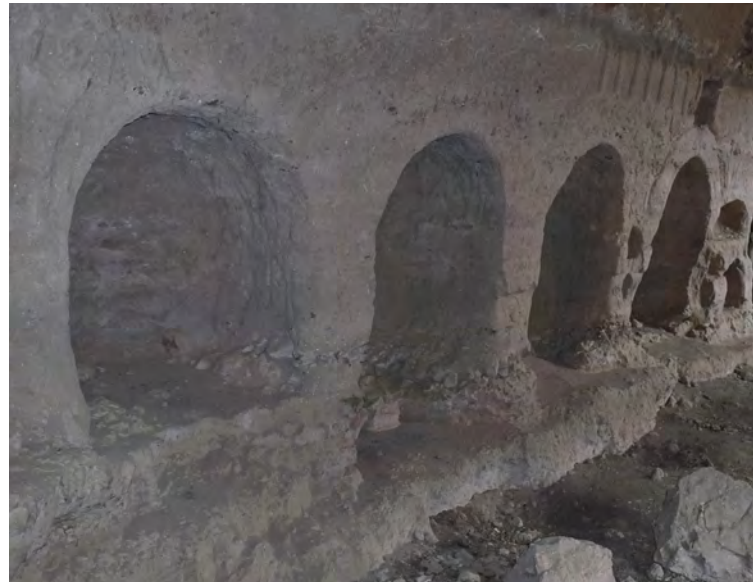
Fig. 5. The niches carved into the north-western wall (Iconem 2020)
