HERITAGE
WATCH.AI

ARMENIAN CULTURAL HERITAGE SITES
CONDITIONAL REPORT

2 0 2 0

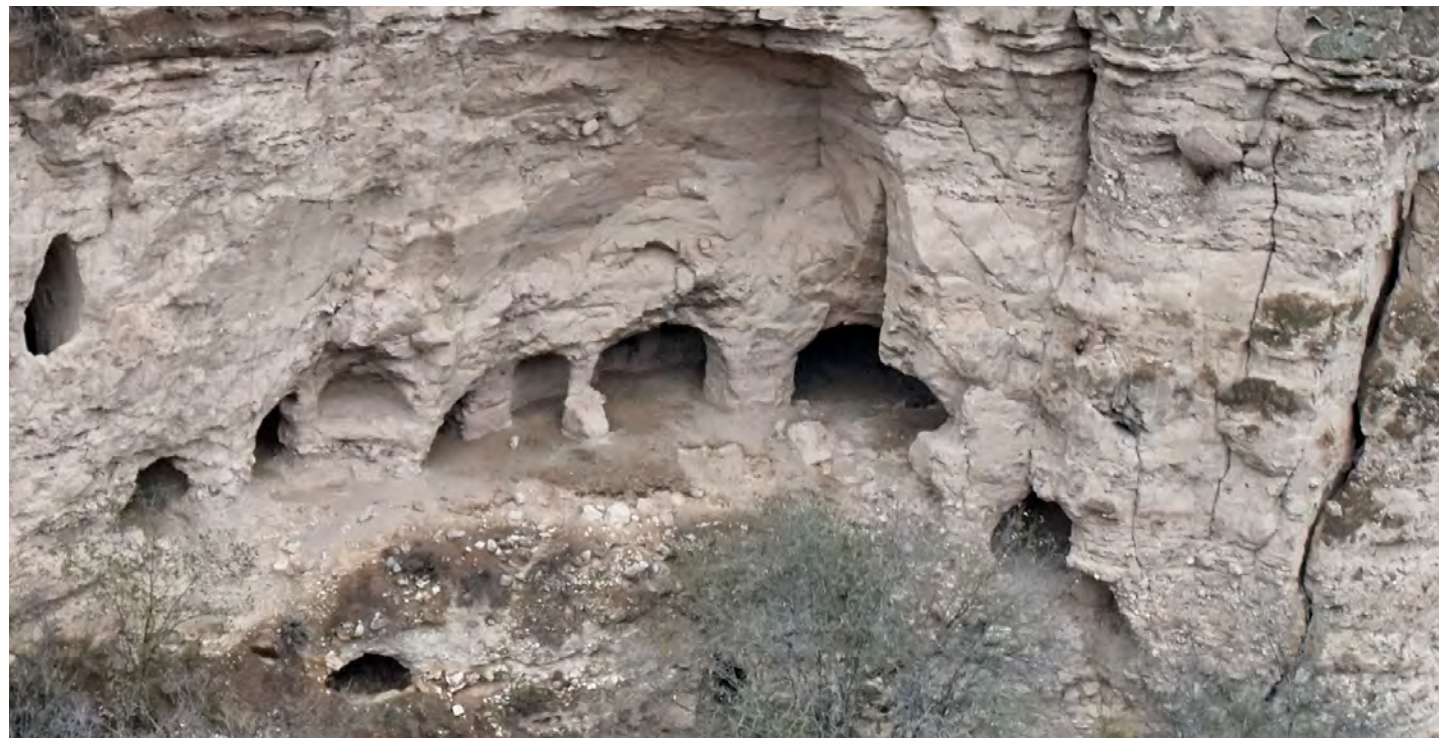
Besides the church, there is another large cave with rock-cut columns (fig. 7), identified with the number 8 (fig. 3). Several niches of different sizes are also carved on the interiors. Most likely, it served as the refectory of the monks, which was also mentioned by Arakel Davrijetsi⁷. A narrow rock-cut corridor opens on the north-eastern side of the room and goes into the precipice, which Shahinyan believes was the only entrance that originally lead to the monastery for safety purpose.

Fig. 7. Aerial view of the refectory (?) (Iconem 2020)

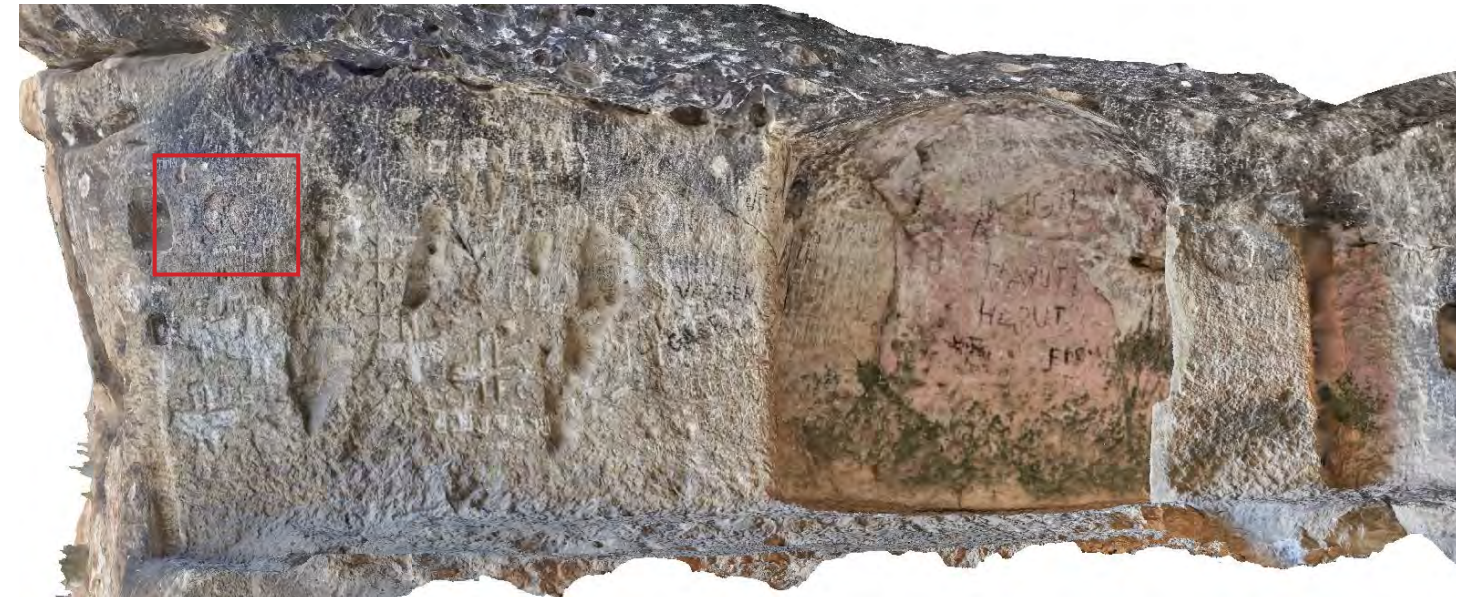
According to the archeologist H. Petrosyan, the architectural plan of the church is quite unusual because the chancel has a north-south orientation, with an apse-like ending on the southern side (fig. 3-4). However, a traditional apse is carved into the eastern side (fig. 5). Based on this evidence, and taking into account the karstic nature of mount Vankasar, he suggested that the church was installed by reshaping a pagan cave, which was itself installed in a pre-existing natural cave⁴. A platform develops on the northwestern side of the church, outside the entrance, with an altar-like design on the western side, identified as a narthex (fig. 3 and 7)⁵. A great number of early-Christian crosses are carved inside the church (fig. 5 - 6), on the western wall of the narthex (fig. 7), as well as all along the path leading to the church (fig. 8)⁶. Some of them keep traces of polychromy, indicated that they were painted in red. Several inscriptions in Greek and in Armenian, mainly *graffiti* from pilgrims and the monogram of Christ in greek (IC XC), around the carved crosses, have also been found (fig. 6). The structure of the church is not particularly endangered. However, the walls, including the carved crosses, have suffered of degradation, both from recent *graffiti* and from the scratching of the crosses.

Fig. 5. Orthoimage of the north-eastern wall (Iconem 2021)

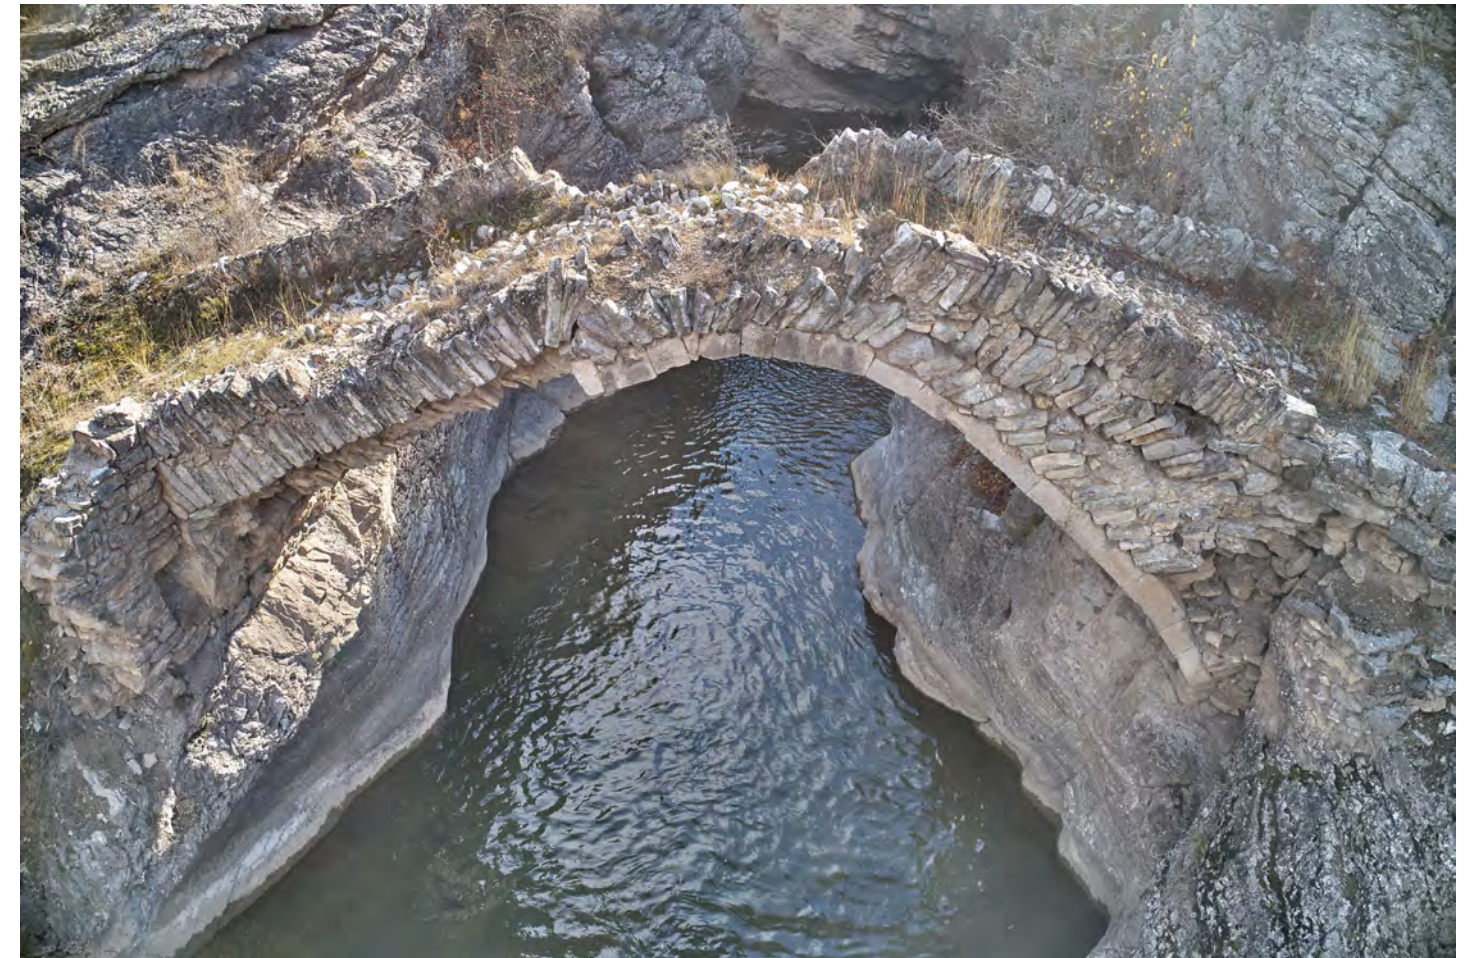
Fig. 2. Aerial view of Gandza bridge (Iconem 2020)

The bridge is located 700 meters east from the village of Gandza (Seyidlar), on the river Shalua, also called Arquet (fig. 1). It is a 10 meters long arched bridge with a width of 3 meters, founded on the natural rocks (fig. 2 - 3). The bridge's arch is almost pointed. The extremities of the lower row are made of cut and polished stones and the rest of the bridge is built with thin flagstones assembled vertically with lime mortar.

On the eastern part of the bridge, the polished stones of the lower row have collapsed, but the bridge is still standing thanks to the internal structure of the bridge with the flagstones. However, parts of the flagstones are also missing, especially near the bases of the bridge, which could endanger the structure.

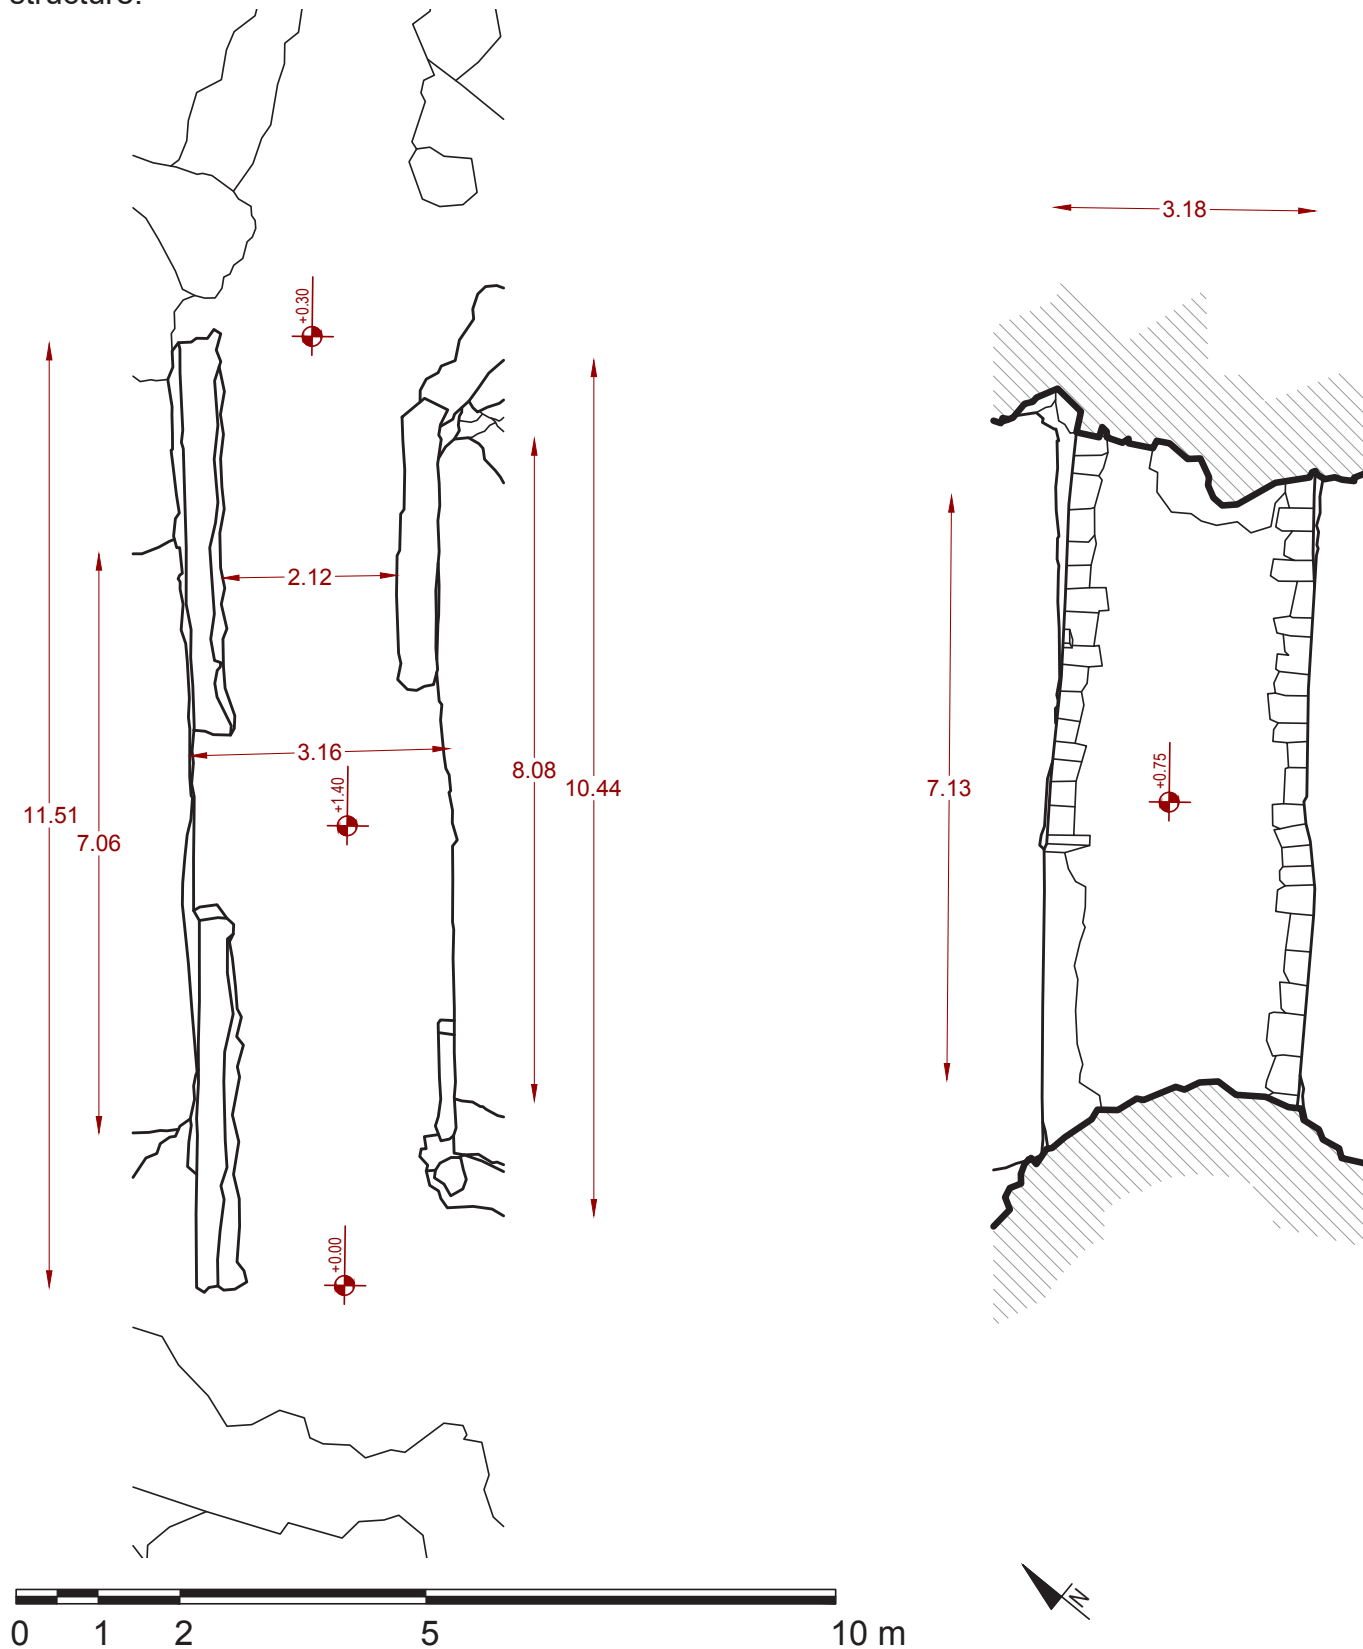
Fig. 3. Plan of Gandza bridge (Iconem 2021)

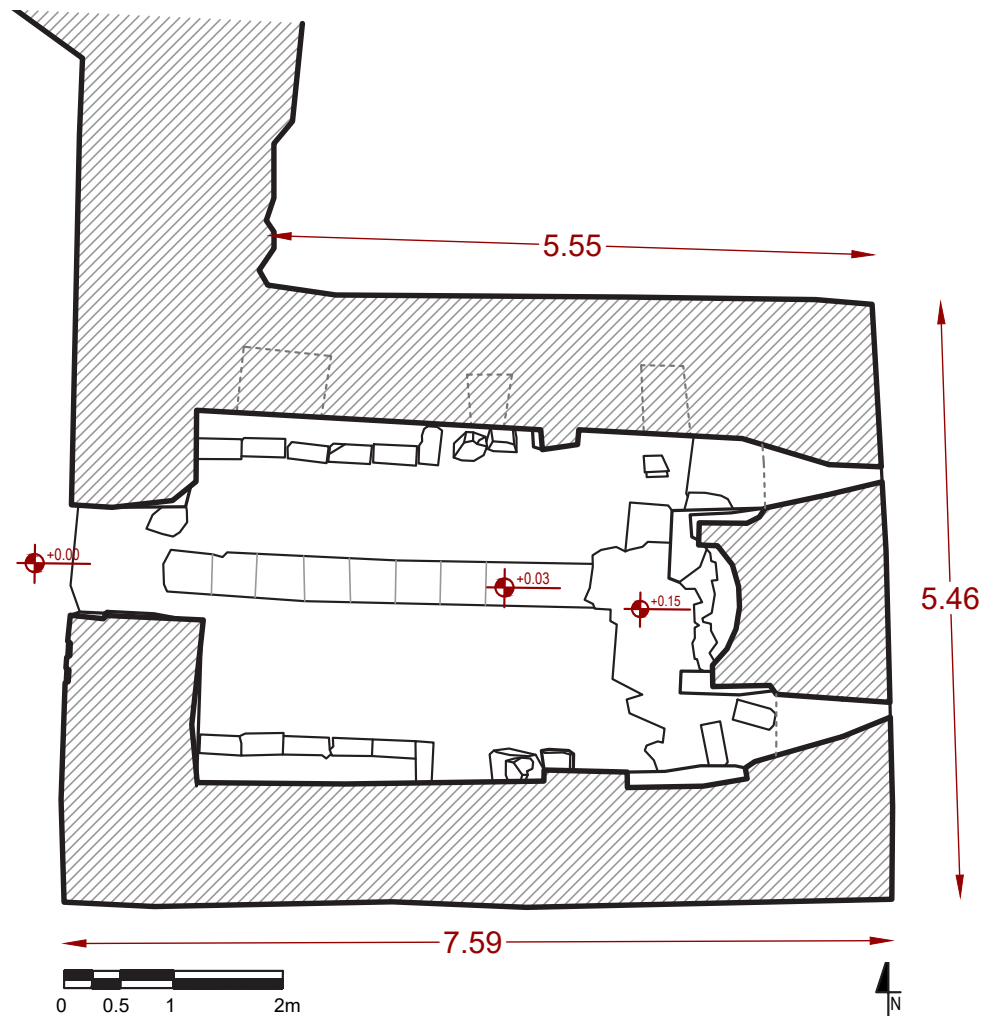
The church is a quadrangular single nave basilica of small dimensions (7,46 x 5,58 m), built with semi-processed stone blocks assembled with a lime mortar (fig. 1 - 3). The original semi-circular vault has not been preserved and has been replaced by sheet roofing. When the church was first documented in 1993 the vault had already collapsed. There is no apse as the eastern wall is flat on the inside and the outside, which could explain the presence of a semi-circular altar (fig. 4), a specificity of this church. The altar is very damaged but part of its *antependium* has been preserved and is carved with crosses.

Fig. 3. Plan of Takyaghaya's church (Iconem 2021)

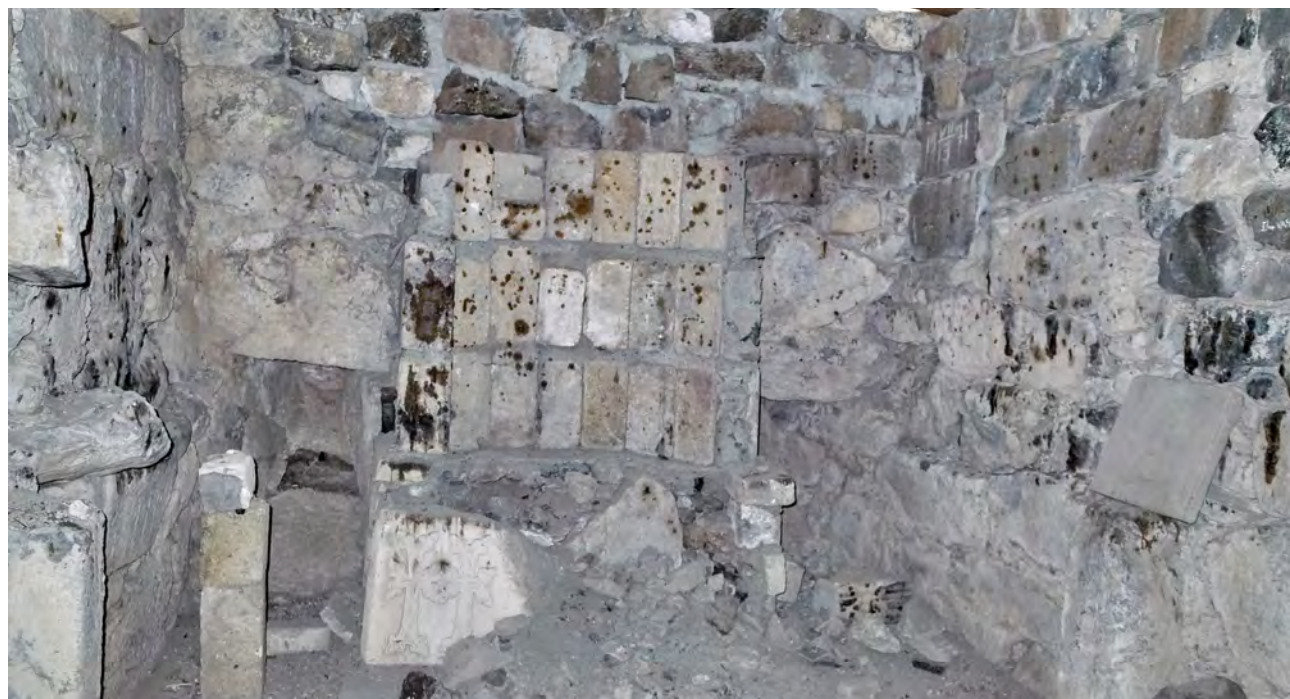
Fig. 4. The church's altar (Iconem 2020)

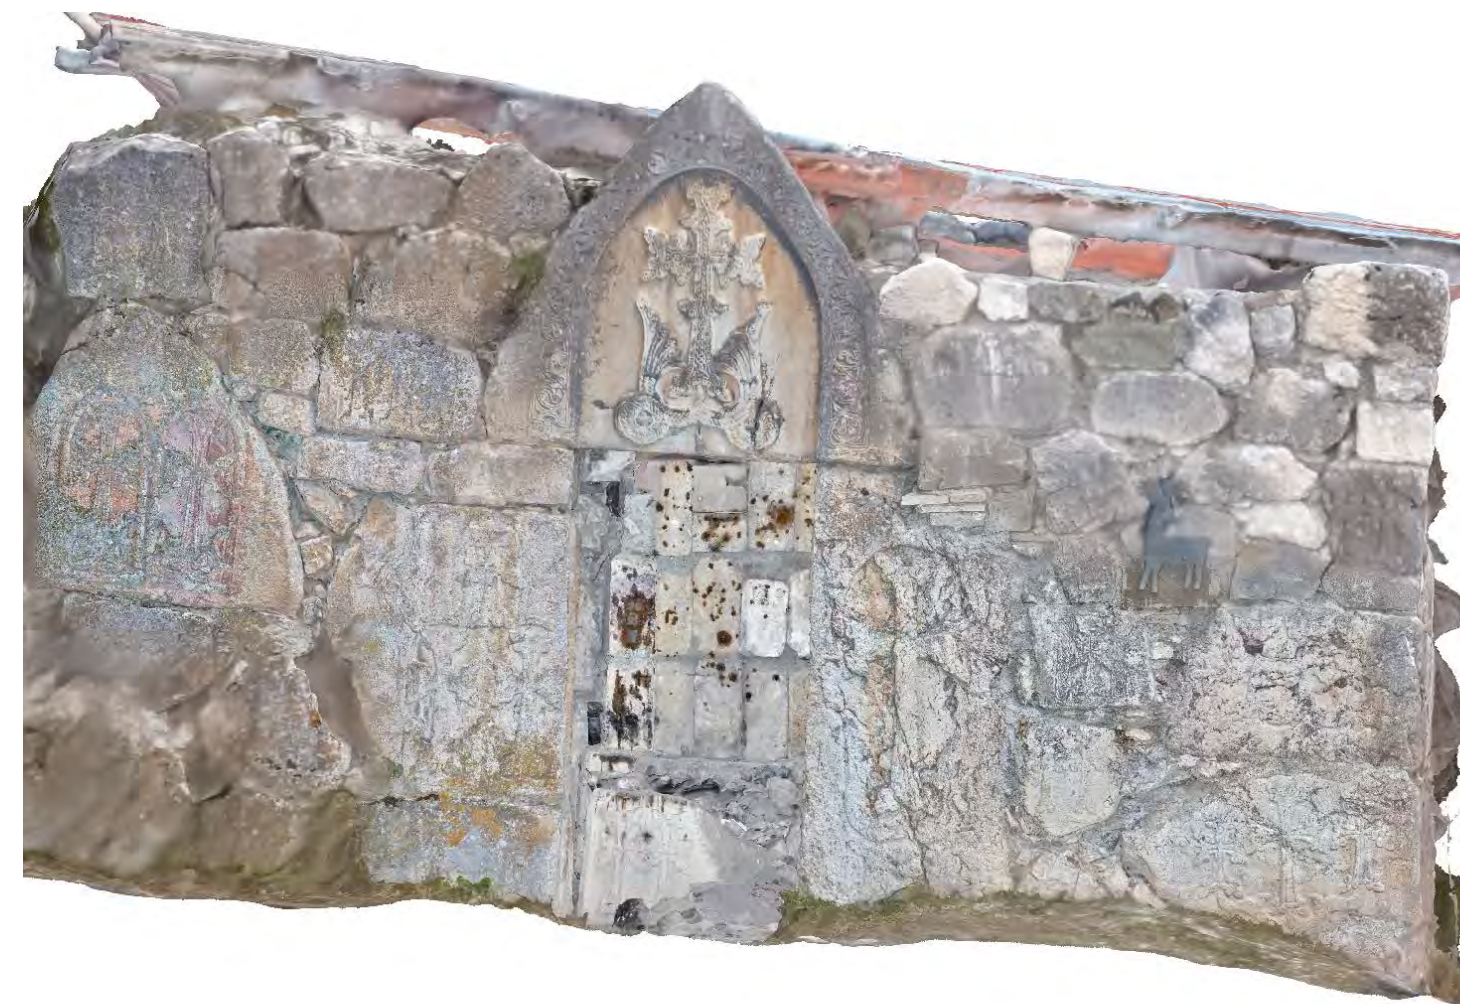
Besides the altar, there are many carved crosses on the façades of the church and near it. The western façade is quite remarkable for the profusion of carved crosses (fig. 5). The cross carved on the tympanum is particularly noteworthy, not only because of the quality of its carving but also because of its strong similarity with a *khachkar* precisely dated from 1330¹, probably made by the same hand (fig. 6). There are also carved stones on the rocks around the church.

Fig. 5. Orthoimage of the western facade (Iconem 2021)

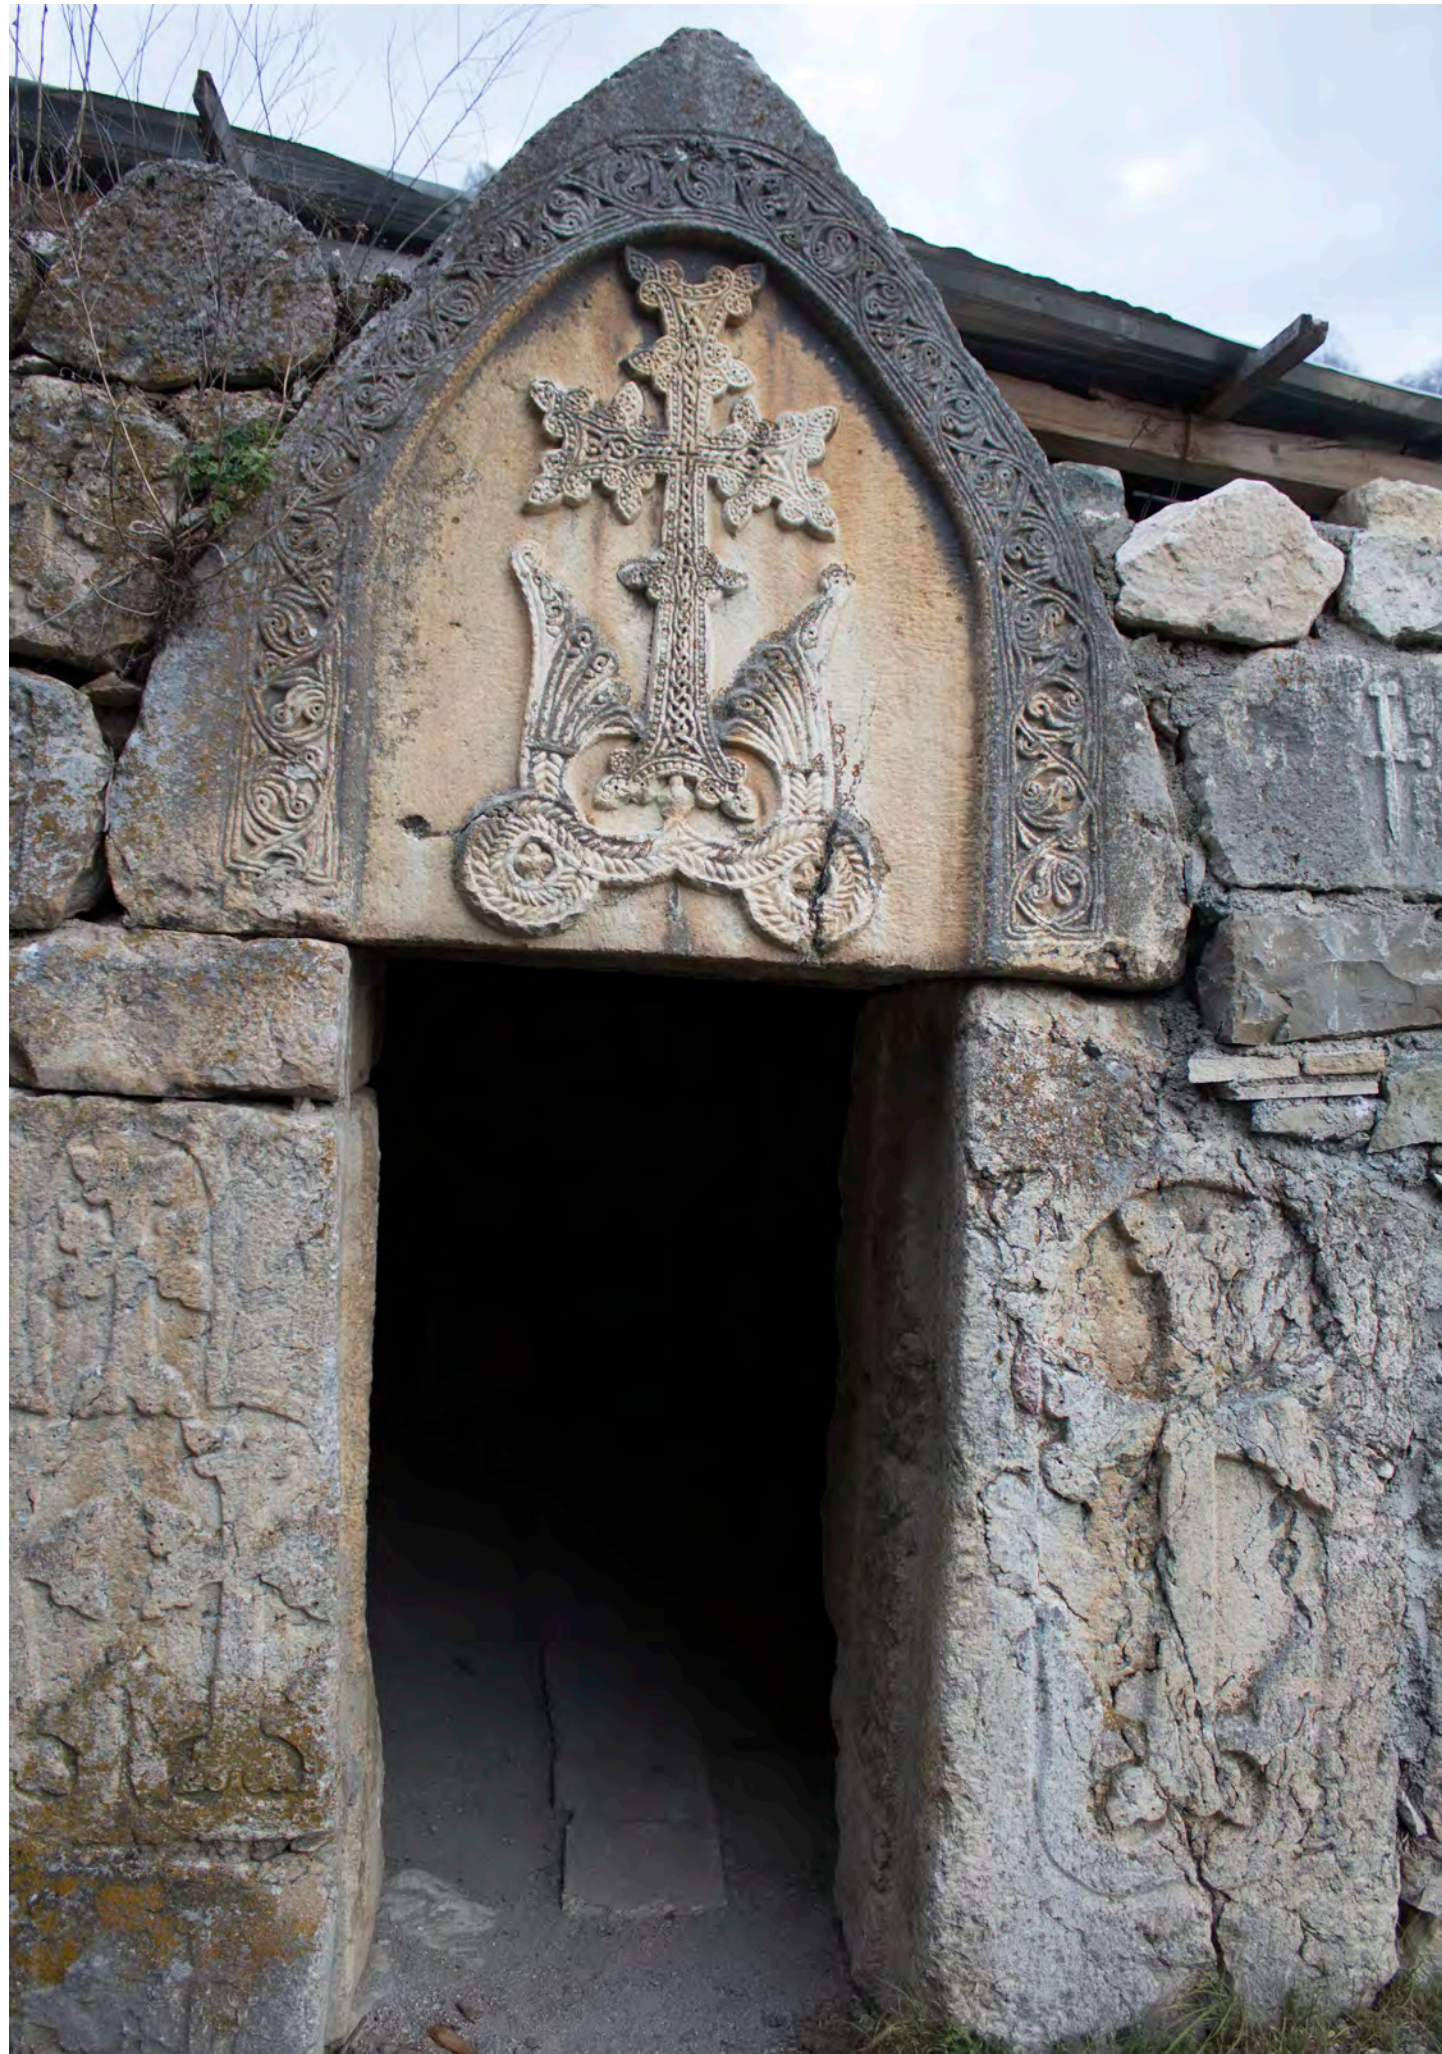
Fig. 6. The western entrance and its carved crosses (Iconem 2020)

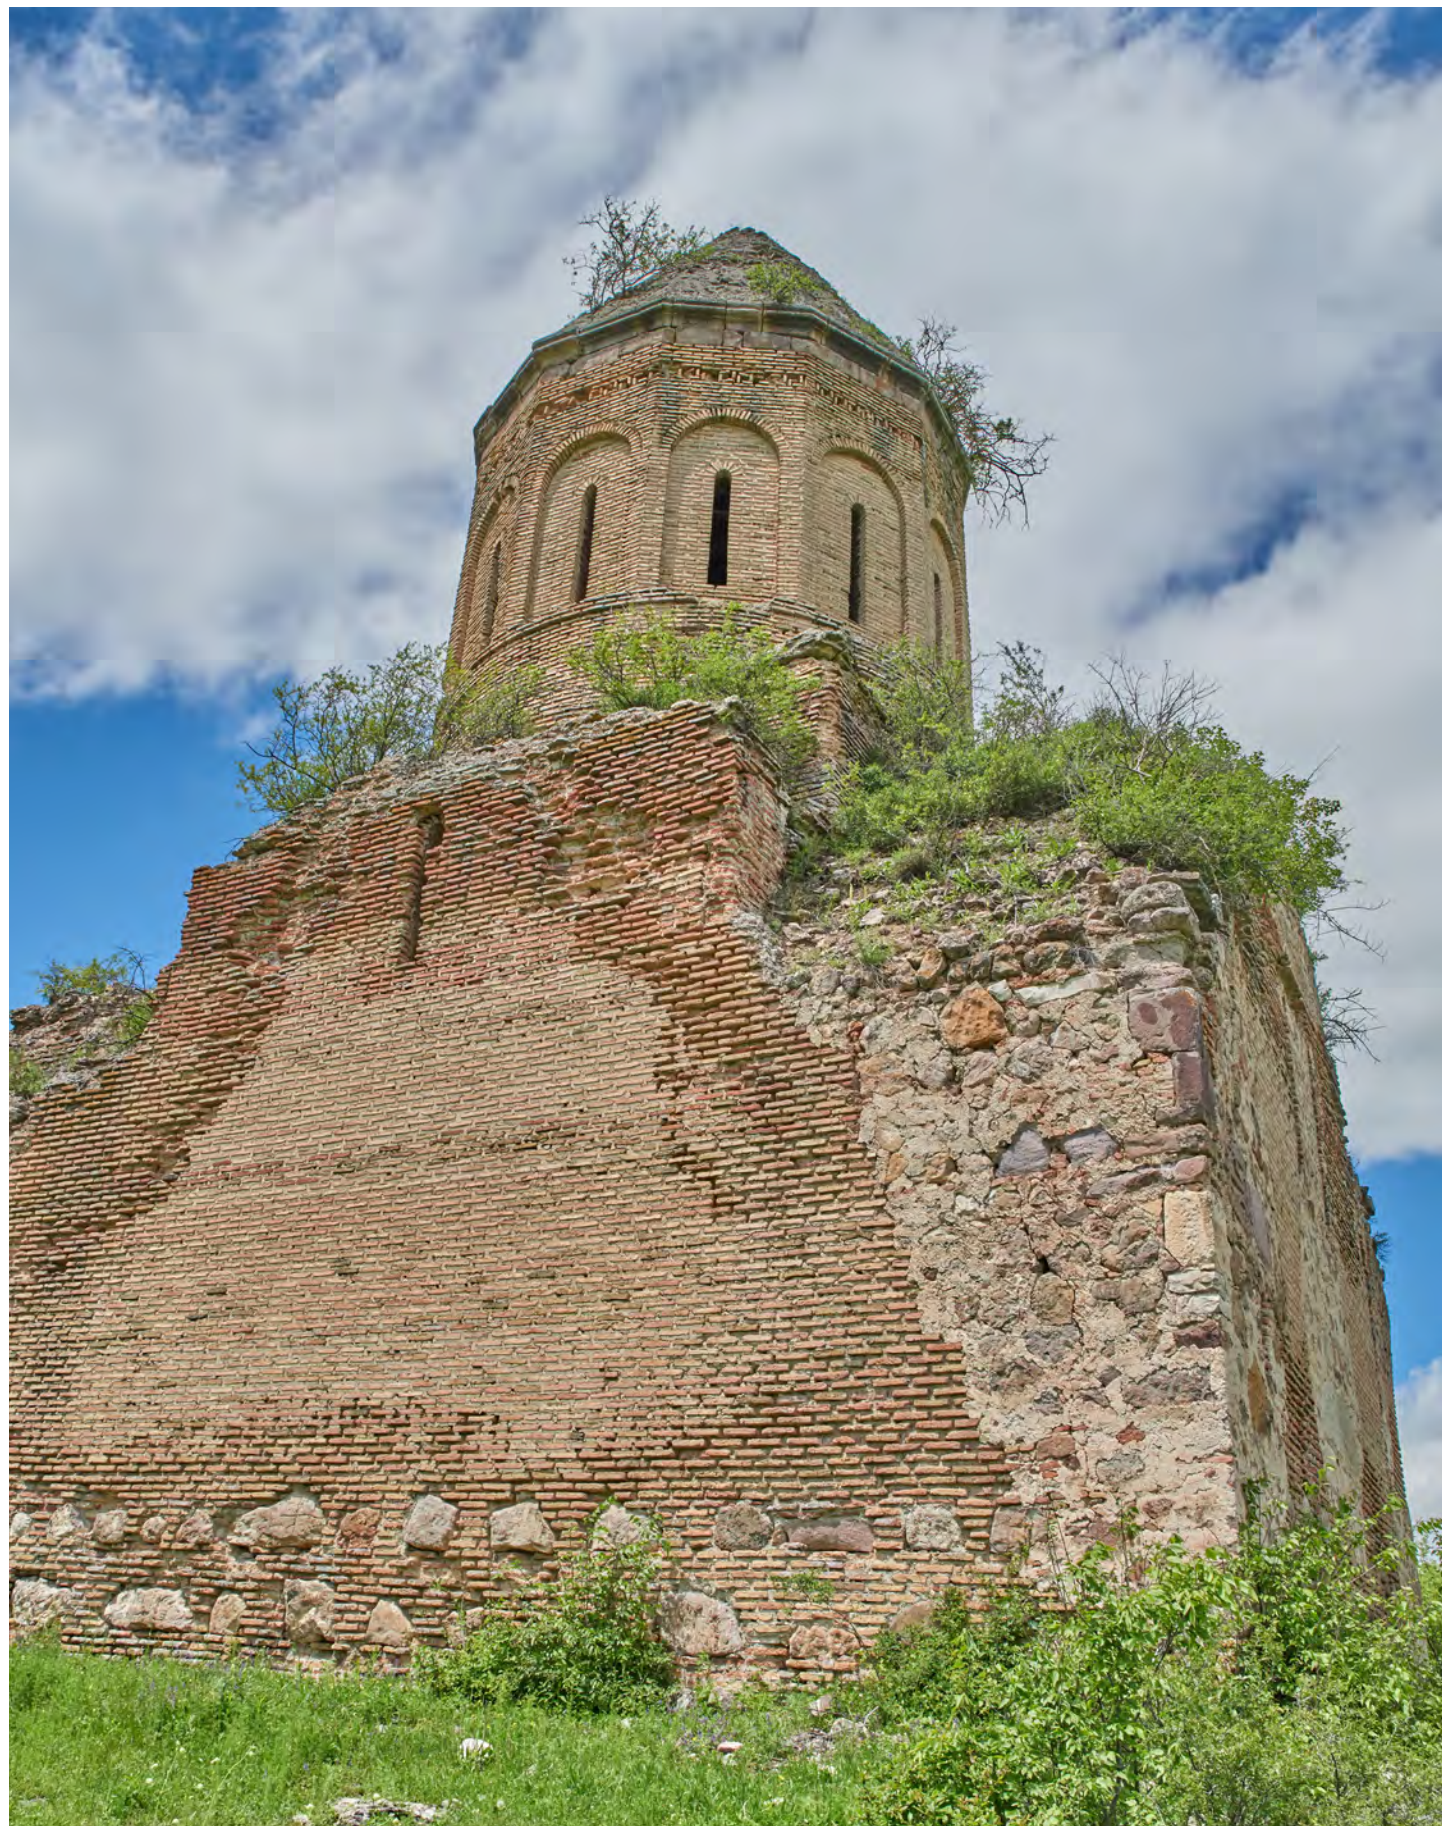
Fig. 3. Southern facade of Surb-Nshan church (Iconem 2021)

The main church was dedicated to the Holy-Sign (Surb-Nshan), as evidenced by an inscription on the altar. Although the first rows of the church are built with stone rocks, the rest of it is made of bricks (fig. 3), a Georgian specificity which can also be found in the churches of Kirants and Berdavan². The church is topped with a high pointed dome resting on a dodecagonal drum. It has an inscribed apse flanked by two sacristies (fig. 4). On the northern wall, an arched niche contains a baptismal font. Several *khachkars* and other architectural elements from another structure have been inserted in the walls, probably during renovations (fig. 5). The church has been renovated several times, more precisely the eastern façade’s corners, the main apse, the western entrance and the dome. The western part of the church has collapsed (fig. 6).

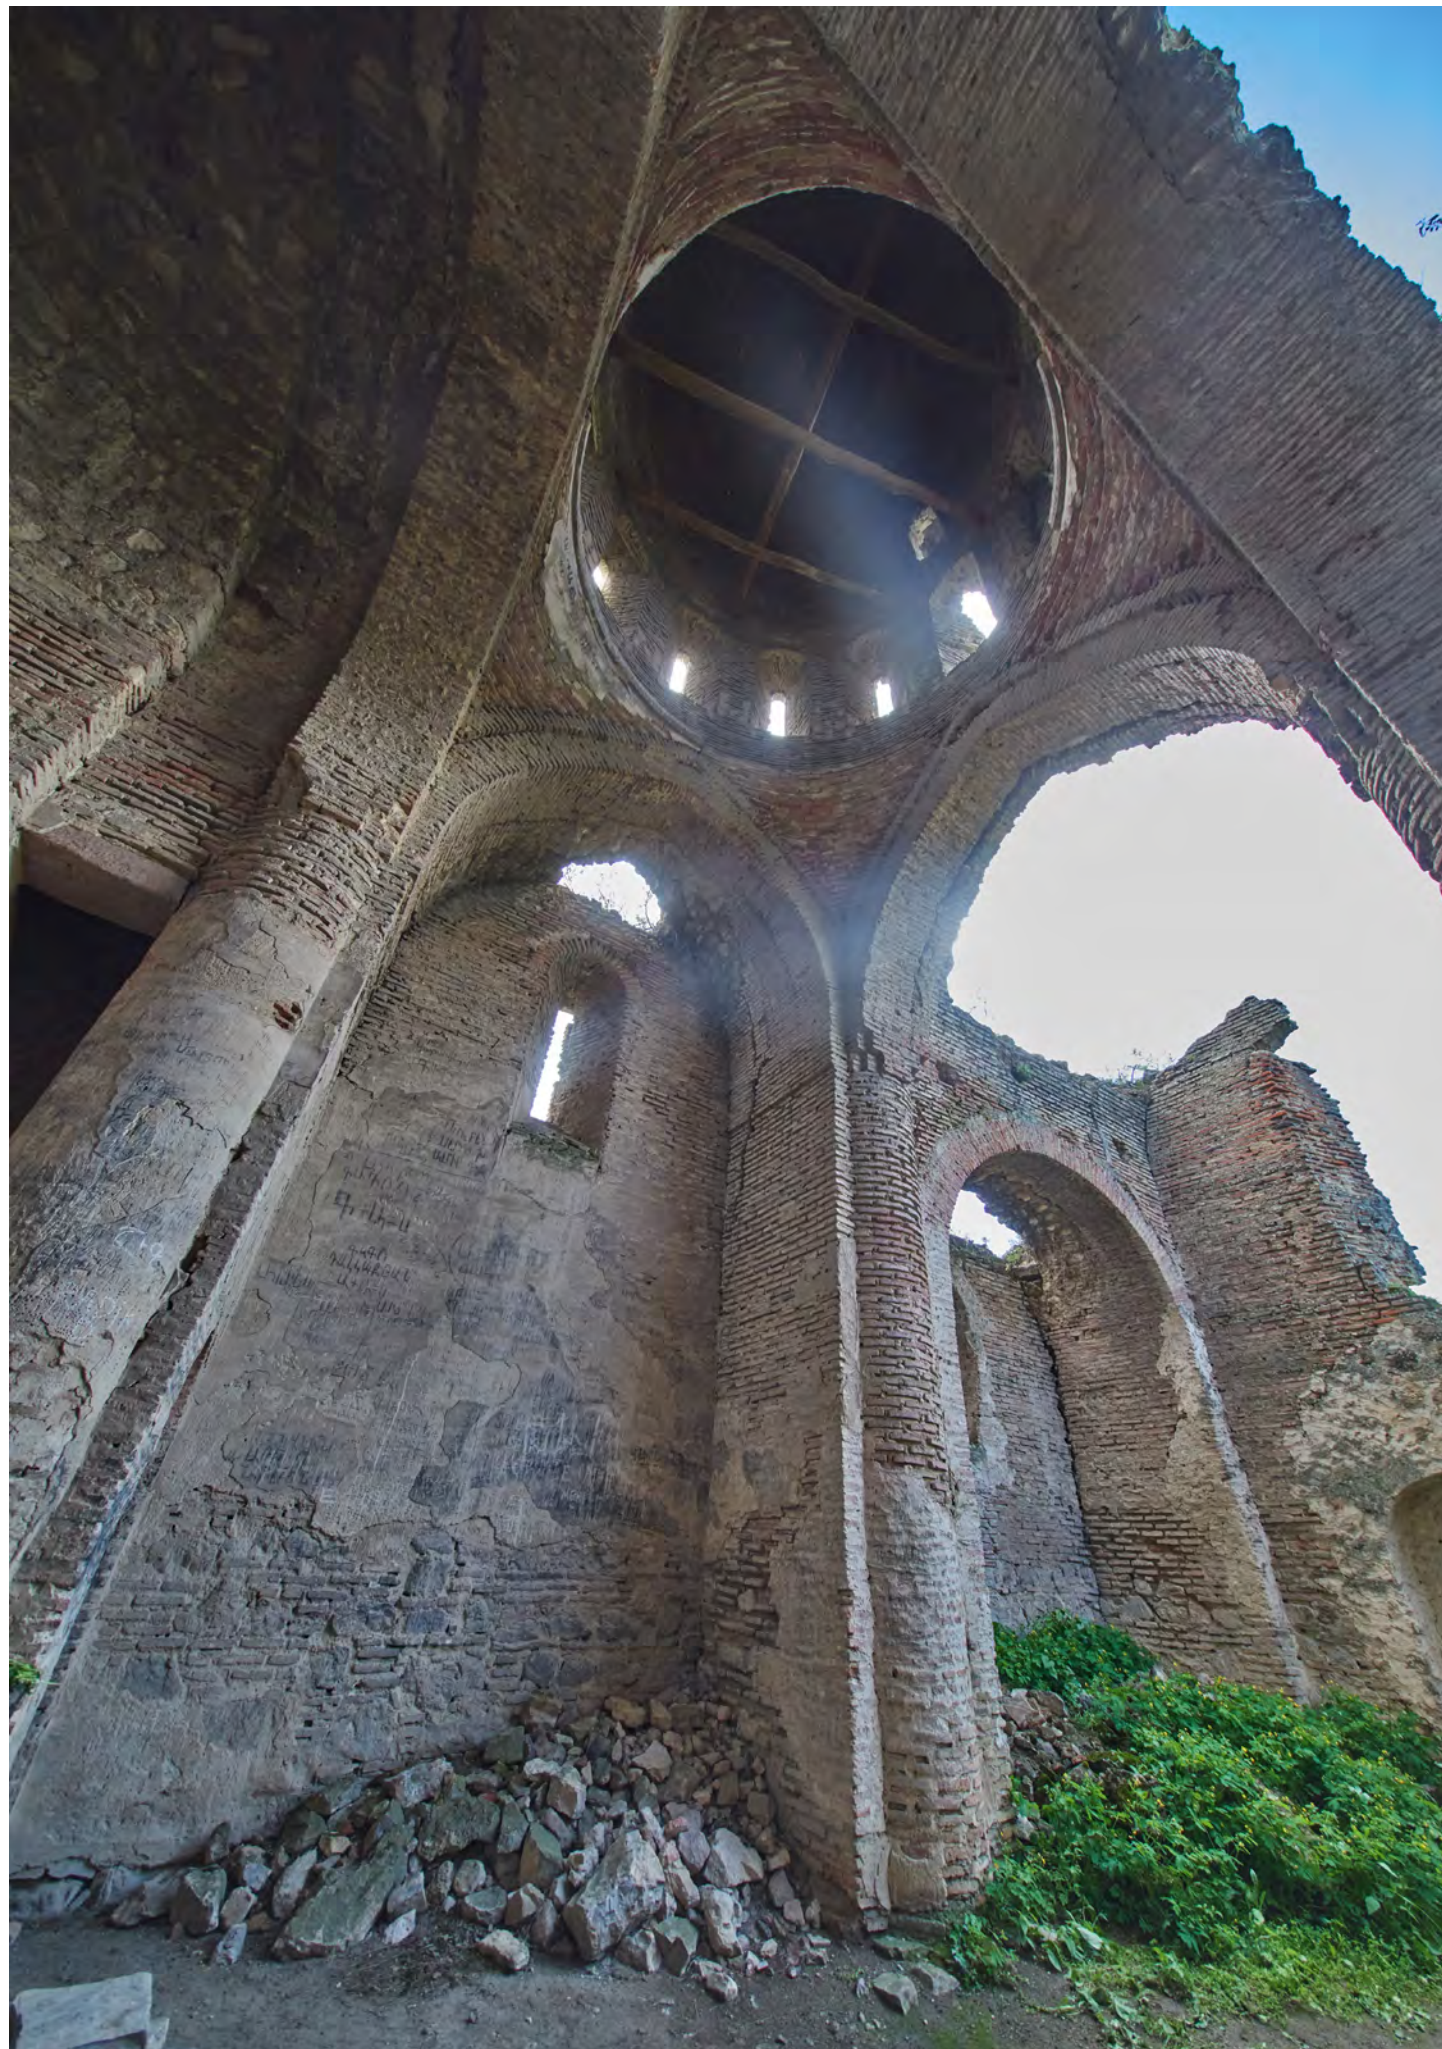
Fig. 6. Interior view of the western part of the church (Iconem 2021)

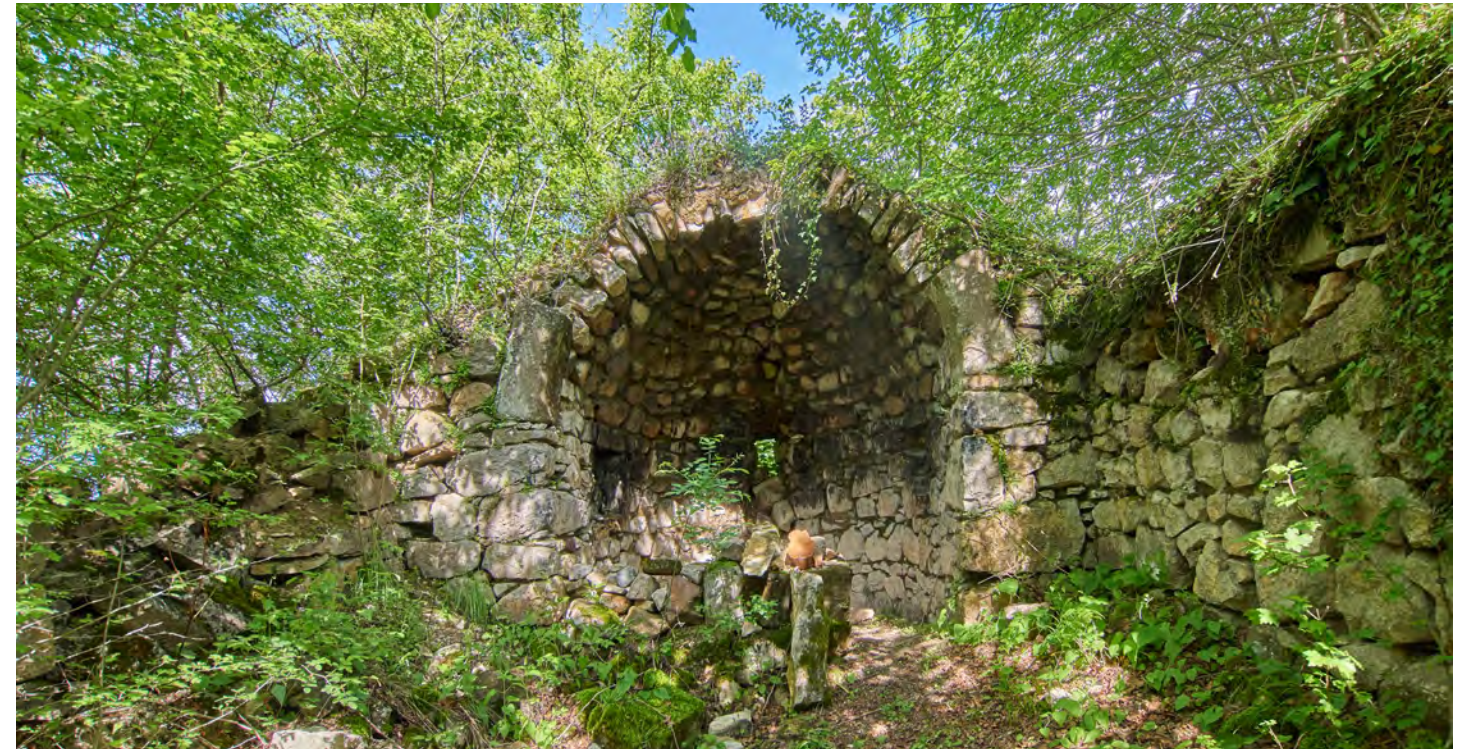
Another small church was built with stone blocks in the end of the 19th century, dedicated to the Holy-Mother-of-God (Surb-Astvatsatsin), on the northern side of the monastic complex (fig. 1 and 7). An original medieval *khachkar*, which is carved with two large crosses and one small cross in the middle, was inserted in the left side of the main entrance (fig. 8). The roofing has entirely collapsed and the church is invaded by vegetation.

Fig. 7. South-western corner of Surb-Astvatsatsin church (Iconem 2021)

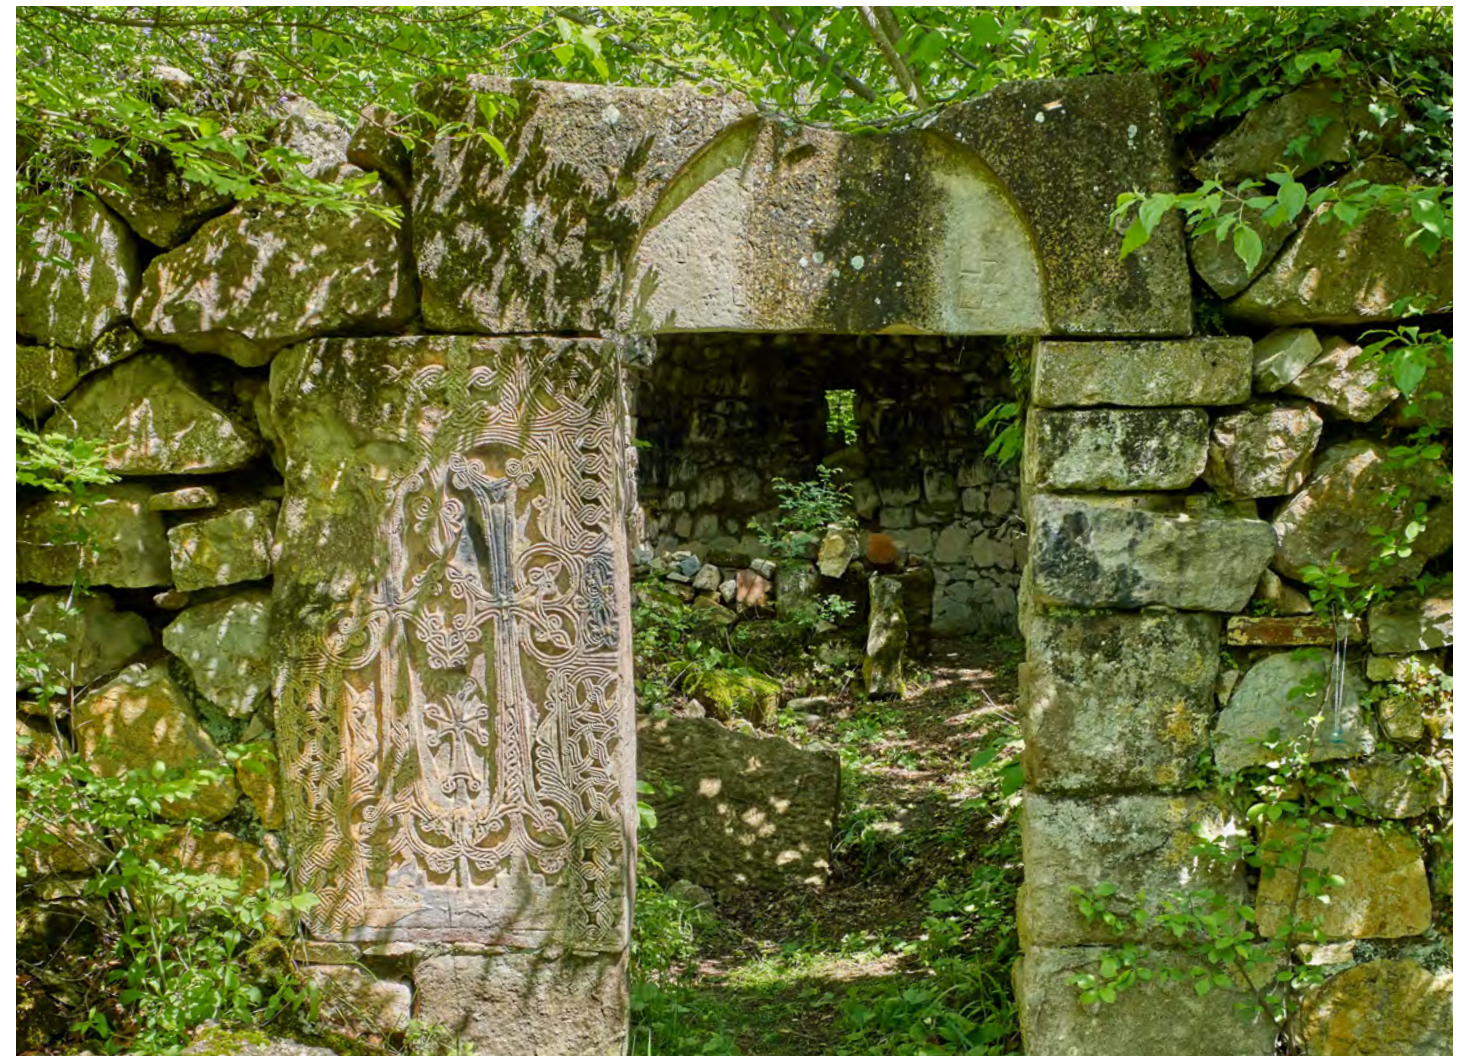
Fig. 8. The main entrance of Surb-Astvatsatsin church (Iconem 2021)
