HERITAGE
WATCH.AI

ARMENIAN CULTURAL HERITAGE SITES
CONDITIONAL REPORT

2 0 2 0

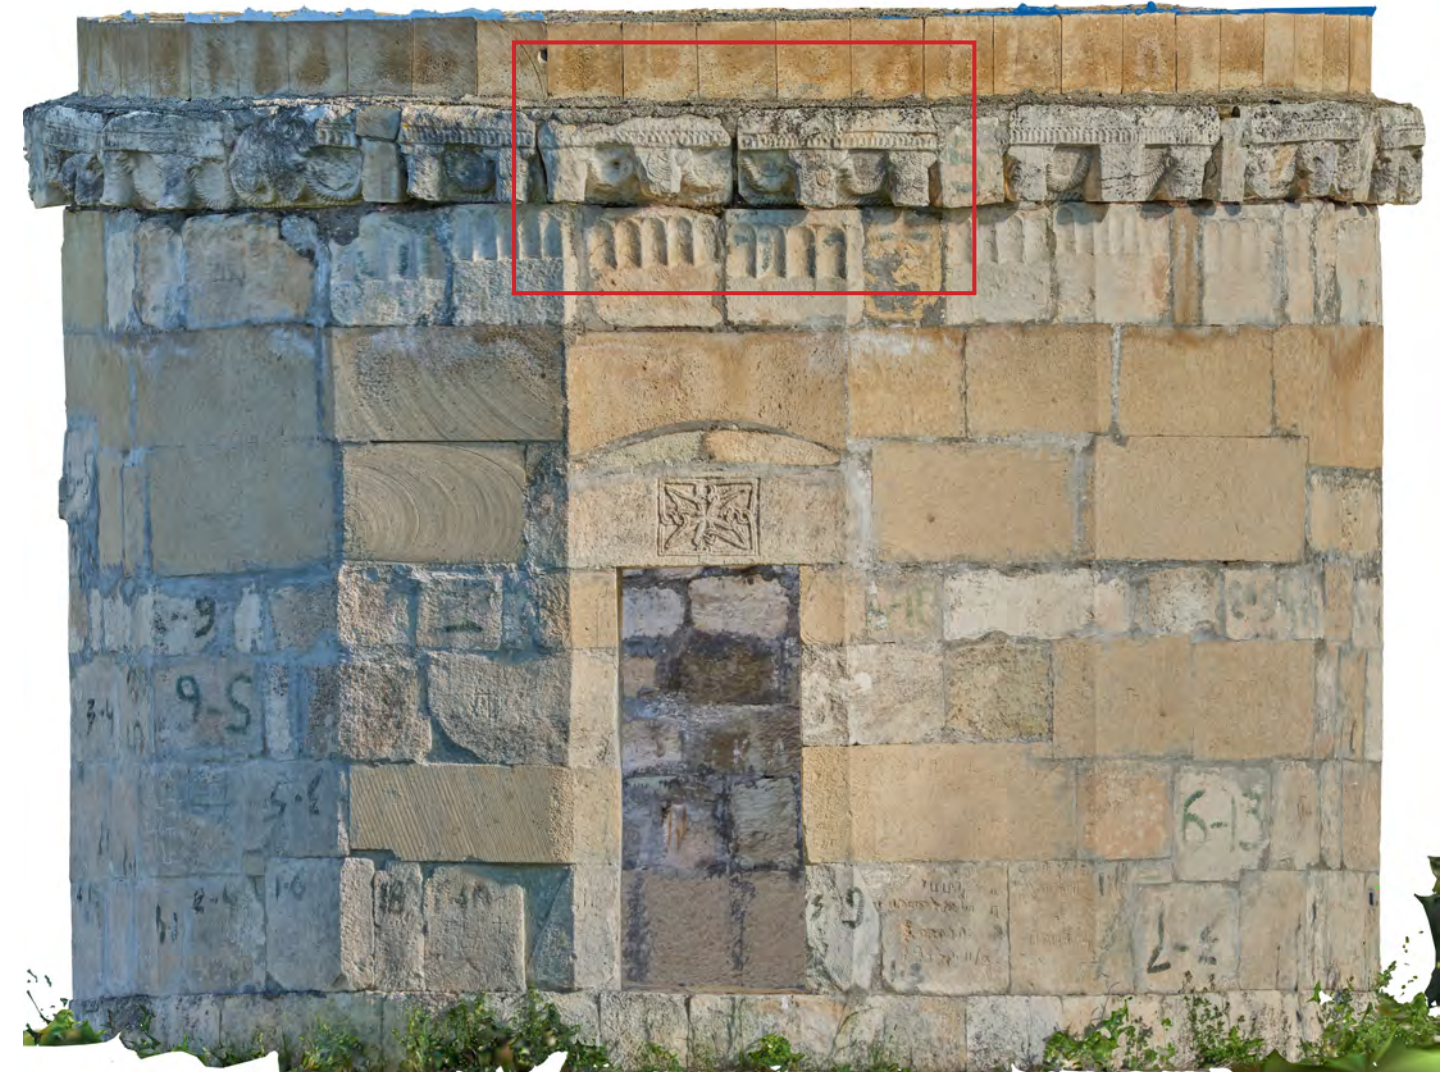
The mausoleum's entablature is carved with garlands intercepted with heads of various animals (ox, ram, boar...). There are also vegetal motives, such as acanthus leaves and flowers (fig. 6-7). A carved band of leaves surmounts the window's arch (fig. 5).

Fig. 6. Ortho-image of the mausoleum's southern facade (Iconem 2021)

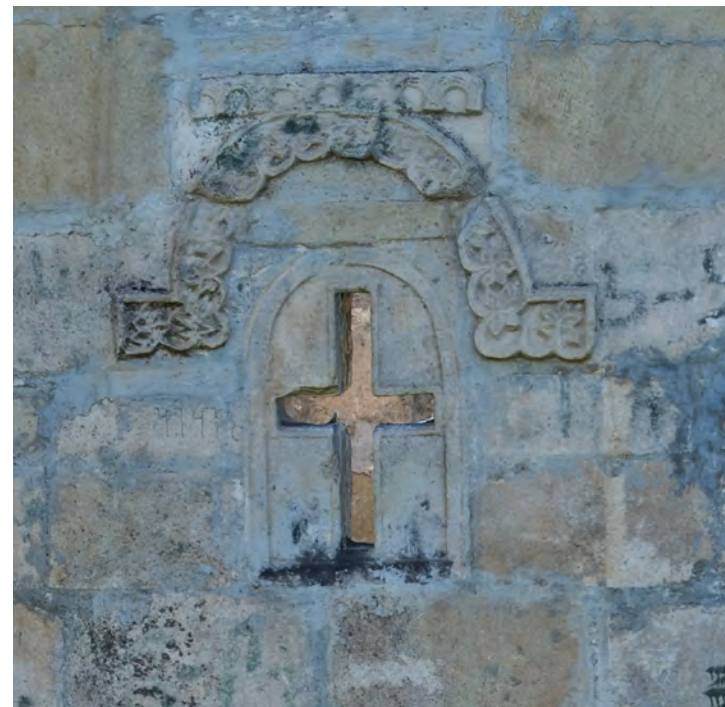
Fig. 5. The eastern window (Iconem 2021)

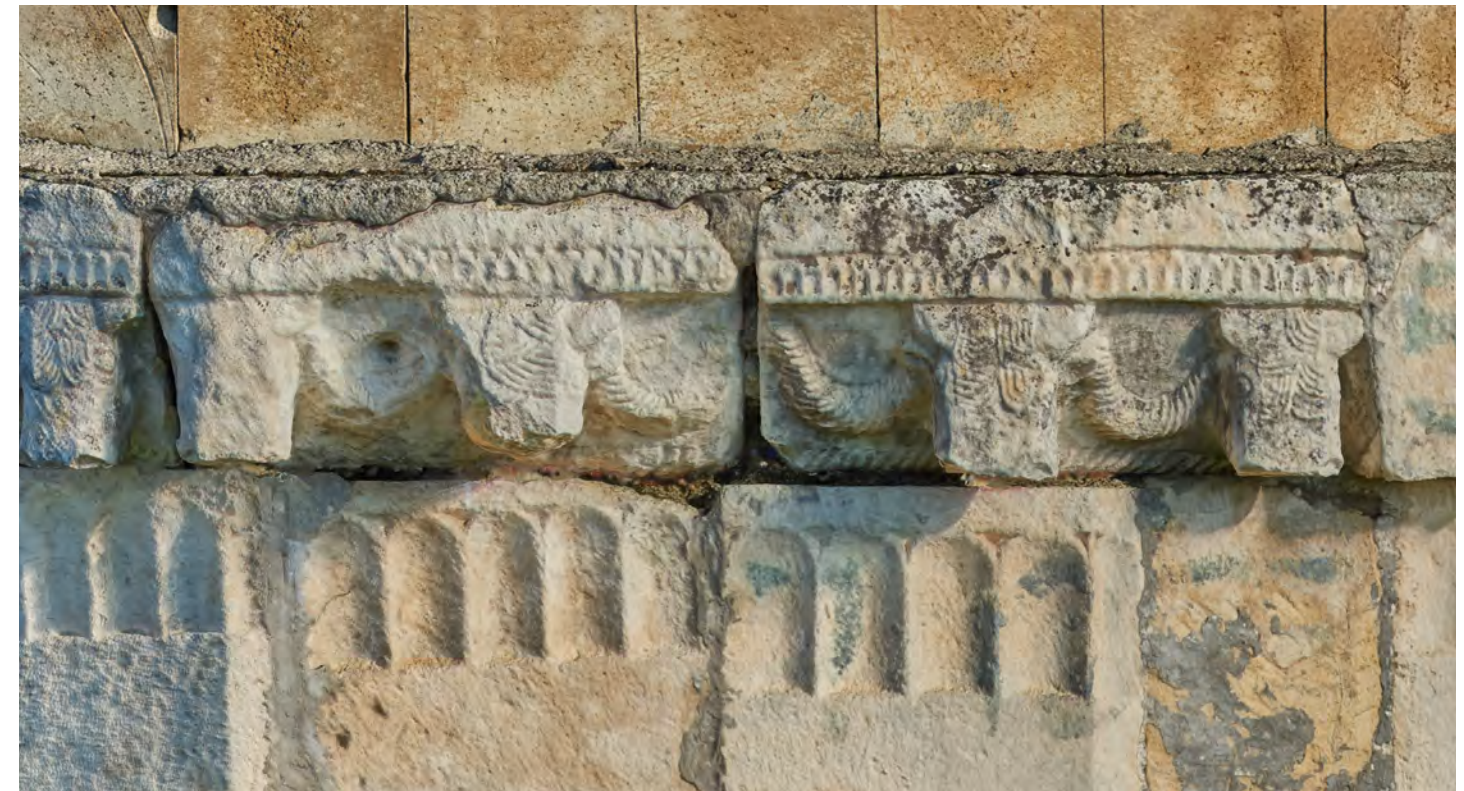
Fig. 7. Detail of the entablature extracted from the ortho-image (Iconem 2021)

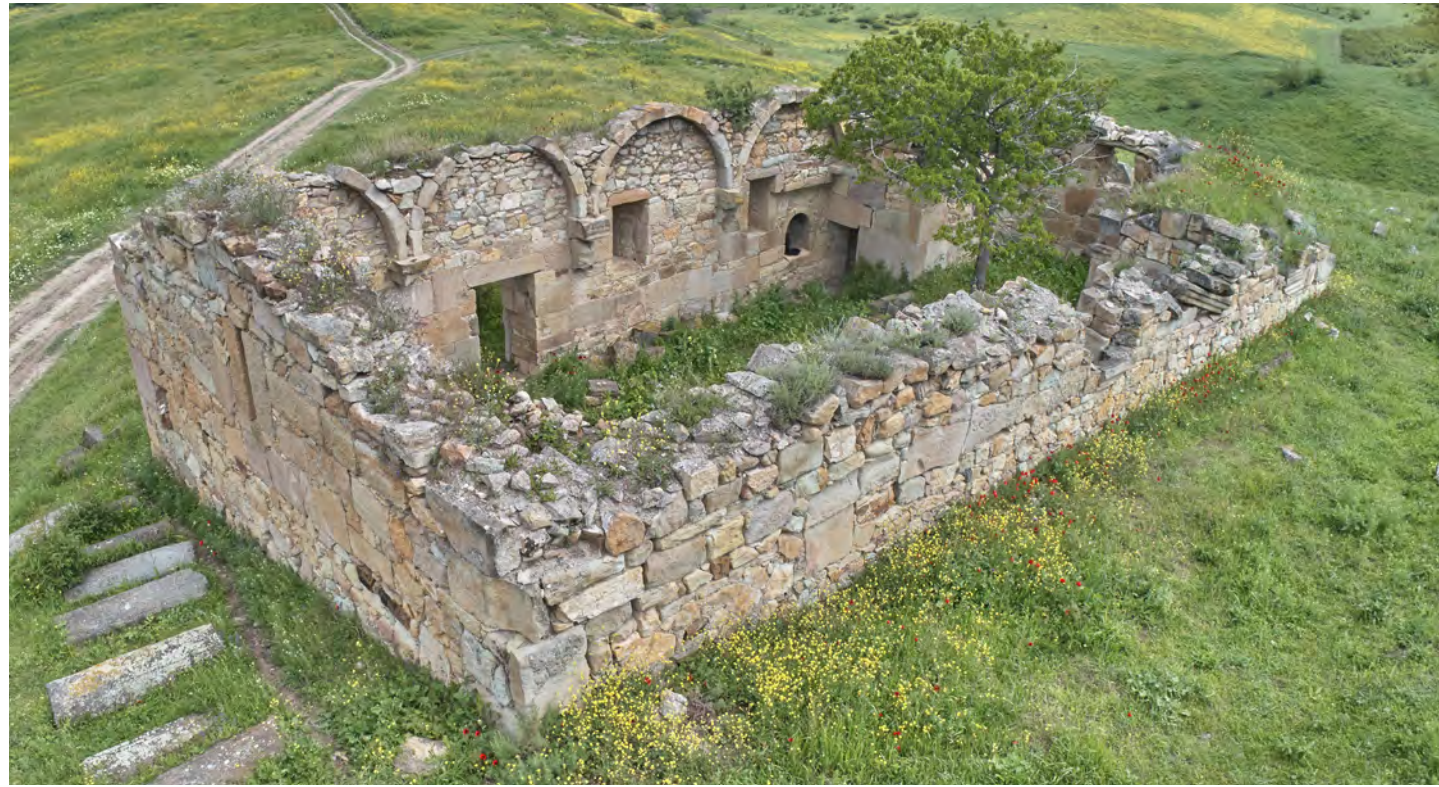
200 meters southwest of the fortress stands the Holy-Sign (Surb-Nshan) church, dated to the 18th-19th centuries (fig. 6). It is a three-nave basilica with an inscribed apse flanked with two sacristies. The roofing has not been preserved. There is a single entrance on the northern façade and several window openings. Part of the arcature of the northern and southern walls is preserved. However, the church's roof has collapsed and is invaded by vegetation.

Fig. 6. Aerial view of Berdavan's church (Iconem 2021)

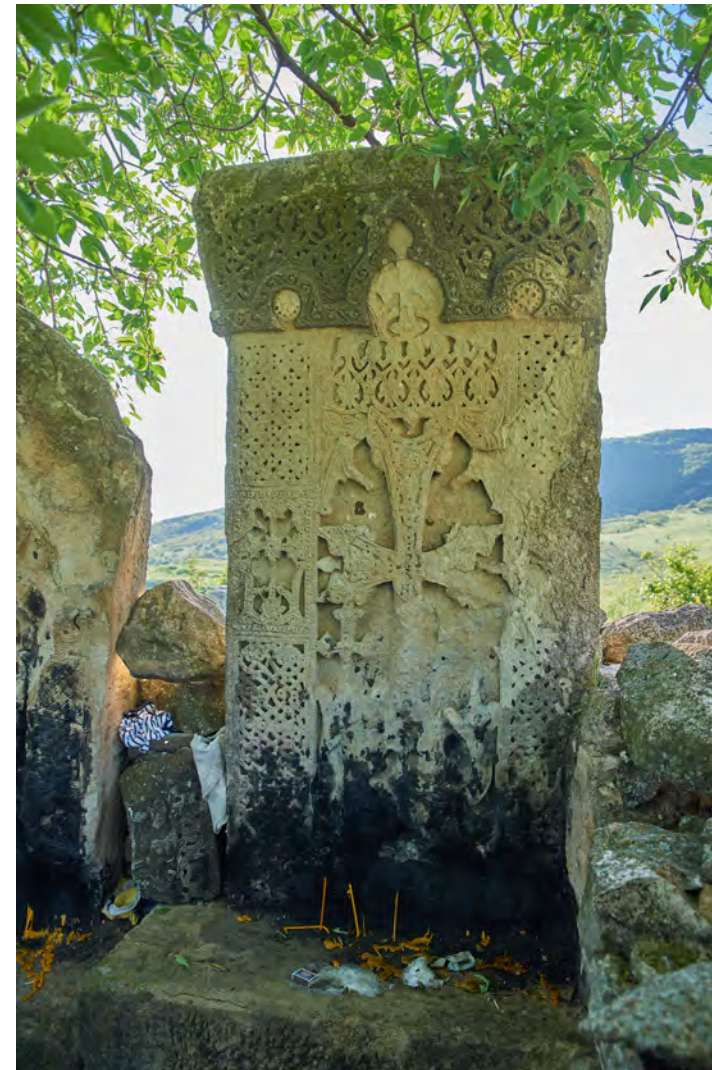
The cemetery lays 50 meters south of the church, with a small chapel, *khachkars* and several tombstones with inscriptions and representations of the deceased, dated to the 13th to the 17th centuries (fig. 7-8). A couple of *khachkars* are inside the small chapel (fig.9) The free-standing cross (13th century) is particularly noteworthy (fig. 10)³. The cemetery's tombstones and *khachkars* are quite deteriorated as well.

Fig. 9. A *khachkar* inside the chapel (Iconem 2021)

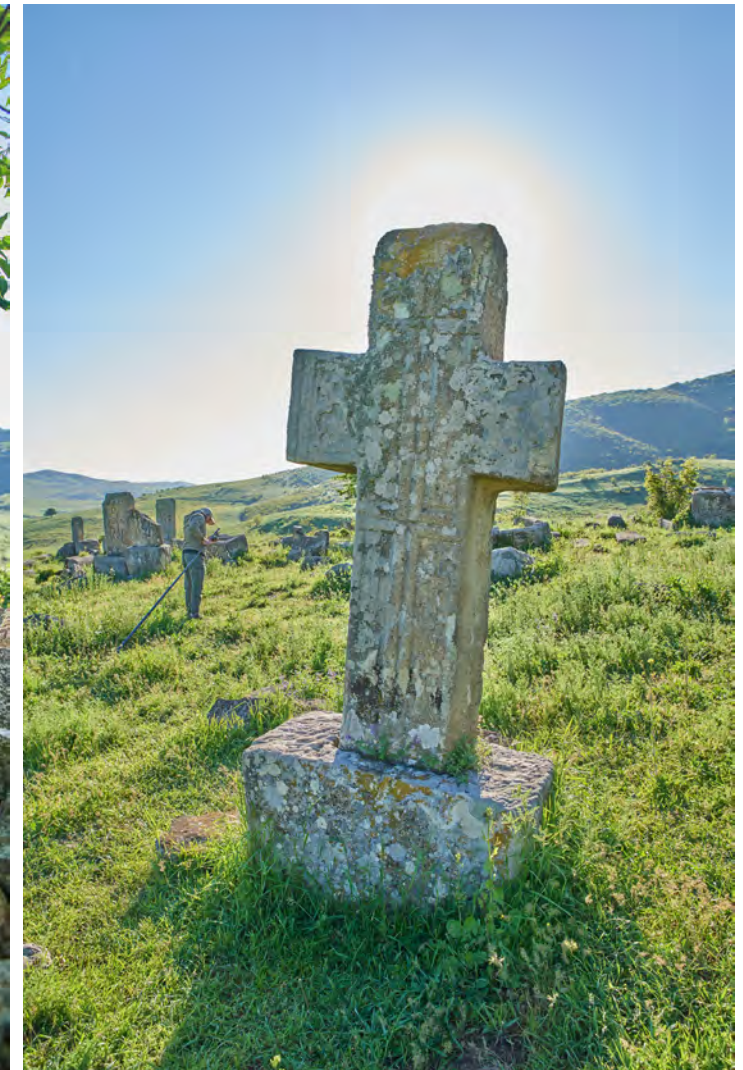
Fig. 10. The free standing cross (Iconem 2021)

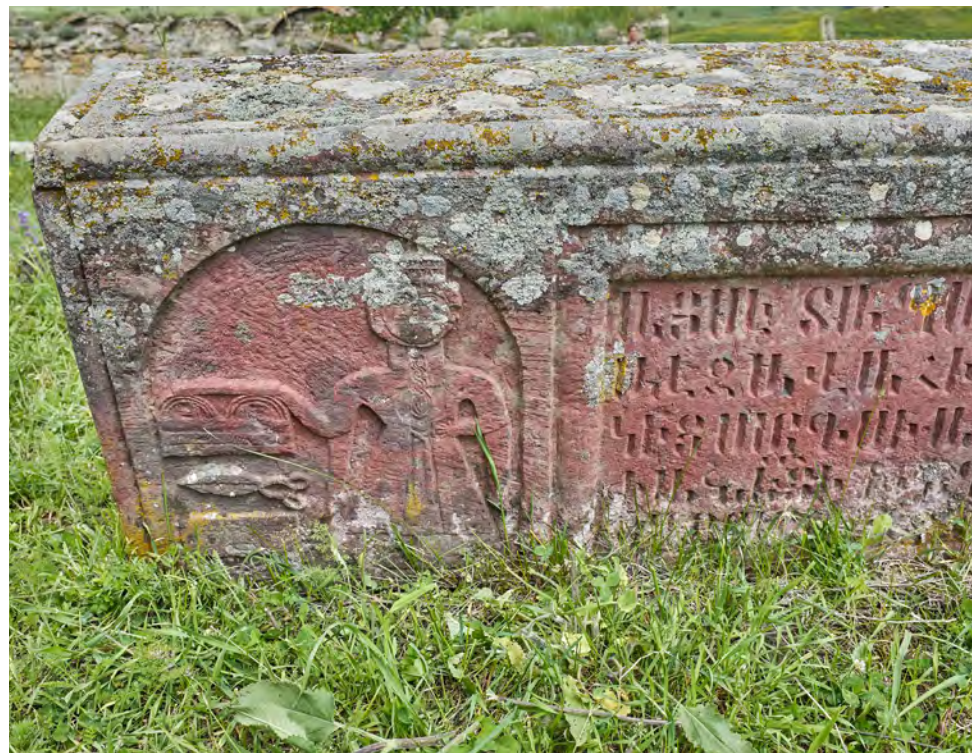
Fig. 7. A tombstone from the cemetery (Iconem 2021)

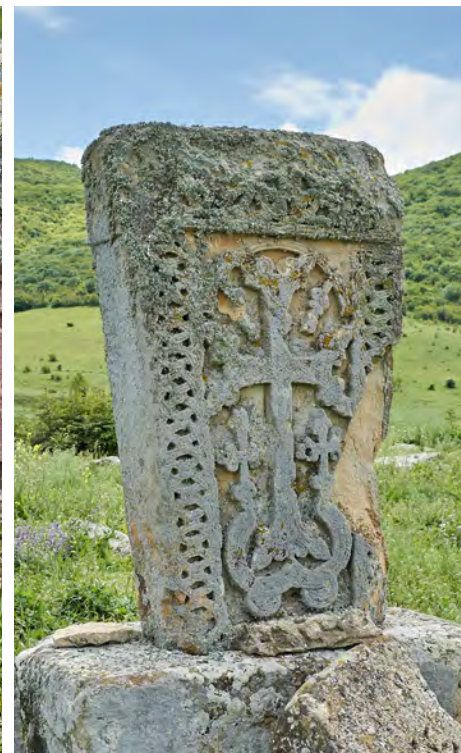
Fig. 8. A *khachkar* from the cemetery (Iconem 2021)

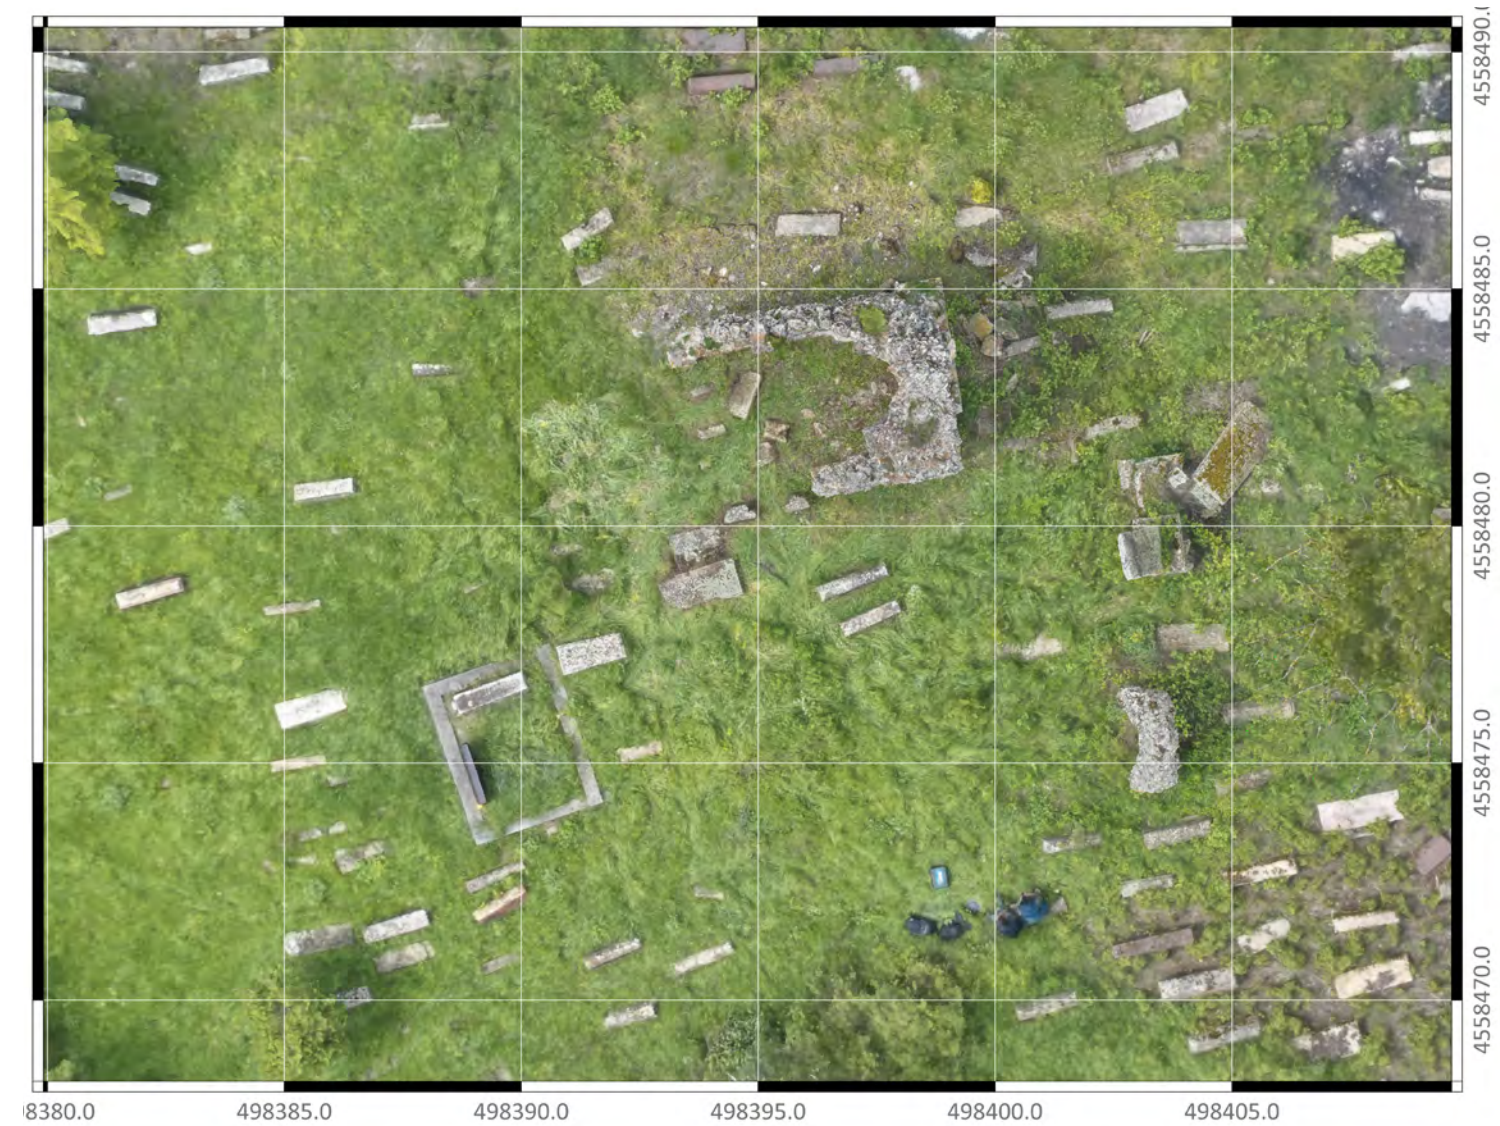
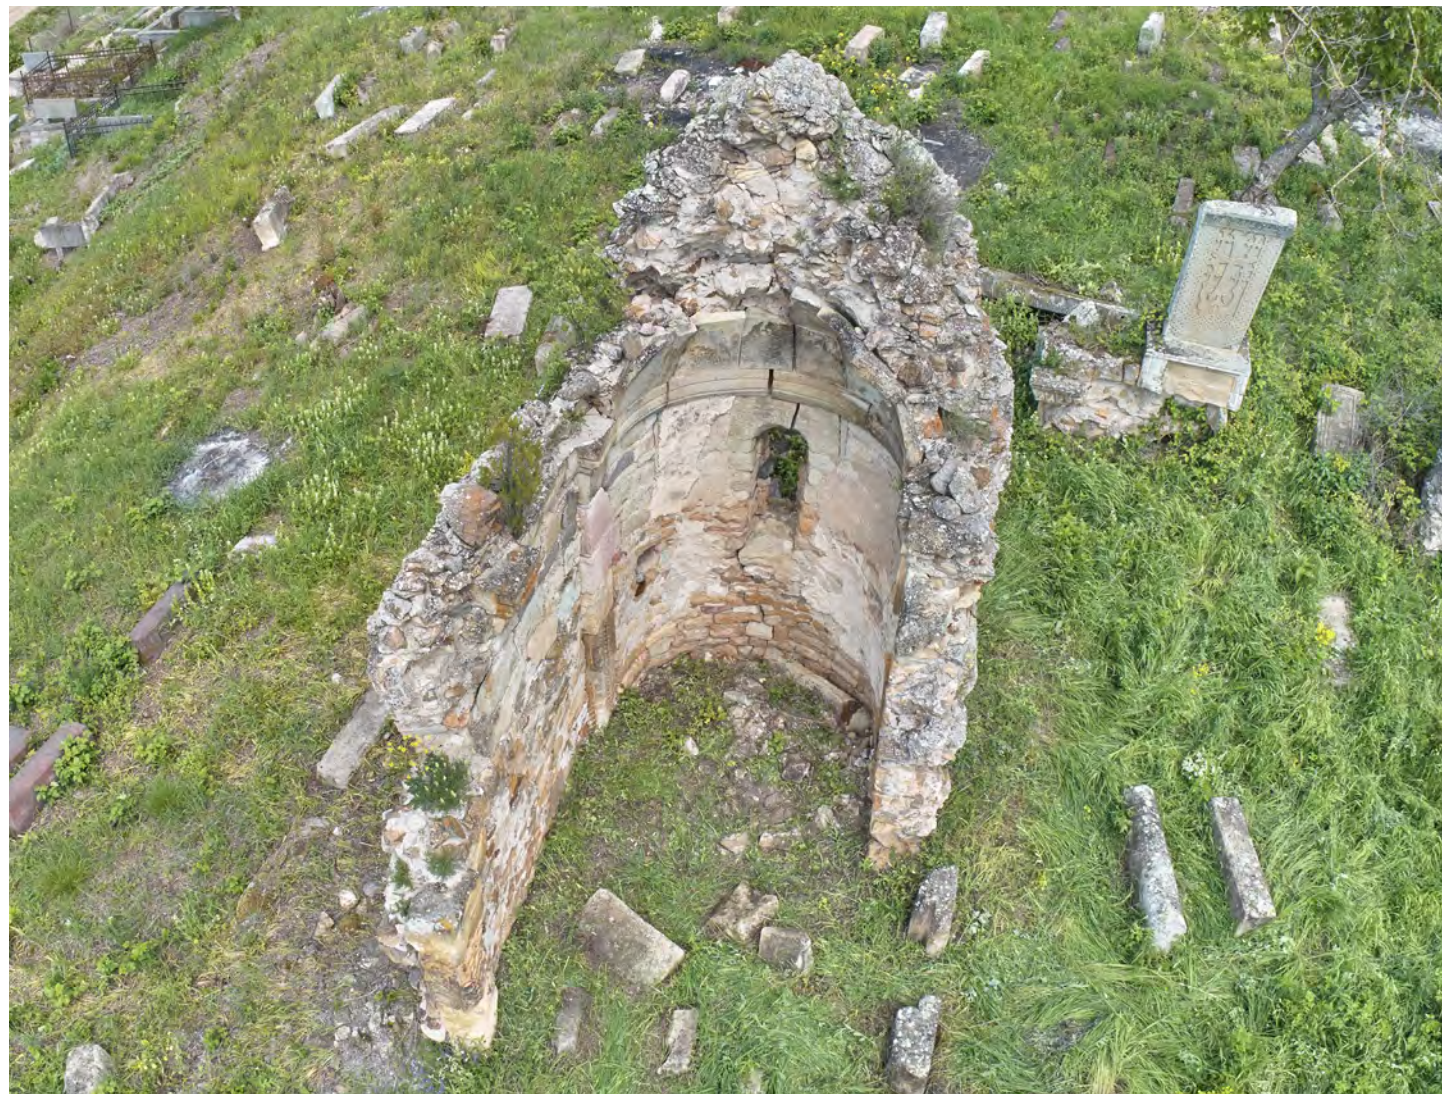
Fig. 2. Georeferenced ortho-image of the cemetery's church extracted from the textured 3D scan (Iconem 2021)

Fig. 3. Aerial view of the cemetery's church (Iconem 2021)

The cemetery of Koghb is located at the south-east of the village (fig. 1). It is extremely dense with tombstones dating from the Middle Age to nowadays, as it is still active. In its oldest part, there is a 13th century church (fig. 2-3-4), partially ruined. It is a small single nave building with an inscribed apse, built with coarse stones assembled with lime mortar with a cladding of cut stone blocks on the façade. It was not decorated, however 7th century four-sided stelae have been used as building blocks¹.

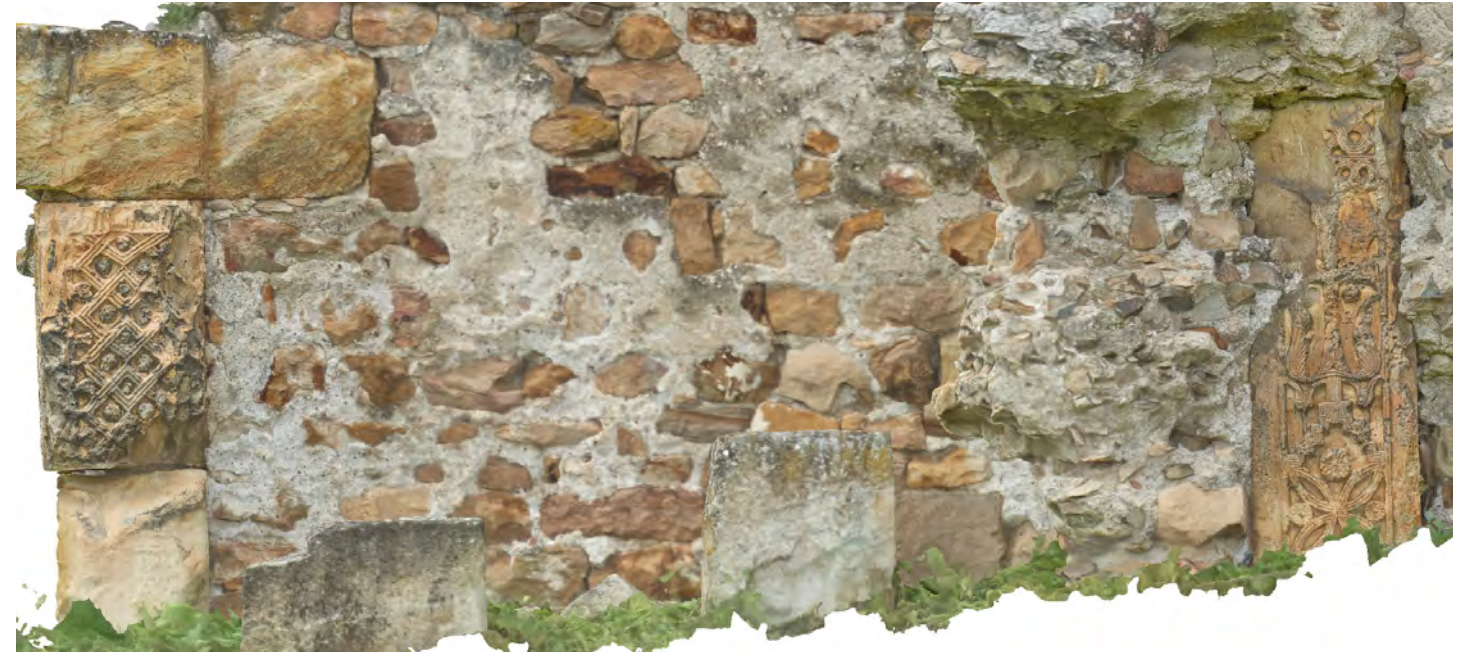
Most of the stelae's faces are hidden due to the re-employment in the building. However the visible faces present figurative, zoomorphic and ornamental carved reliefs with motives of acanthus leaves, crosses, peacock and saints (fig. 5). One of the sculpted blocks (a lintel or a base) presents a figurative scene that either represents a scene of Cross veneration or the restitution of the True Cross by the emperor Heraclius (fig. 6)².

Fig. 5. The northern wall of the church with inserted stela (Iconem 2021)

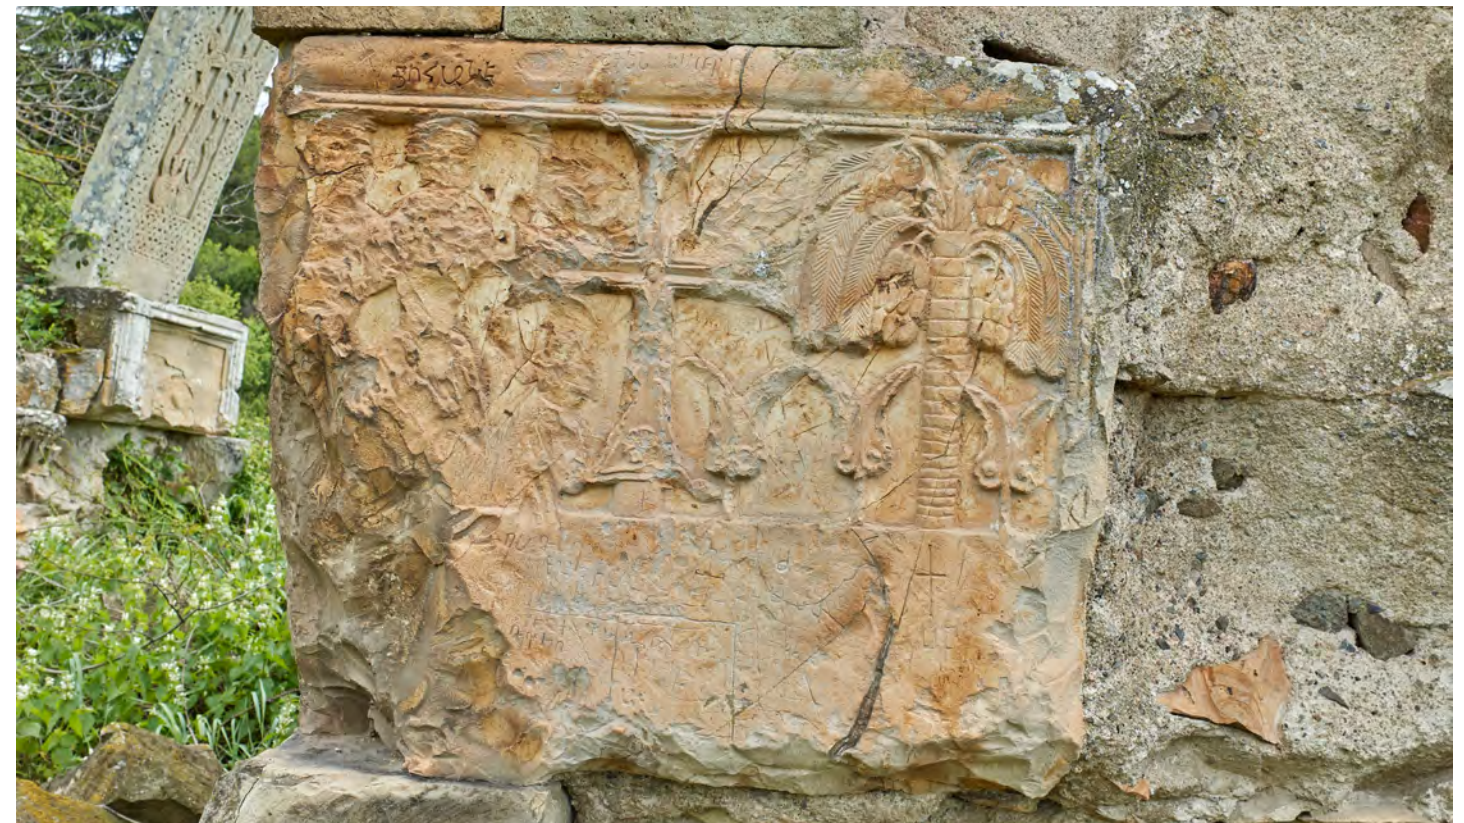
Fig. 6. The inserted lintel/base (Iconem 2021)

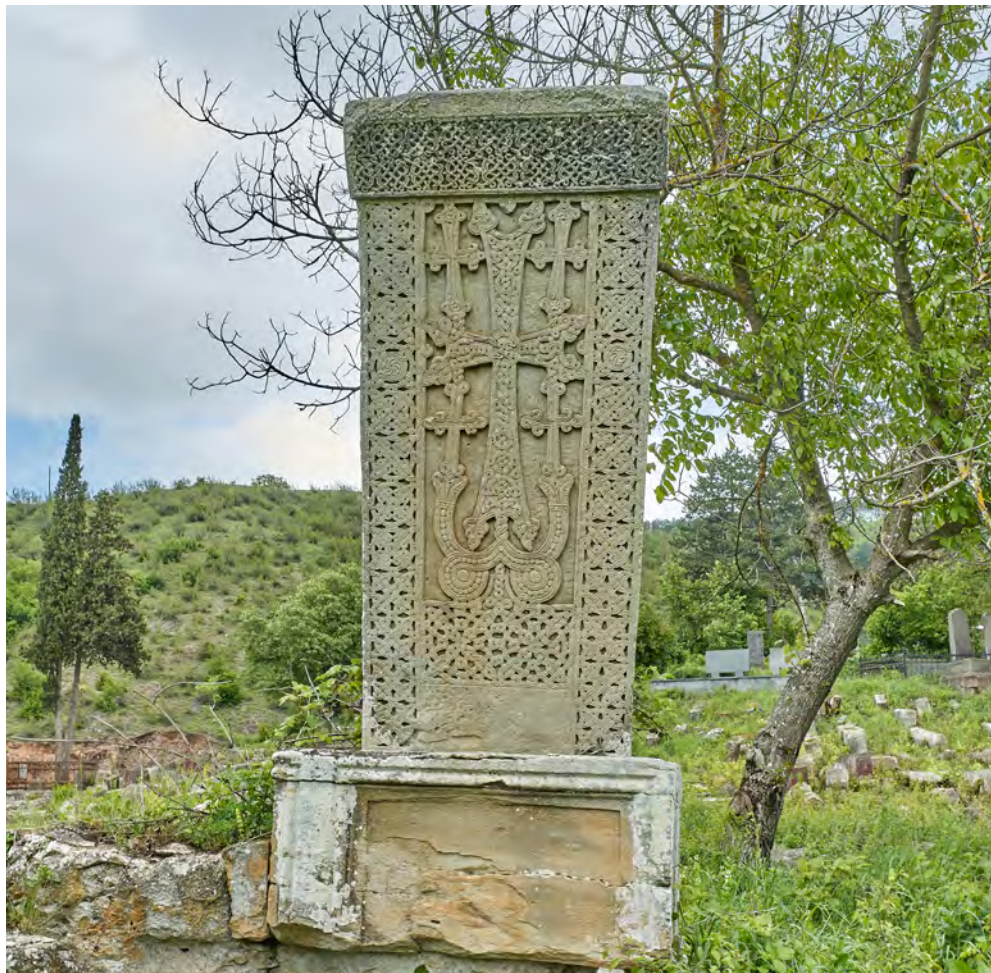
Fig. 7. khachkar in the south to the church (Iconem 2021)

The church is severely deteriorated, as well as the chapel. The chapel's cladding's stone blocks have disappeared almost entirely: only some of them are preserved on the eastern façade. An archive photography from 1935 shows that the deterioration got worse during the last century (fig. 8.). Although the chapel was already destroyed, its vault was better preserved, especially on the northern wall. The small chapel was in a much better state, with its façade still visible. Both *khachkar* were also still standing in 1935. The one on the ground is covered with moss. As regards the four-sided stelae and the lintel, their re-use allowed preserving them, although they are fragmentary and their relief significantly eroded.

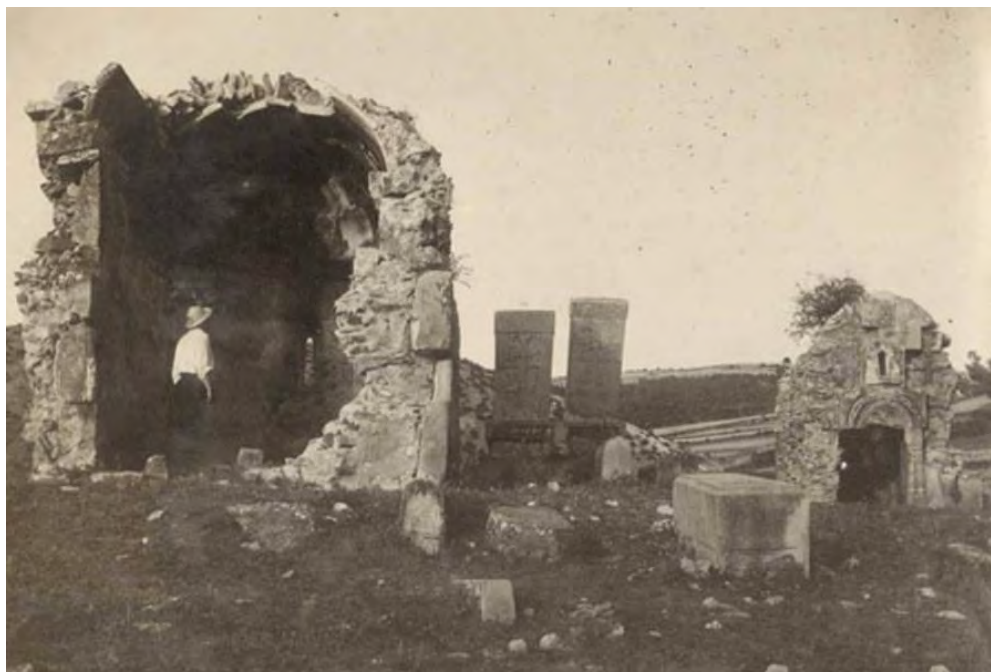
Fig. 8. Archive photography from 1935 by Ghevond Ghukasyan (History Museum of Armenia)

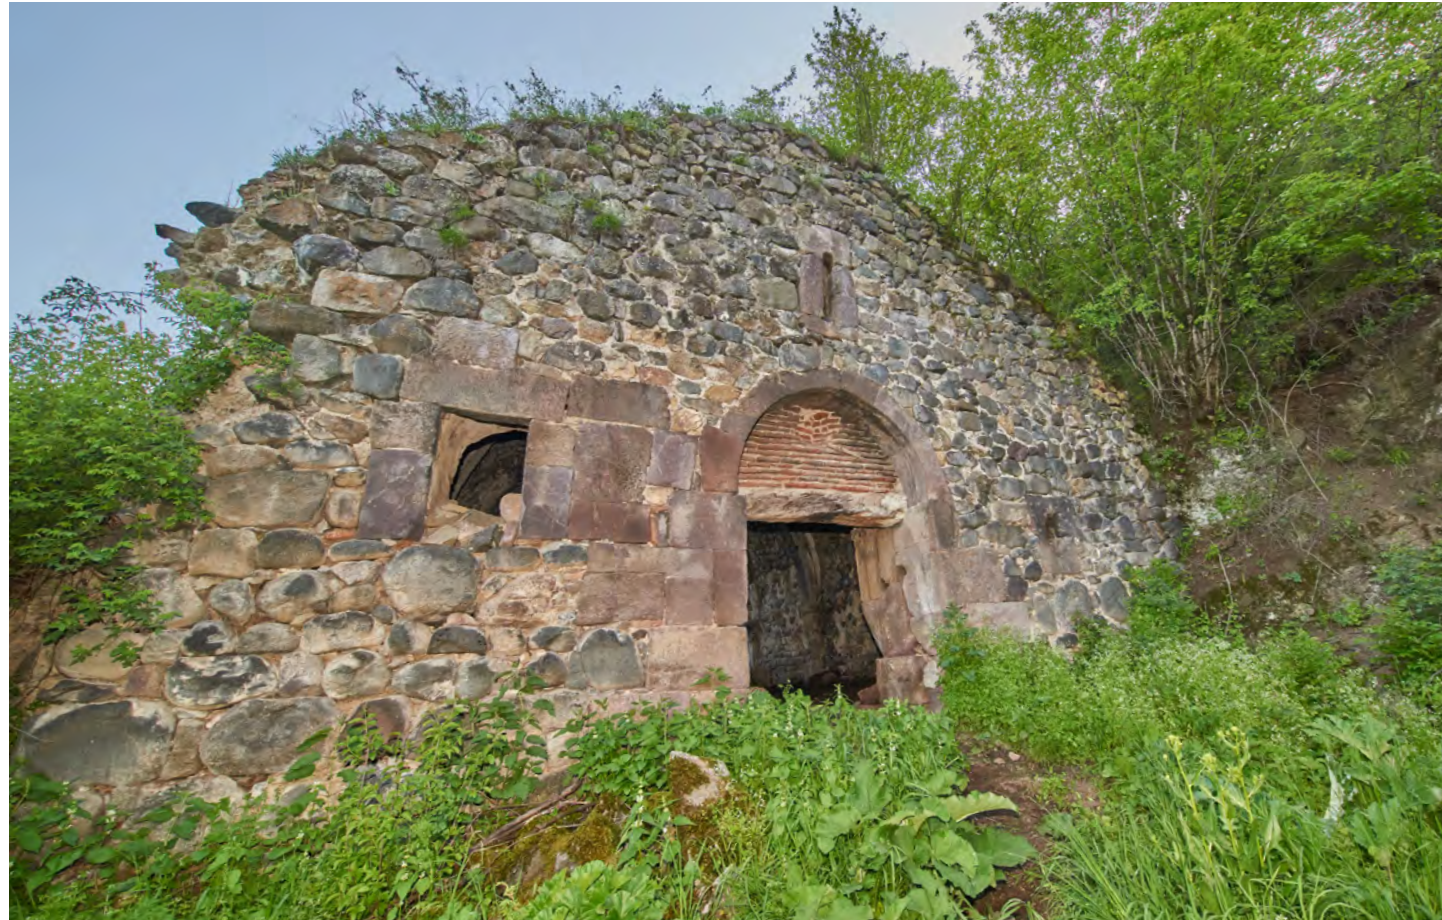
The refectory is located on the church's west. It is a rectangular building with a barrel vault. There is a single entrance at the east and windows on the southern and western walls. The building is very deteriorated, especially the southern part (fig. 8-9).

Fig. 8. The main entrance of the refectory (Iconem 2021)

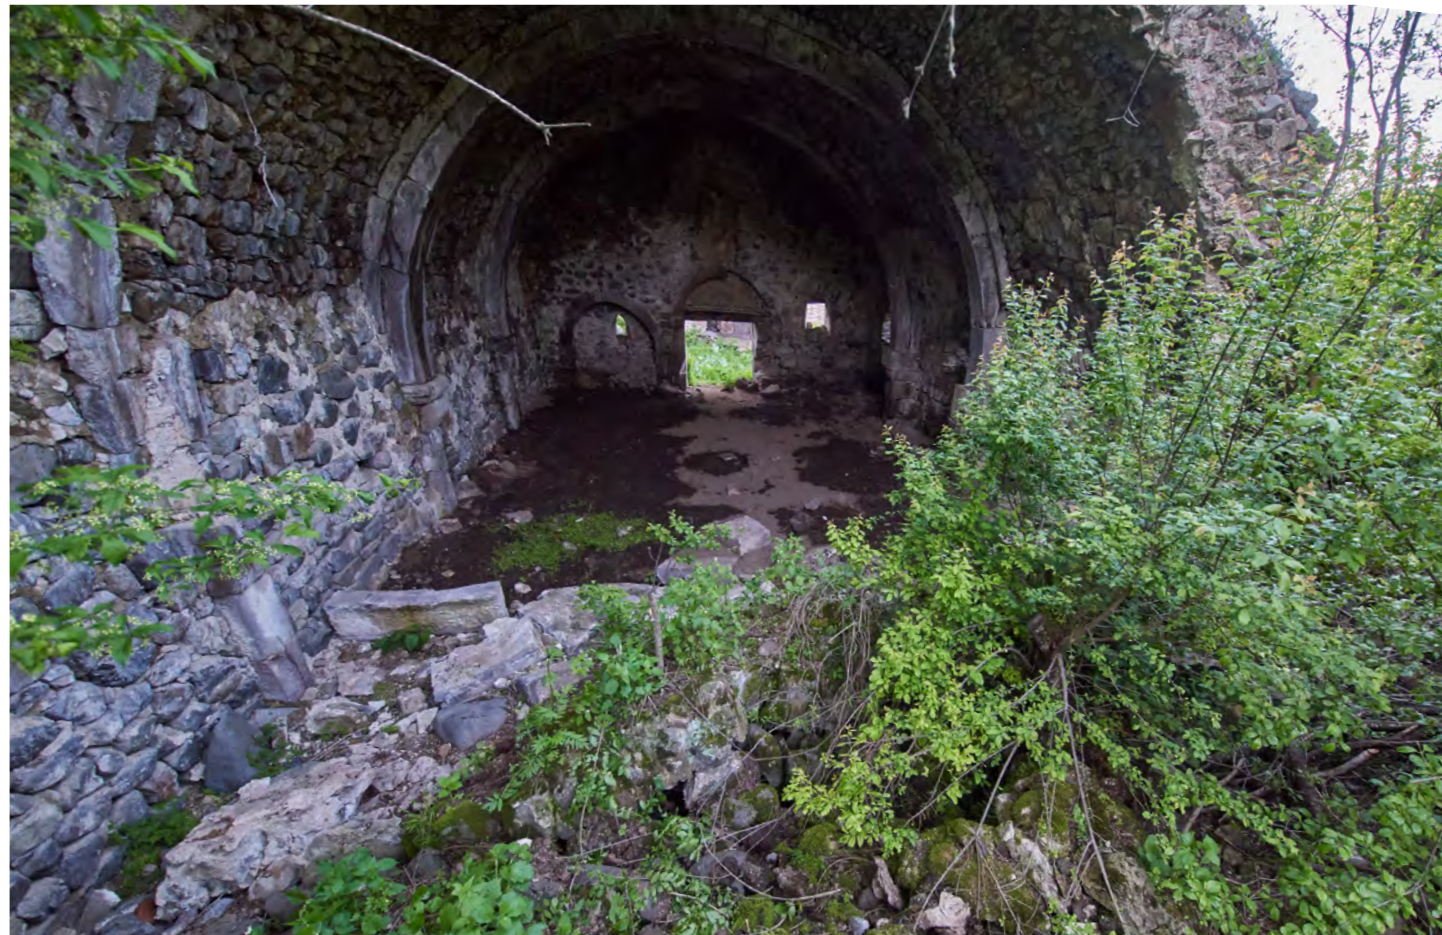
Fig. 9. Interior view of the refectory (Iconem 2021)

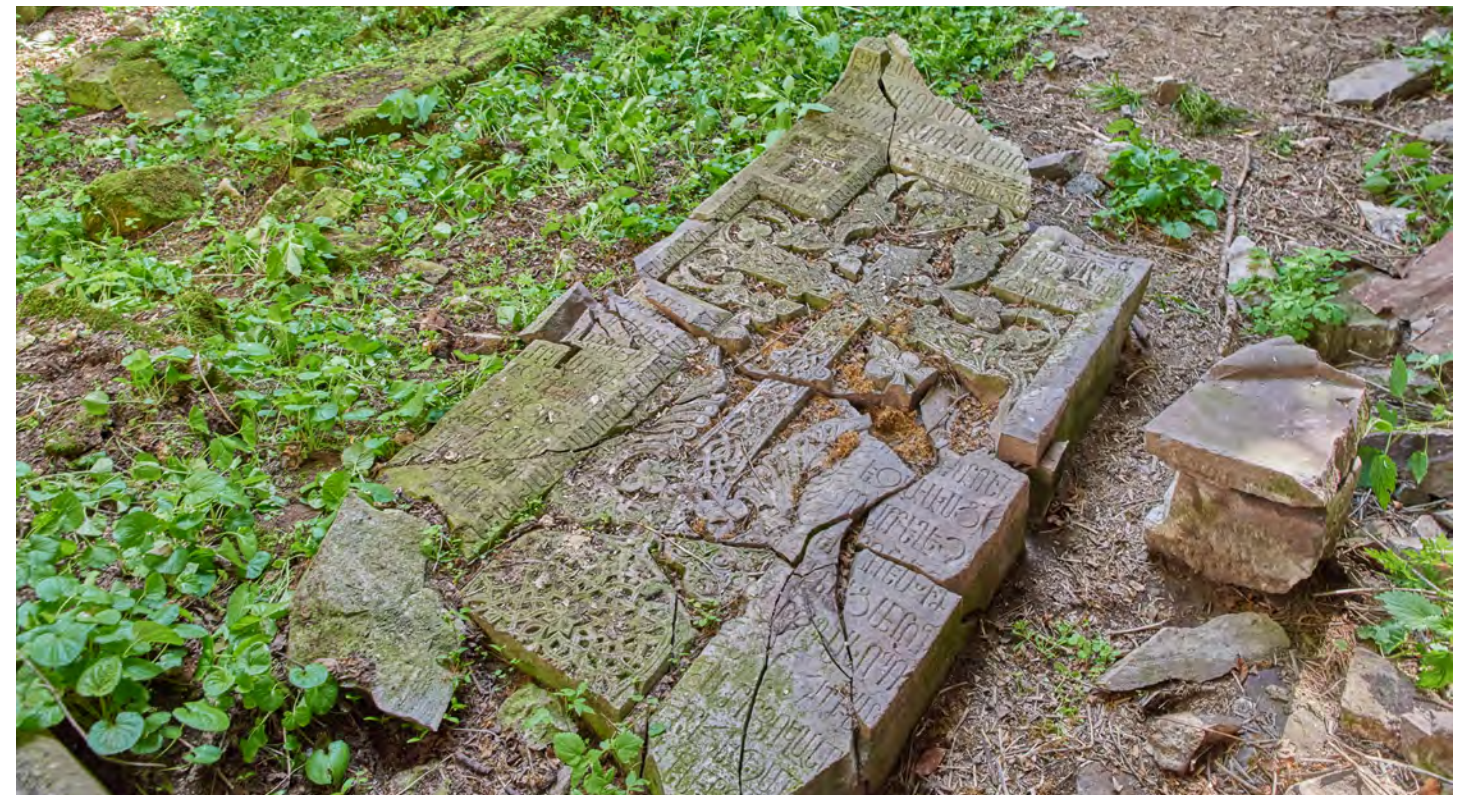
Fig. 5. The fragmented *khachkar* inside the church (Iconem 2021)

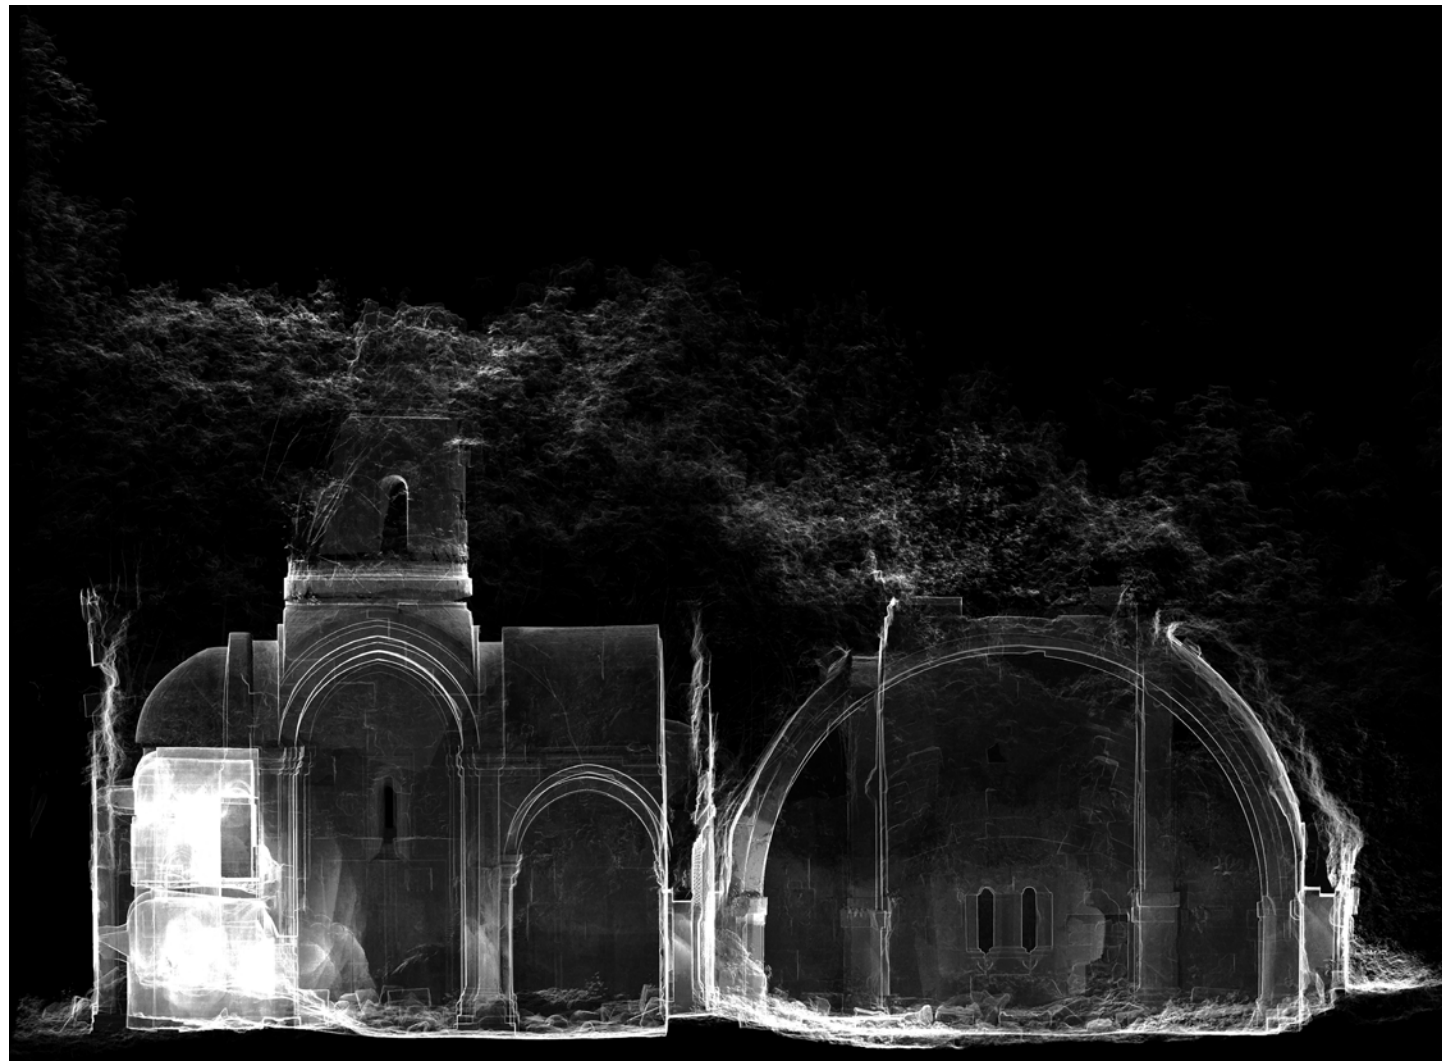
Fig. 6. transparent plan and section of the De-ghdznut church (Iconem 2021)

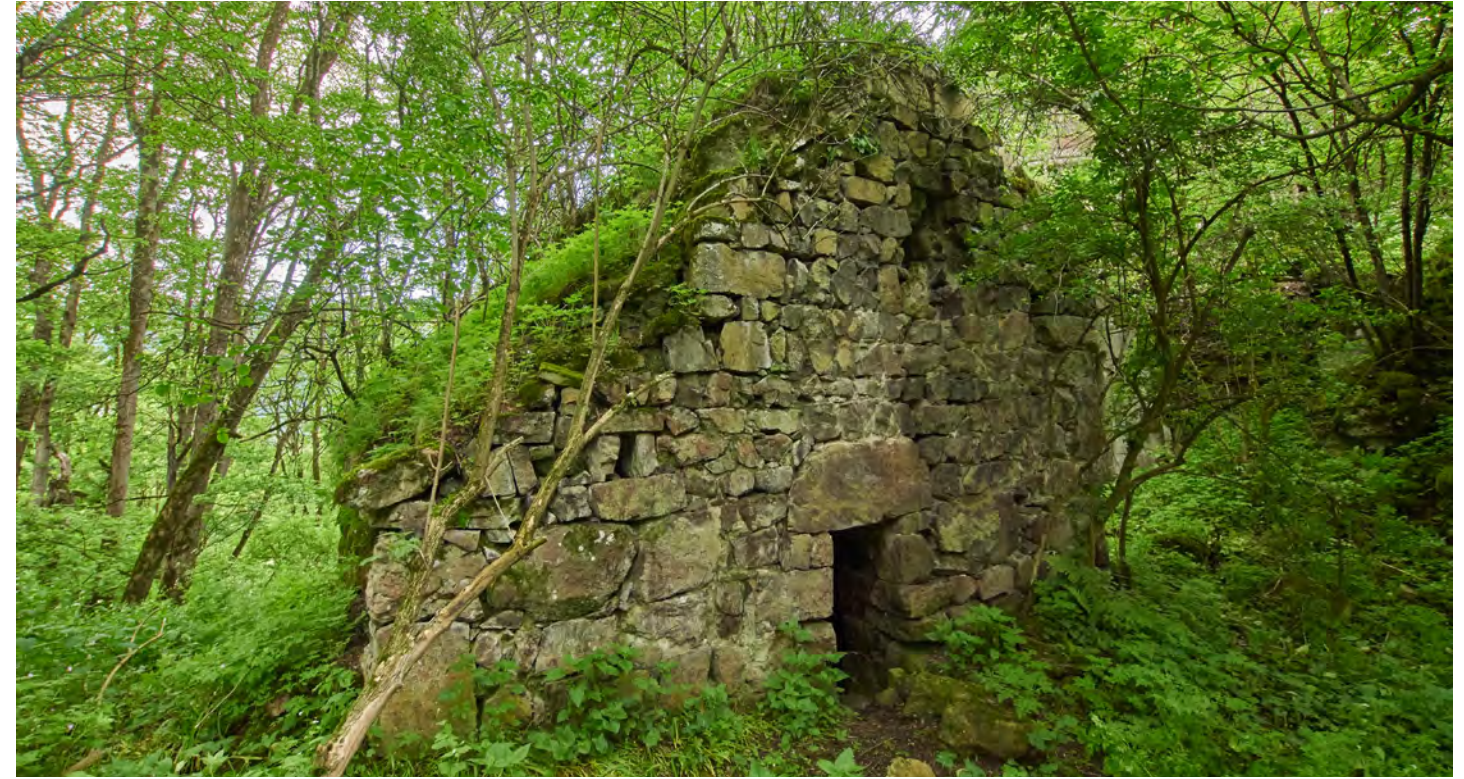
A second smaller church is located at the main church's north. It is a single nave vaulted church with two smaller rooms on its northern side (fig. 1, 7 and 8). It is also dated to the 13th century, but at the contrary of the main church, it was built with roughly cut stone-blocks. The roof is covered by vegetation.

Fig. 7. Western facade of the second church (Iconem 2021)
