HERITAGE
WATCH.AI

ARMENIAN CULTURAL HERITAGE SITES
CONDITIONAL REPORT

2 0 2 0

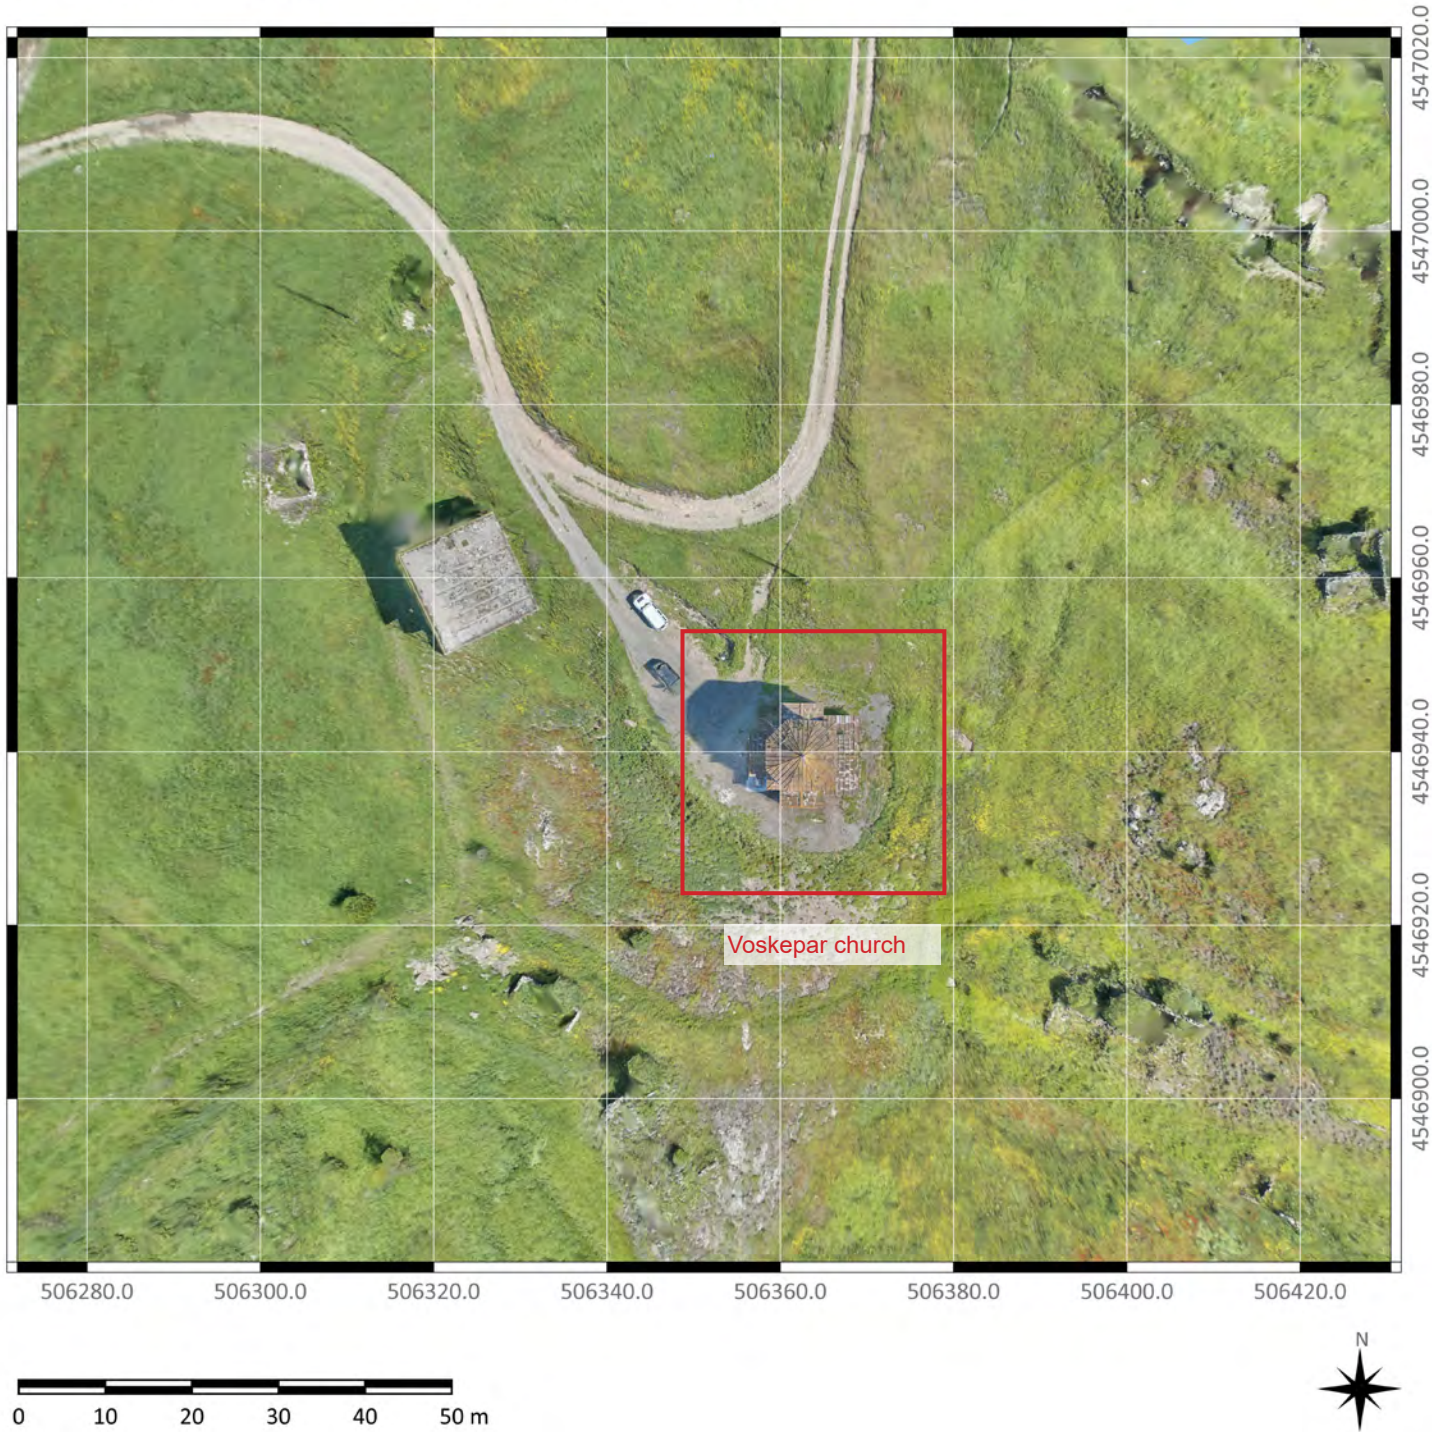
Fig. 1. Georeferenced ortho-image of Voskepar church extracted from the textured 3D scan (Iconem 2021)

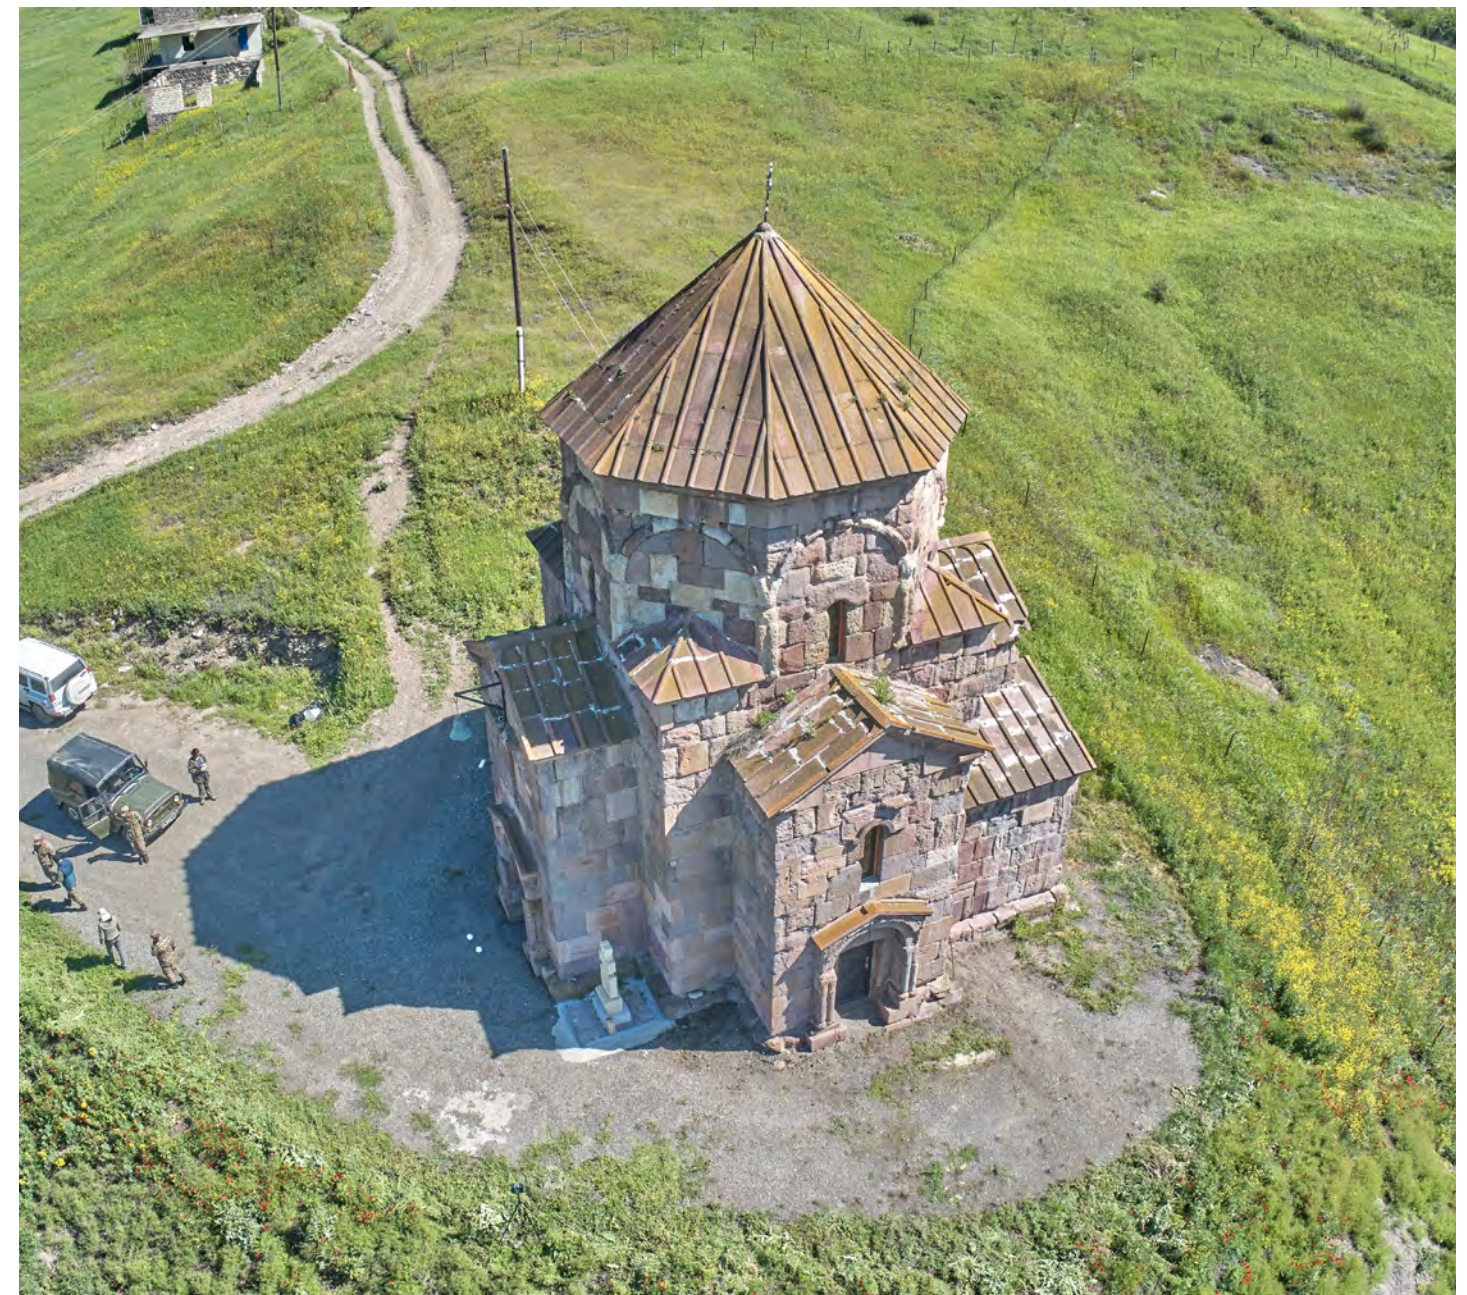
Fig. 2. Aerial view of Voskepar church (Iconem 2021)

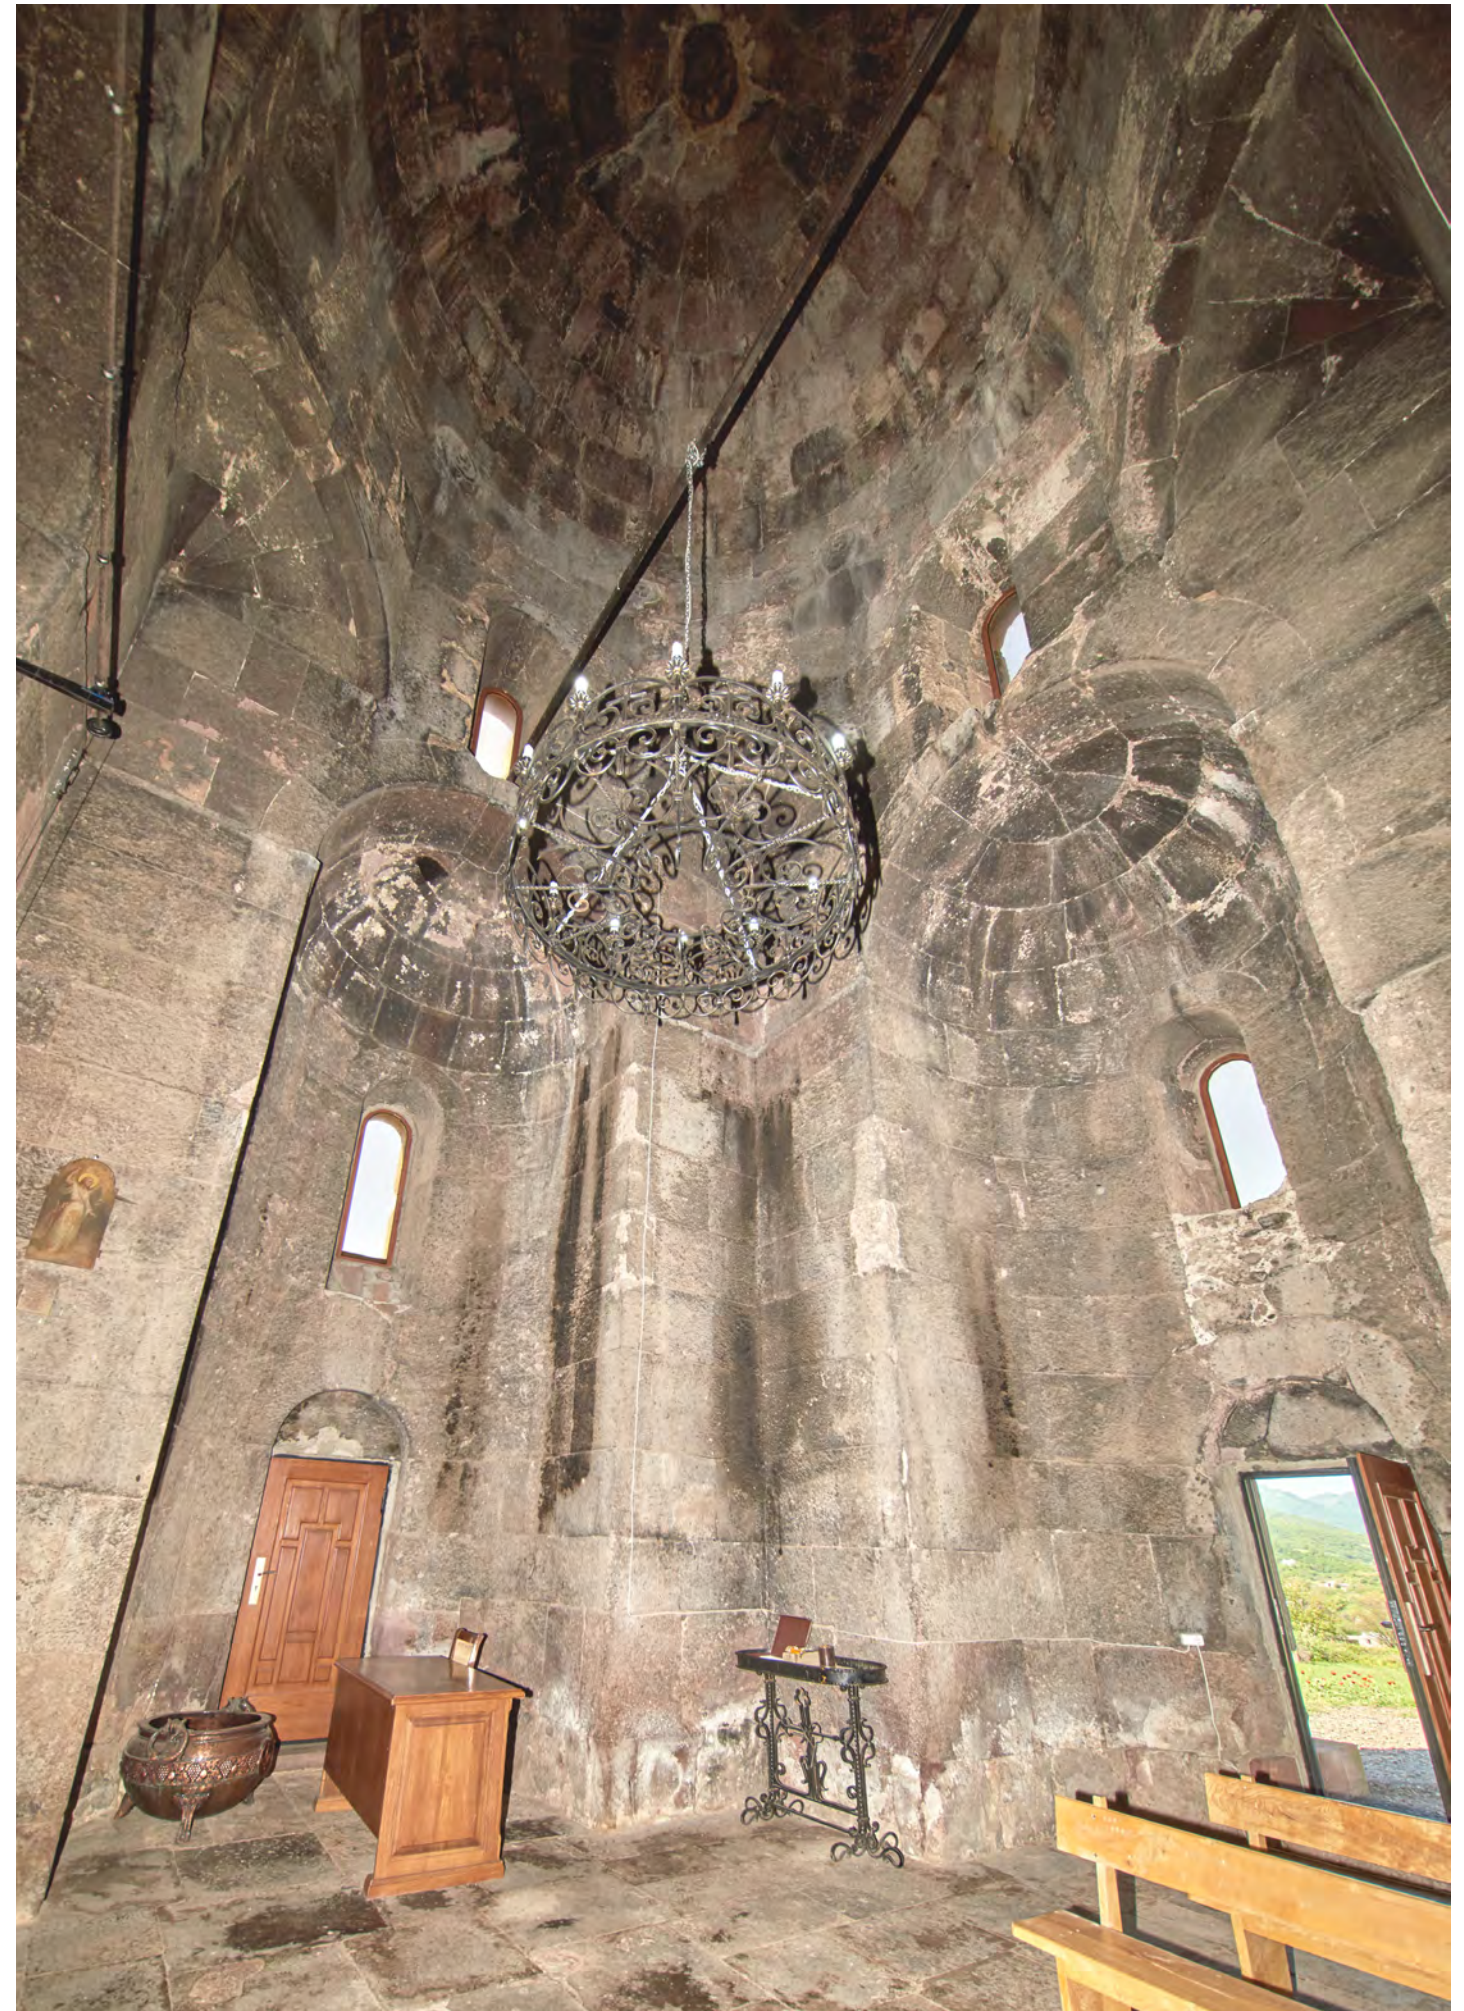
Fig. 4. South western view of the interior of the church (Iconem 2021)

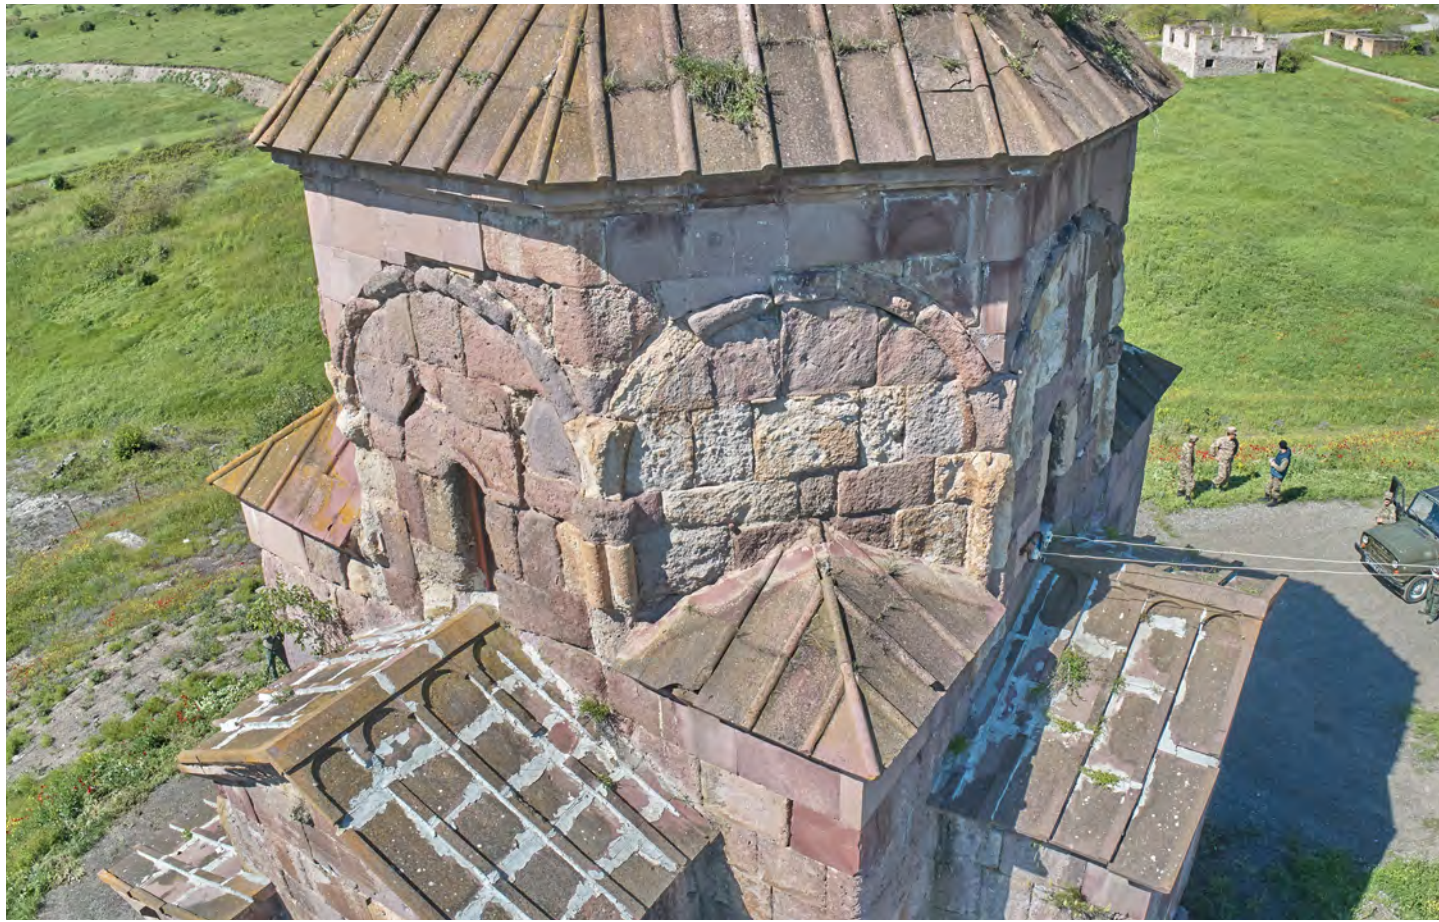
Fig. 5. Aerial view of the church's drum (Iconem 2021)

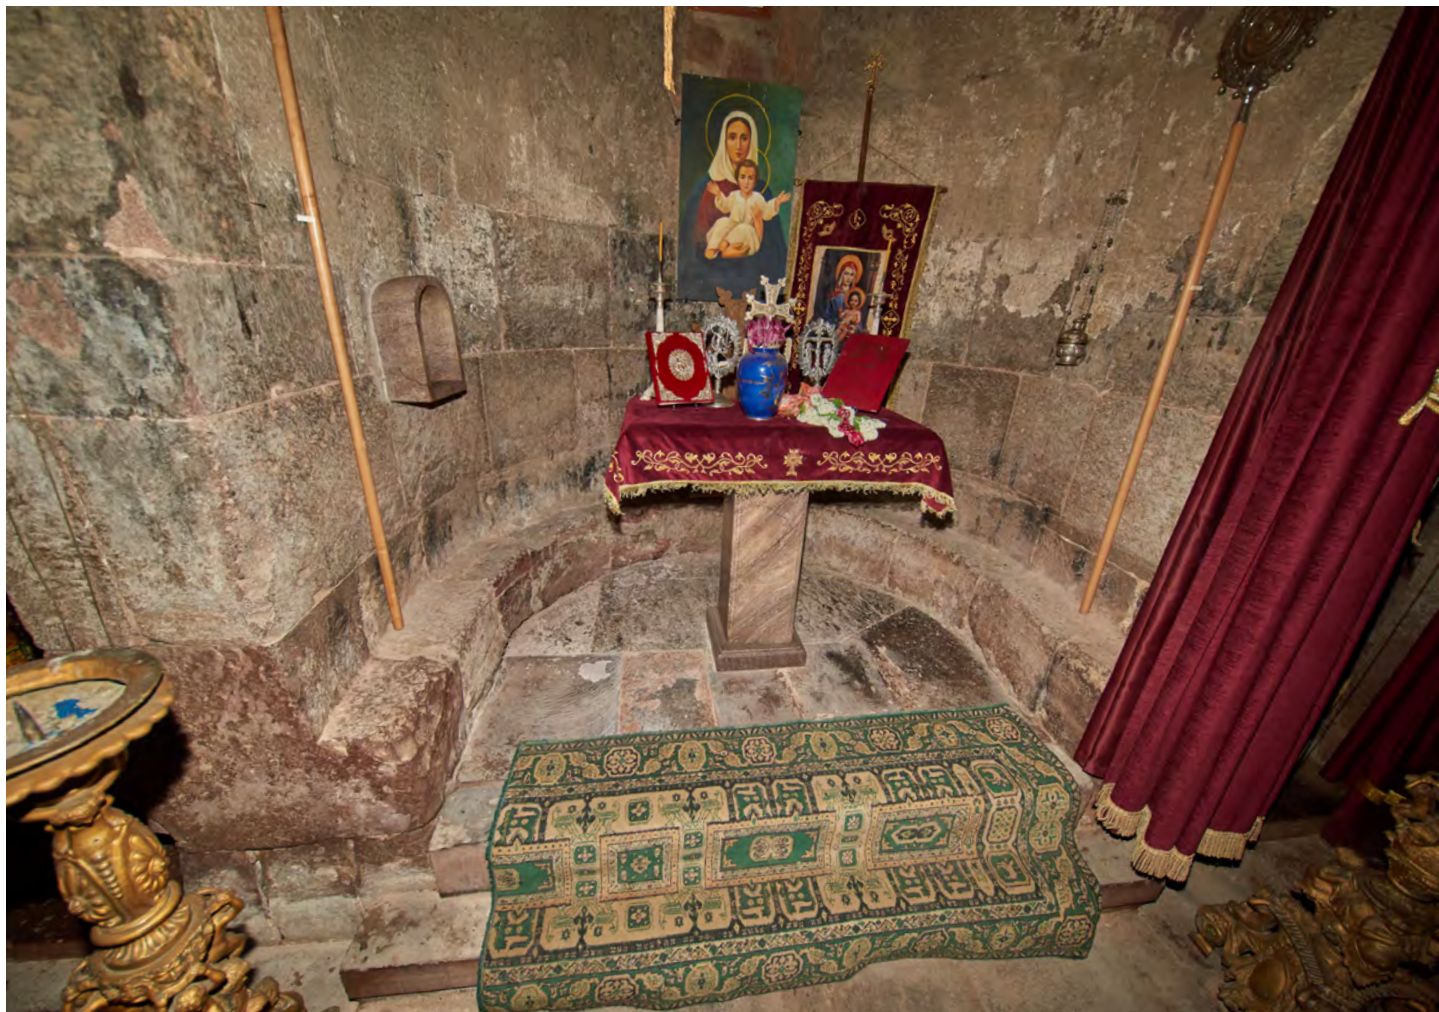
Fig. 6. The *synthronon* inside the main apse (Iconem 2021)

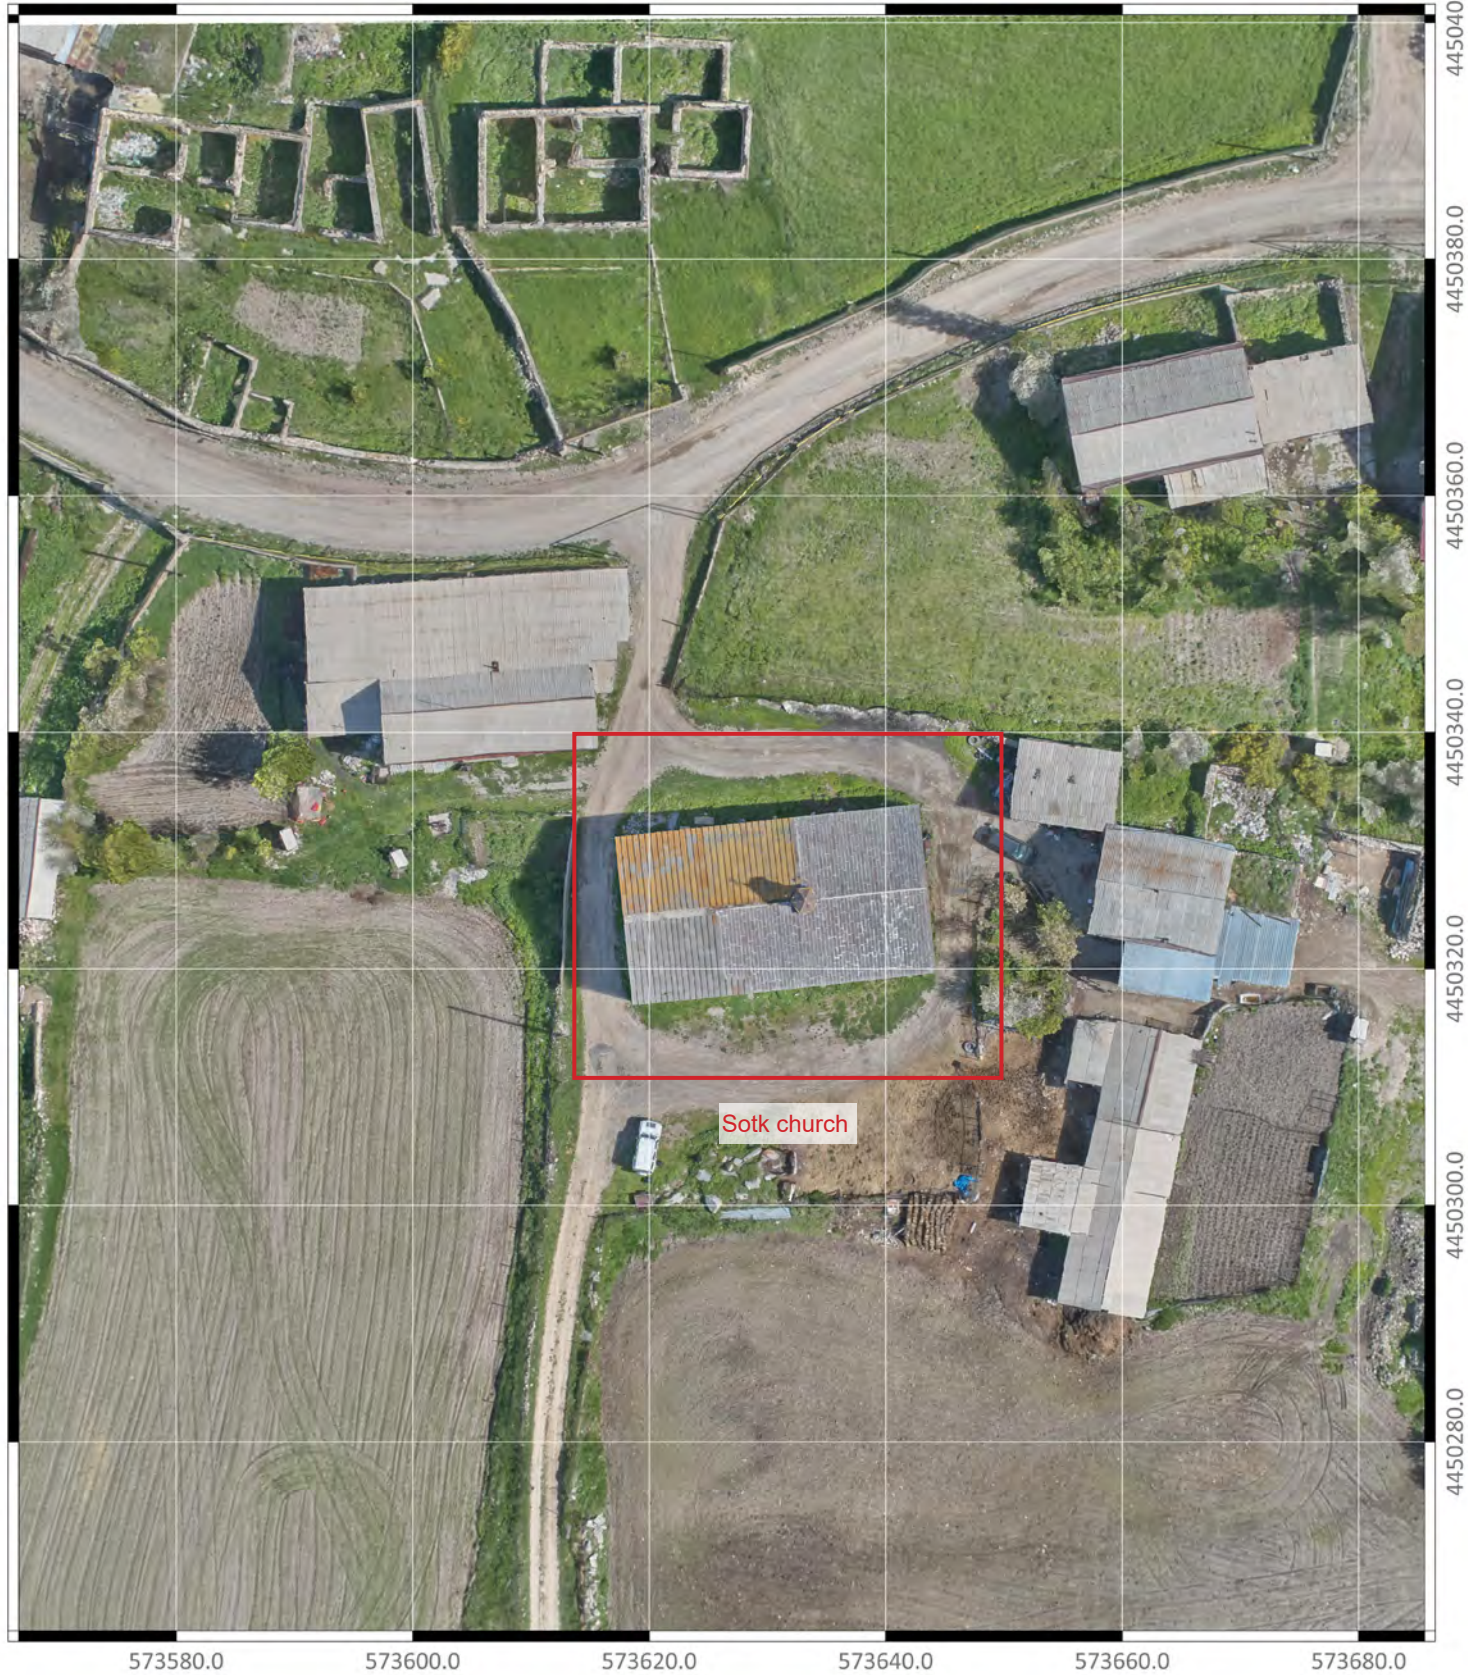
Fig. 1. Georeferenced ortho-image of Sotk church extracted from the textured 3D scan (Iconem 2021)

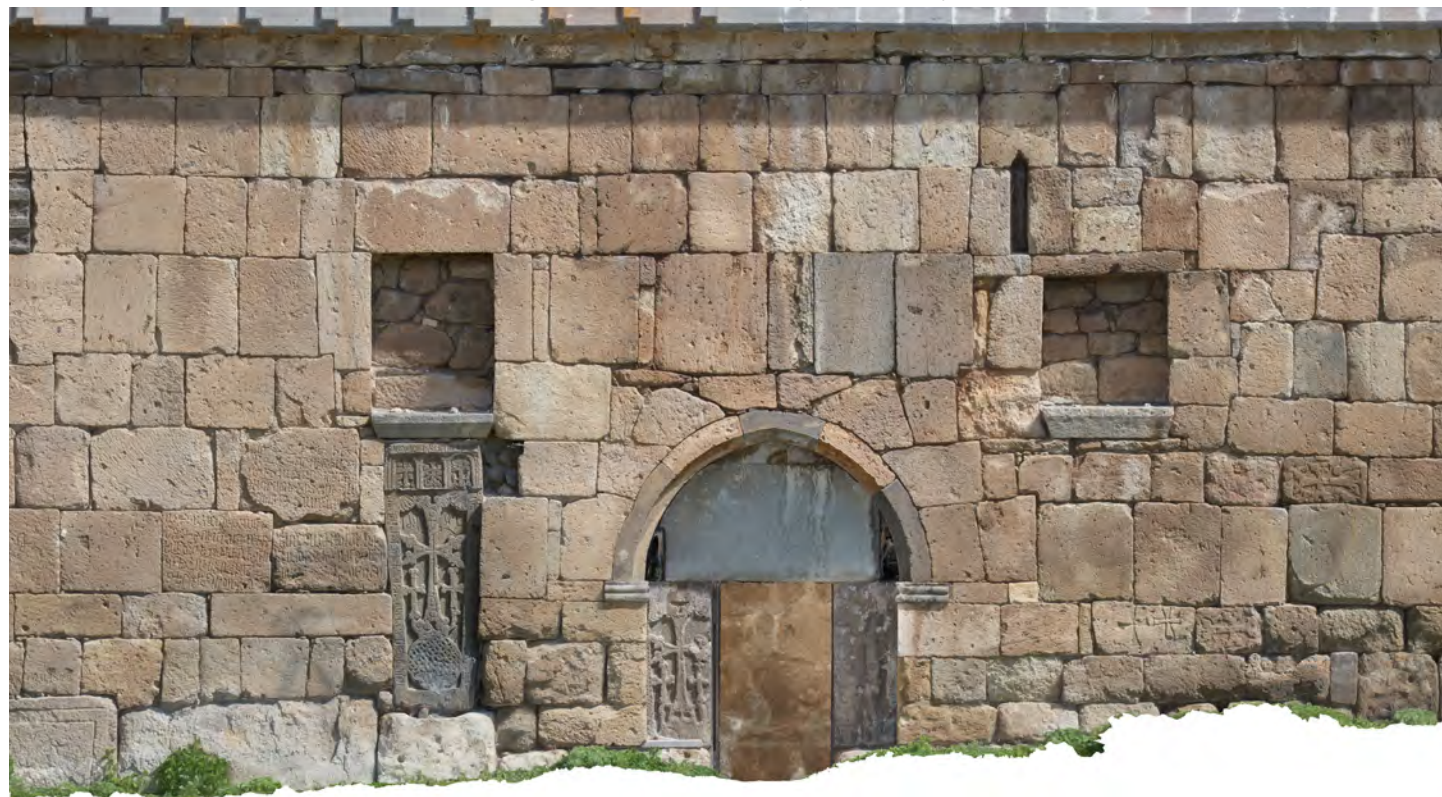
Fig. 4. Ortho-image of the Southern Façade extracted from the textured 3D scan (Iconem 2021)

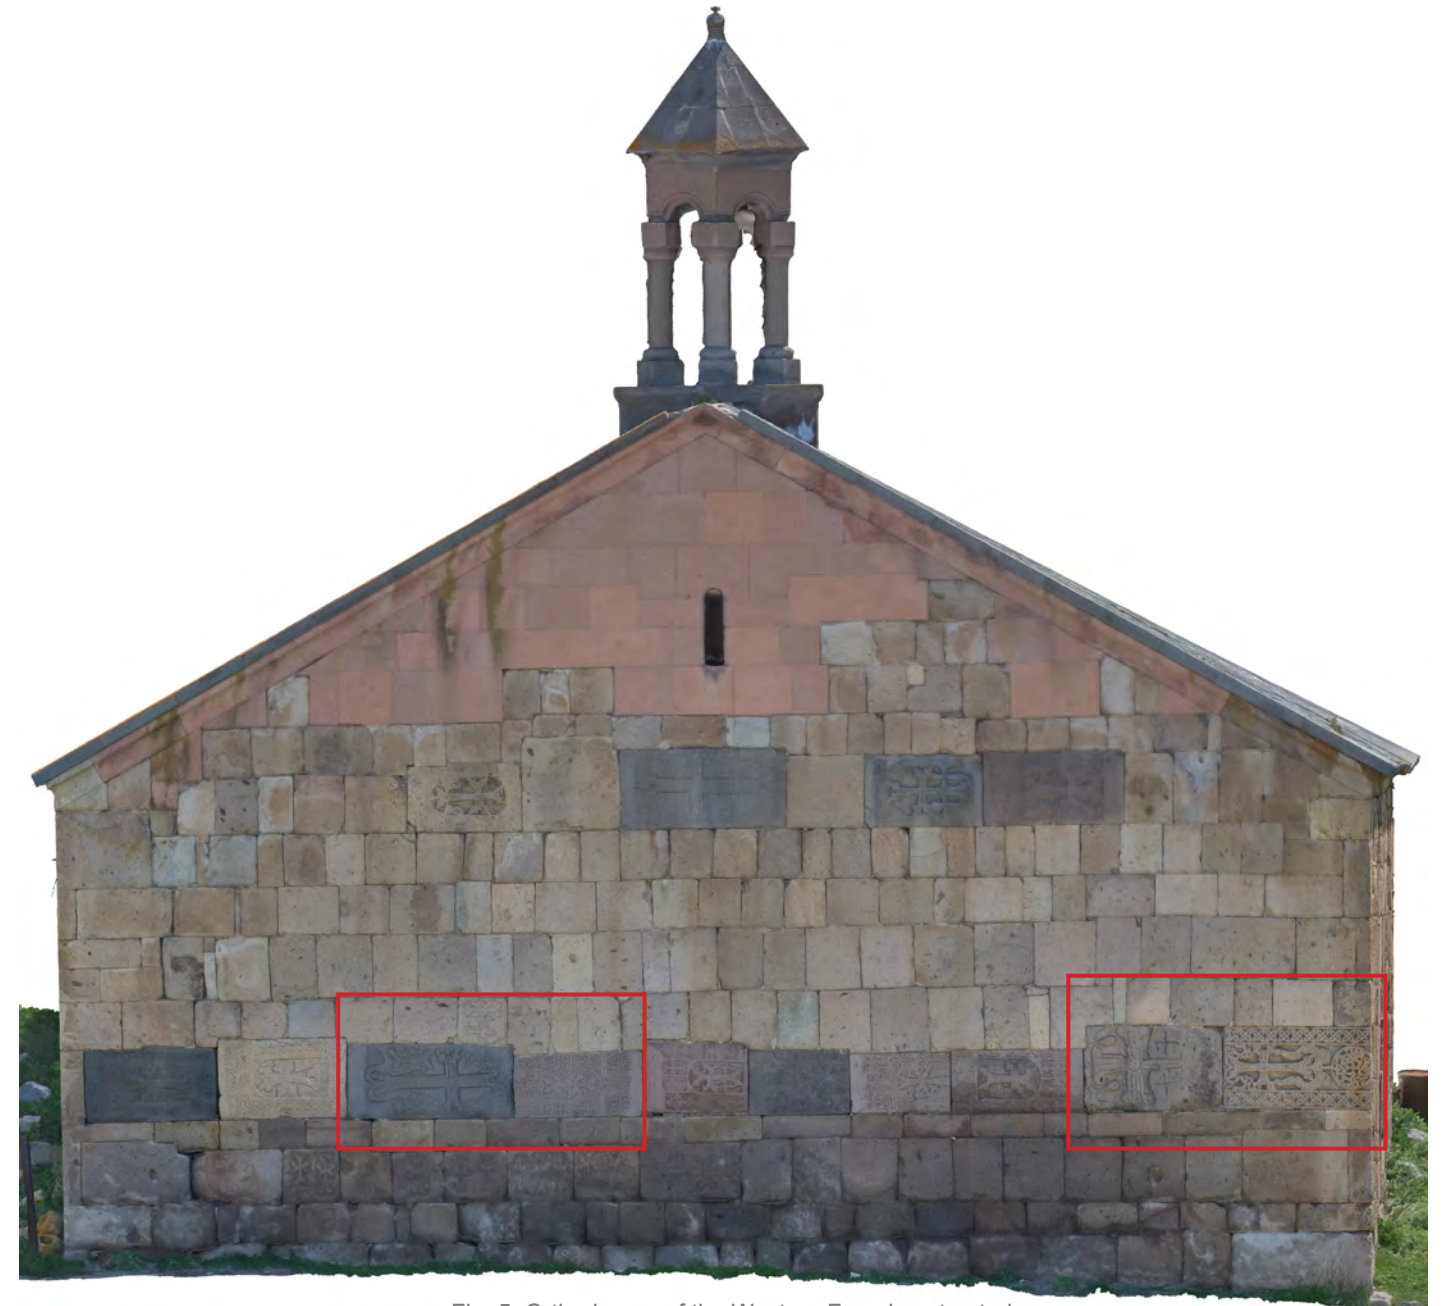
Twenty-seven inscriptions have been documented on *khachkars* and tombstones in the church and in the surroundings, three of them having been discovered lately³. Many *khachkars* are inserted in the church's façades, especially on the western one (fig. 5-7).

Fig. 5. Ortho-image of the Western Façade extracted from the textured 3D scan (Iconem 2021)

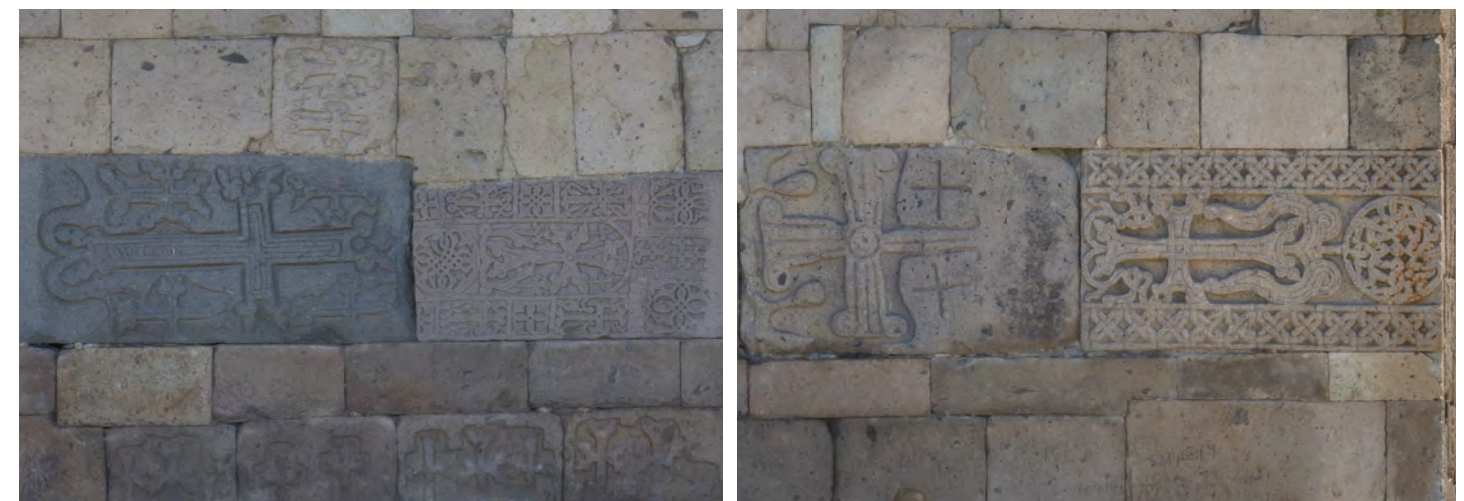
Fig. 6 and 7. Details of the *khachkars* (Iconem 2021)

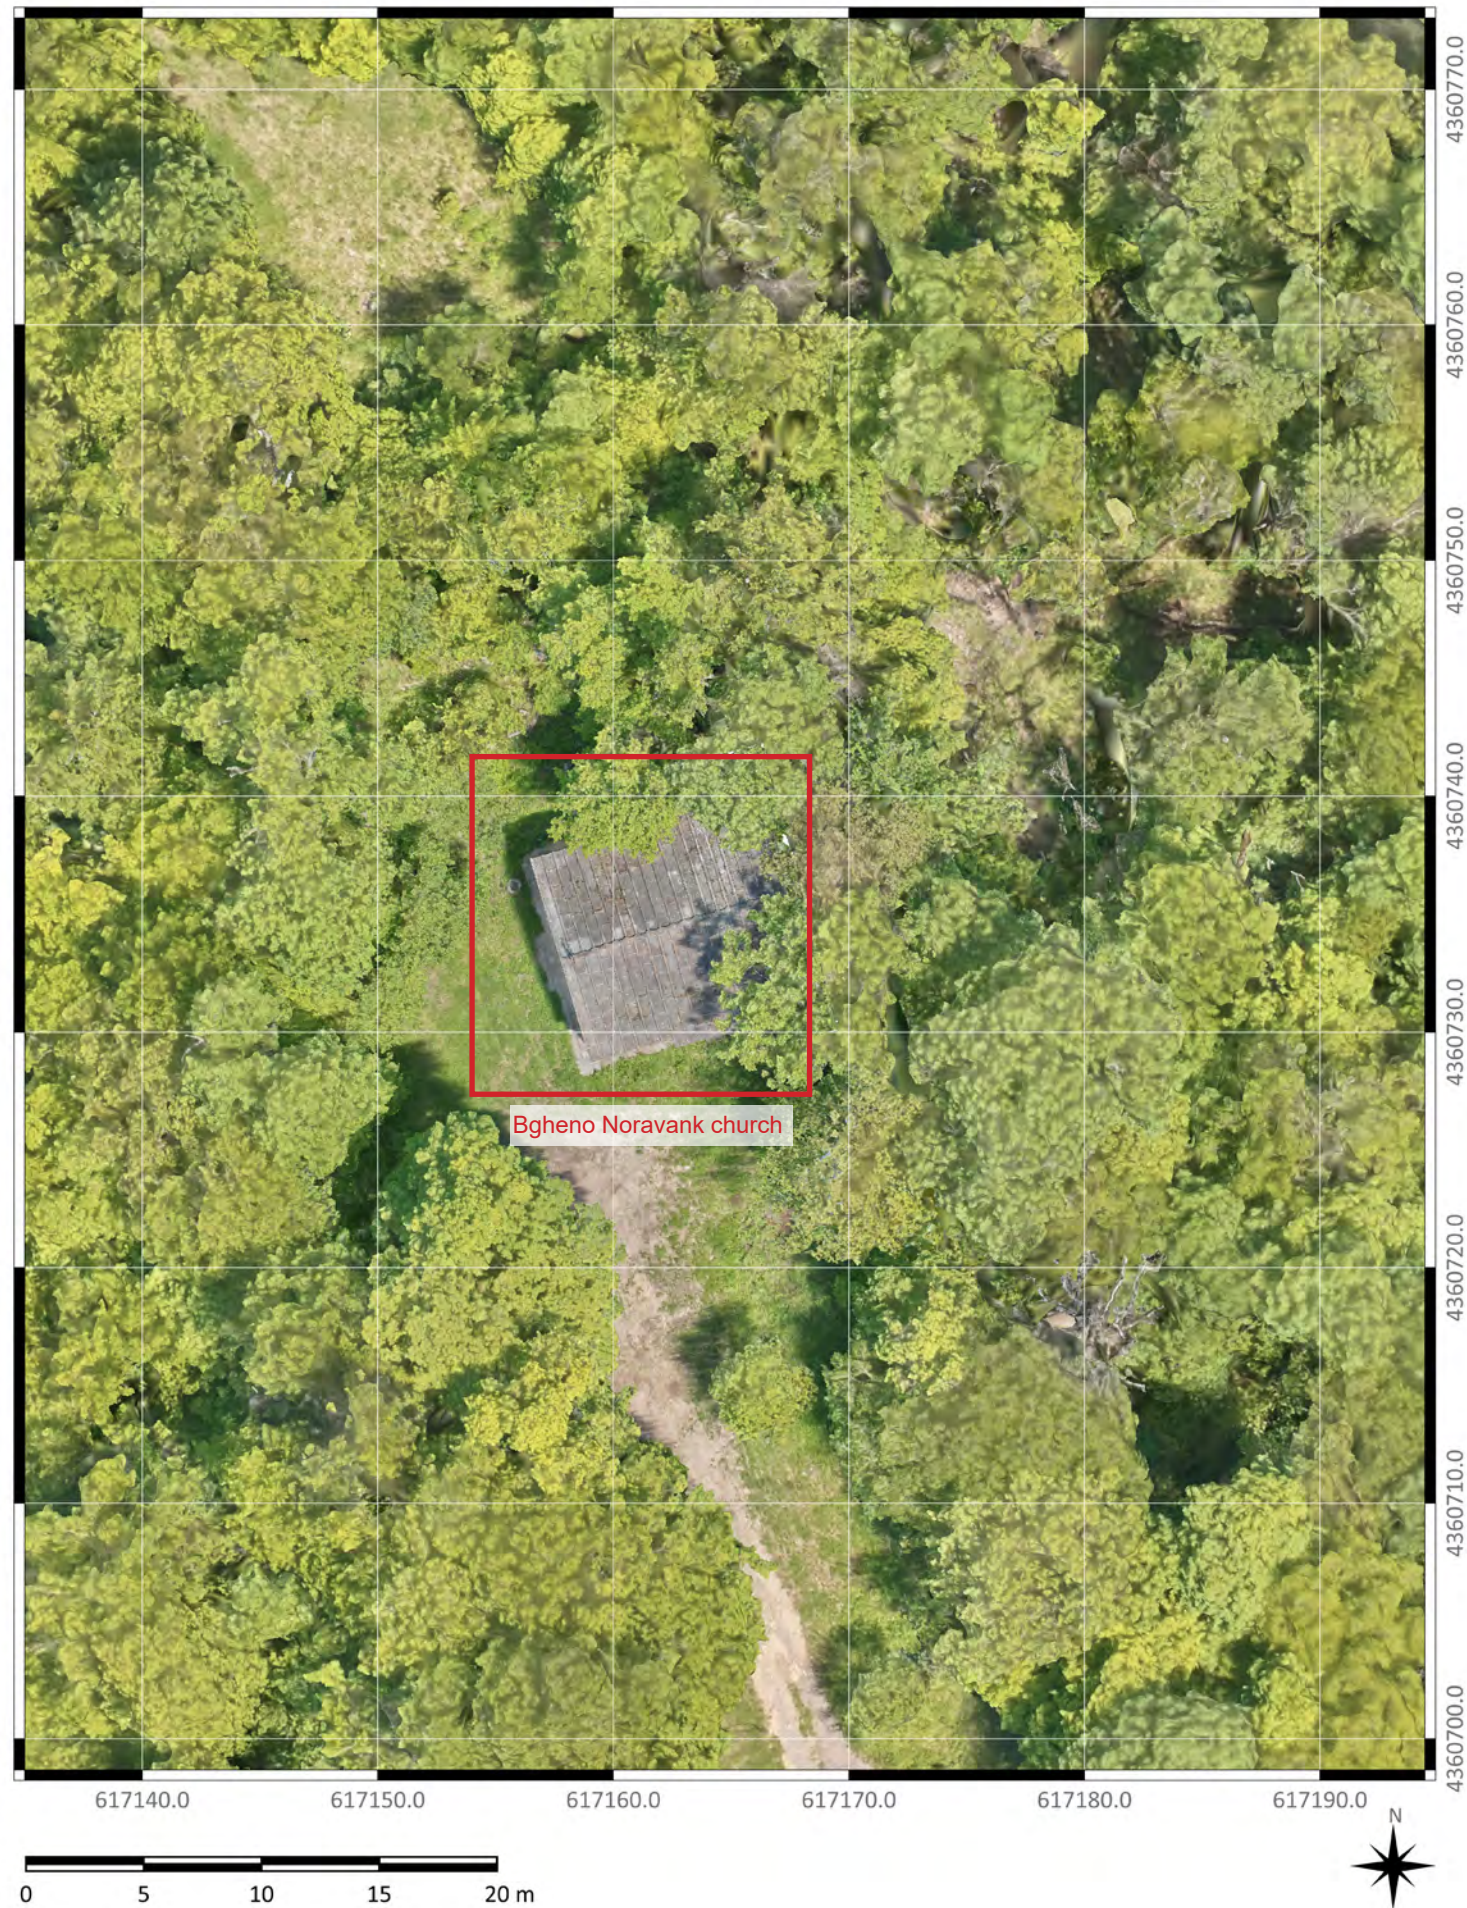
Fig. 1. Georeferenced ortho-image of the site of Bgheno Noravank monastry extracted from the textured 3D scan (Iconem 2021)

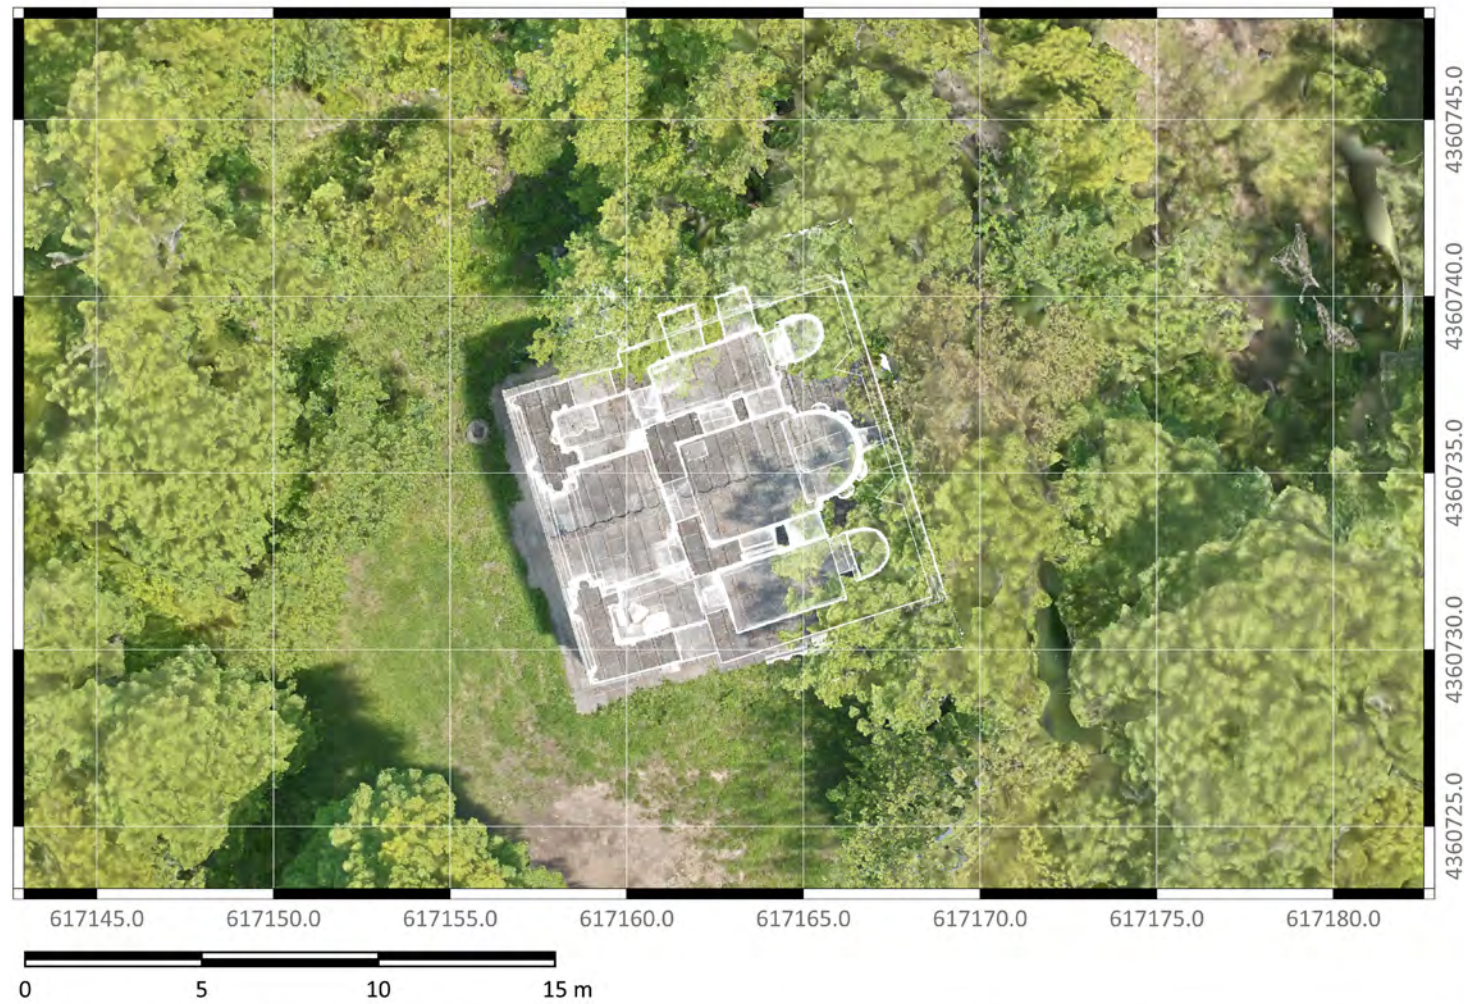
Fig. 3. Transparent view of the first floor plan placed on the Georeferenced ortho-image to show the position of Bgheno Noravank monastery extracted from the textured 3D scan (Iconem 2021)

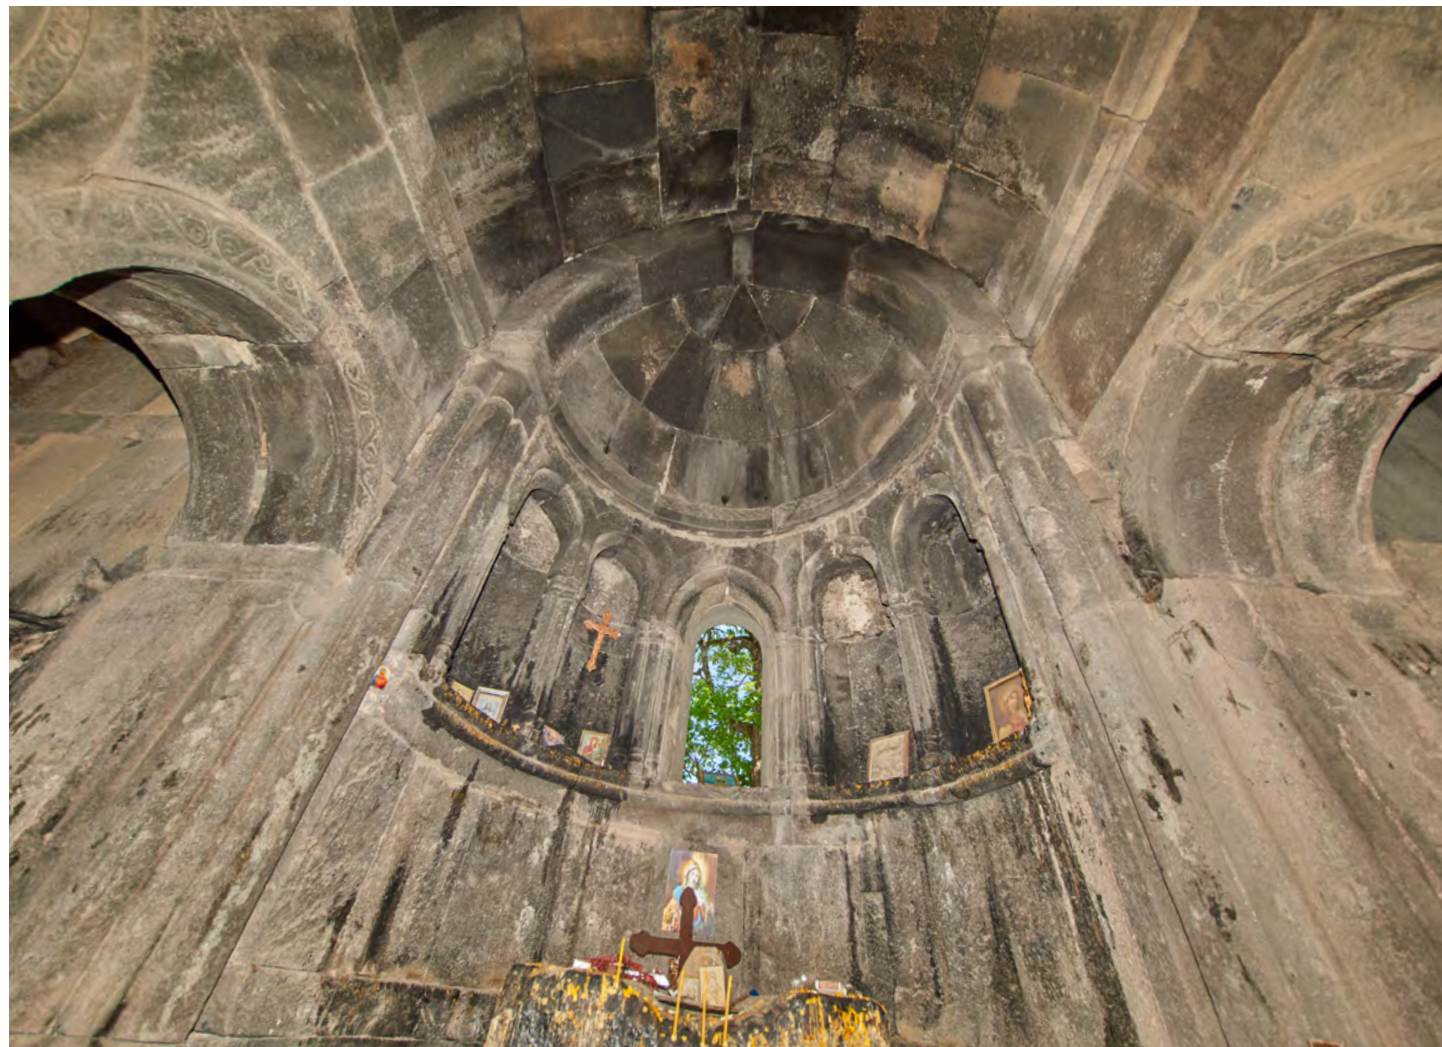
Fig. 5. The main apse (Iconem 2021)

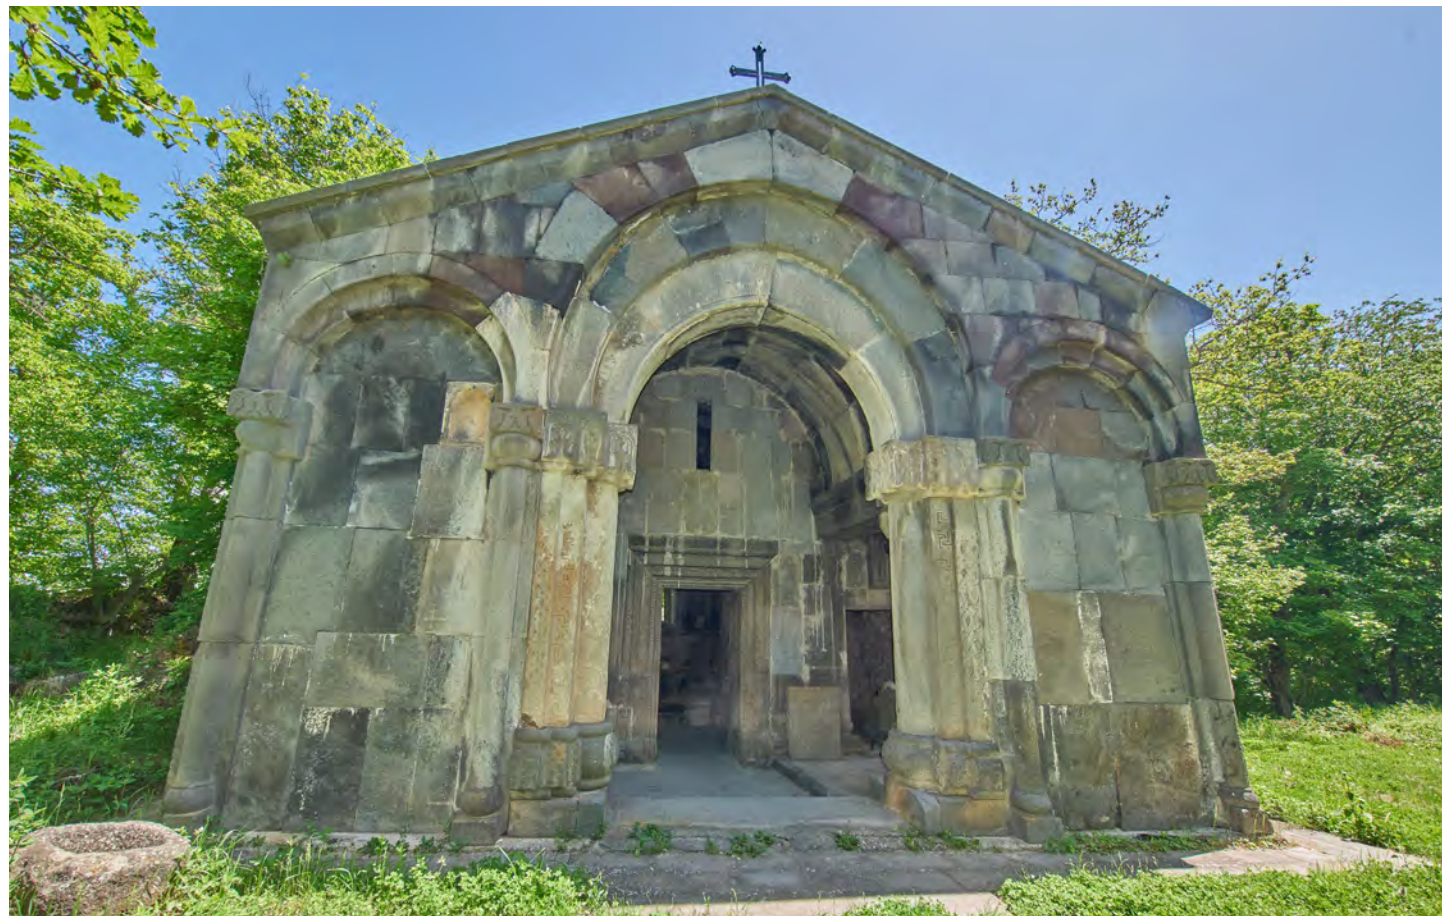
Fig. 6. The western facade of the church (Iconem 2021)
