HERITAGE
WATCH.AI

ARMENIAN CULTURAL HERITAGE SITES
CONDITIONAL REPORT

2 0 2 0

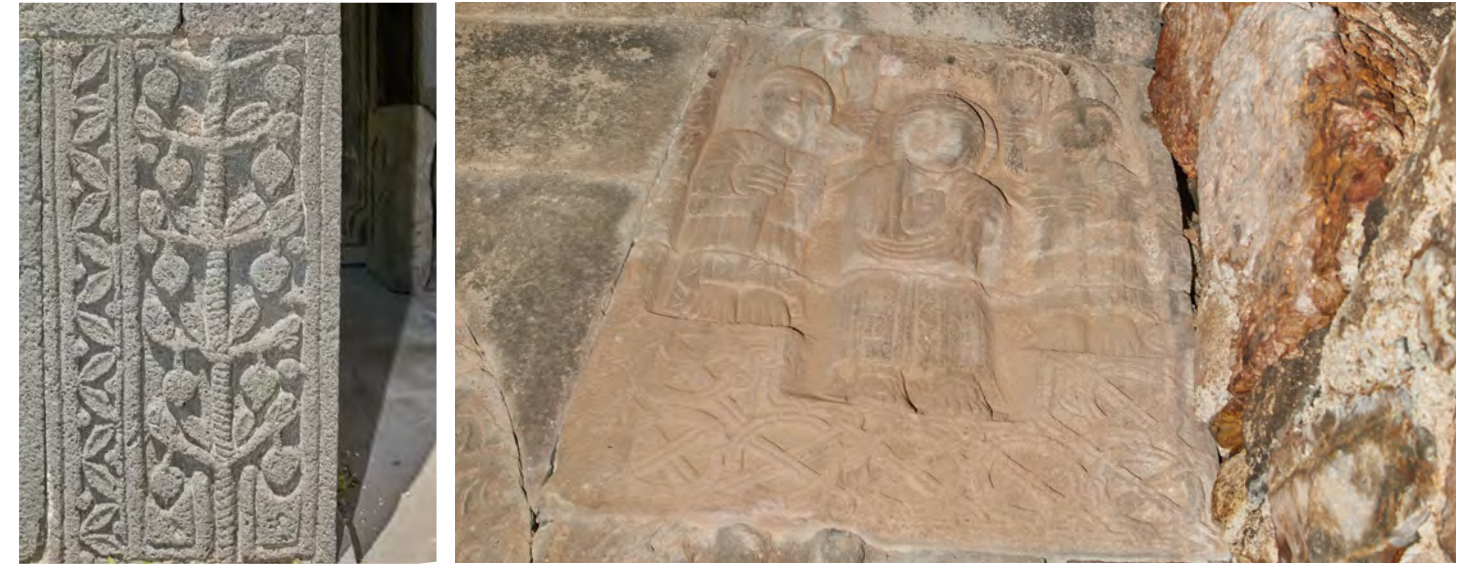
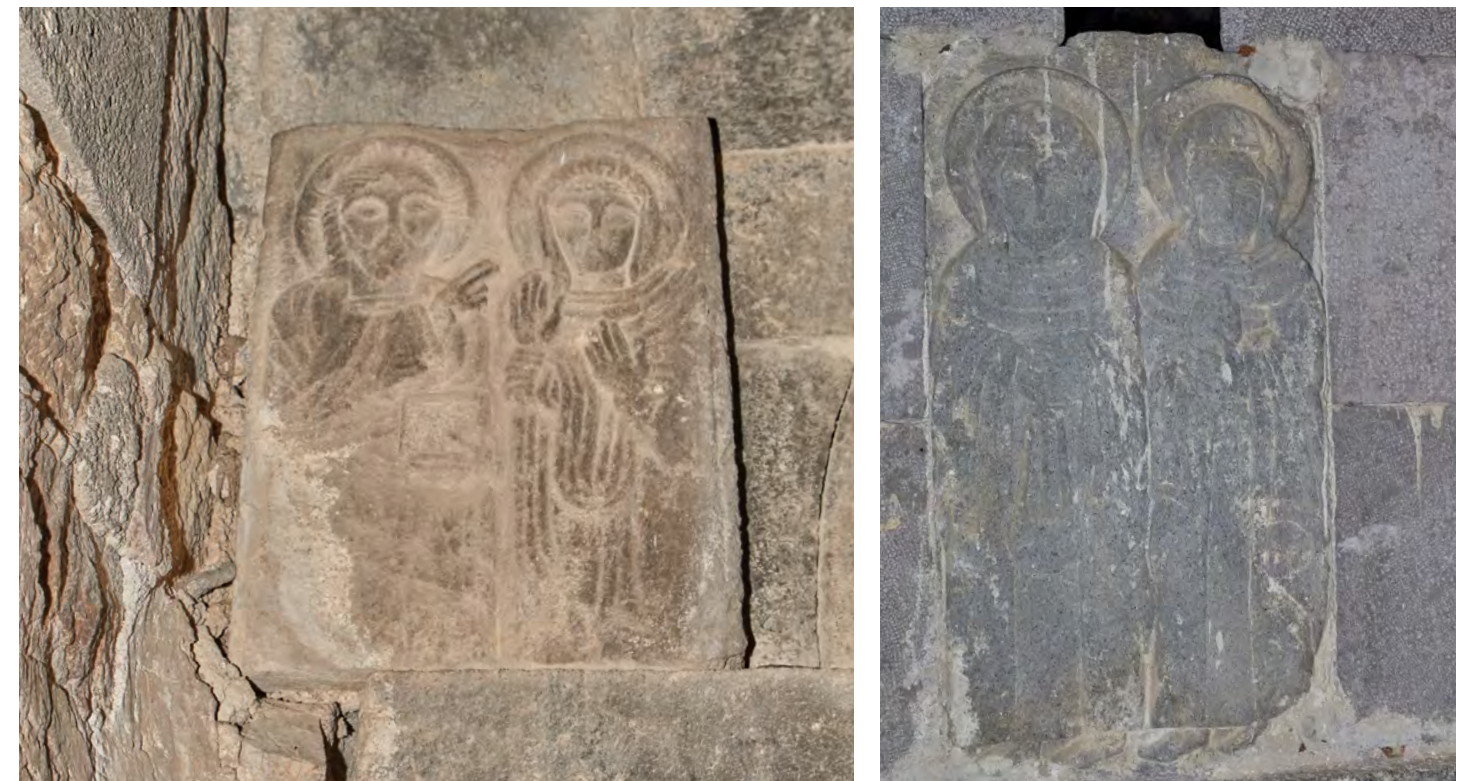
The carved decoration of the church is profuse, with figurative and ornamental themes, both outside and inside the building. It shows parallels with the school of Ani, as well as the churches of Zvartnots, Holy Cross of Aghtamar, Sissian, and other examples of medieval Armenia⁴. The ornamentation uses architectural, geometrical and vegetal themes (vines, pomegranate), which belong to the “symbolic repertoire of redemption” and participated to the faithful’s liturgical experience (fig. 7)⁵. The iconographical stone relieves, although not located in their original location, display themes such as the Annunciation to Mary, the myrophores and the Christ in Majesty, and date back most probably to the 10th century (fig. 8-10)⁶.

Fig. 7-8-9-10. Some examples of vegetal and figural sculpture: pomegranate tree, Christ in Majesty, Christ blessing Mary Magdalena, the myrophores (Iconem 2021)

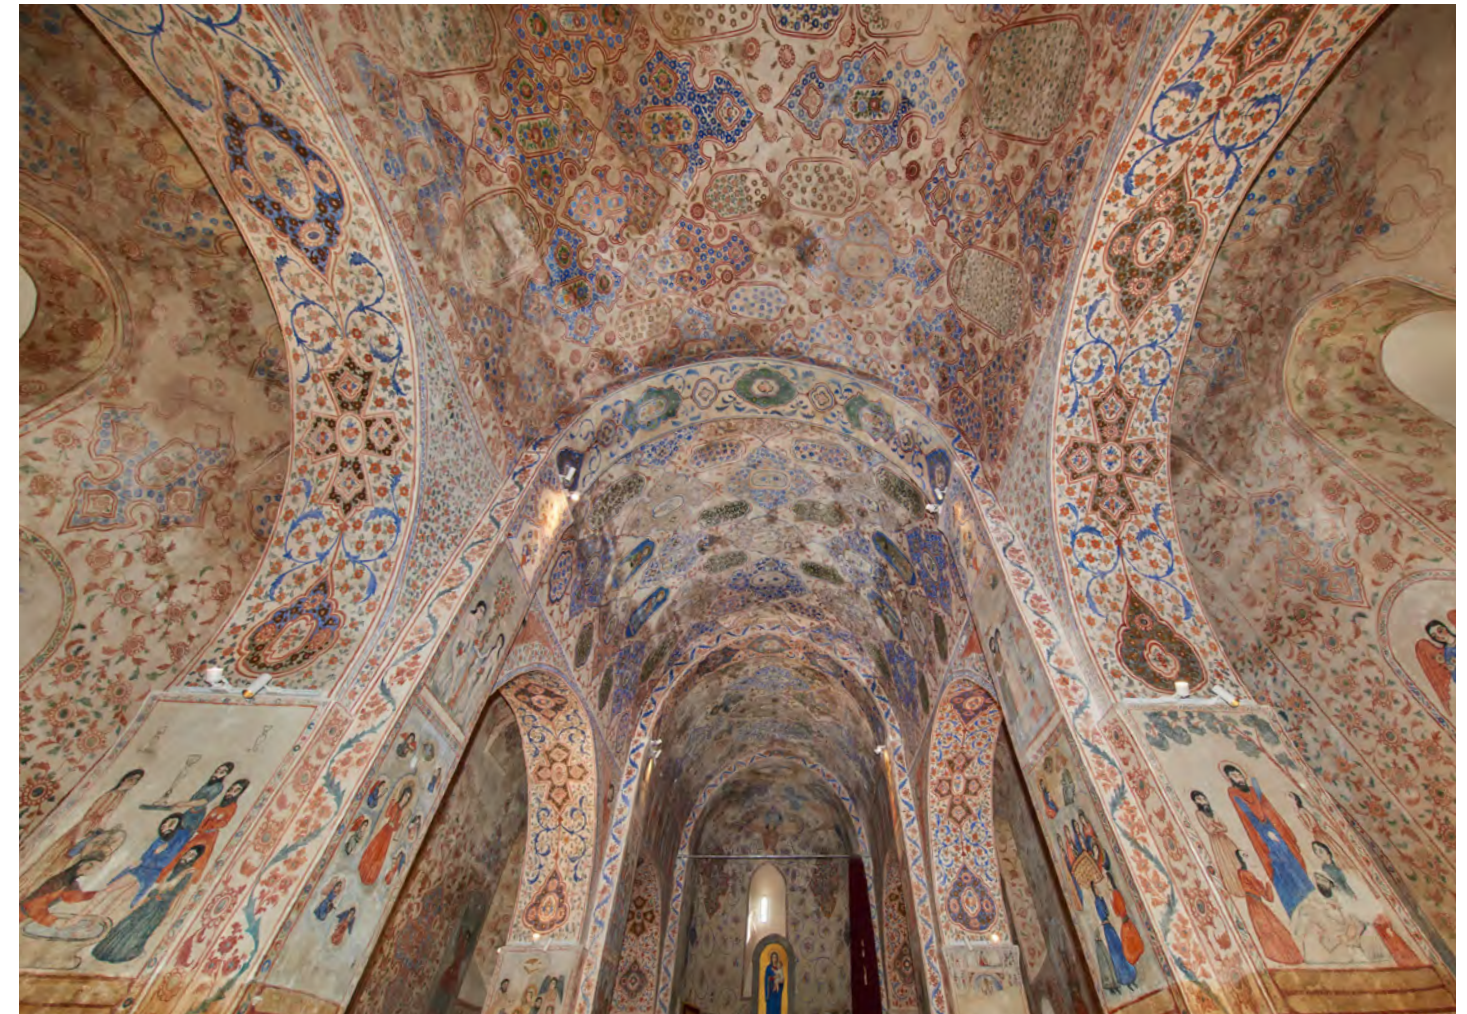
Fig. 5. Inside view of the monumental paintings (Iconem 2021)

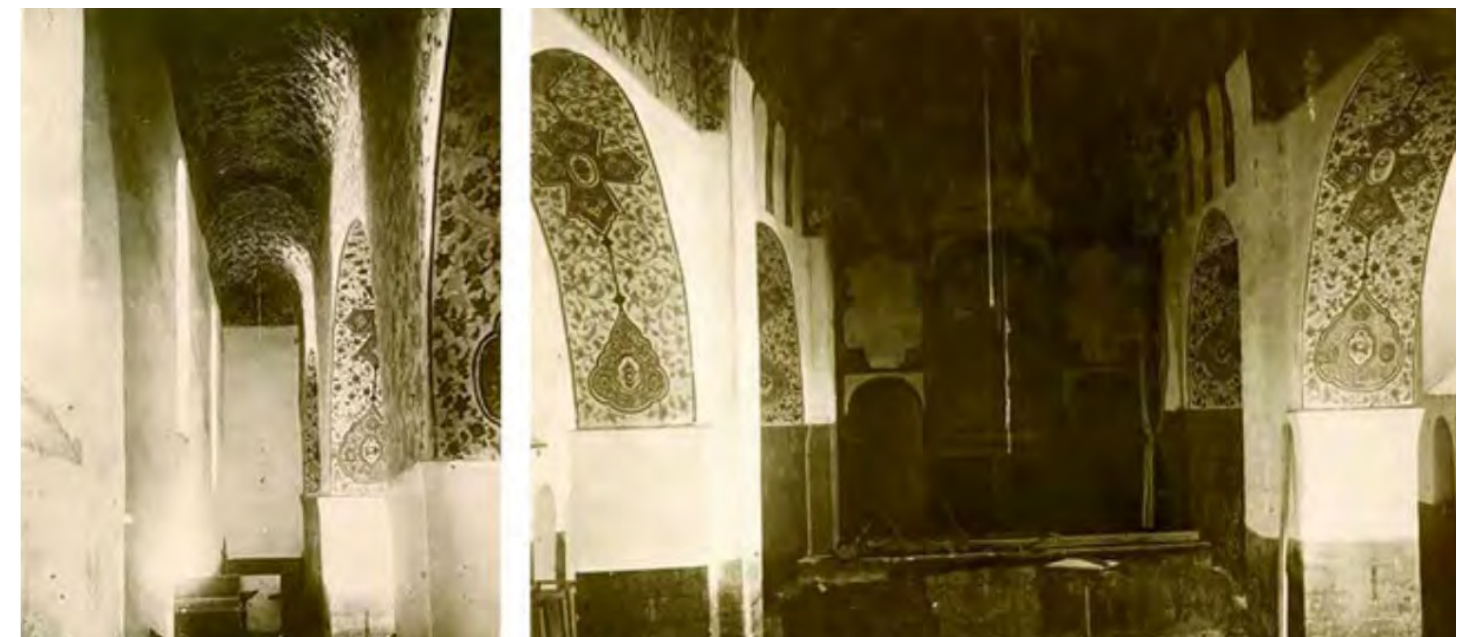
The paintings were damaged throughout the history for different reasons. Specialists have identified a layer of paint displayed on the lower parts of the walls at the end of 19th c., a layer of oil paint and lime covering the iconographic program and applied in the 1920's (fig. 6), the scratching of this lime layer by locals during the 20th c., iconoclastic destruction during the soviet times, and deteriorations due to water infiltration from the roof and the western window³. Some restorations were made in the 1984-1986 and 1994-1995, but had to be renewed in 2018-2019 after a meticulous study for restoring both the building and the paintings⁴.

Fig. 6. Inside view of the church in 1932 (Photography of P. Grigoryan, from Avetisyan 2020, fig. 2-3)

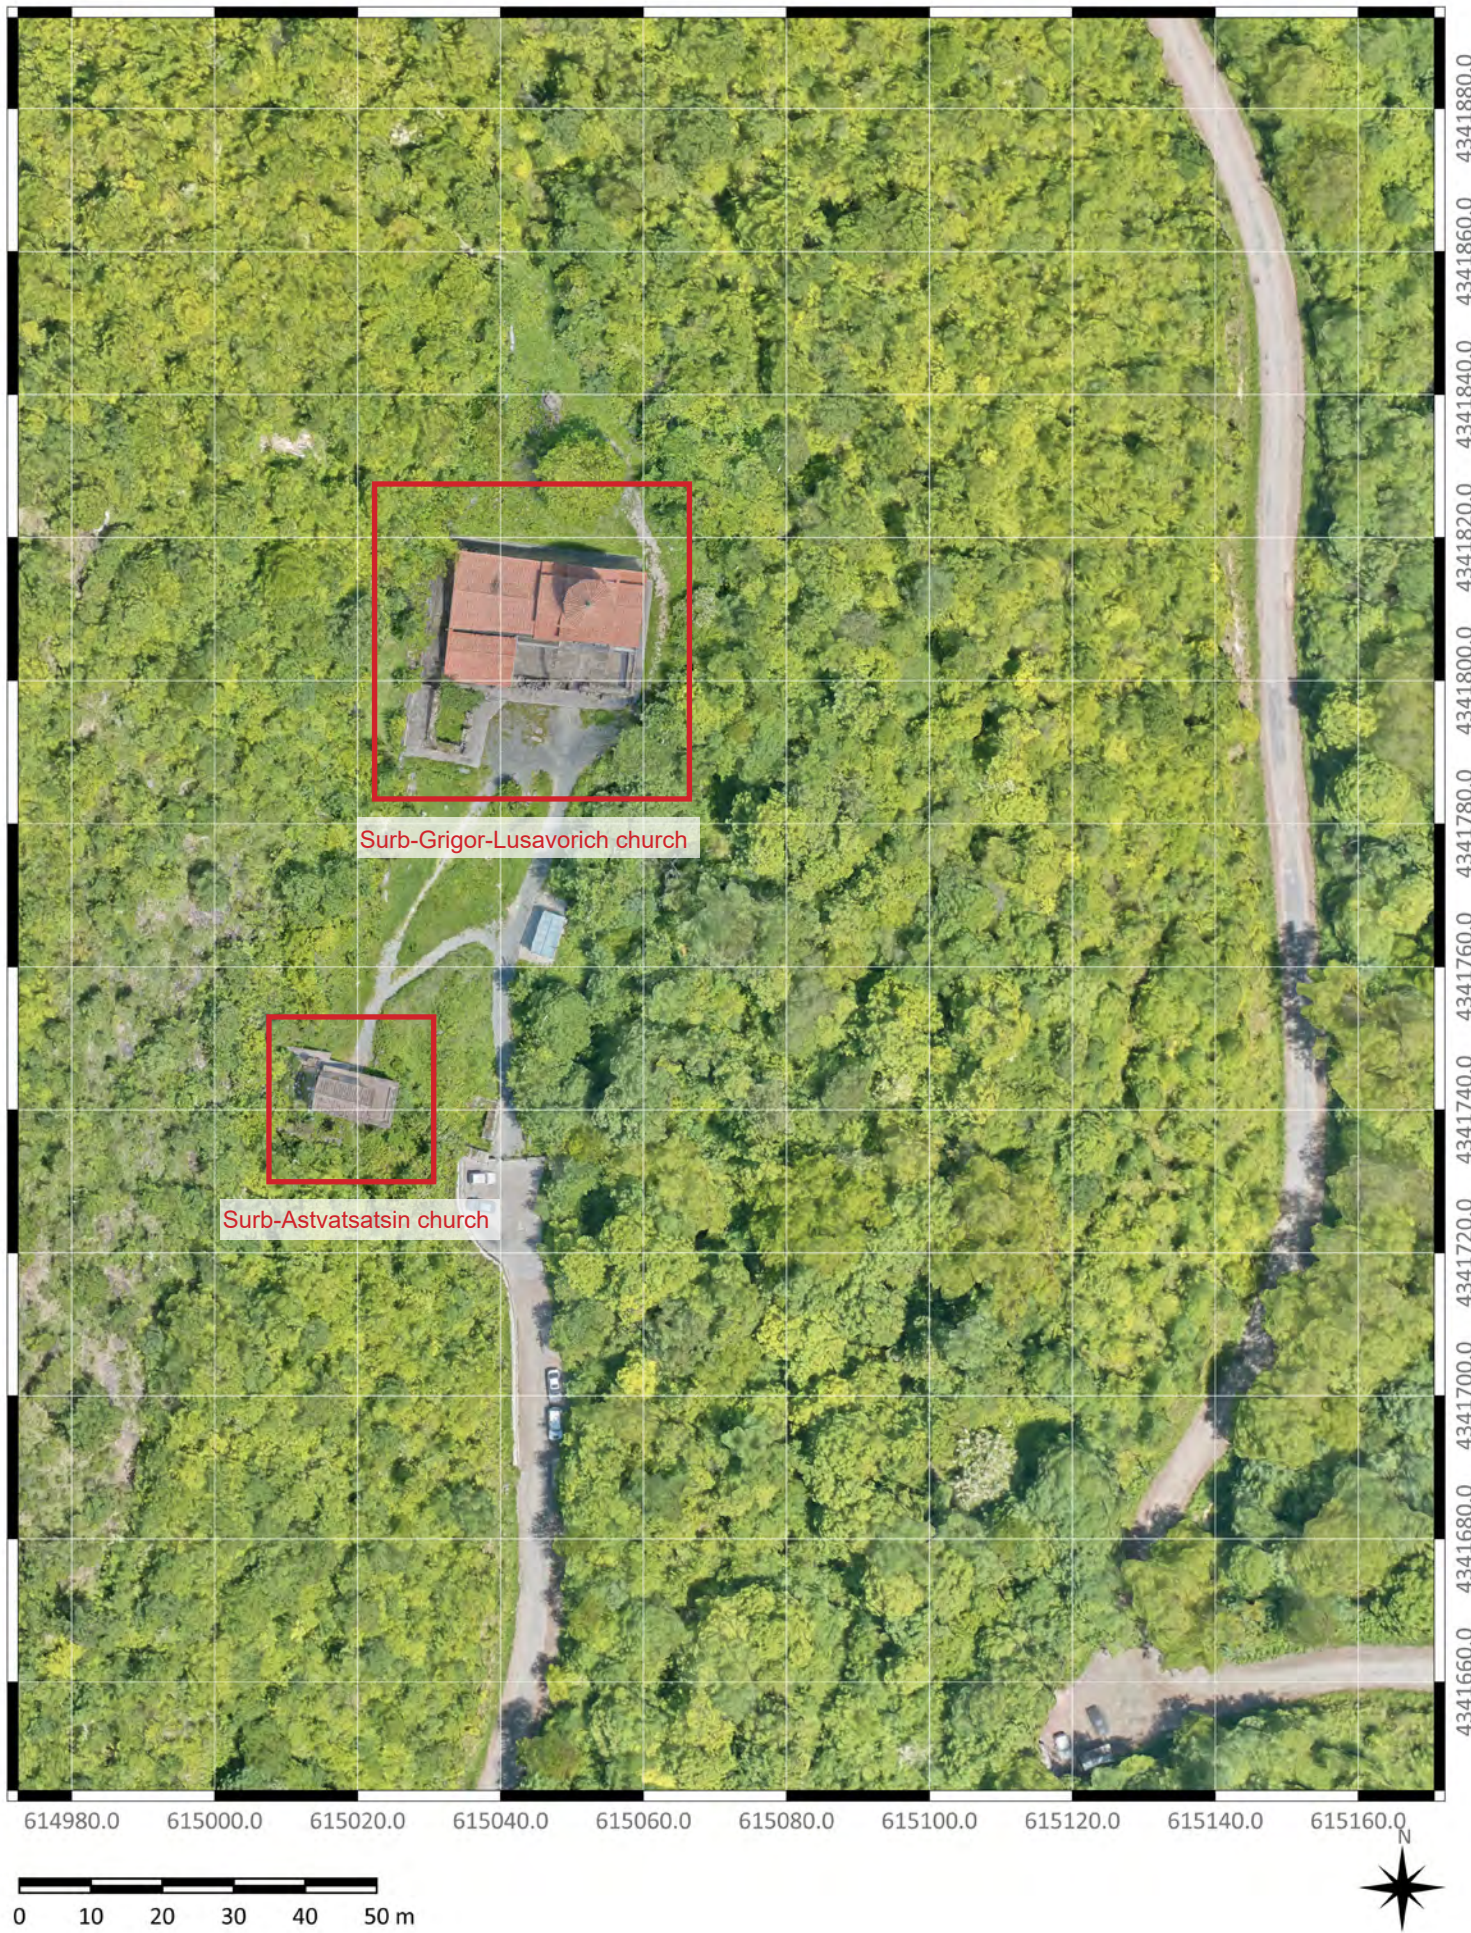
Fig. 1. Georeferenced ortho-image of the site of the monastery of Vahanavank extracted from the textured 3D scan (Iconem 2021)

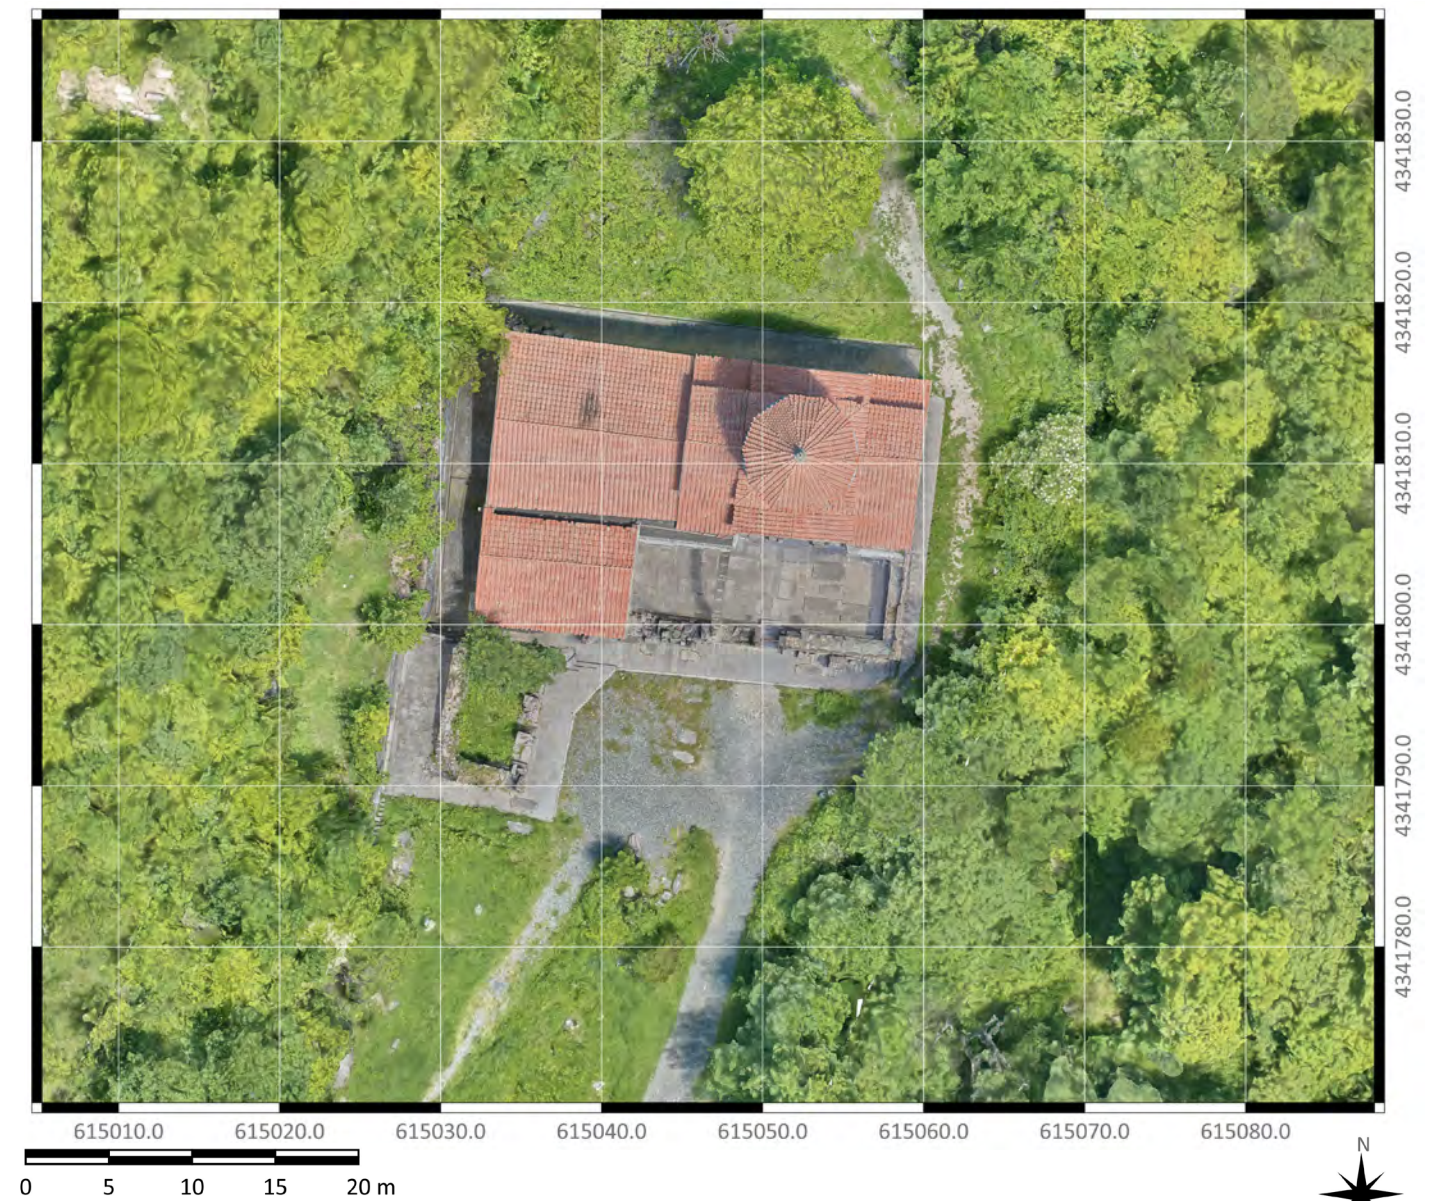
Fig. 2. Georeferenced ortho-image of the monastery of Vahanavank extracted from the textured 3D scan (Iconem 2021)

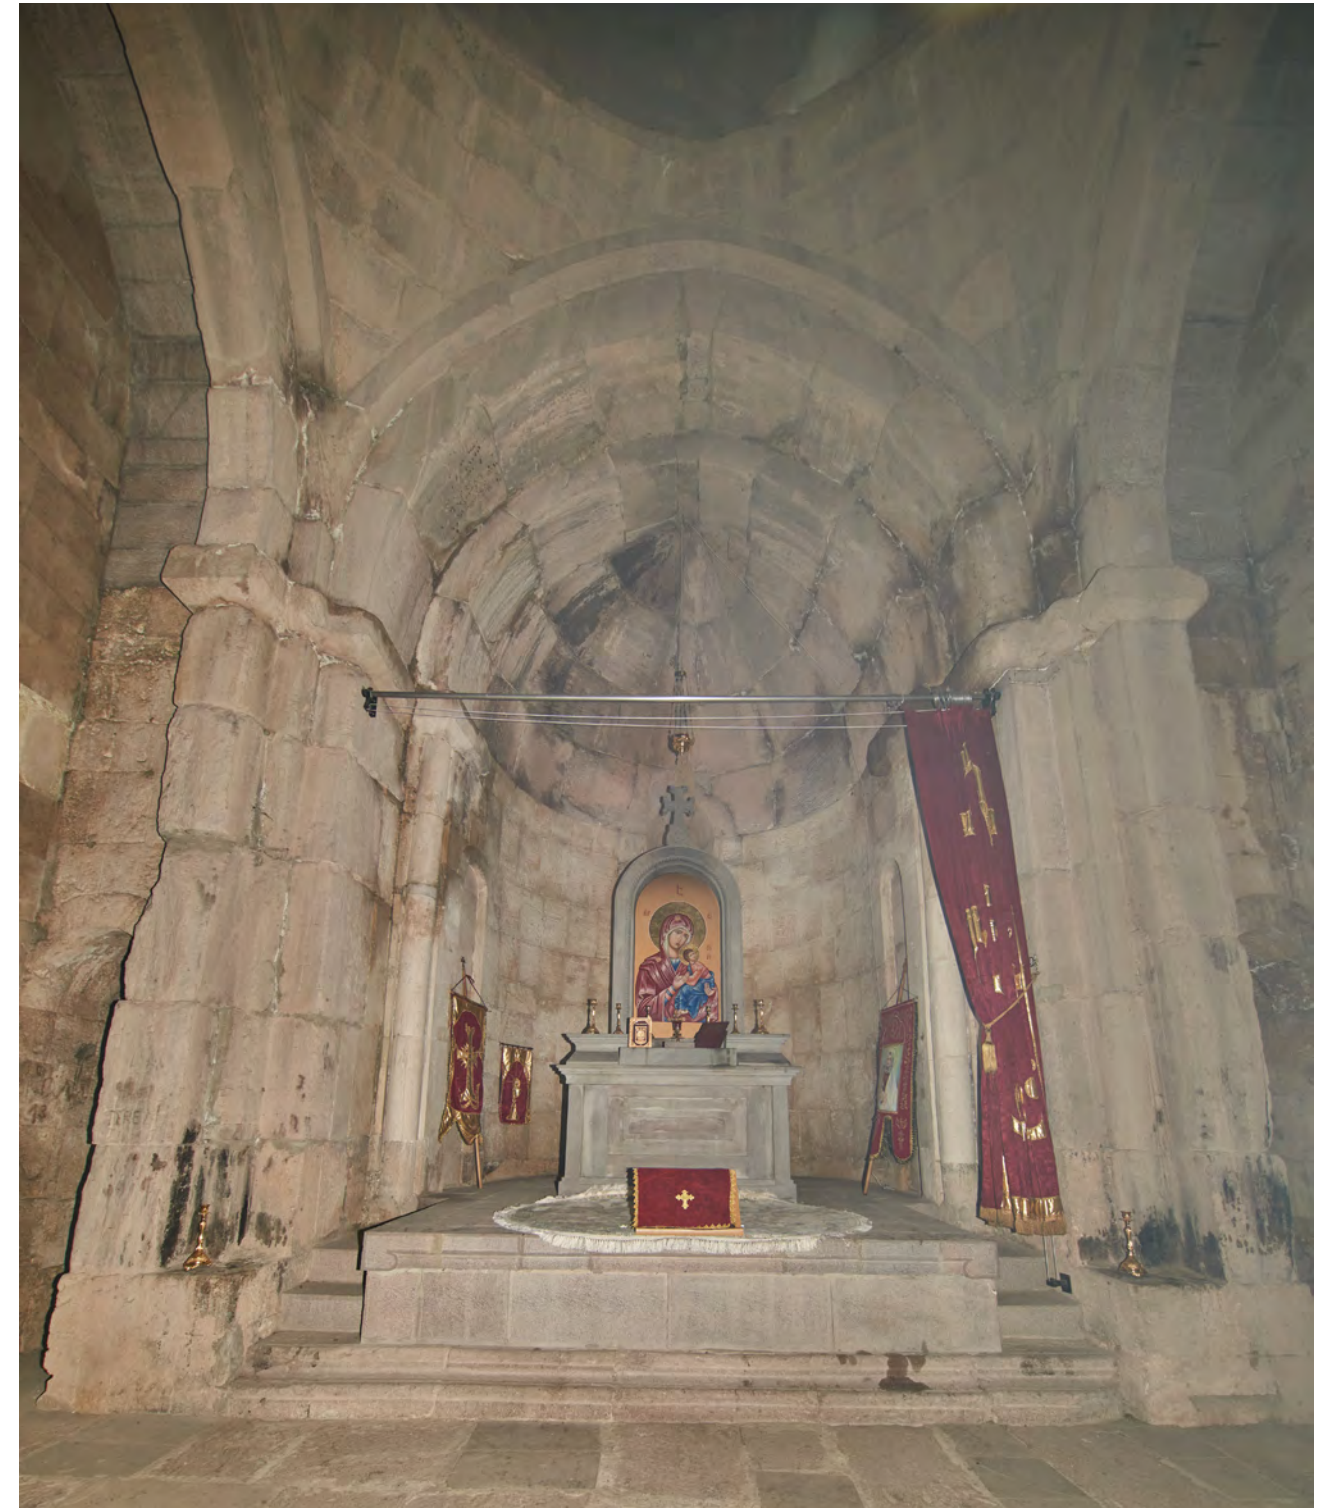
Fig. 5. Interior view of the the church of St-Gregory-the-Illuminator (Iconem 2021)

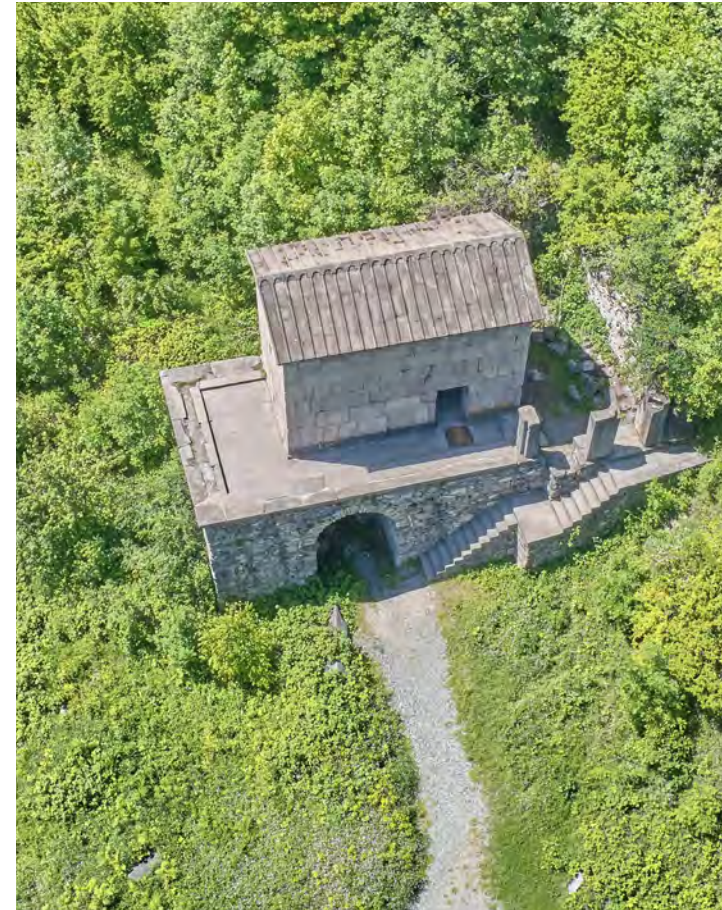
The church of Surp Astvatsatsin is located 50 meters south of the main church (fig. 1 and 7). It is a two-story building : the first floor was used as a mausoleum and the church stands on the second floor. It is a small single-nave building with a barrel vault (fig. 8), which was renovated during the soviet period. There are several inscriptions in the monastery (fig. 9), including one stating the construction the church of St-Astvatsatsin in 1086. A few *khachkars* with inscriptions were documented, mainly dated from the 10th-11th centuries (fig. 10).

Fig. 7. Aerial view of the church of Surp Astvatsatsin (Iconem 2021)

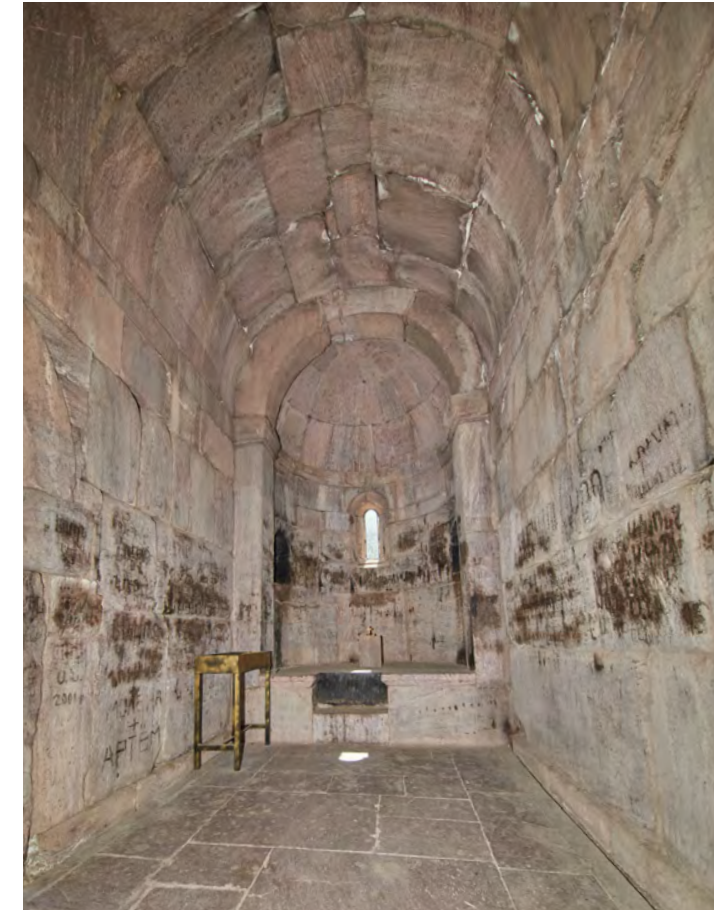
Fig. 8. Interior view of the church (Iconem 2021)

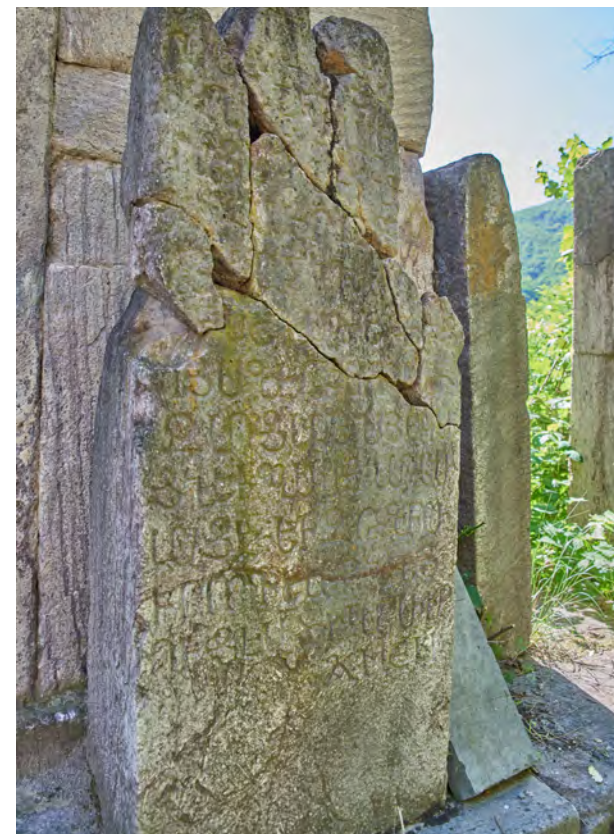
Fig. 9. An 11th century inscription near the entrance of the church (Iconem 2021)

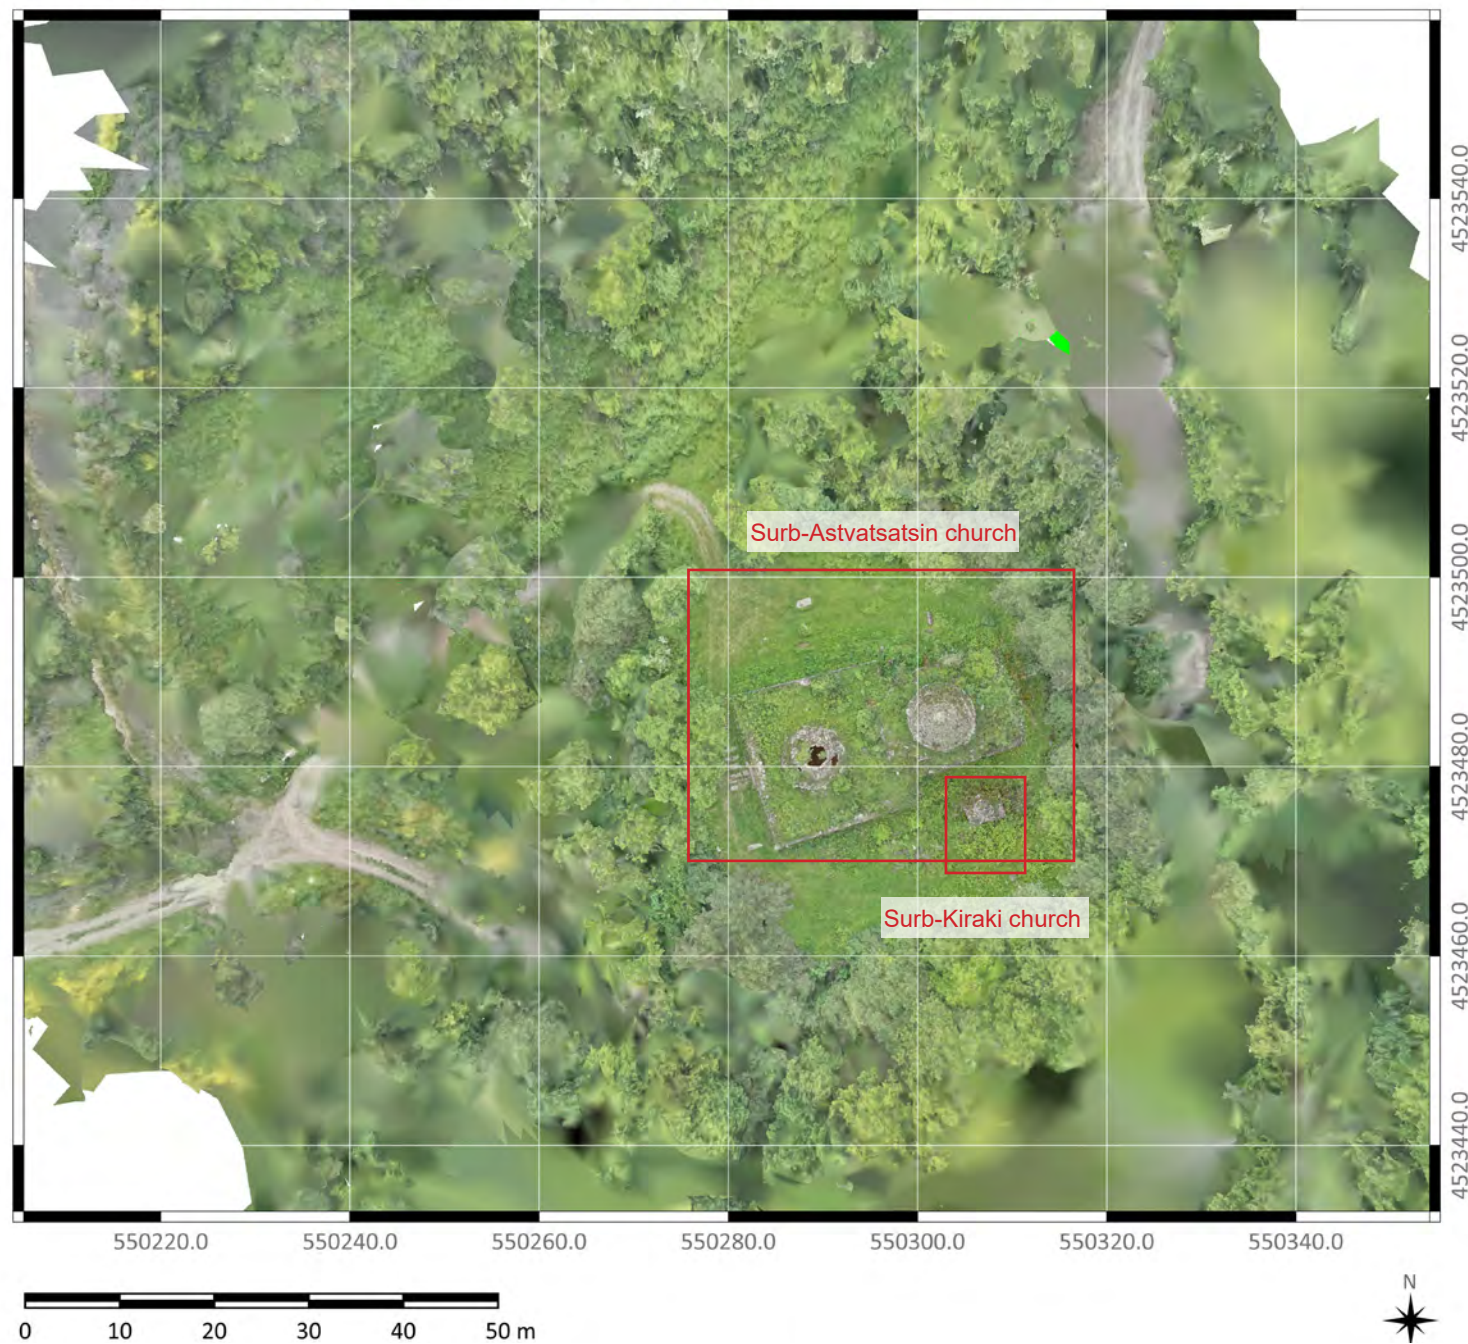
Fig. 1. Georeferenced ortho-image of Khoranasat monastery extracted from the textured 3D scan (Iconem 2021)

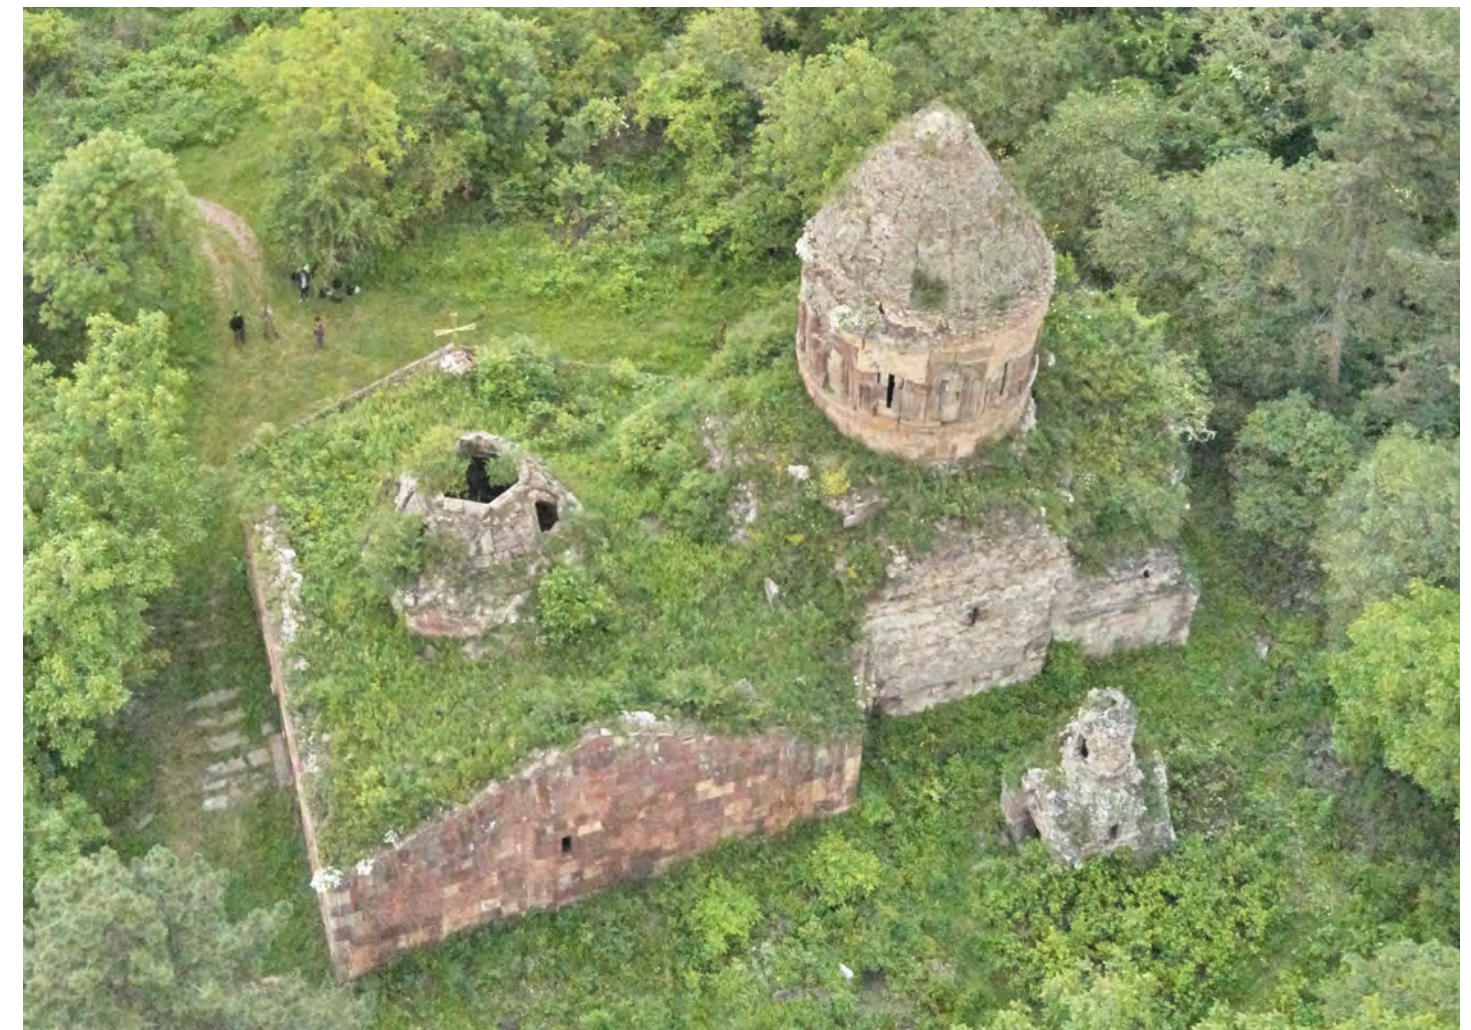
Fig. 2. Aerial view of of Khoranasat church (Iconem 2021)

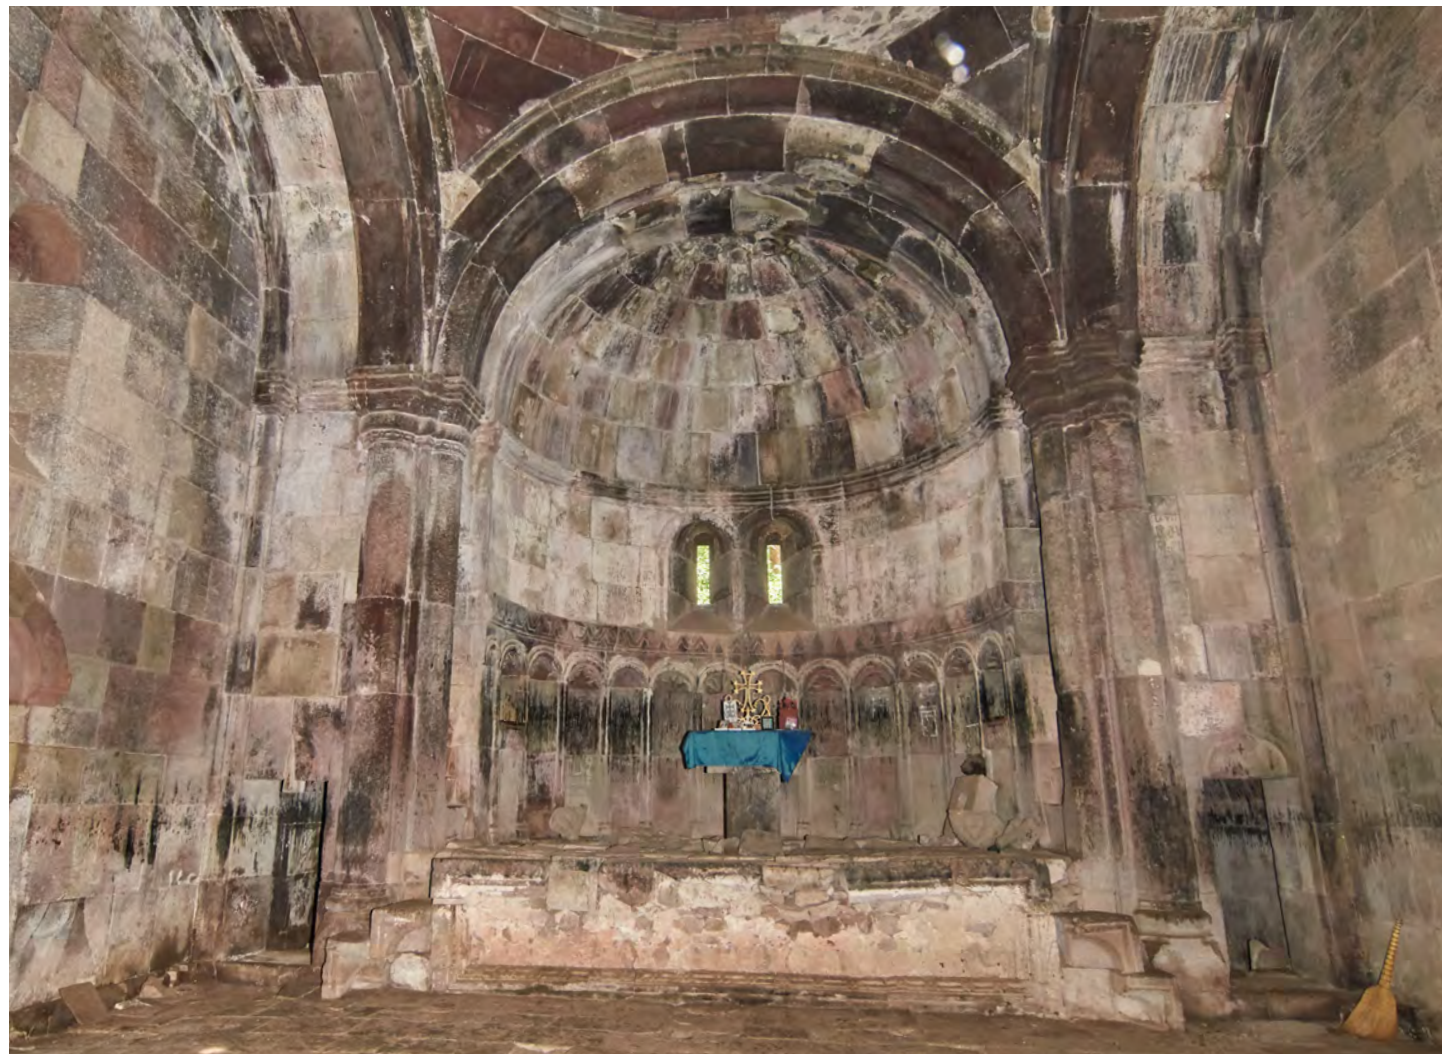
Fig. 5. The main apse of Surb-Astvatsatsin church (Iconem 2021)

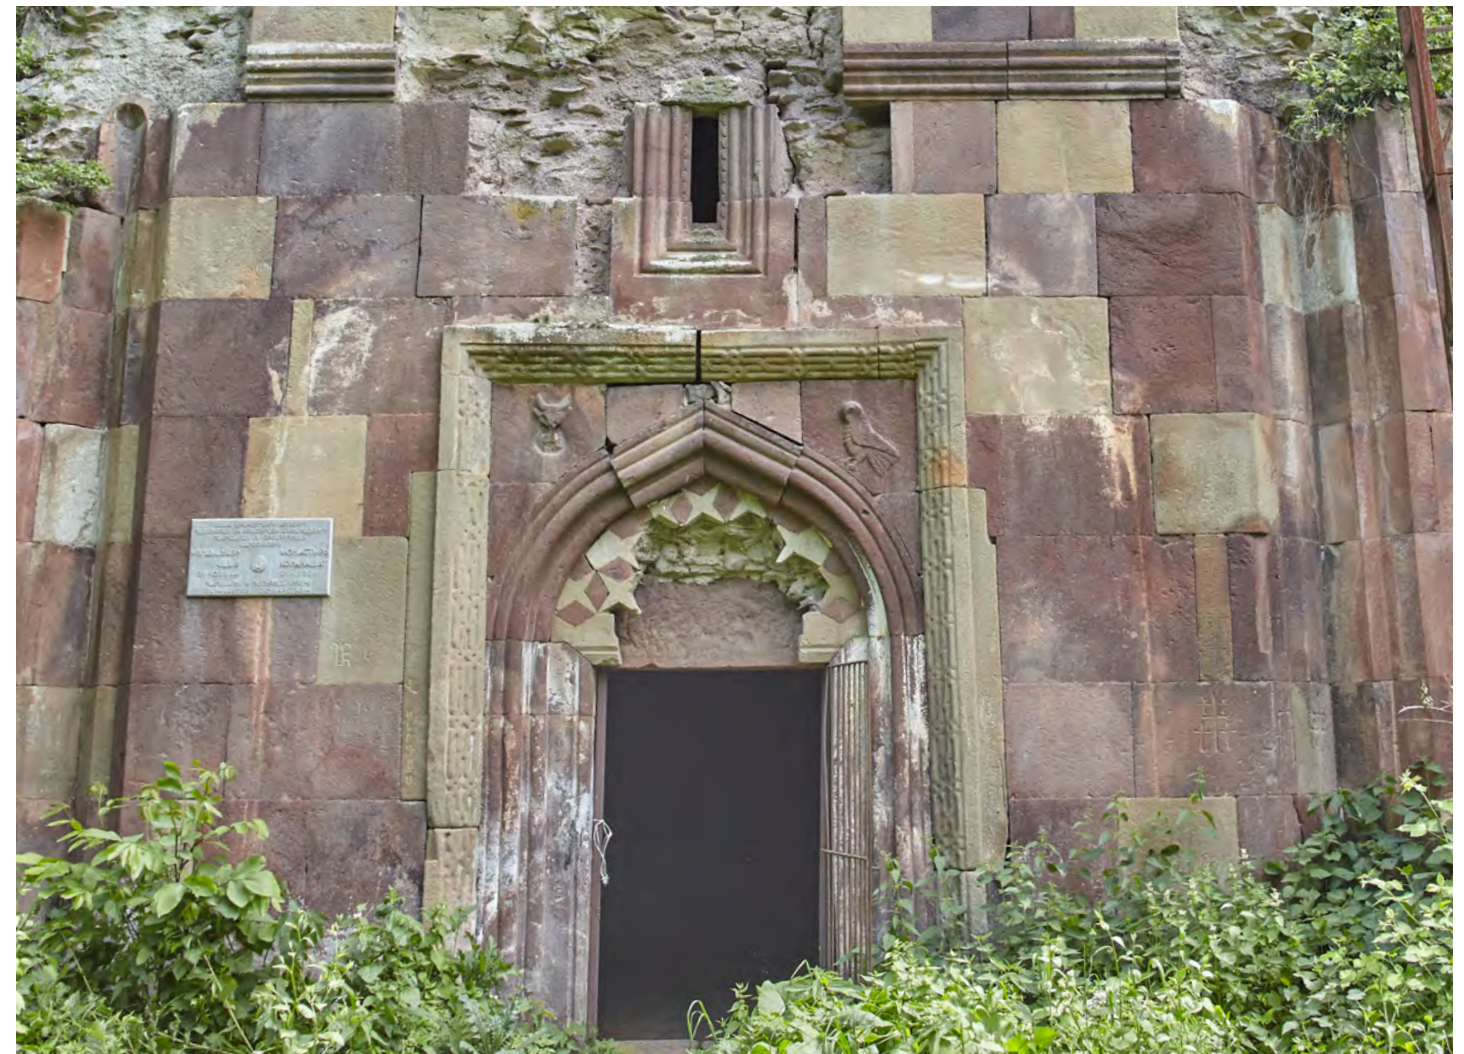
Fig. 7. The northern portal of Surb-Astvatsatsin church (Iconem 2021)

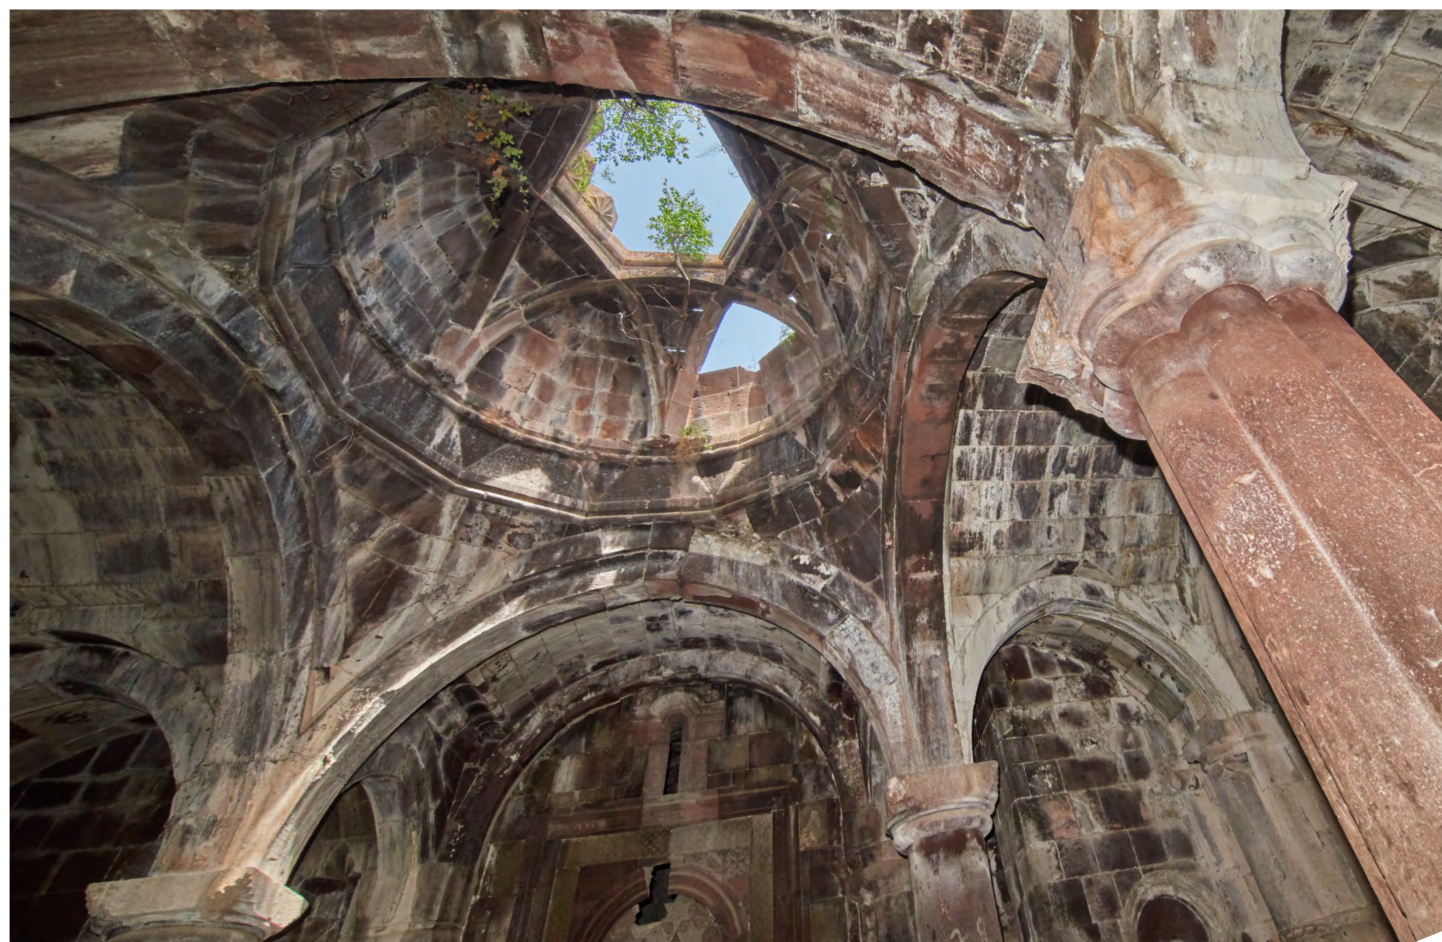
Fig. 6. The gavit's dome of Surb-Astvatsatsin church (Iconem 2021)

The monastery’s buildings are quite deteriorated, especially the domes. They are entirely covered with vegetation. Many architectural stone blocks, sometimes carved, are kept inside the church of Surb-Astvatsatsin. Some of them are particularly noteworthy, such as the four triangular stone blocks with a sculpted face kept on the *bema* and the southern sacristy : they were probably the pendentives supporting the dome. The floor is dilapidated in some part, especially in the sanctuary (the *bema* and the two sacristies), which may indicate looting.

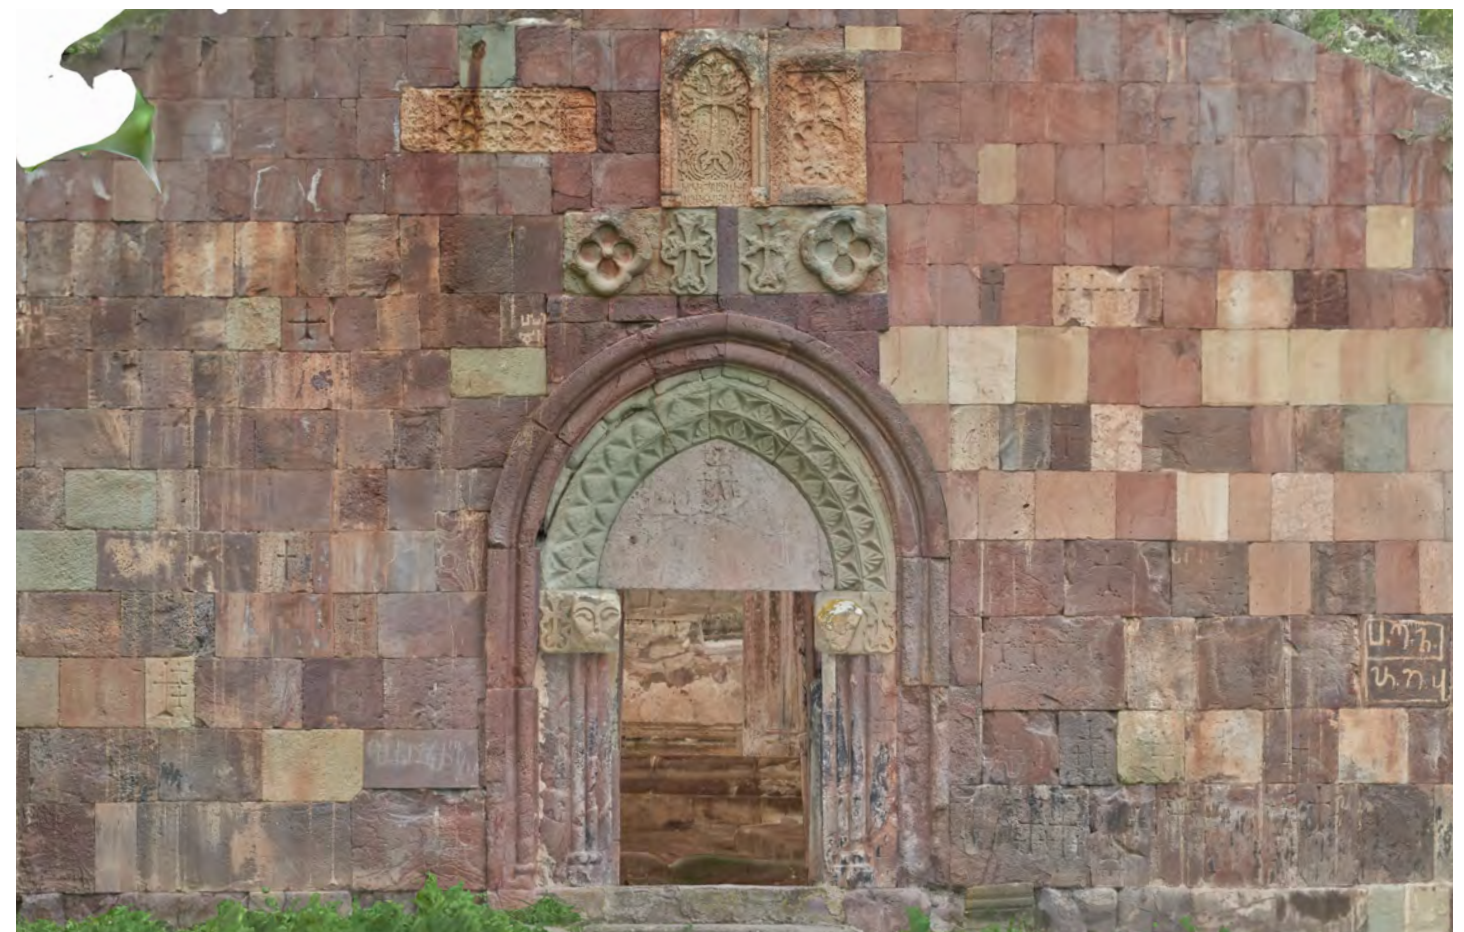
Fig. 9. Ortho-image of the western portal of Surb-Astvatsatsin church (Iconem 2021)
