HERITAGE
WATCH.AI

ARMENIAN CULTURAL HERITAGE SITES
CONDITIONAL REPORT

2 0 2 0

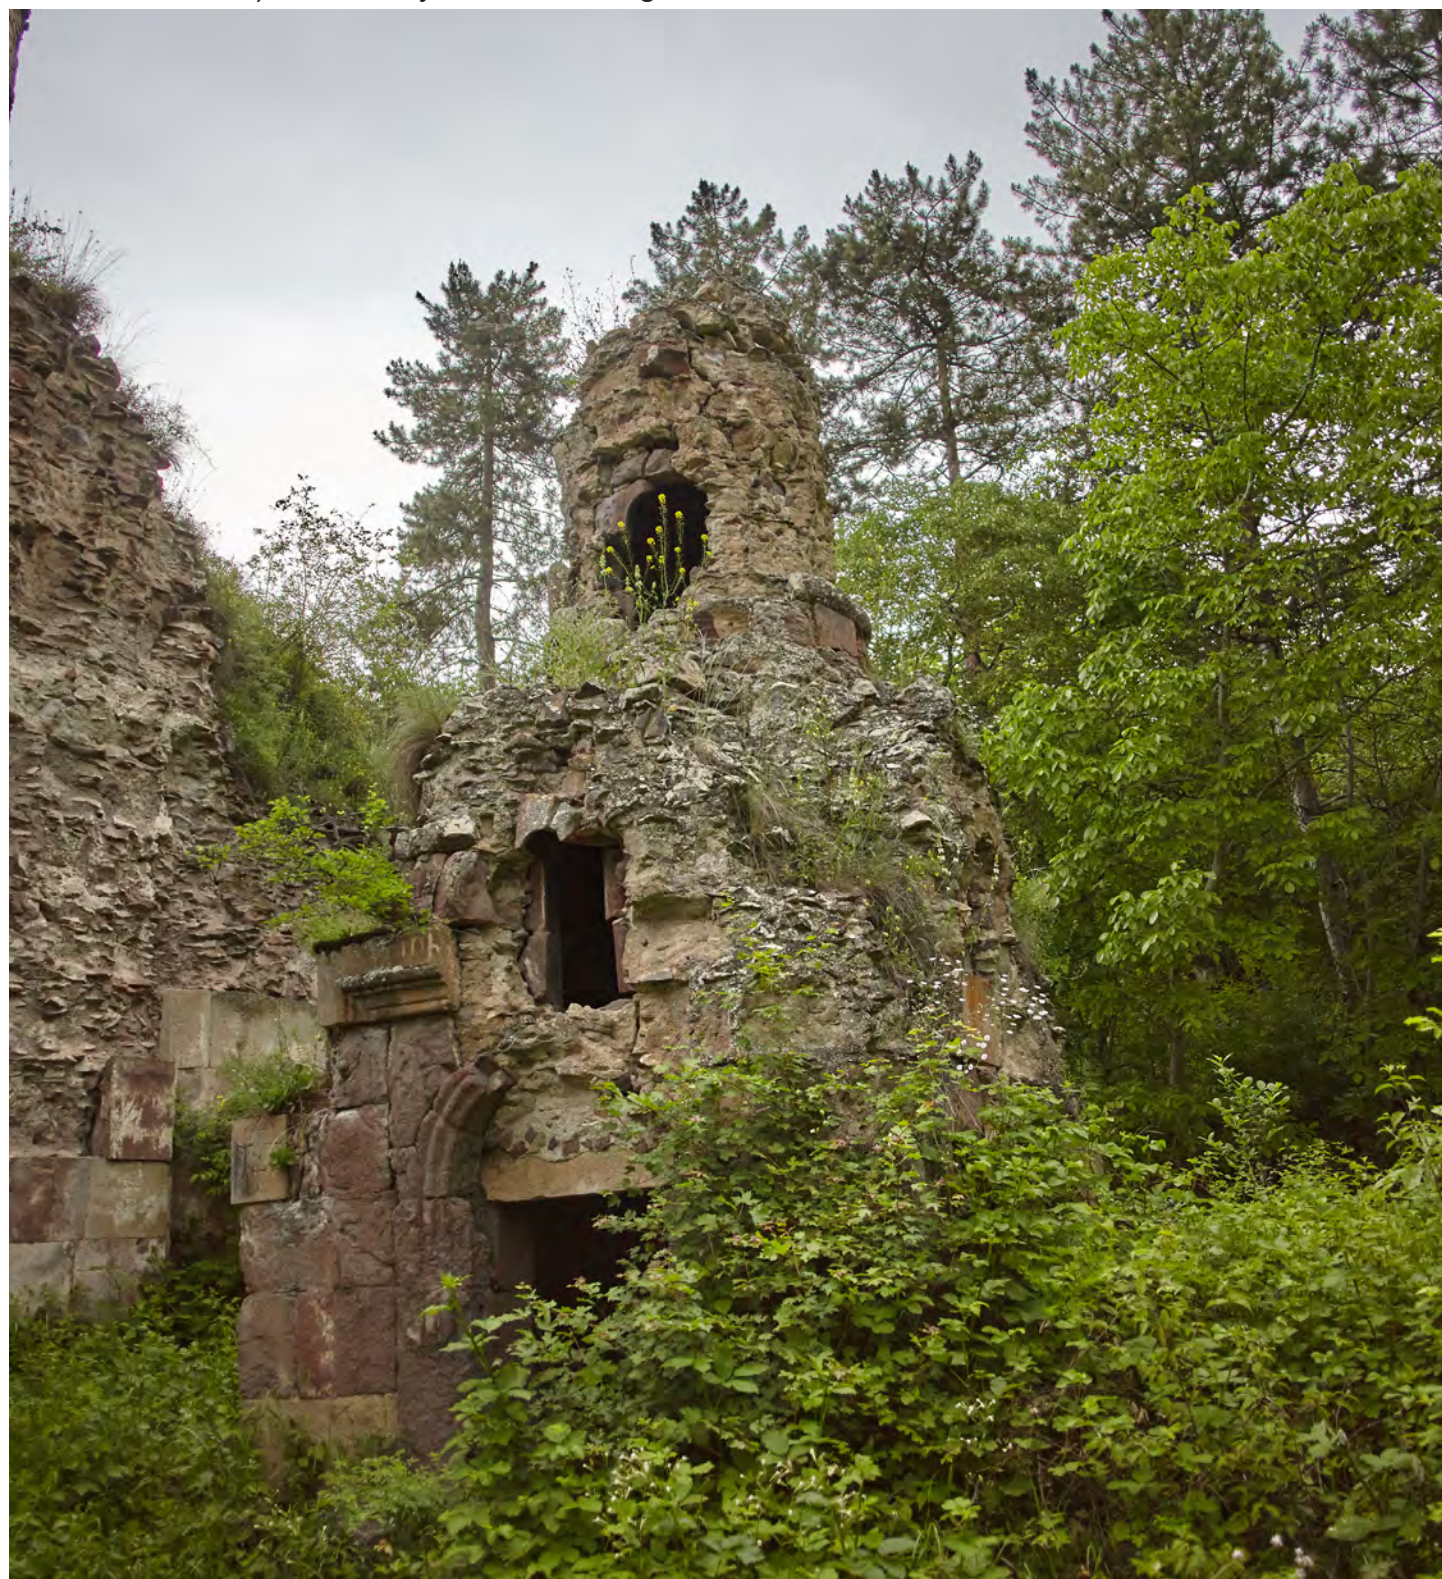
There is another small church 4m south of the church of Surb-Astvatsatsin named Surb-Kiraki. It is a small dome on square plan, called “coupole sur carré” according to the typology established by P. Donabédian (fig. 9)⁶. This architecture was widely used for memorial chapels. Another church, named Surp-Chgnavor, is located 15m east from the enclosure, which is in a state of ruin and does not appear in the model.

Fig. 9. The Surp-Kiraki church (Iconem 2021)
