HERITAGE  
WATCH.AI

IMPACT OF TAPI PIPELINE PROJECT ON  
ARCHAEOLOGICAL SITES IN AFGHANISTAN

2 0 2 3

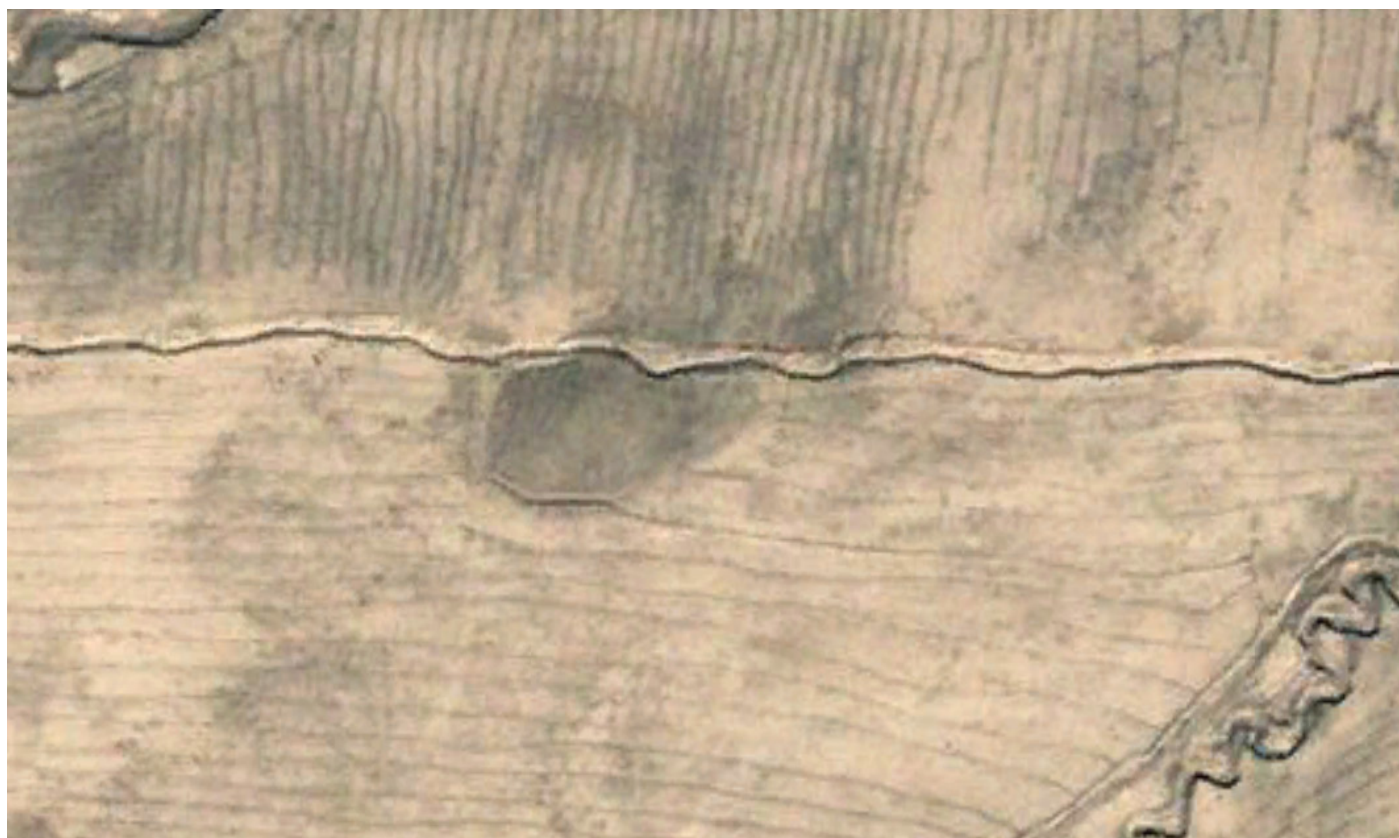
The site is located in the middle of agricultural land. A stream of water on the northern side of the site can be seen expanding between 2004 and 2022. There is little evidence suggesting looting or transformation to the site.

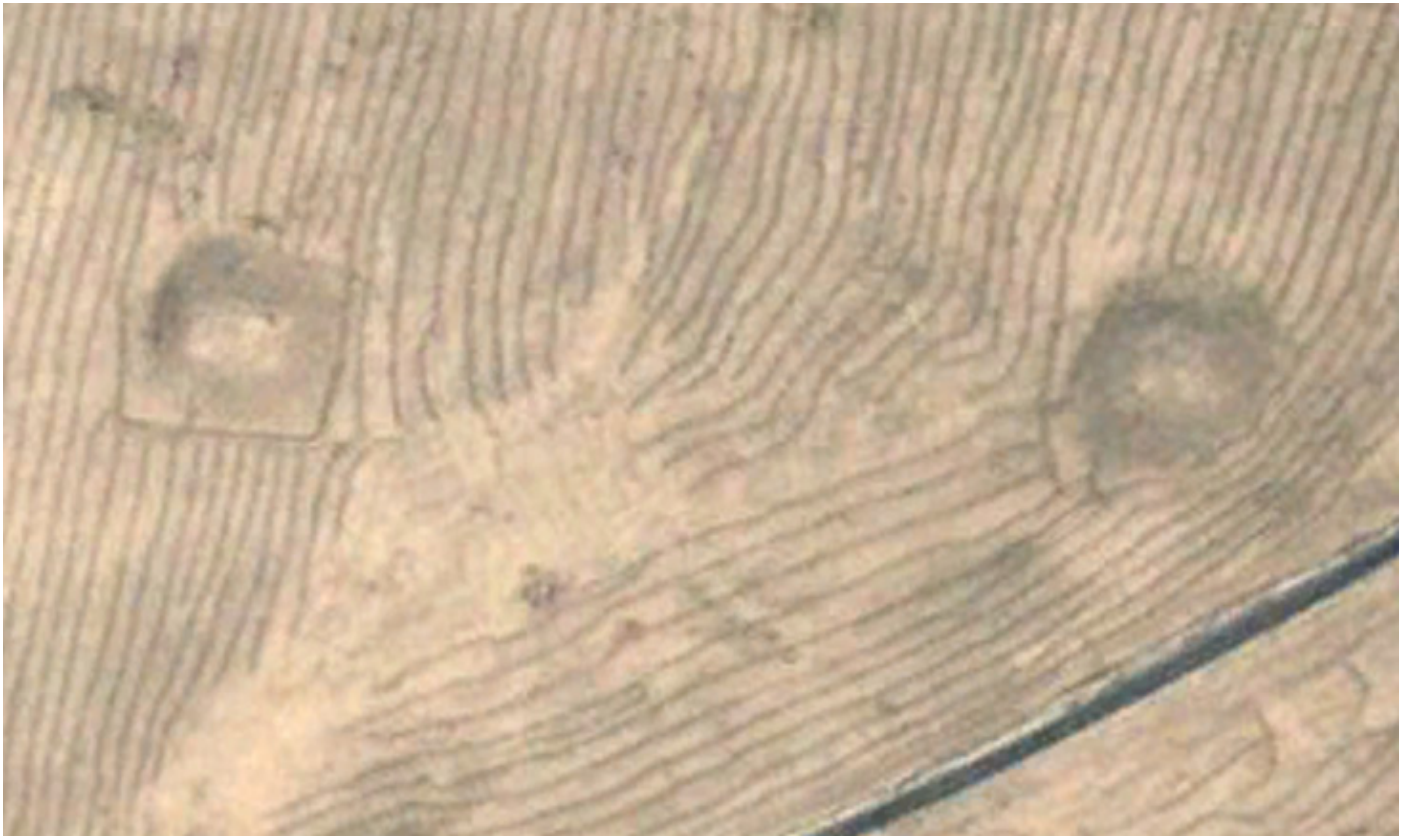
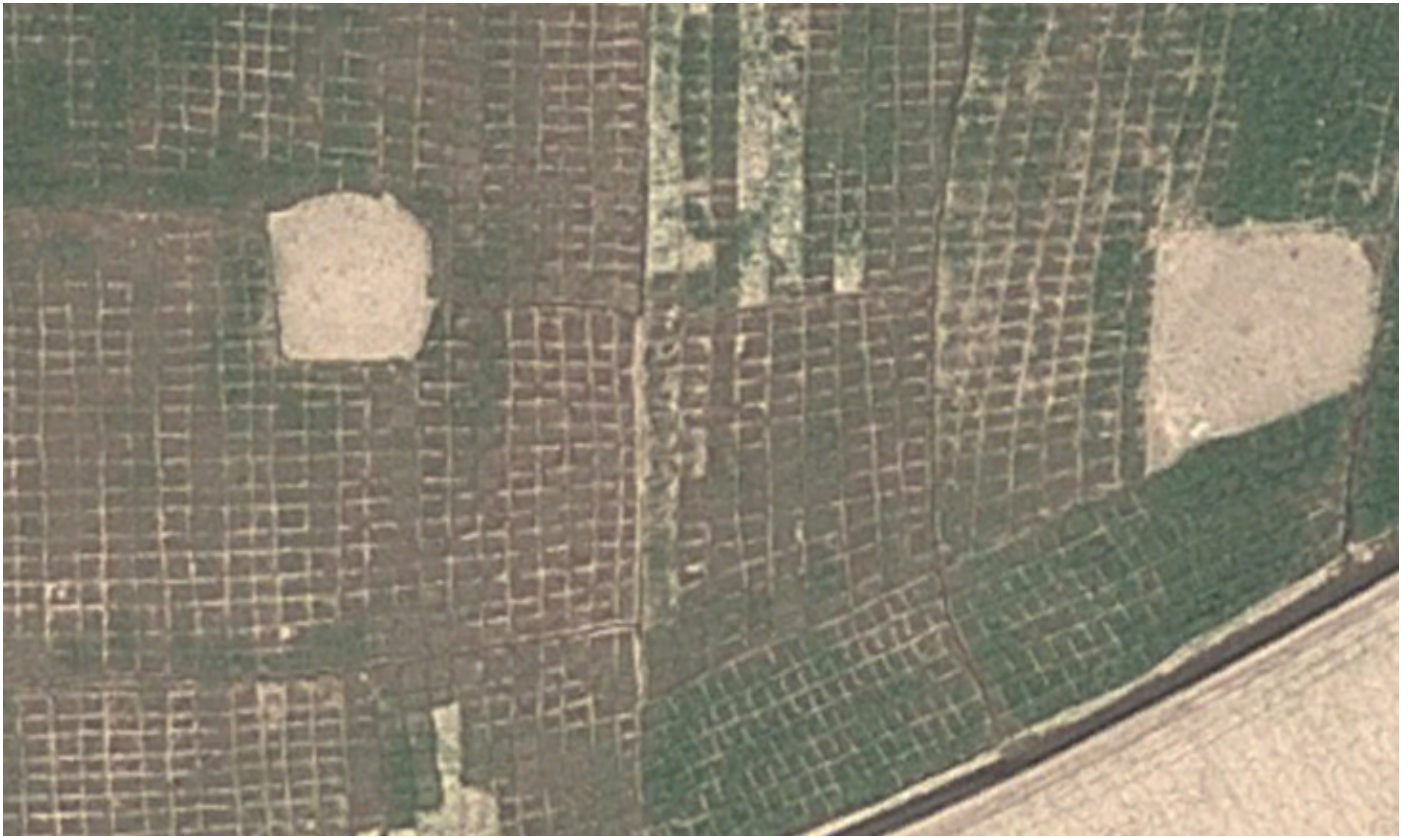
NE2 31°32'33.93"N; 65°13'31.96"E

The site is located in the middle of agricultural land and is comprised of two mounds approximately 100 meters apart. Between 2012 and 2019, the western tepe bears a new construction. The eastern tepe has been completely transformed into agricultural land.

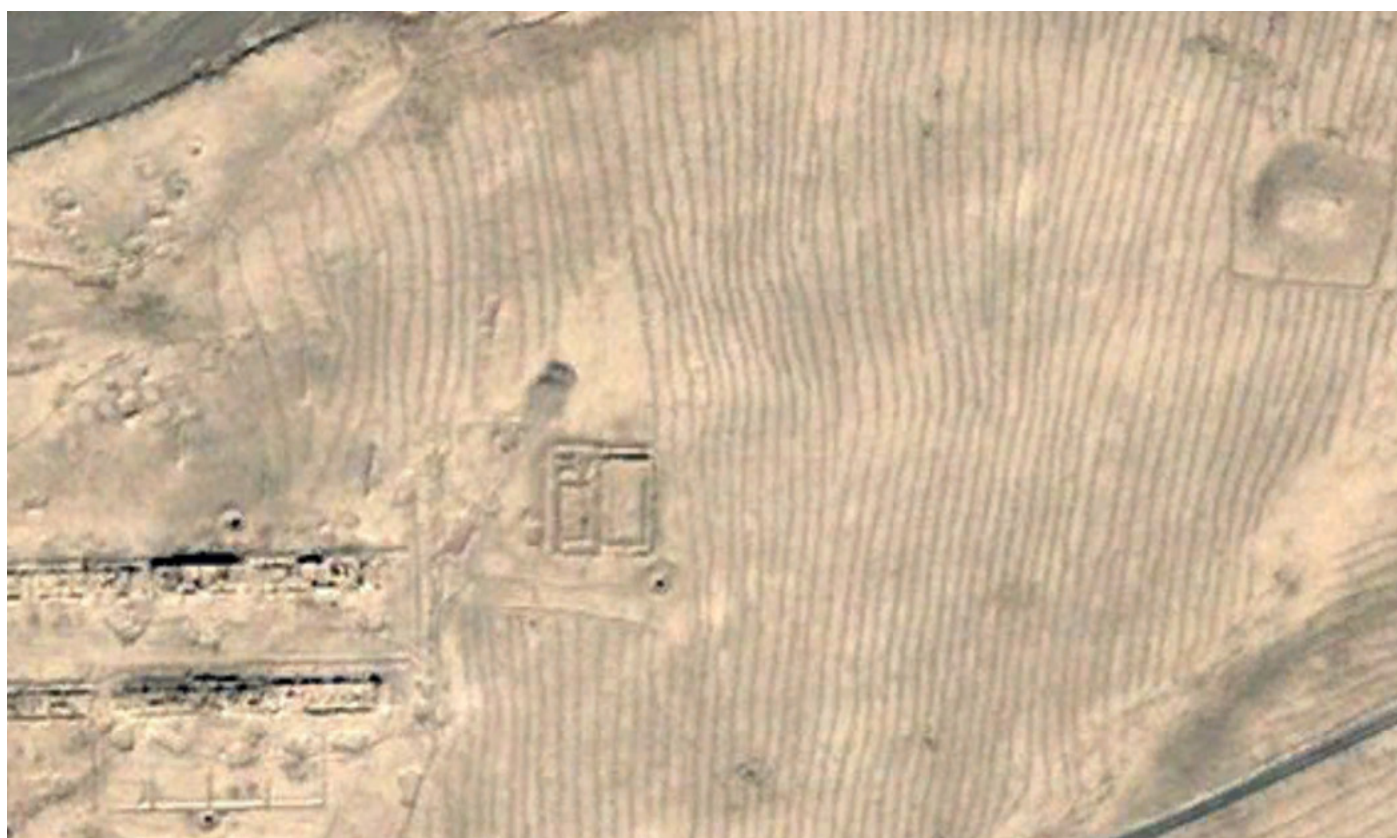
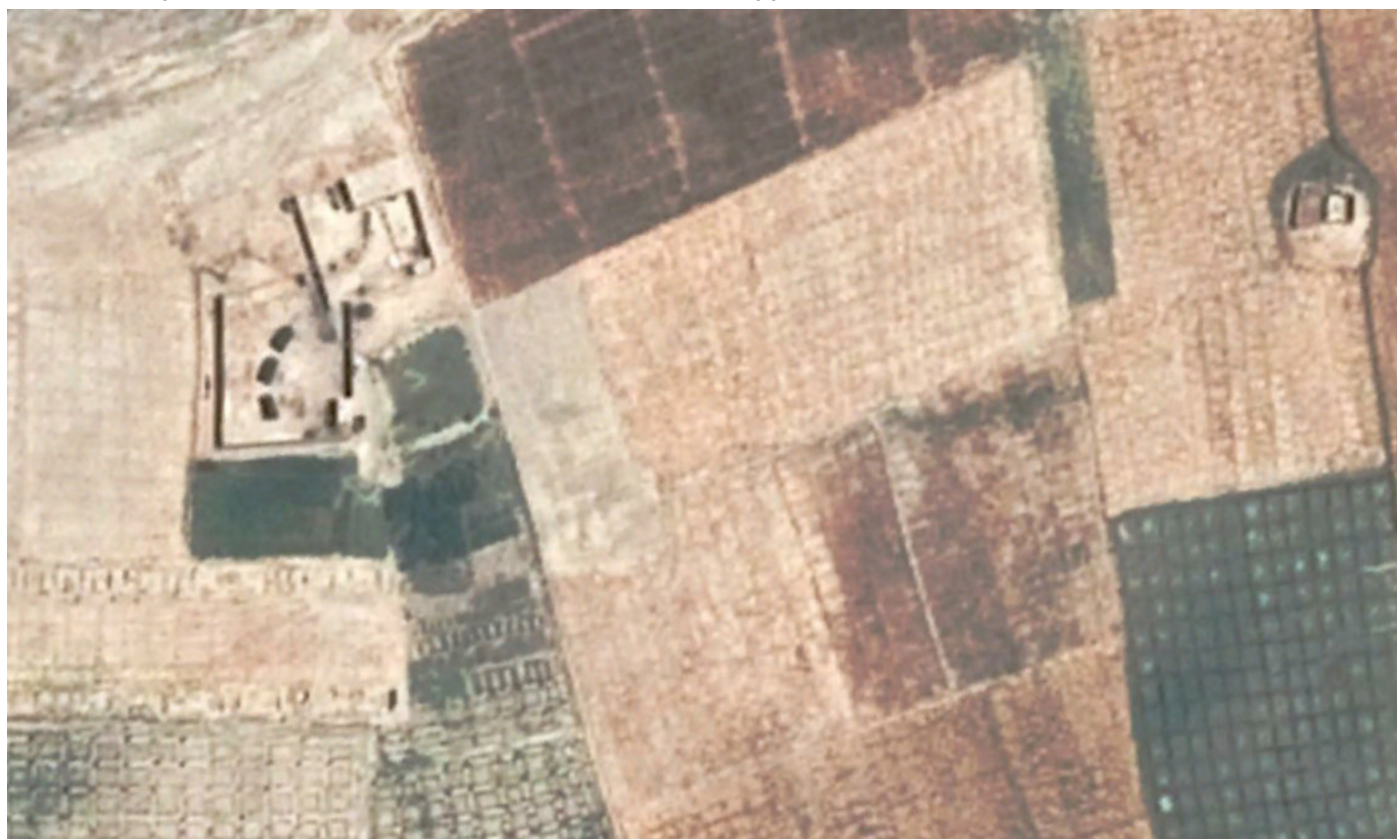
The site is located 130 meters west of the previous site. We can observe the remains of a rectangular structure until 2012. New constructions have appeared between 2012 & 2019 and the land became segmented for agricultural use.

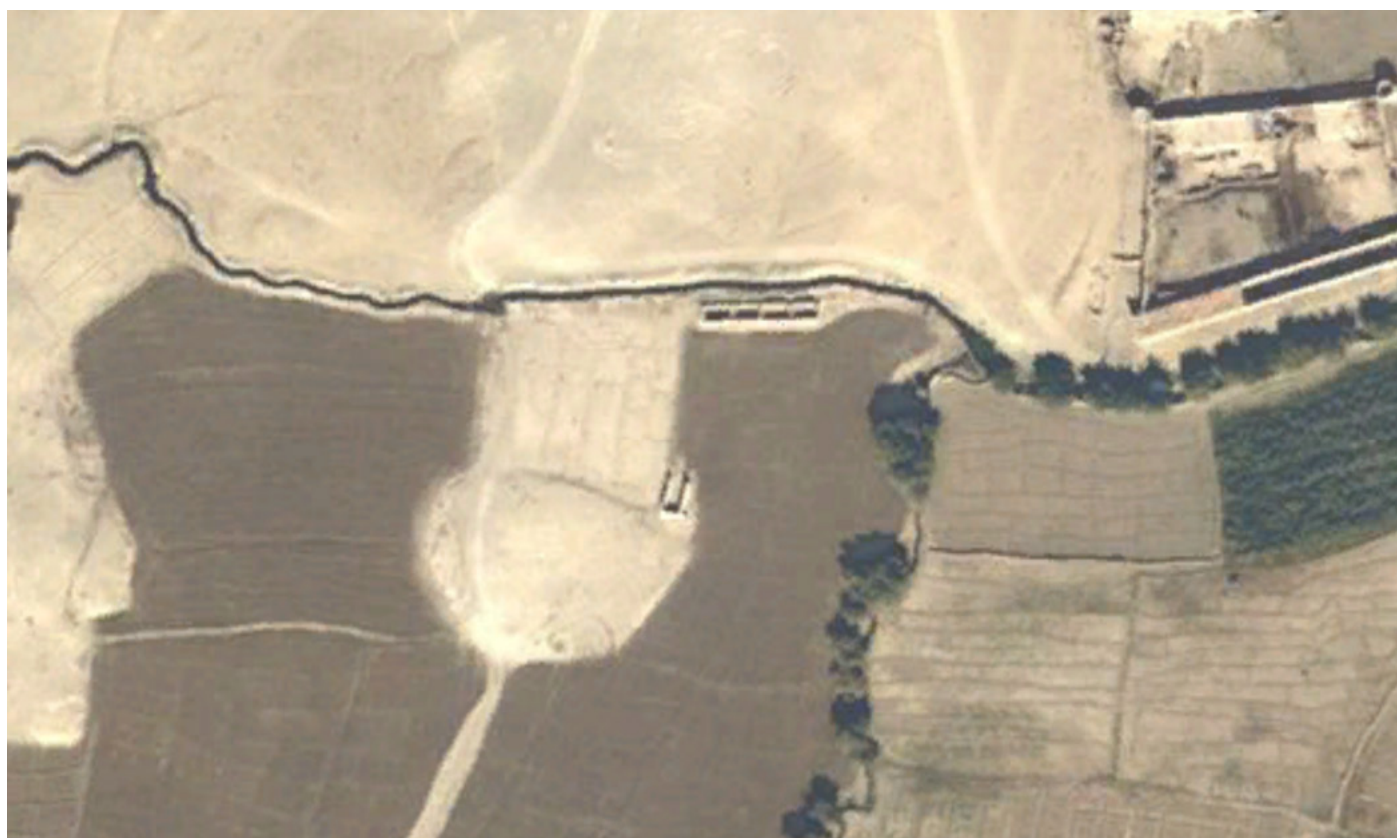
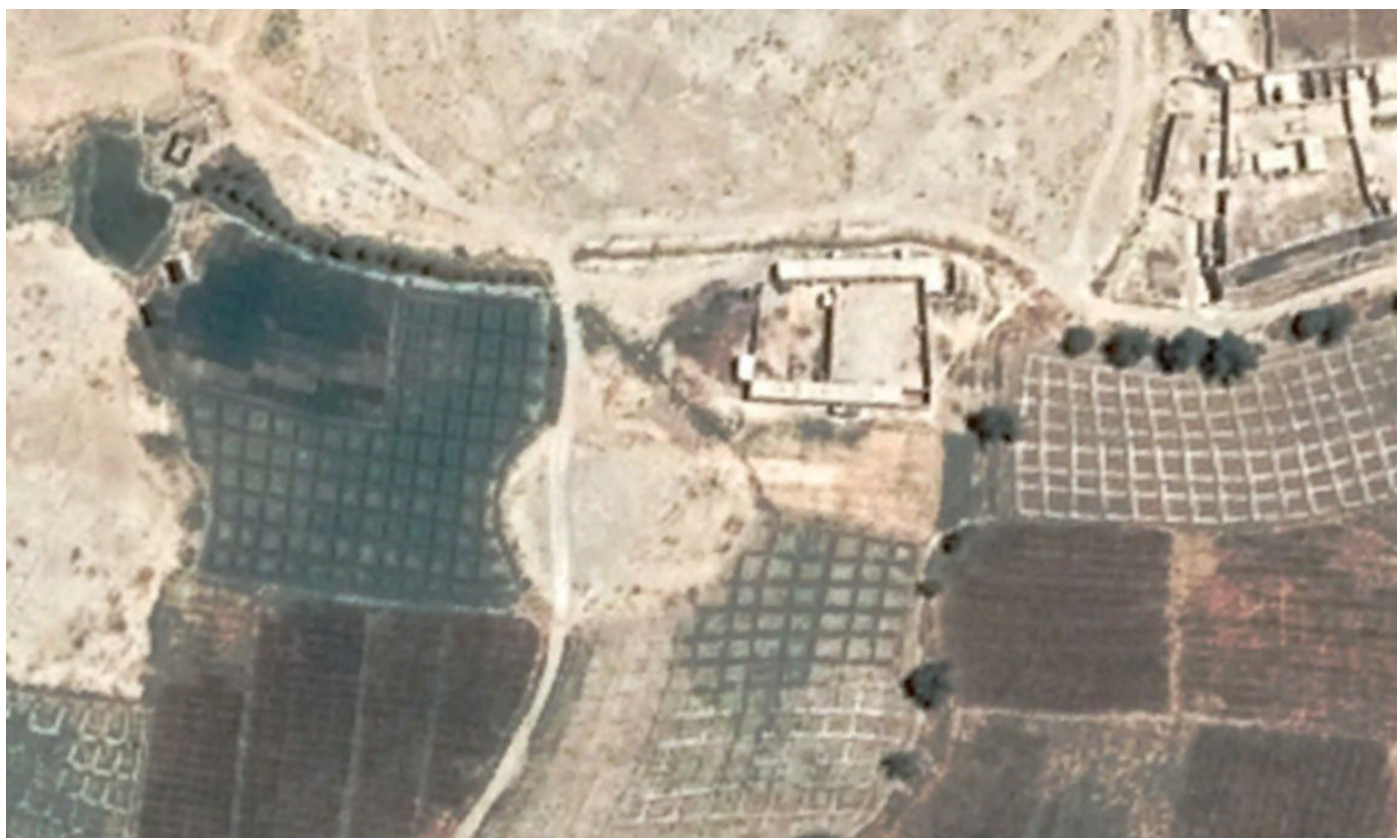
The site is located in the middle of agricultural land, and is crossed by a road. There is little evidence suggesting looting or transformation to the site.

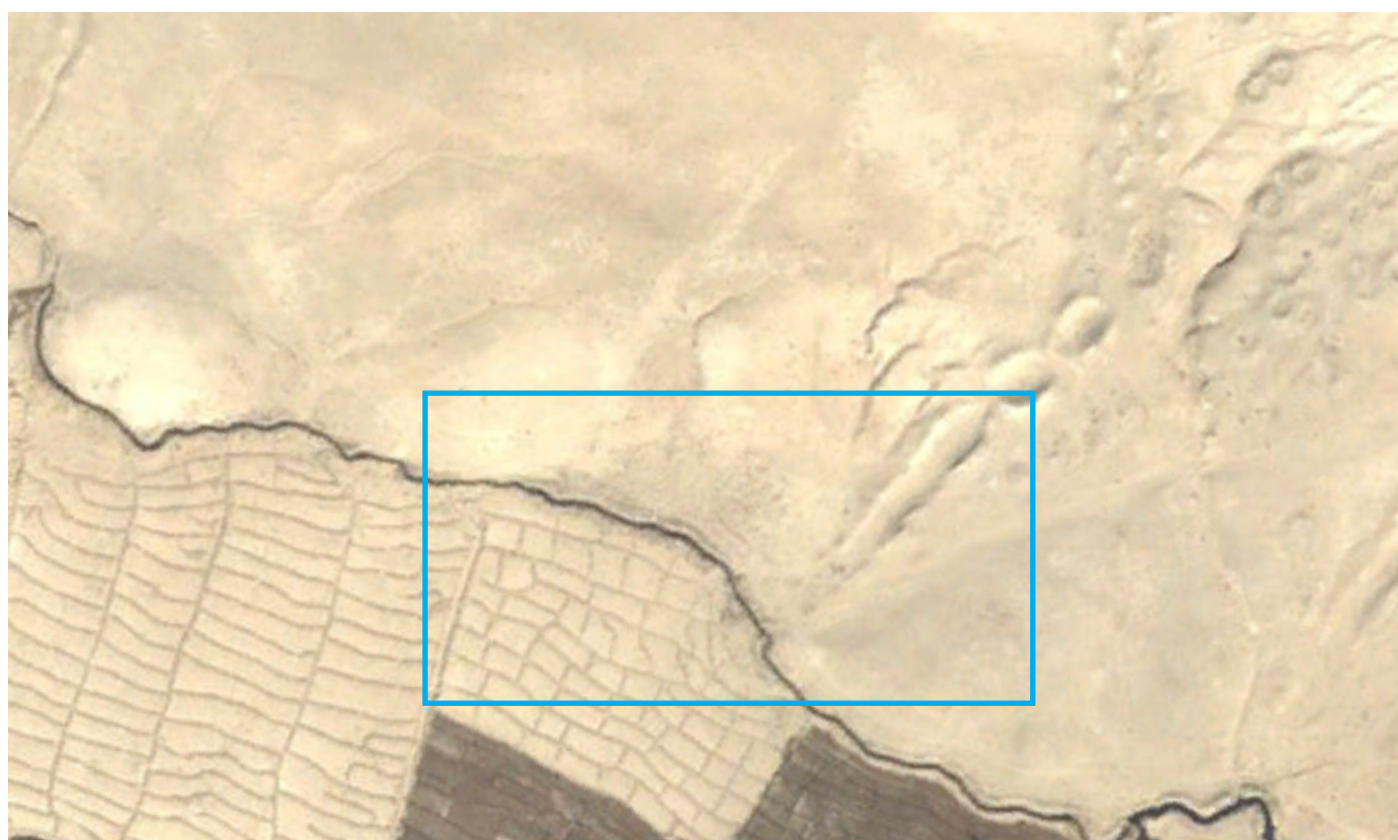
0 20 100 2004

The site is located in proximity to agricultural fields. In 2004 we can observe several holes which seem to have disappeared in more recent images disproving the theory of a cemetery. A watercourse can be seen south of the site as well as major pits east of the site.

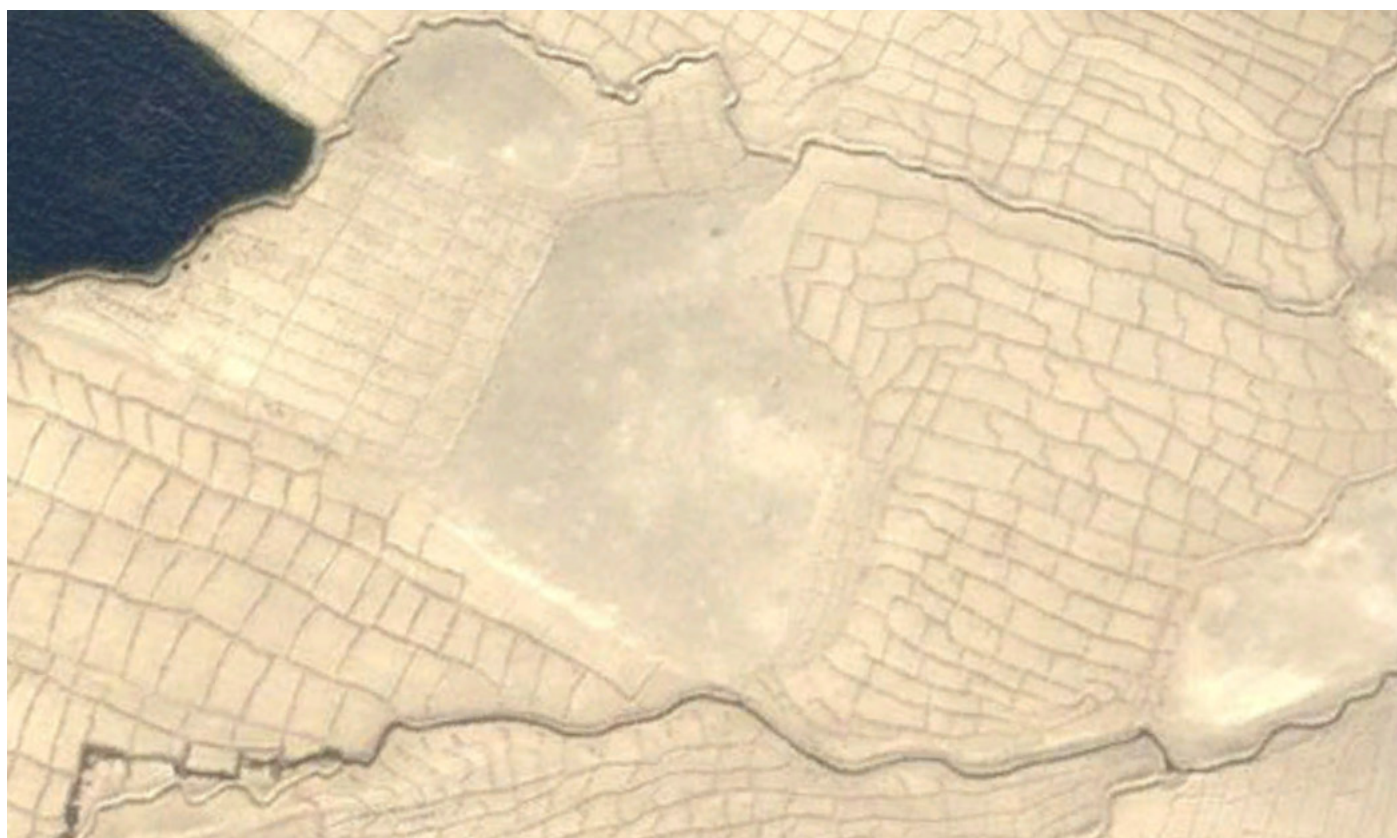
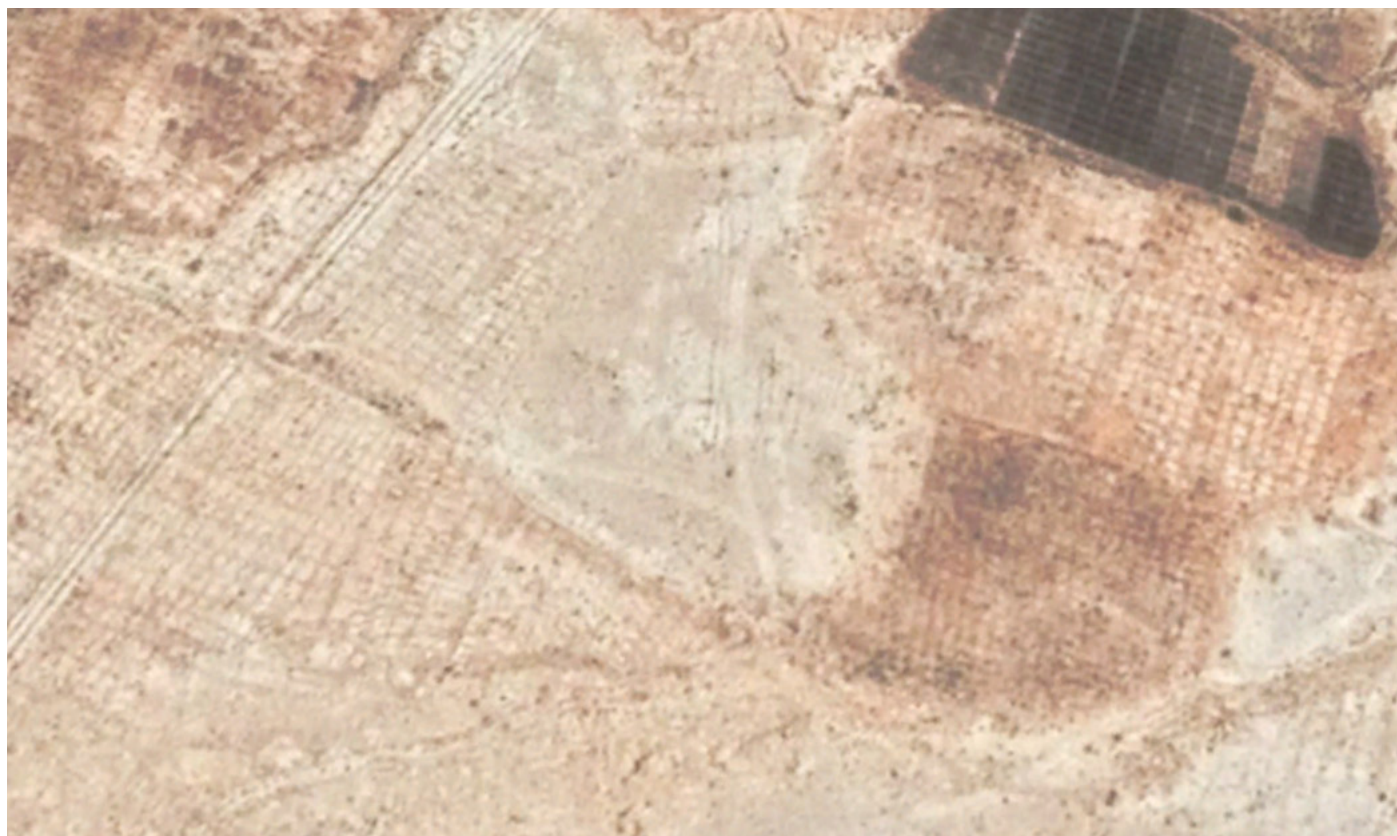
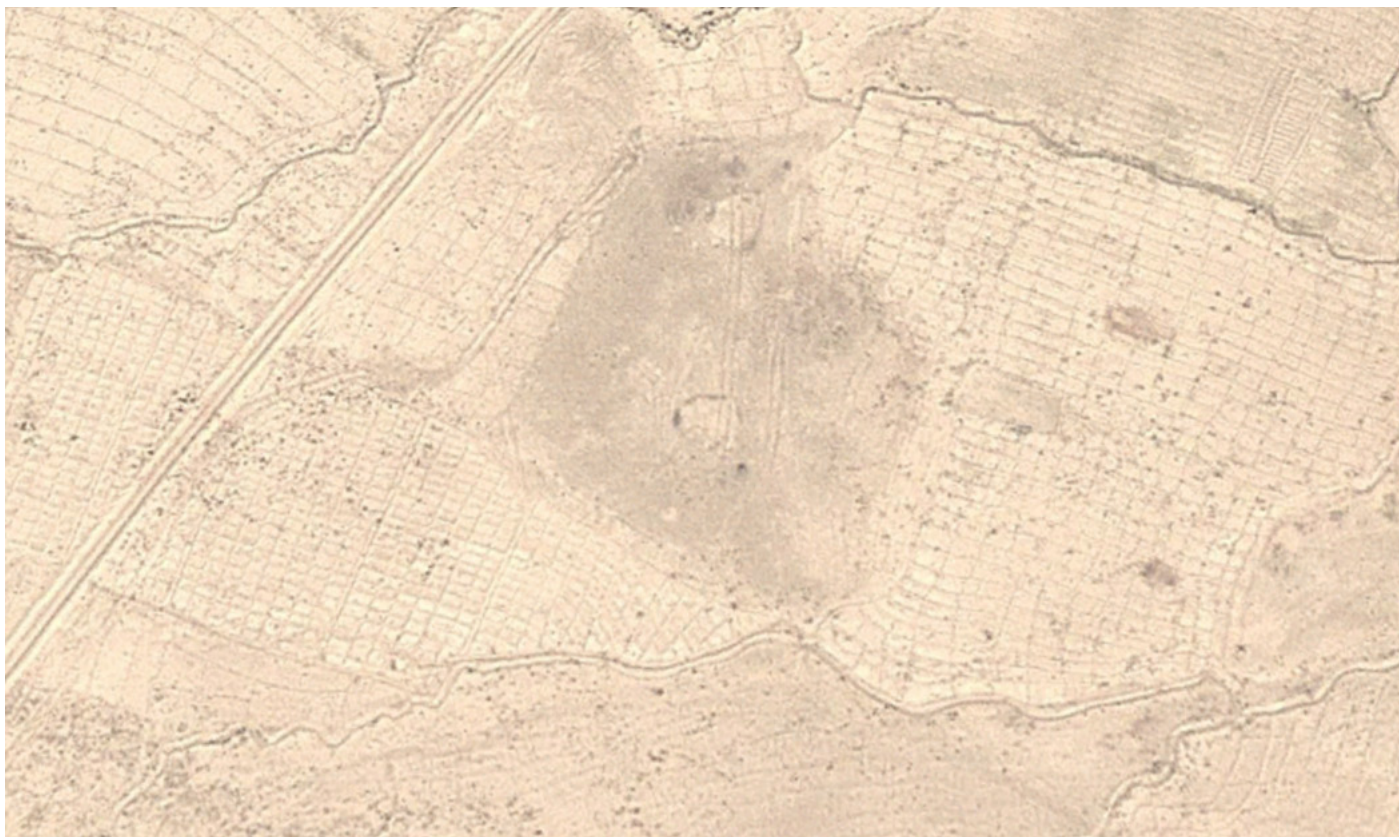
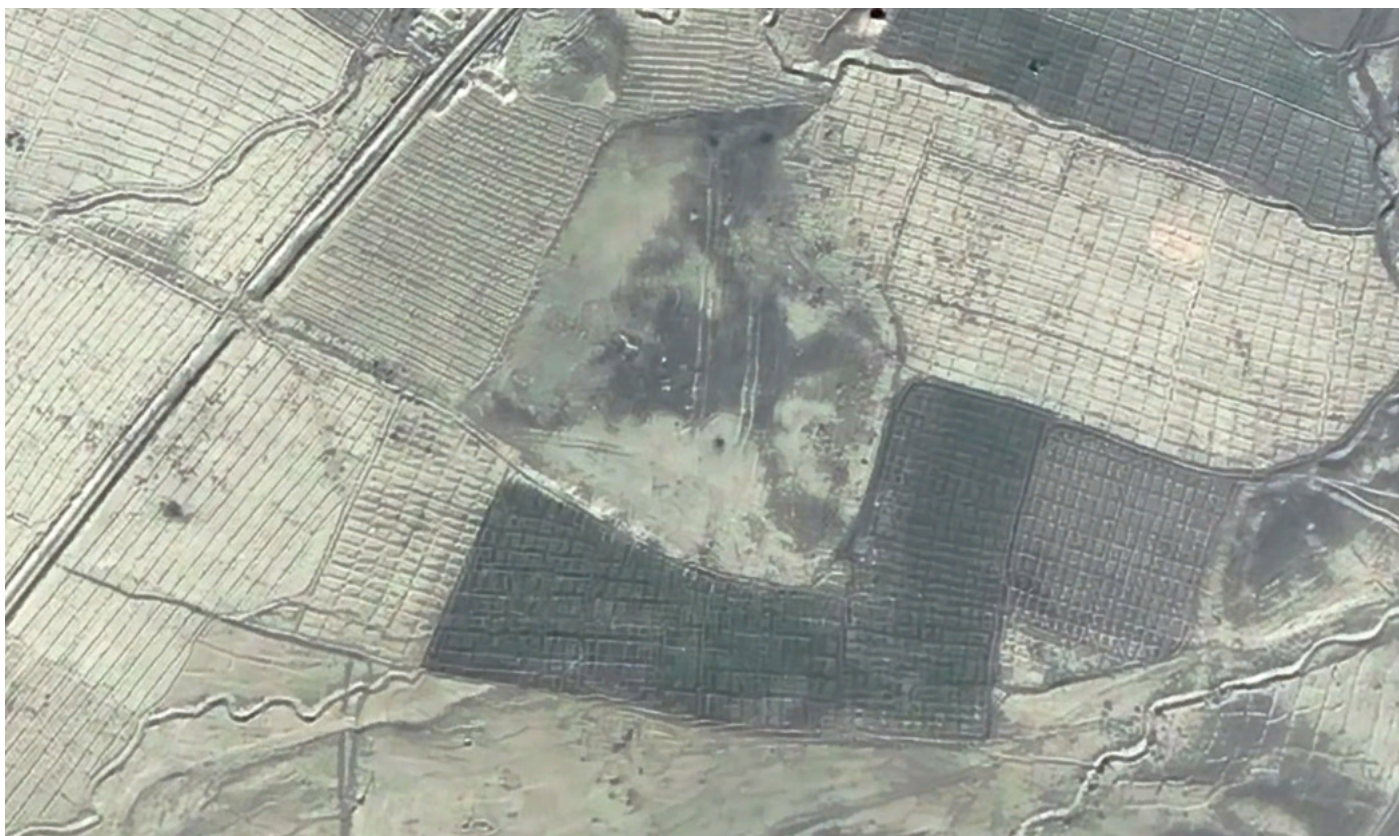
The site is located in the middle of agricultural land. Faint traces of vehicle tracks can be seen as of 2012. There is little evidence suggesting looting or transformation to the site.

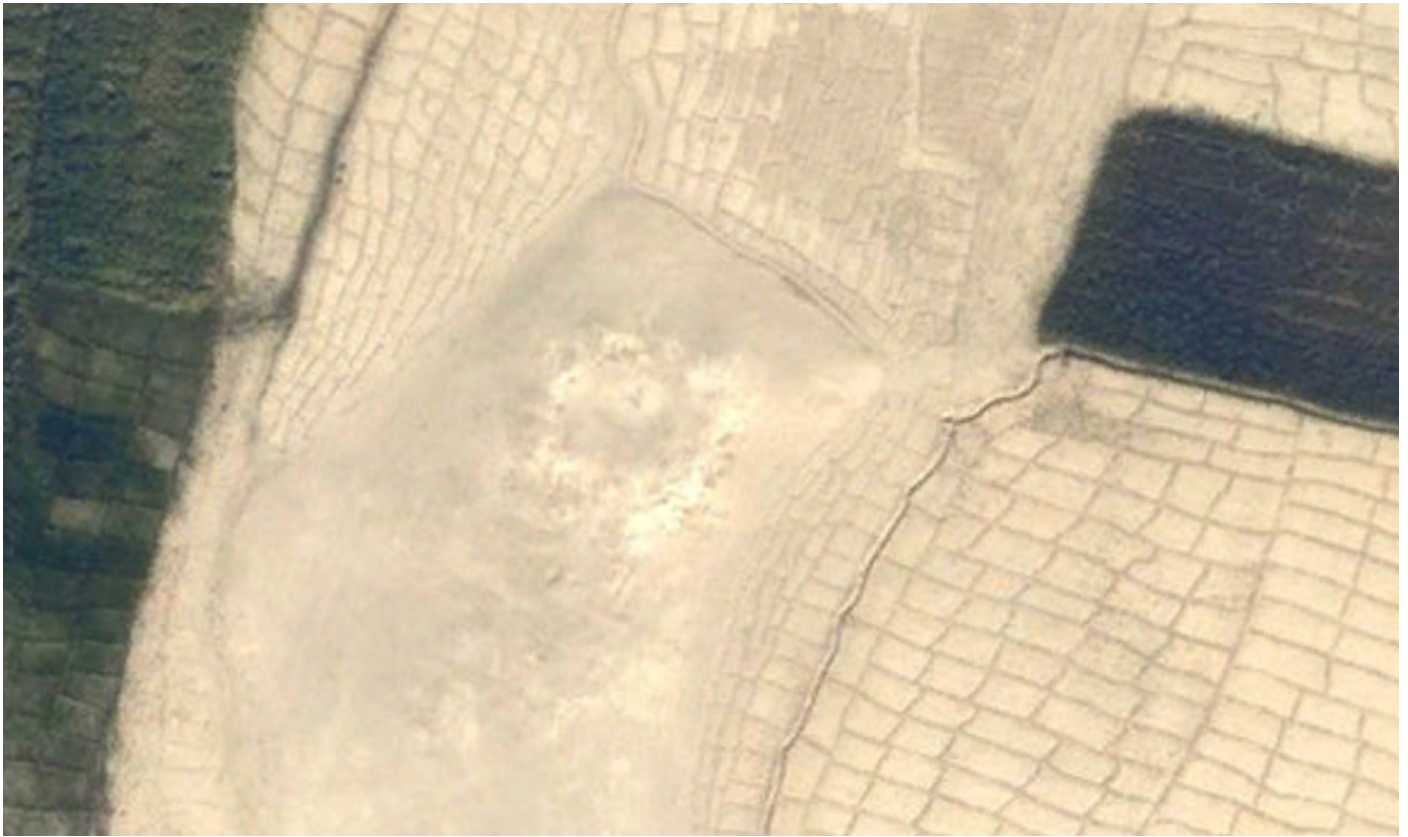
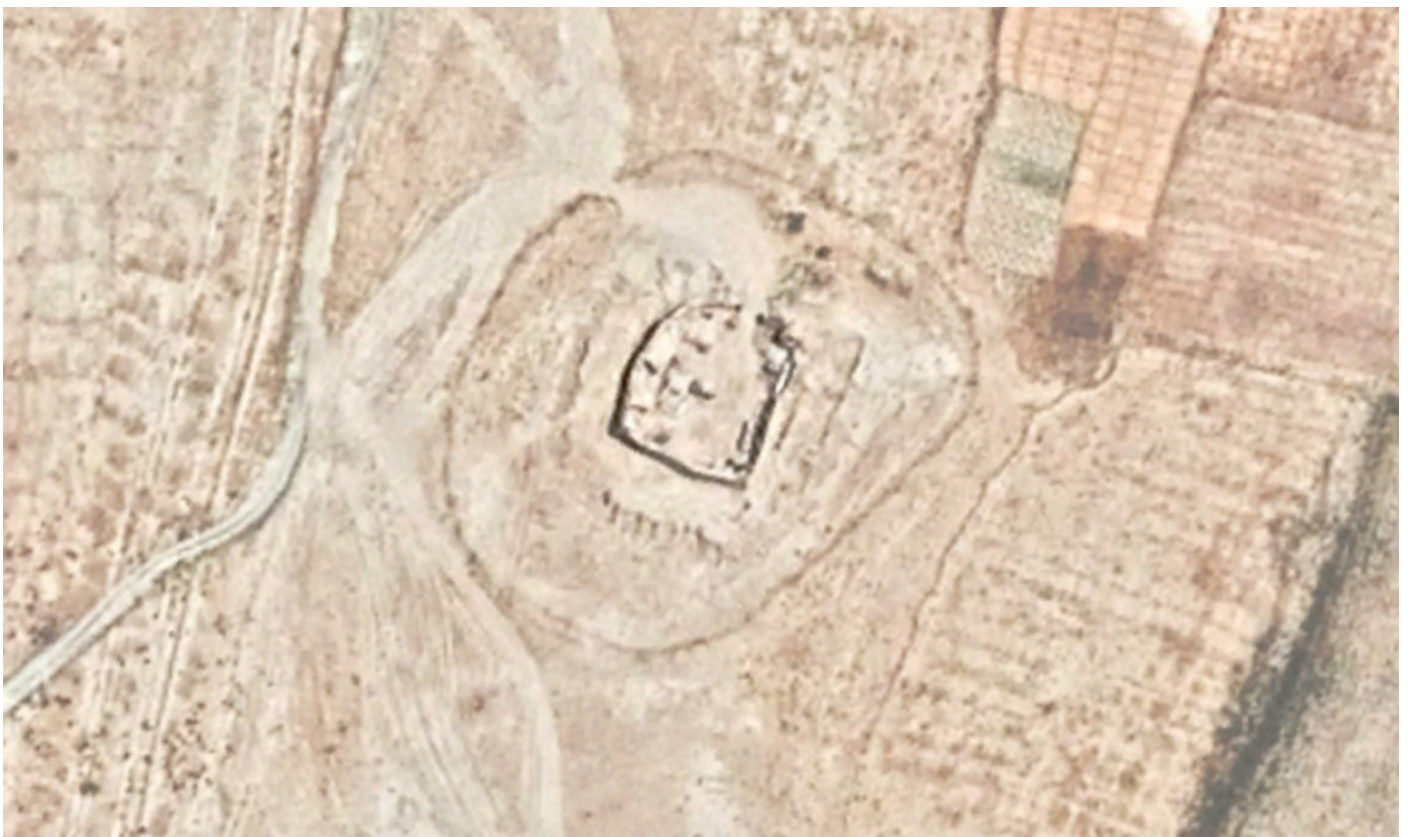
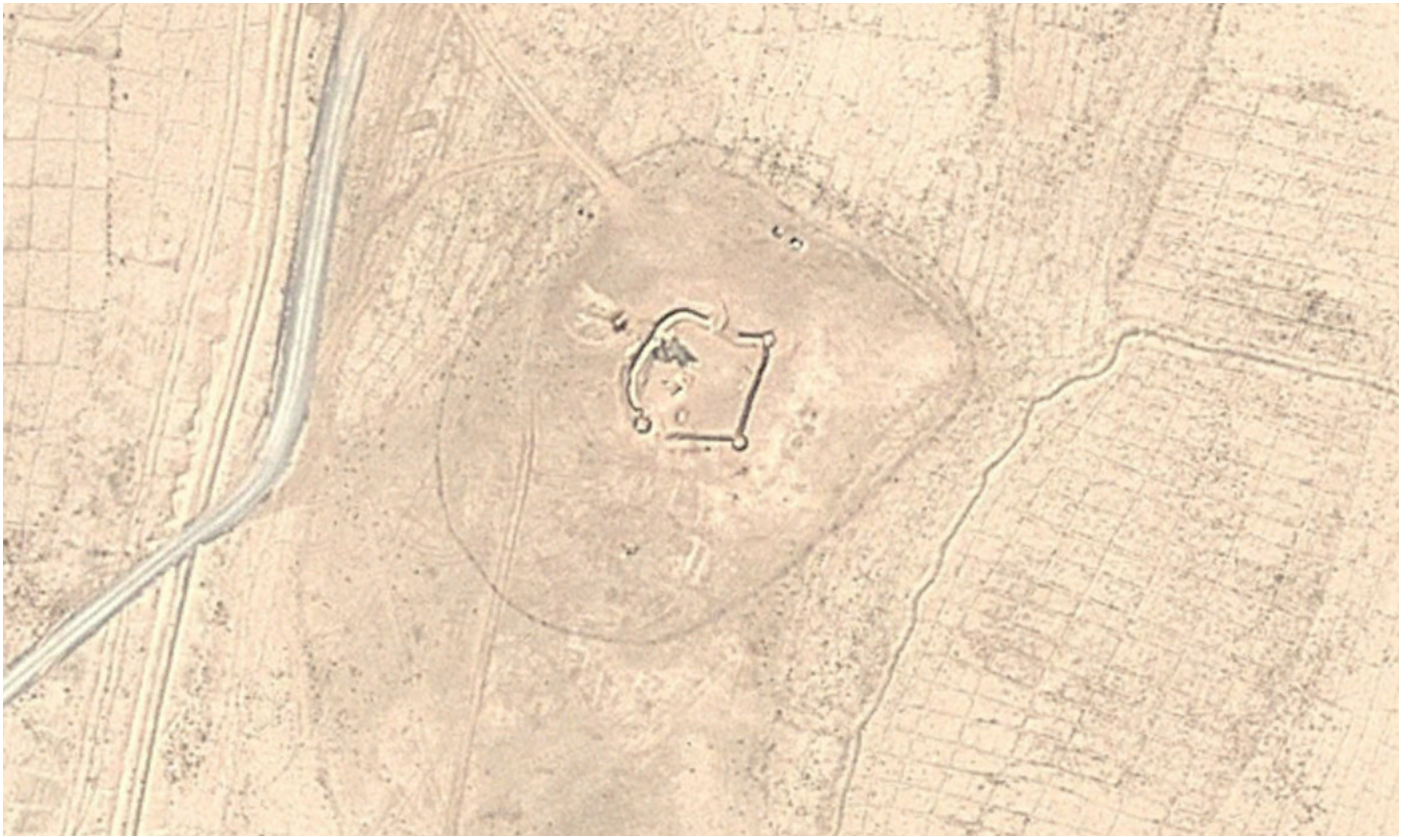
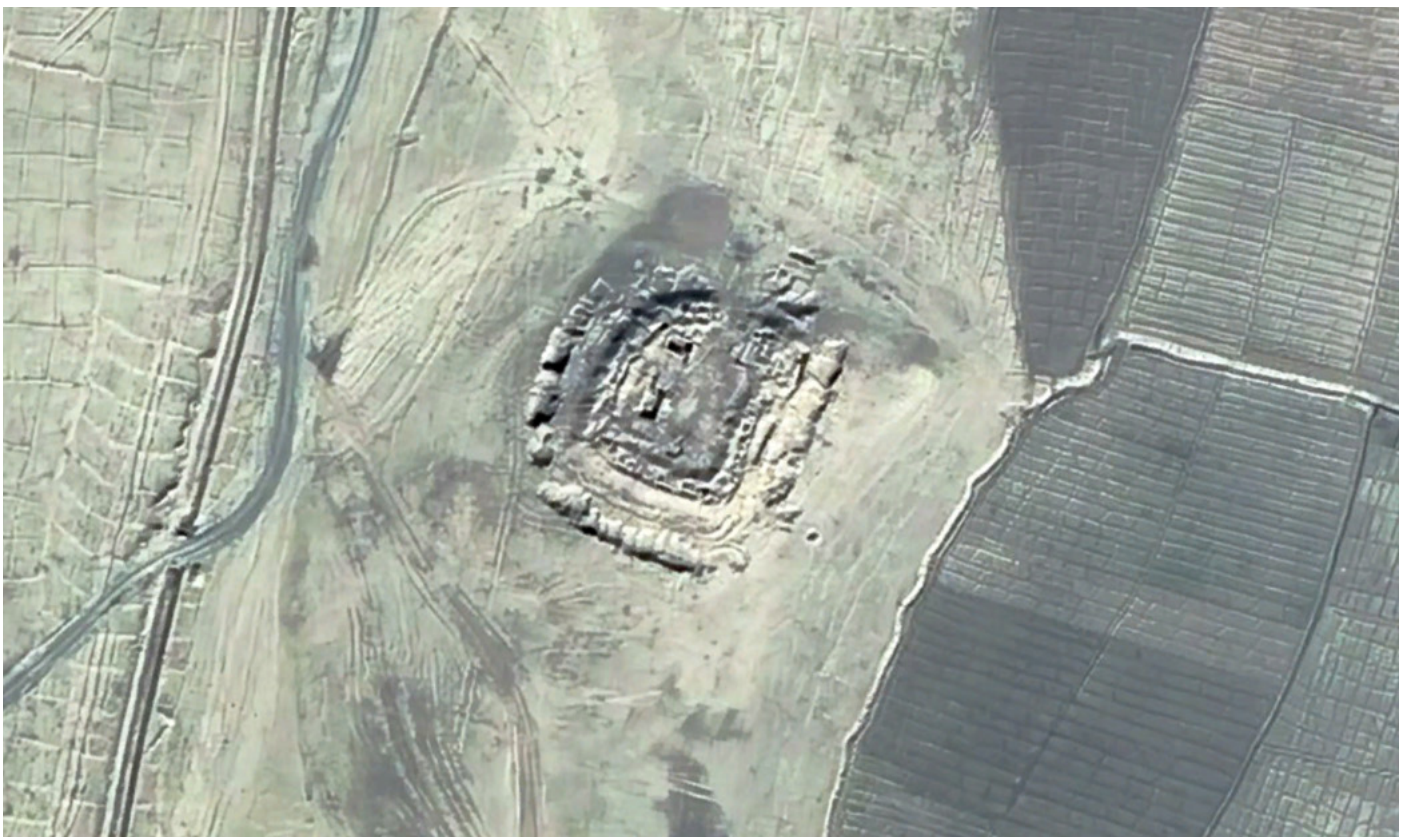
NE5 31°31'53.38"N; 65°10'38.36"E

The site is located in proximity agricultural fields & appears to be remains of a fortified structure. In 2012, a road leading up to the site is visible as well as trenches. In 2019, traces of mechanic looting are visible, the towers have disappeared, larger and additional roads can be seen. In 2022, more extensive looting can be identified: mechanic on the outside of the walls and manual inside.

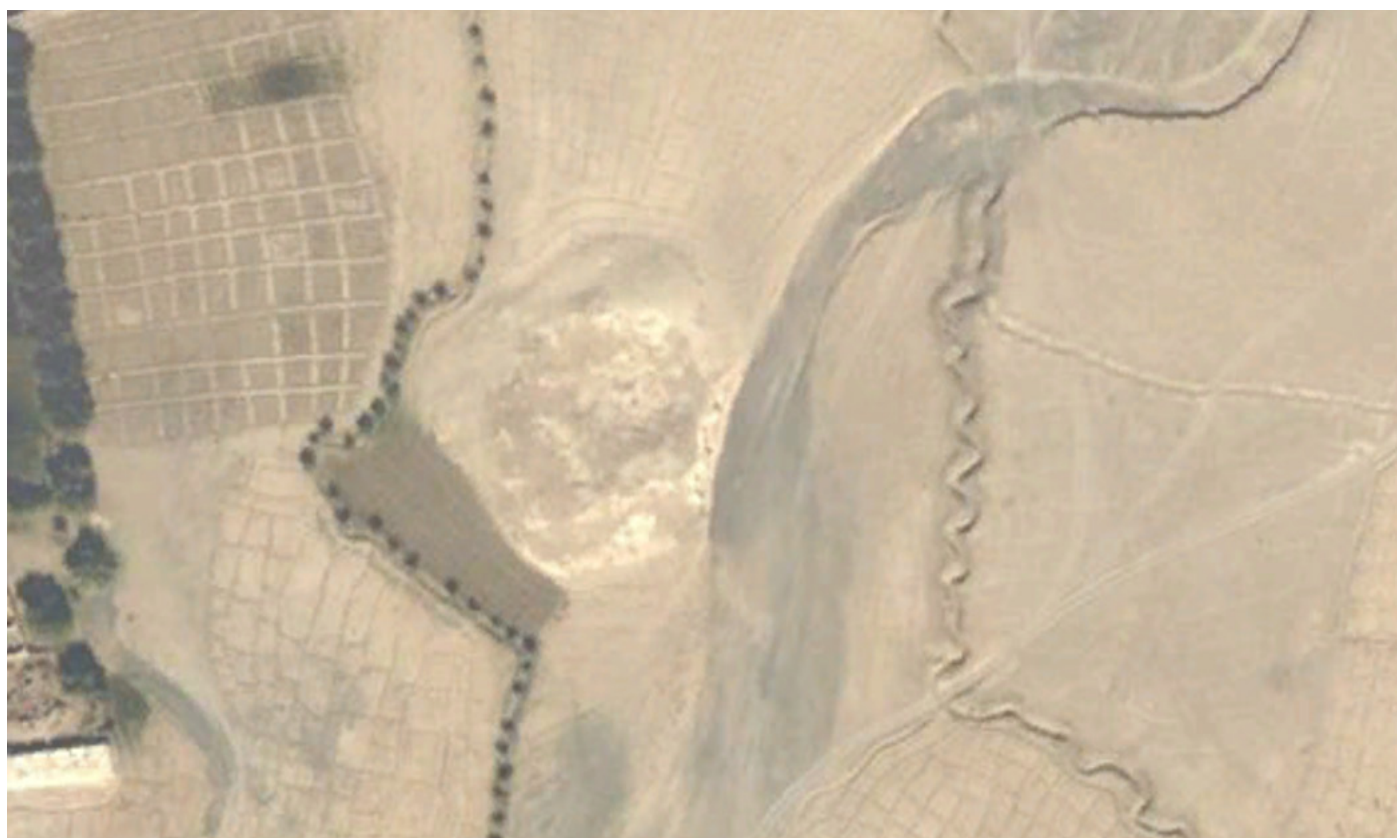
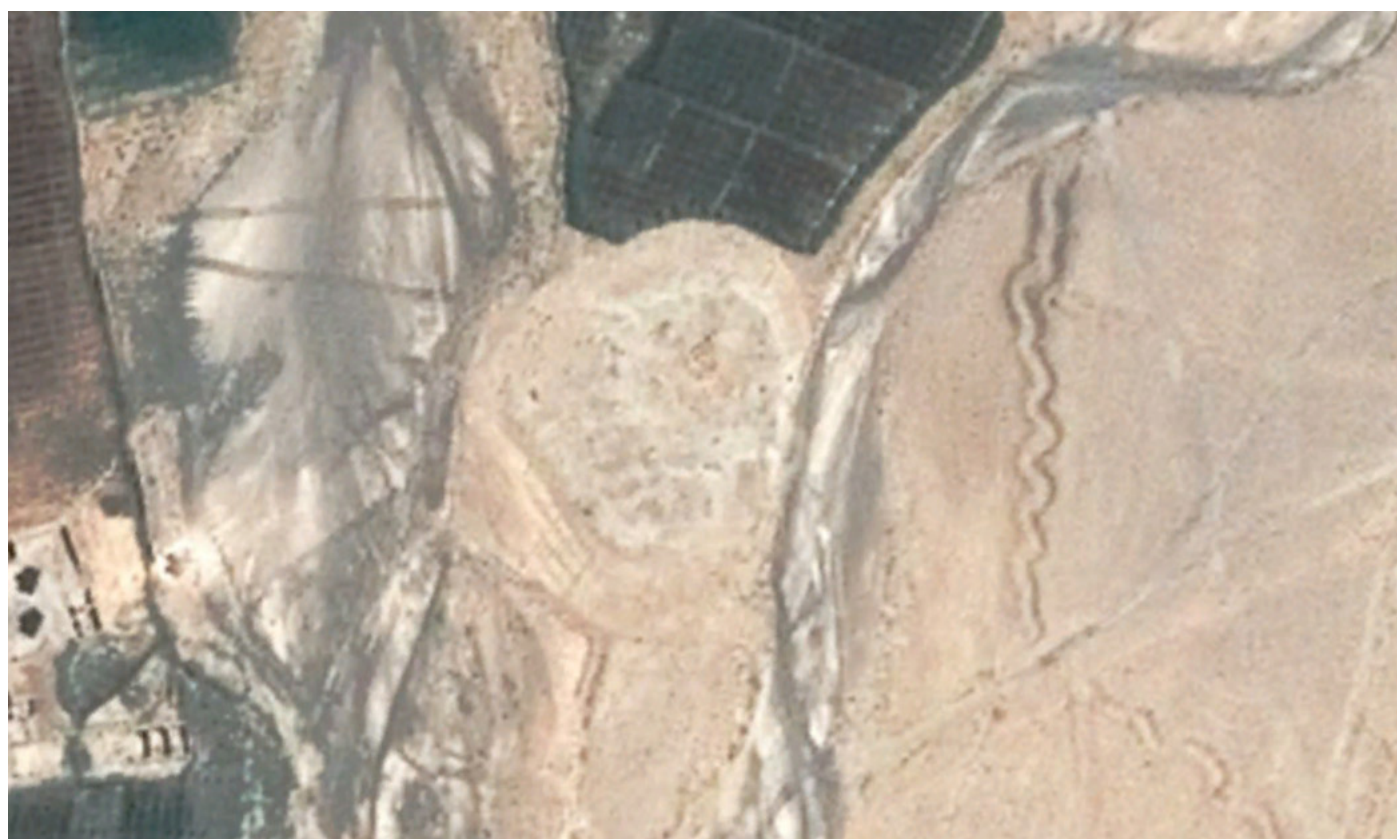
The site is located between a riverbed and agricultural land. There is little transformation to the site itself up until 2022, where we can observe what appears to be a ramp on the southern side of the mound which could imply heavy machinery tracks as well as small excavation pits.
