HERITAGE  
WATCH.AI

IMPACT OF TAPI PIPELINE PROJECT ON  
ARCHAEOLOGICAL SITES IN AFGHANISTAN

2 0 2 3

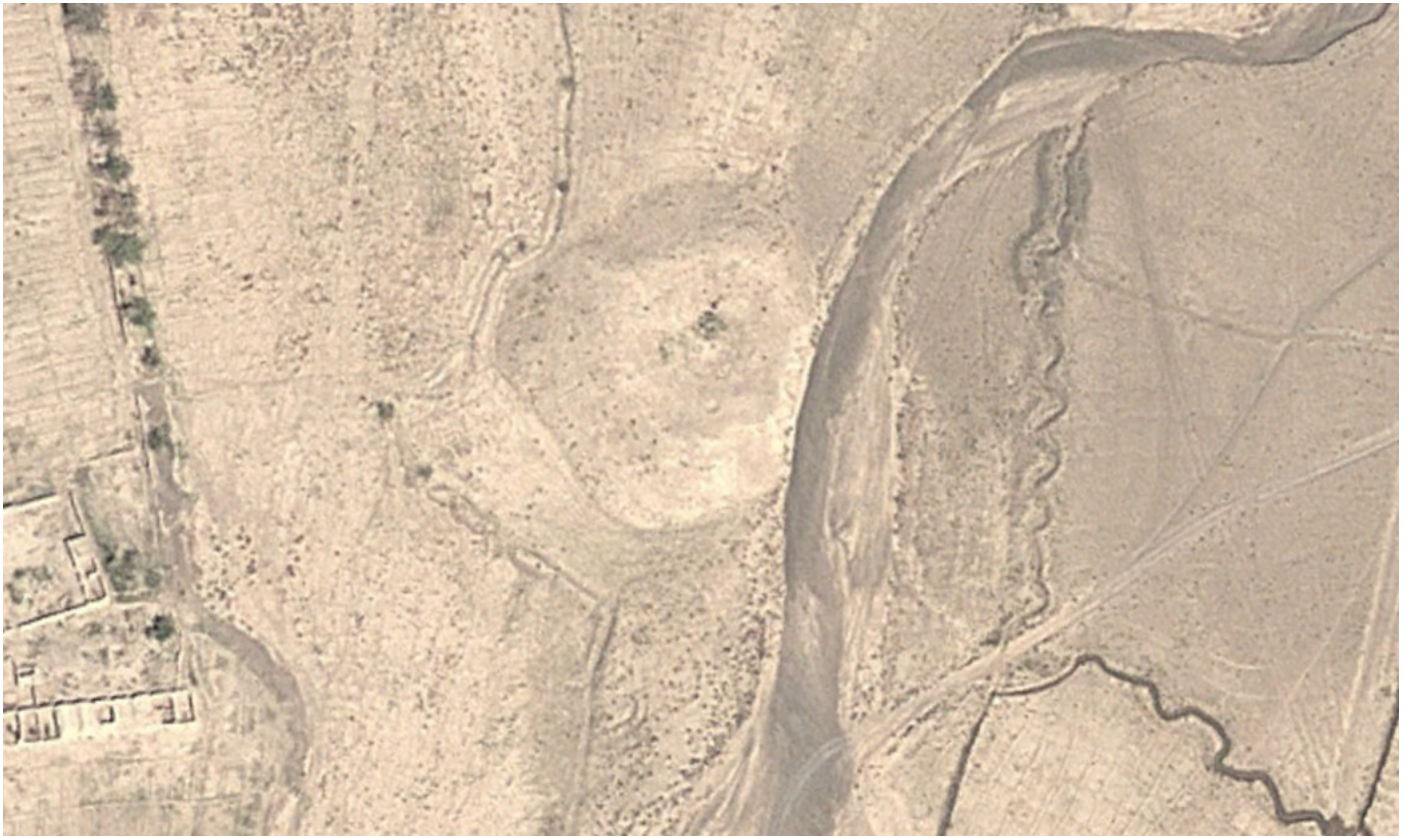
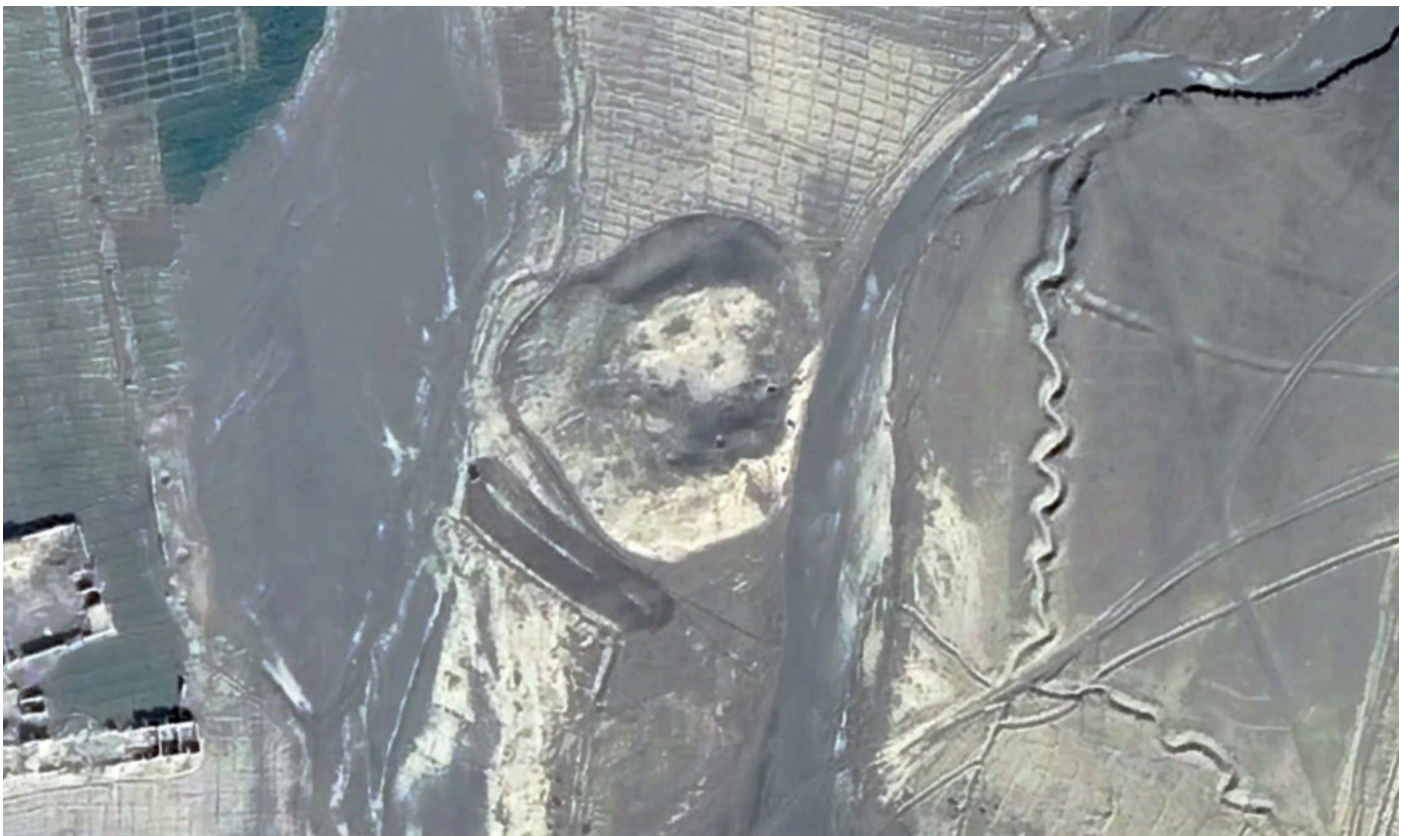
SE1 31°31'29.77"N; 65°11'48.91"E  
TYPOLOGY Mound/Tepe  
AREA (2022) 4238 m<sup>2</sup>  
DIST FROM PIPELINE 130 m

The site is located between a riverbed and agricultural land. There is little transformation to the site itself up until 2022, where we can observe what appears to be a ramp on the southern side of the mound which could imply heavy machinery tracks as well as small excavation pits.

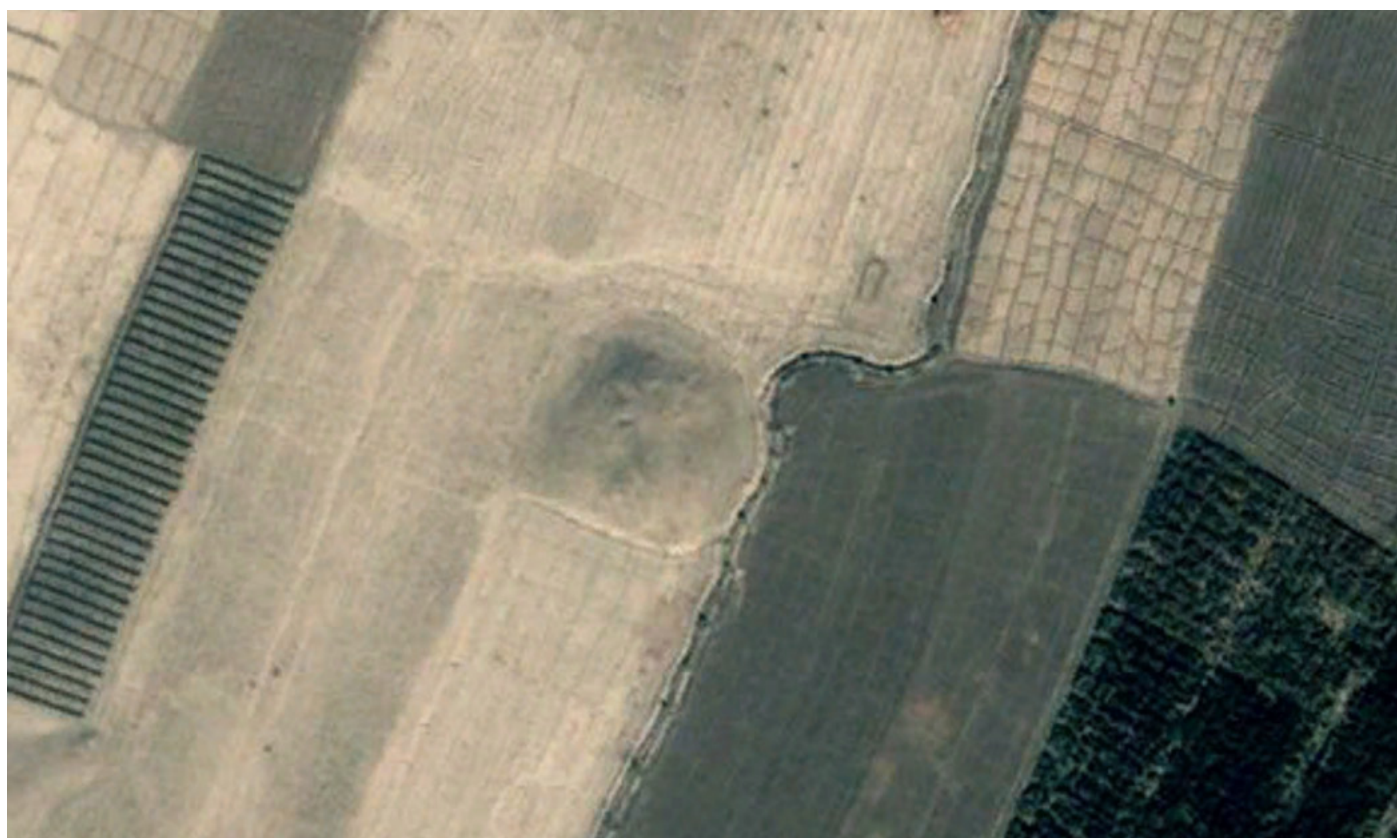
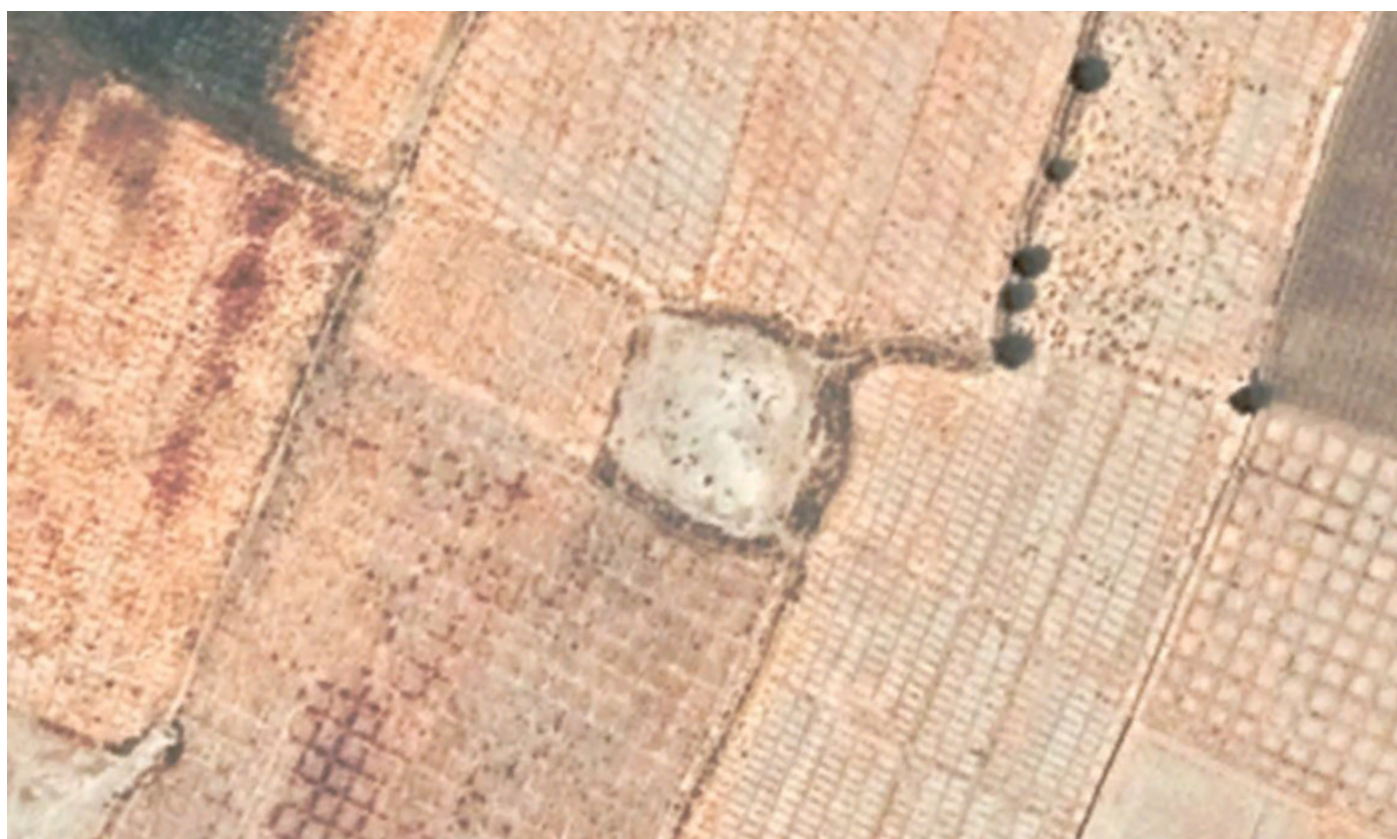
The site is located in the middle of agricultural land. There is a narrow watercourse on its eastern side. We can observe holes that could be excavation pits. There is little evidence suggesting big scale looting or transformation to the site.

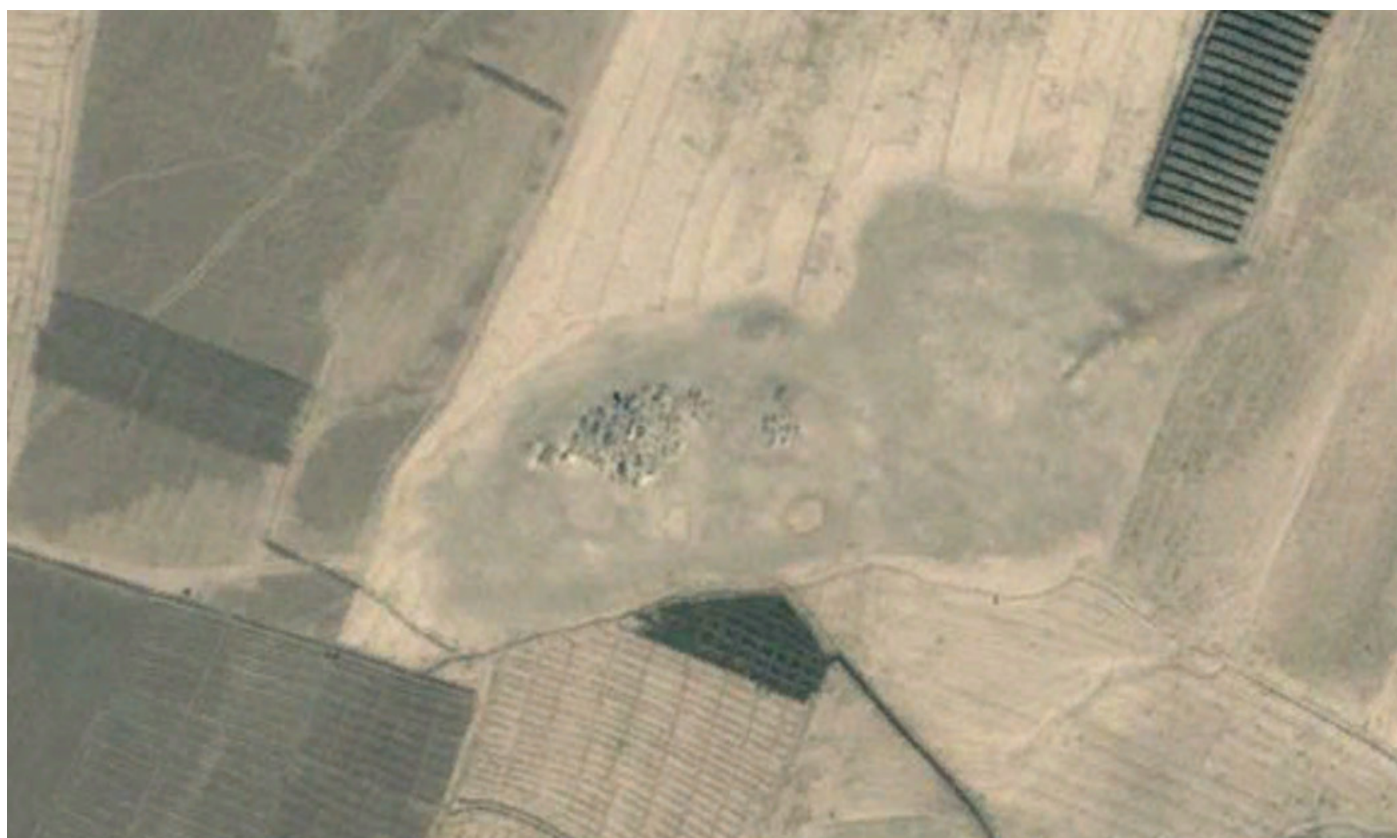
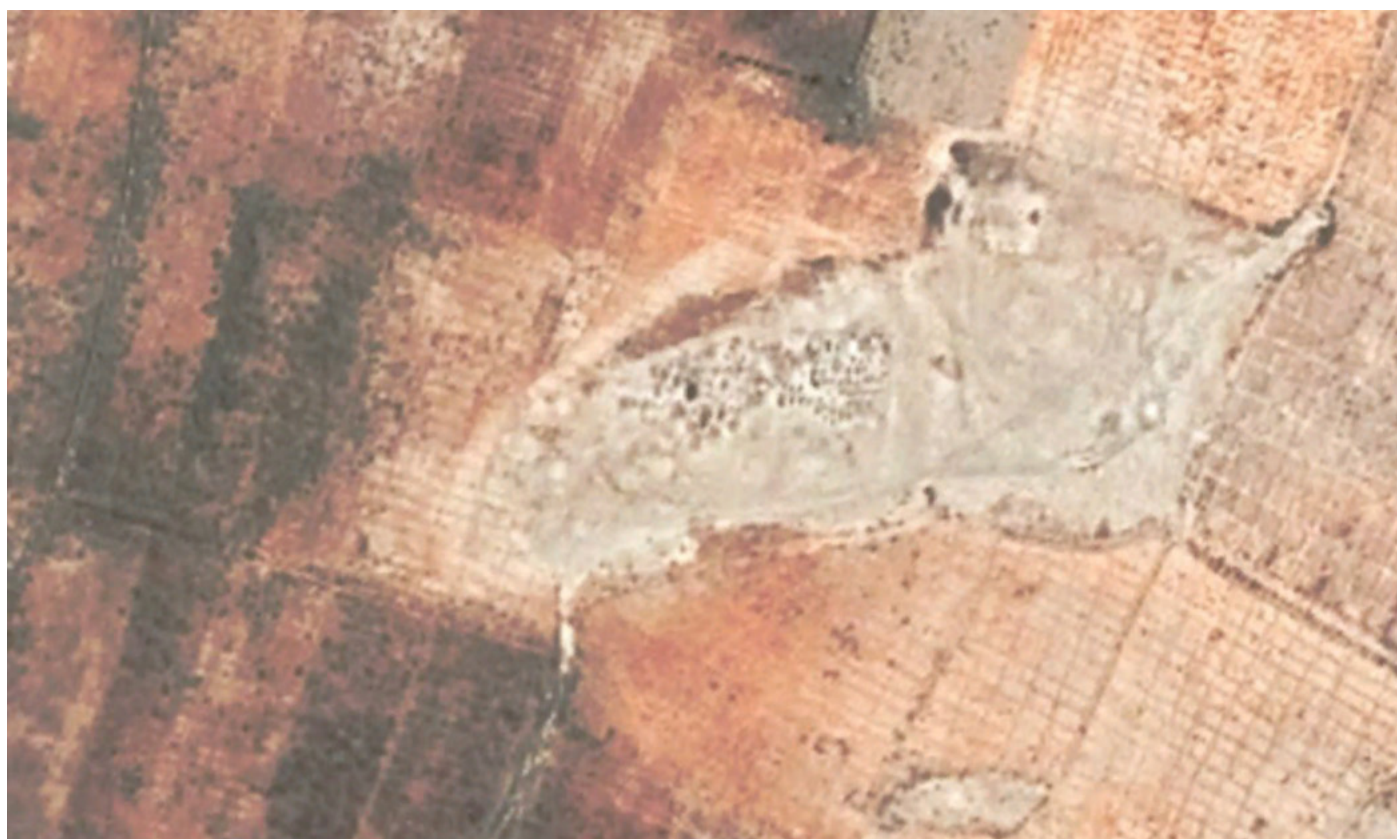
The site is located in the middle of agricultural land. it has an oblong irregular shape. In 2004 we can already observe many holes which only grow in number through time. This is a distinctive feature of afghan cemeteries.

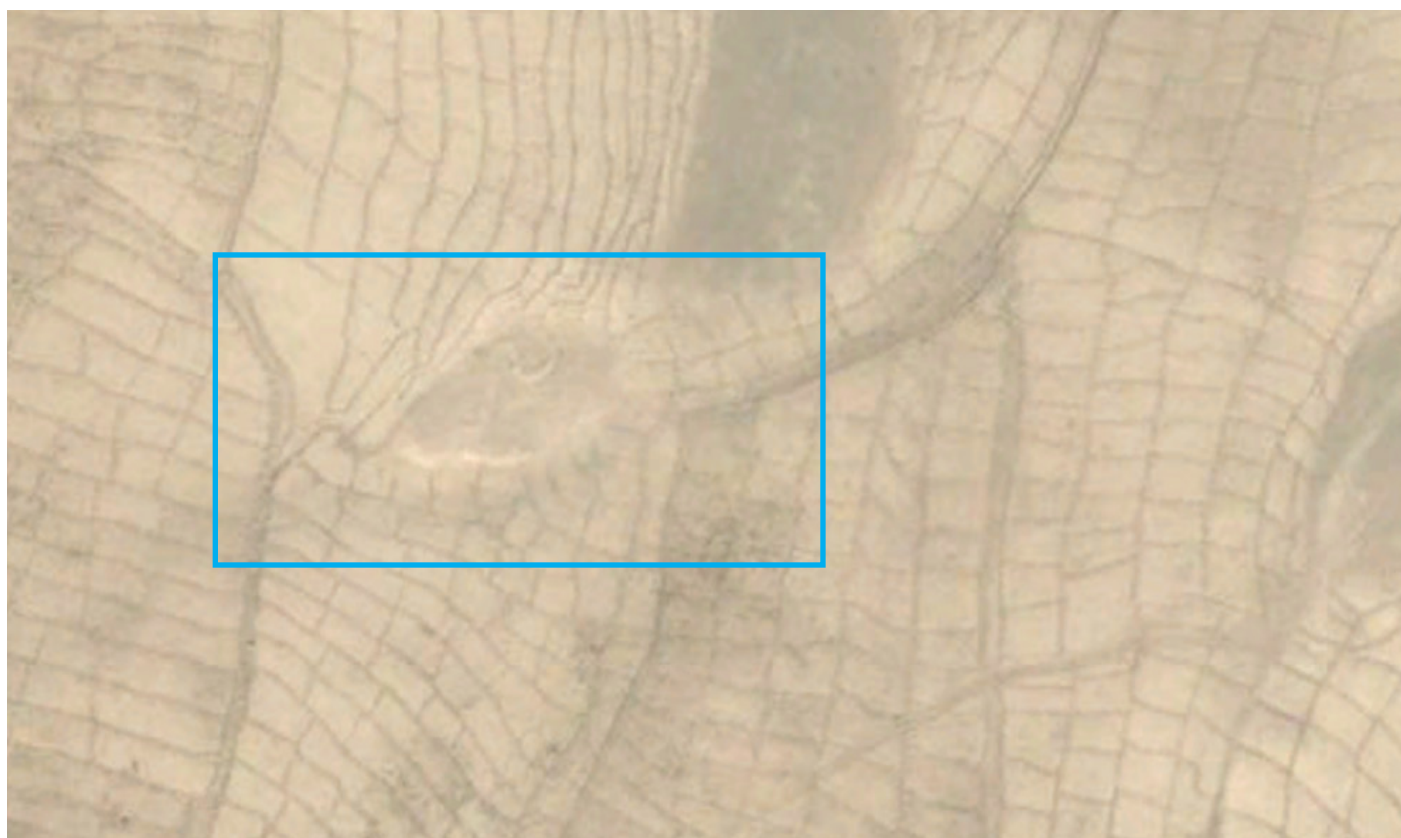
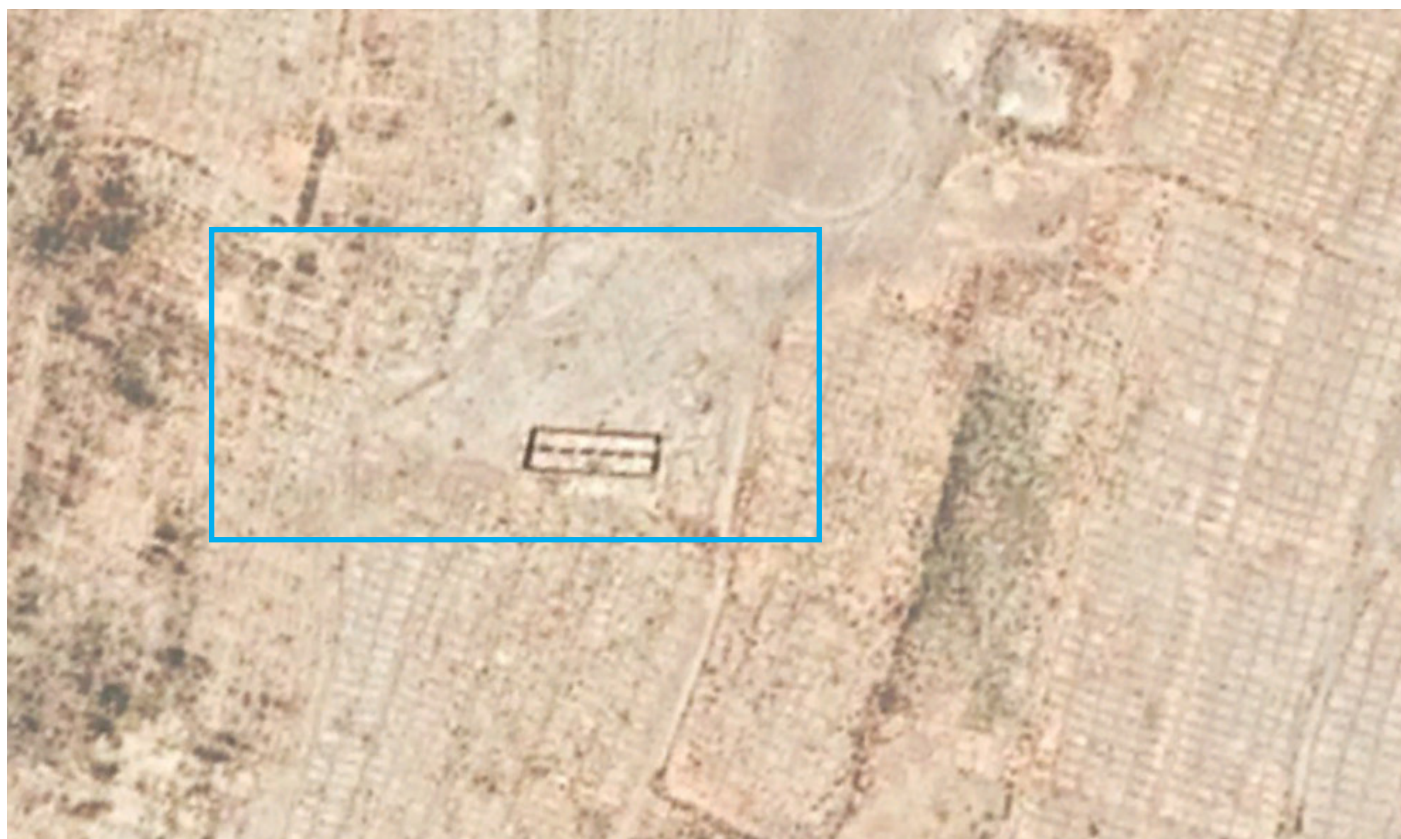
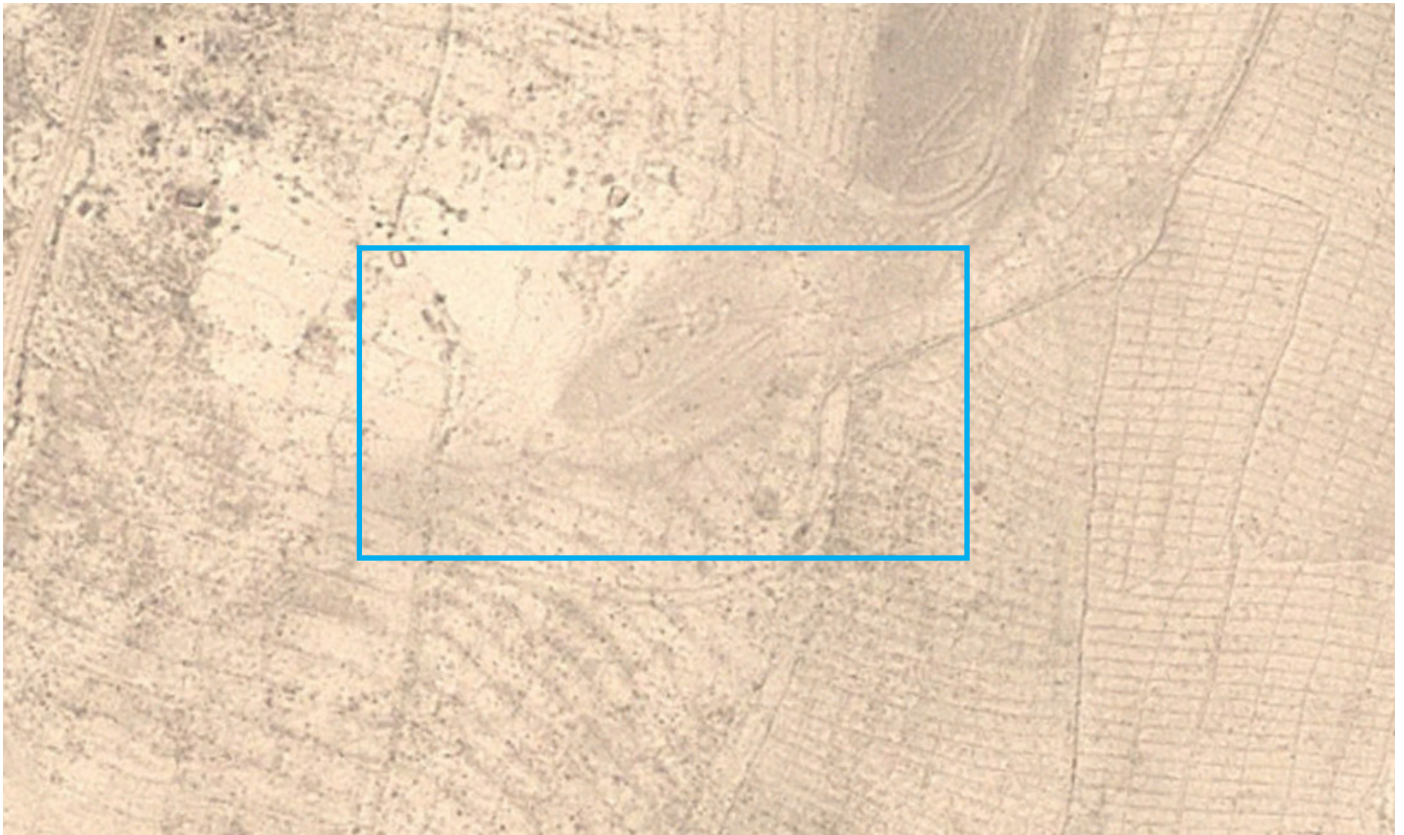
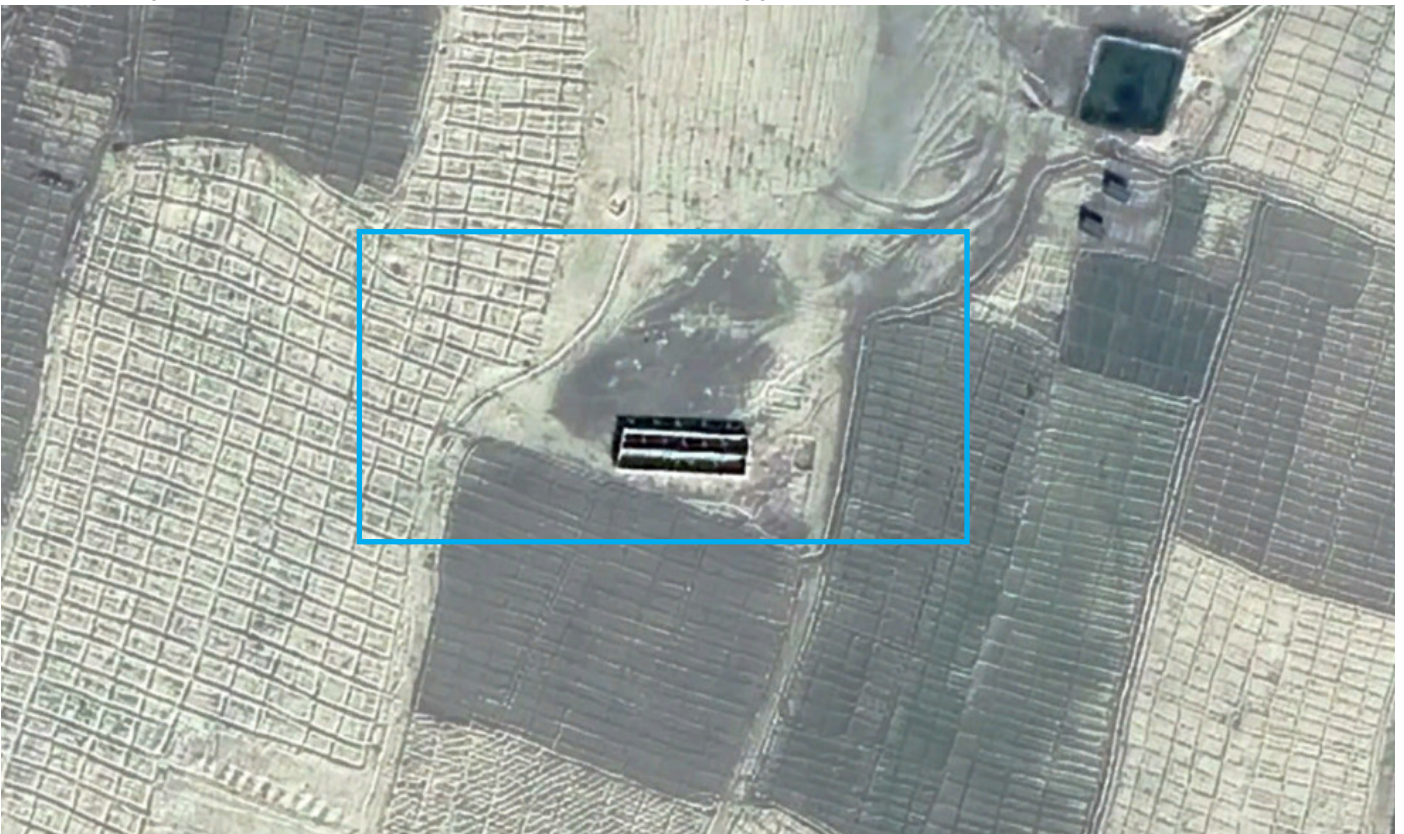
The site is located in what appears to be a non-agricultural area transformed into fields with time. Between 2012 and 2019, the site appears to have been levelled out to make way for a rectangular construction, traces of vehicle tracks can also be seen clearly in 2022.

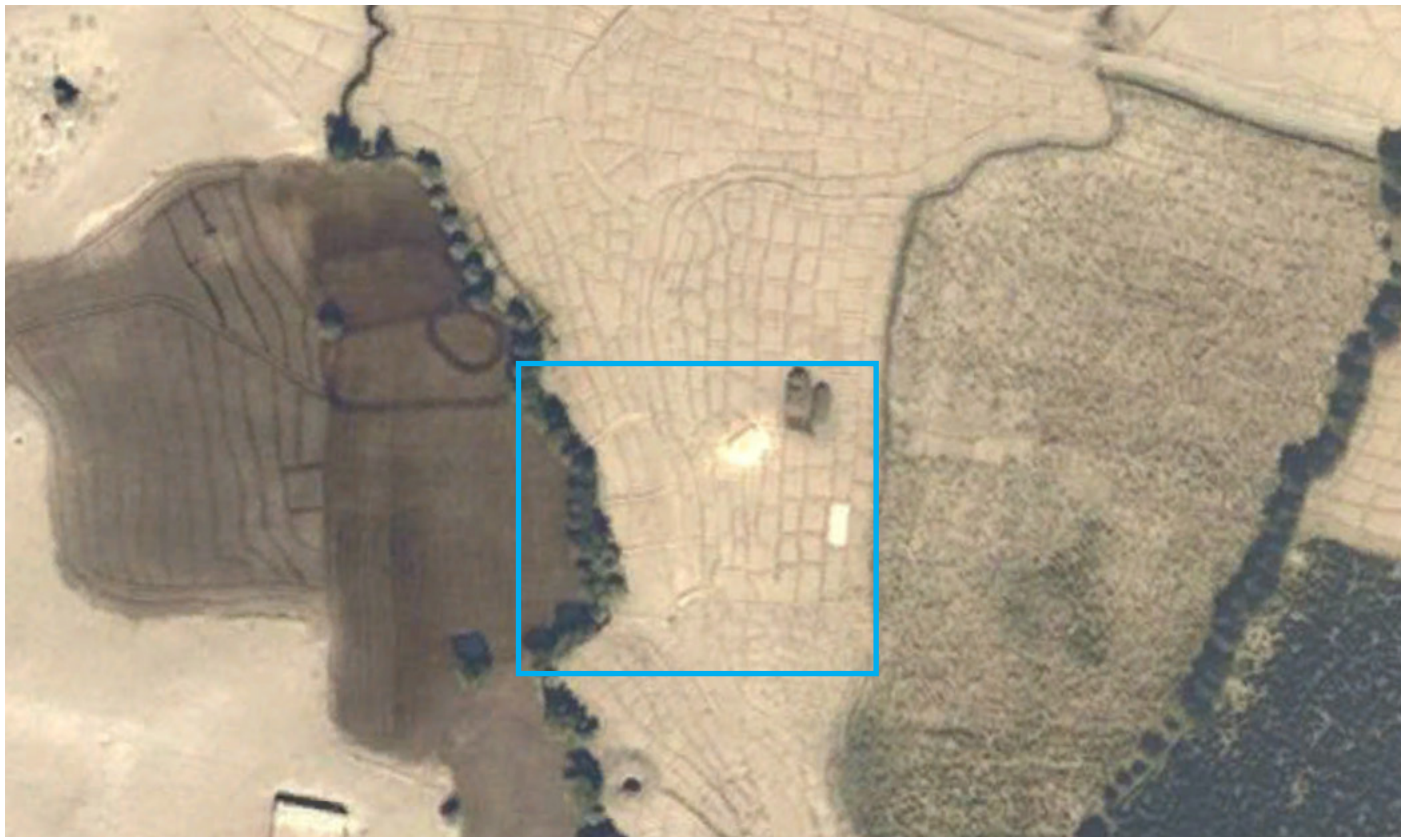
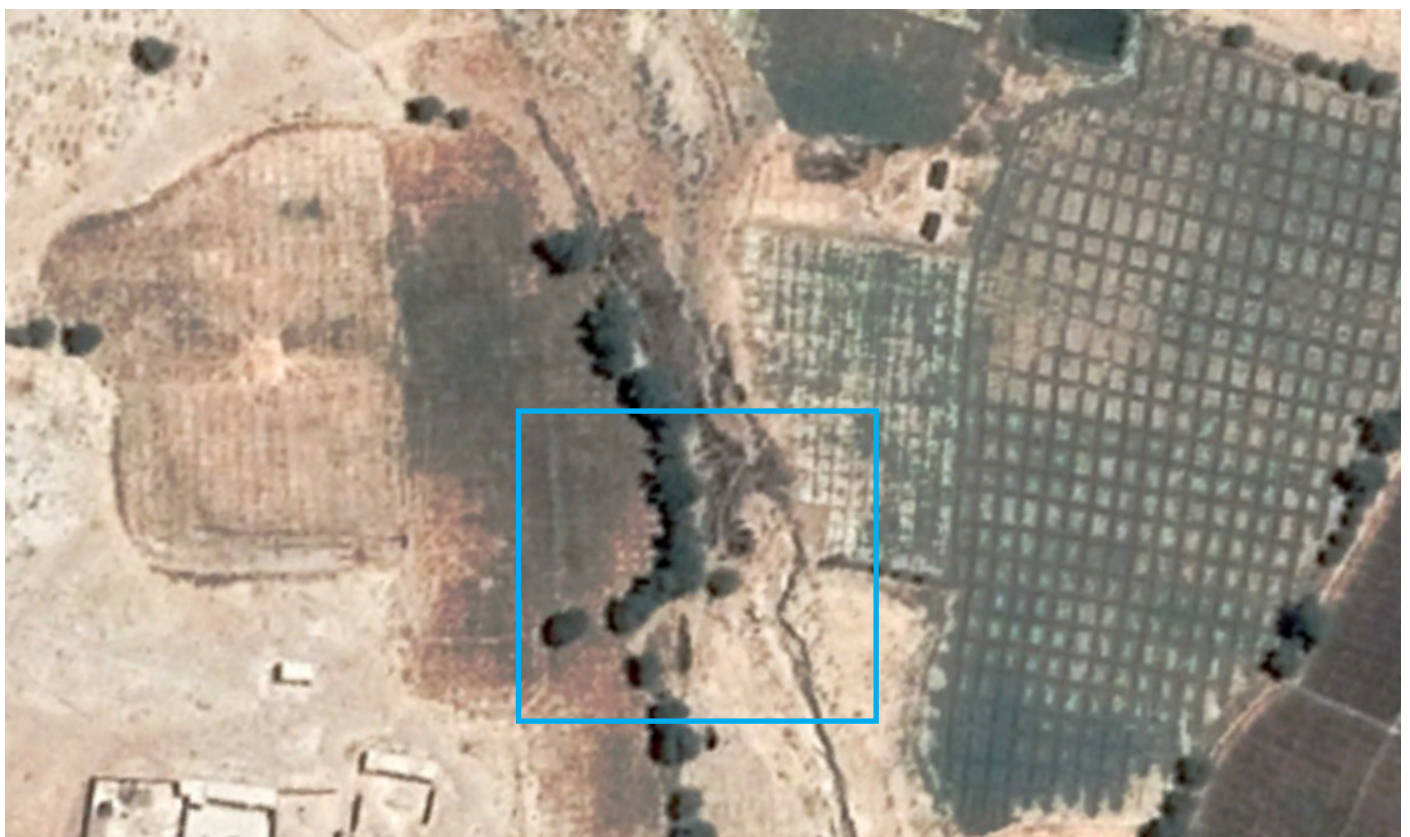
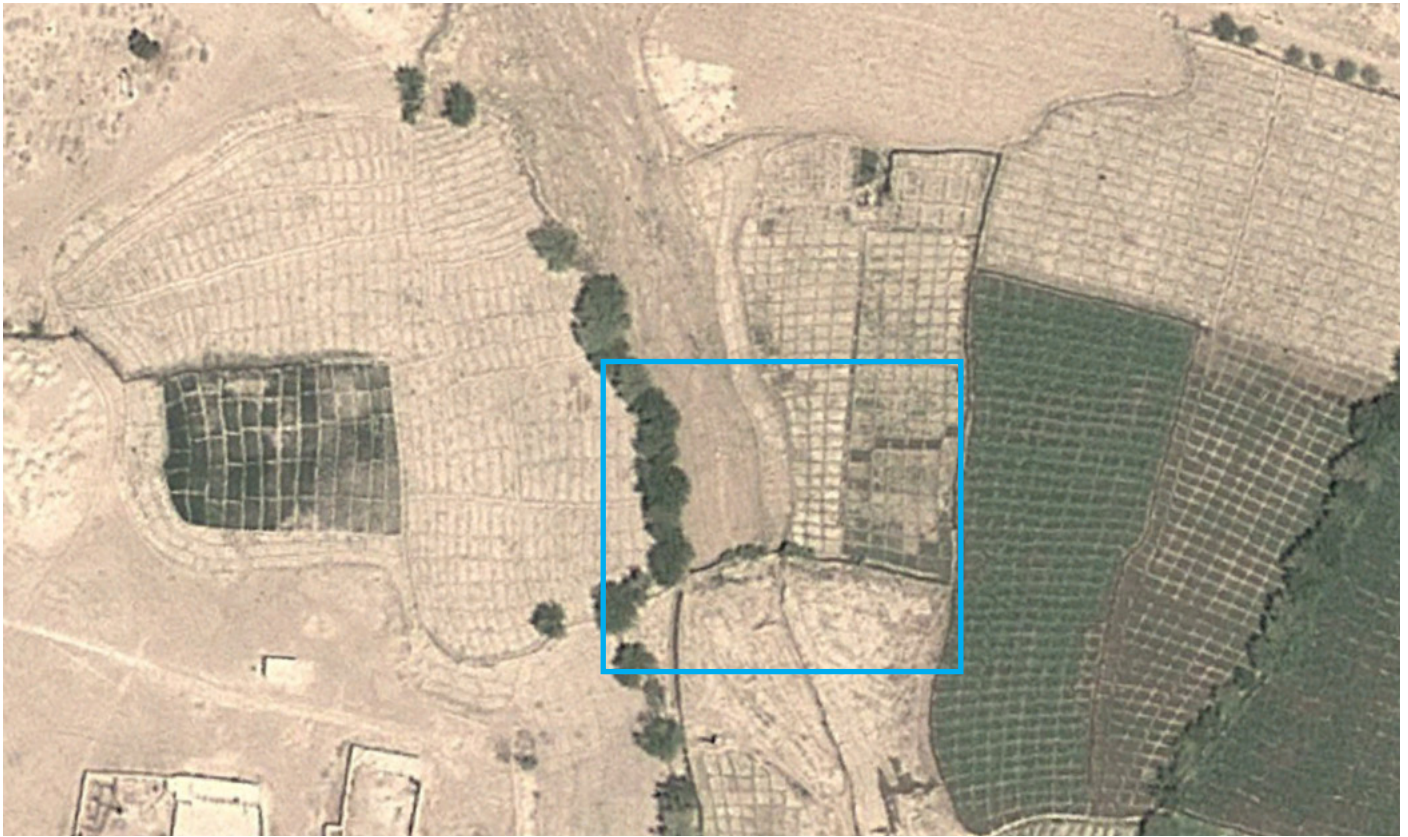
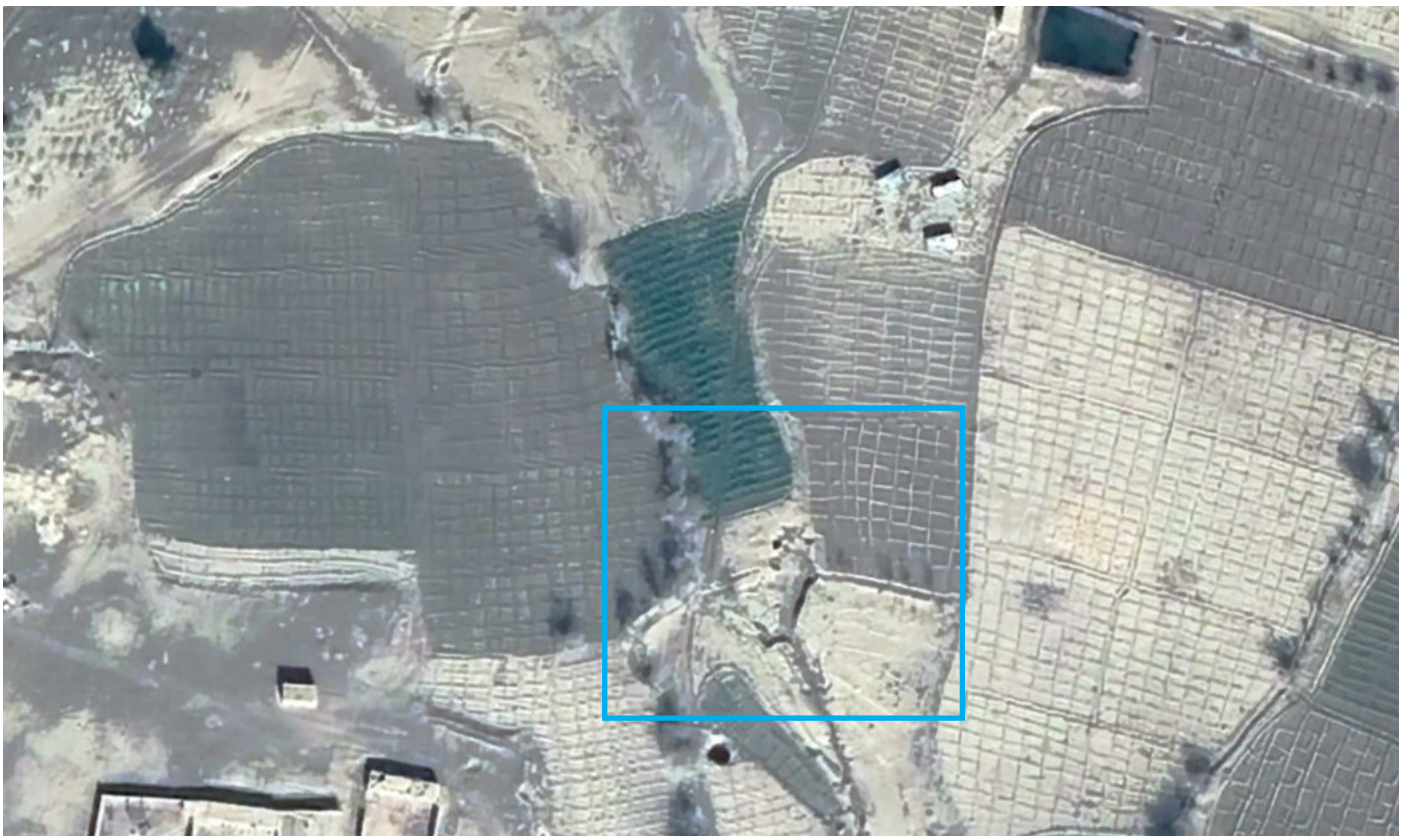
SE5 31°31'38.5''N; 65°11'8.32''E  
 TYPOLOGY Unknown  
 AREA (2022) Unknown  
 DIST FROM PIPELINE 816 m

This site is located in the middle of agricultural fields. It is unclear whether this location bears traces of historic/archaeological remains which could have been transformed into agricultural land.

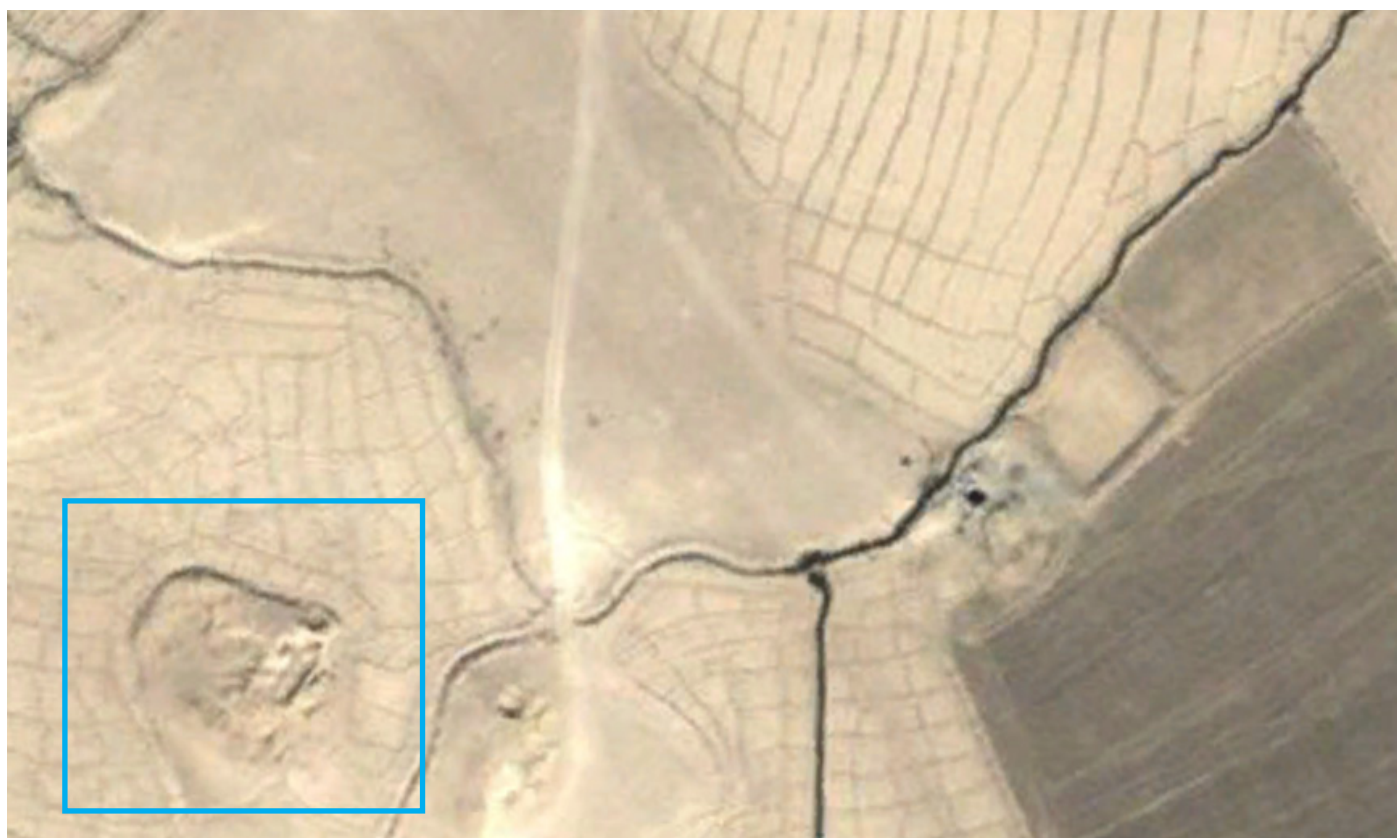
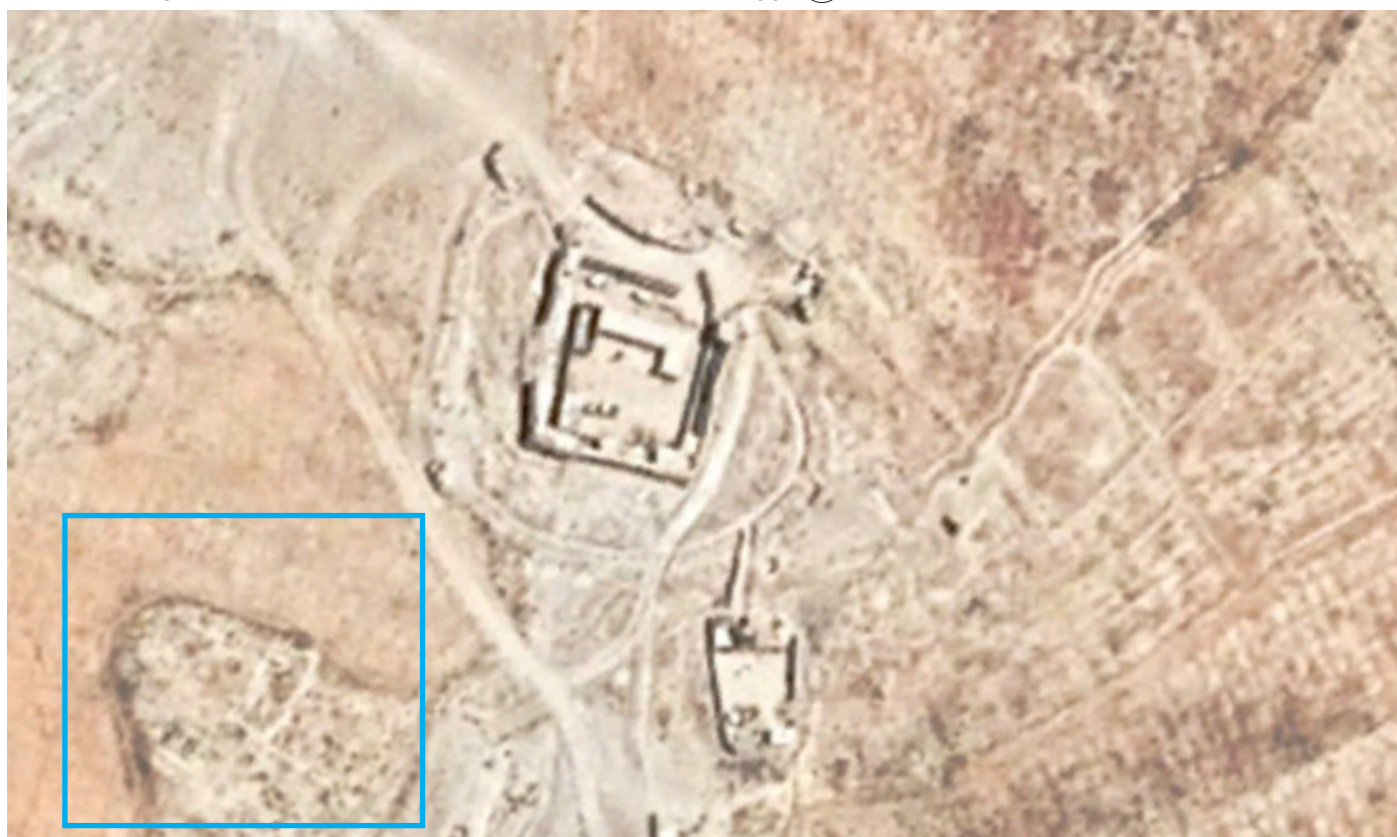
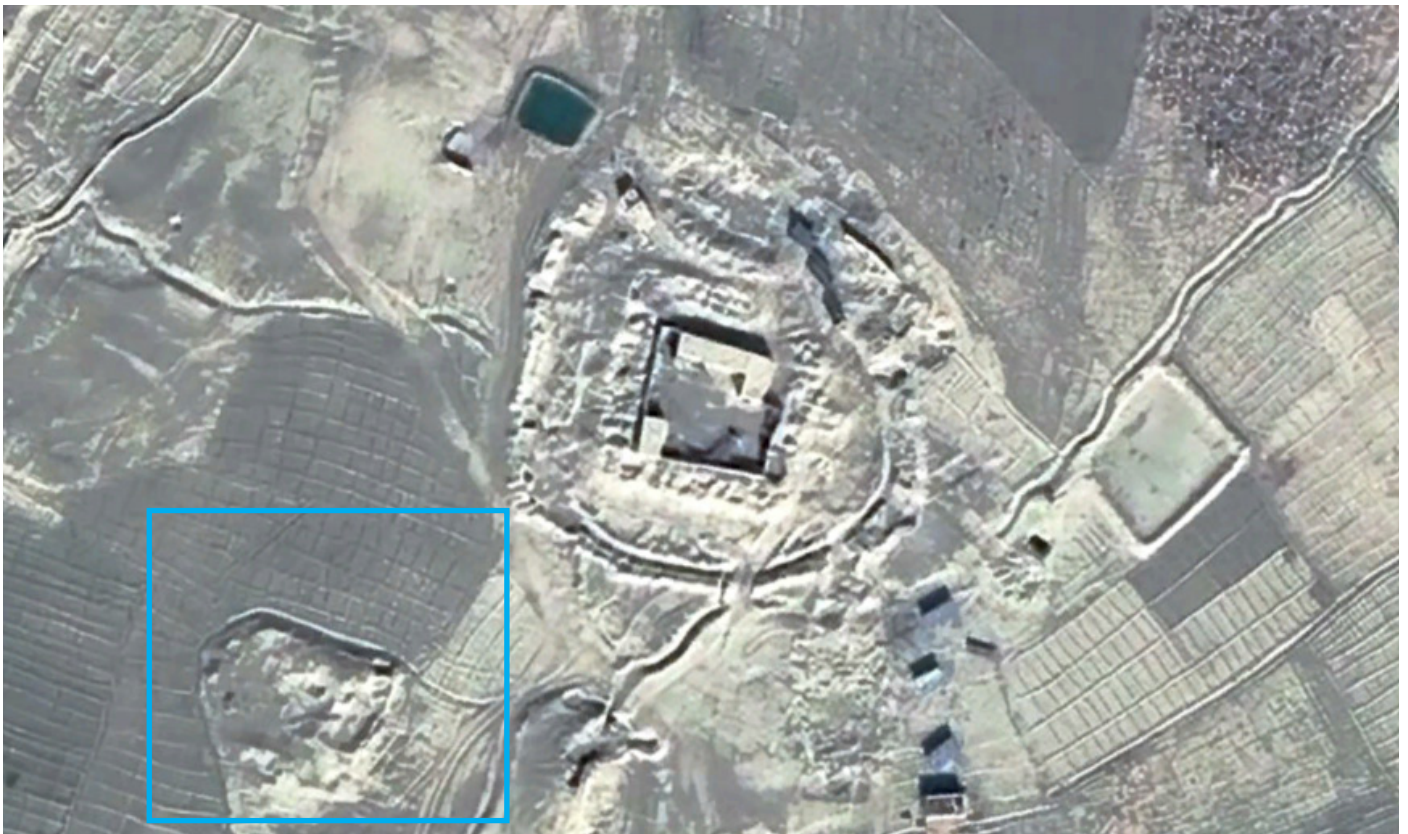
The site is located in proximity to agricultural land. We can observe remains of a fortification in 2004 which has been transformed into agricultural land by 2012, we observe a larger site near the first. By 2019 both sites are excavated, we can see multiple roads as well as trenches (irrigation systems?). In 2022 traces of mechanic looting can be seen around and south of the main structure. The second structure has been levelled, traces of manual looting can also be seen.
