HERITAGE  
WATCH.AI

IMPACT OF TAPI PIPELINE PROJECT ON  
ARCHAEOLOGICAL SITES IN AFGHANISTAN

2 0 2 3

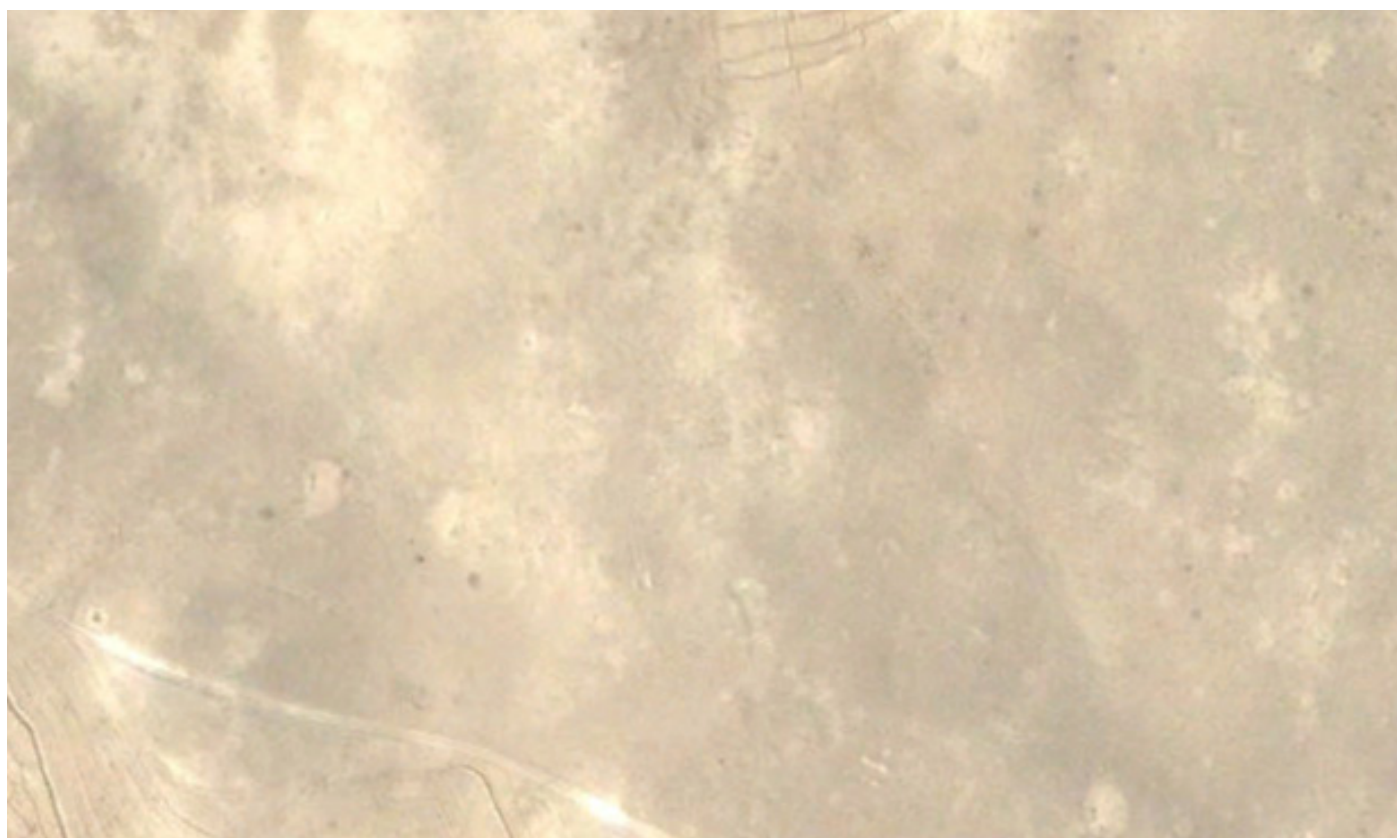
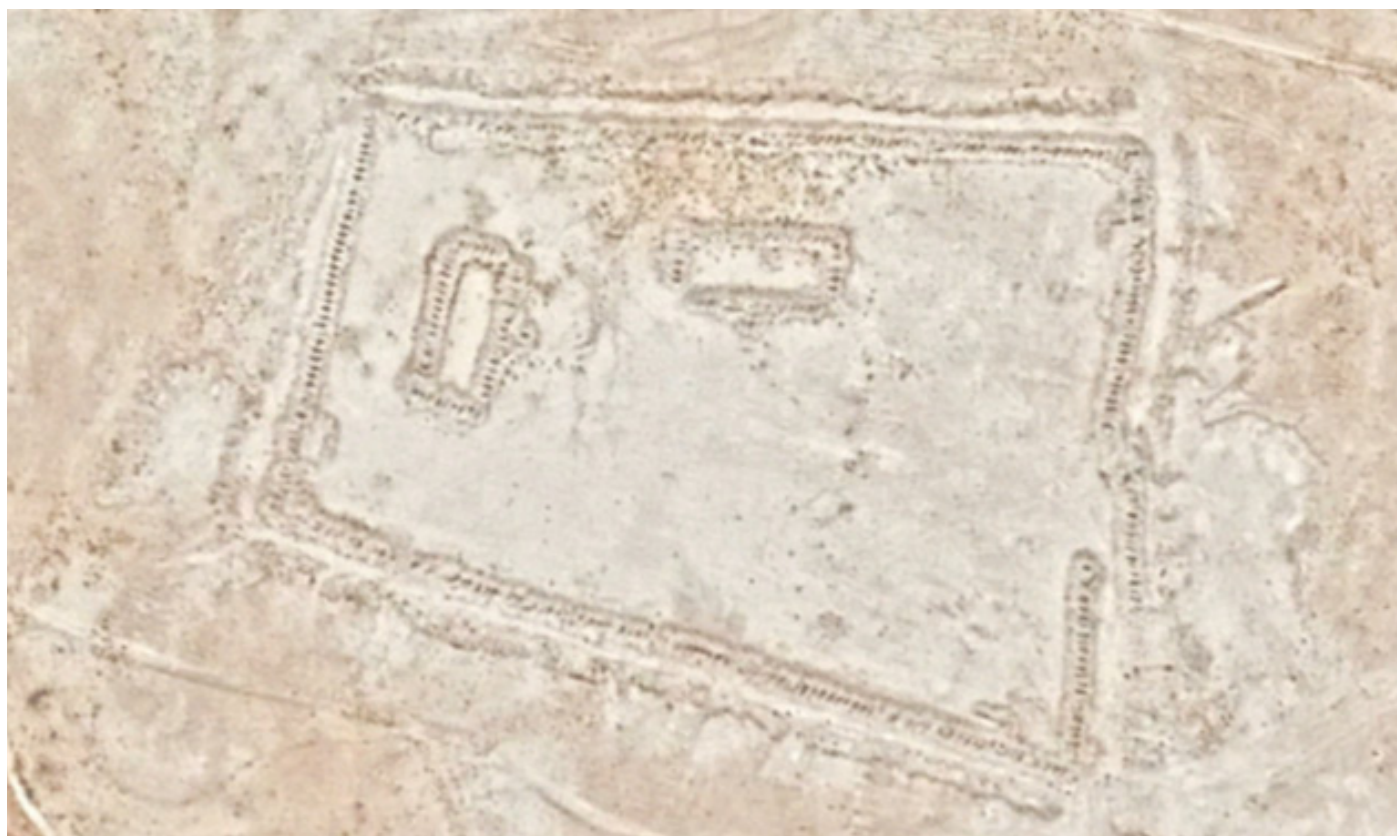
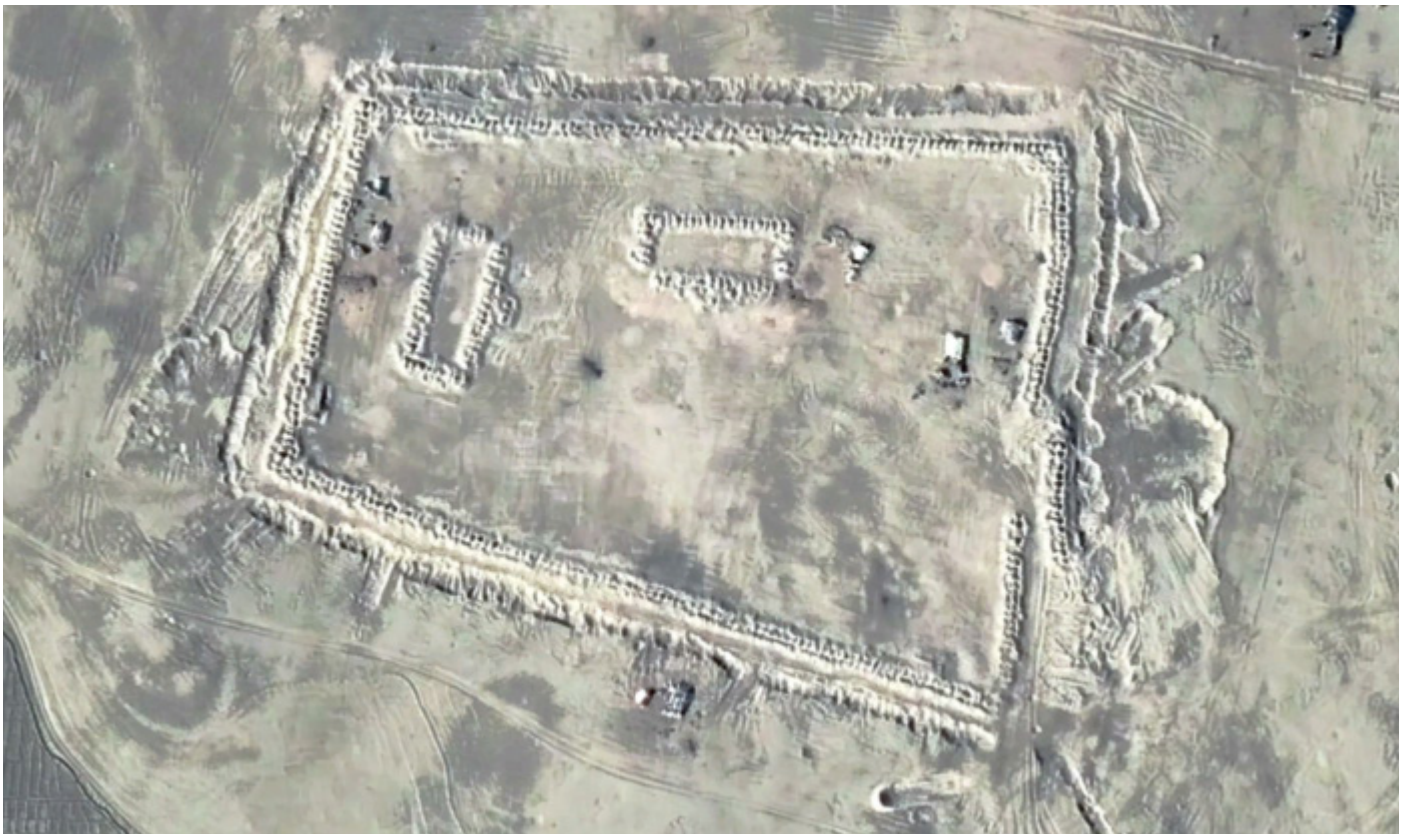
The site is located in a non agricultural area. It has an irregular rectangle shape with two structures within its walls. In 2004 the site was undiscovered, by 2012, substantial traces of excavation can be seen. In 2019 vehicle tracks and mechanic looting traces can be seen. By 2022, holes and trenches all over the site are visible.

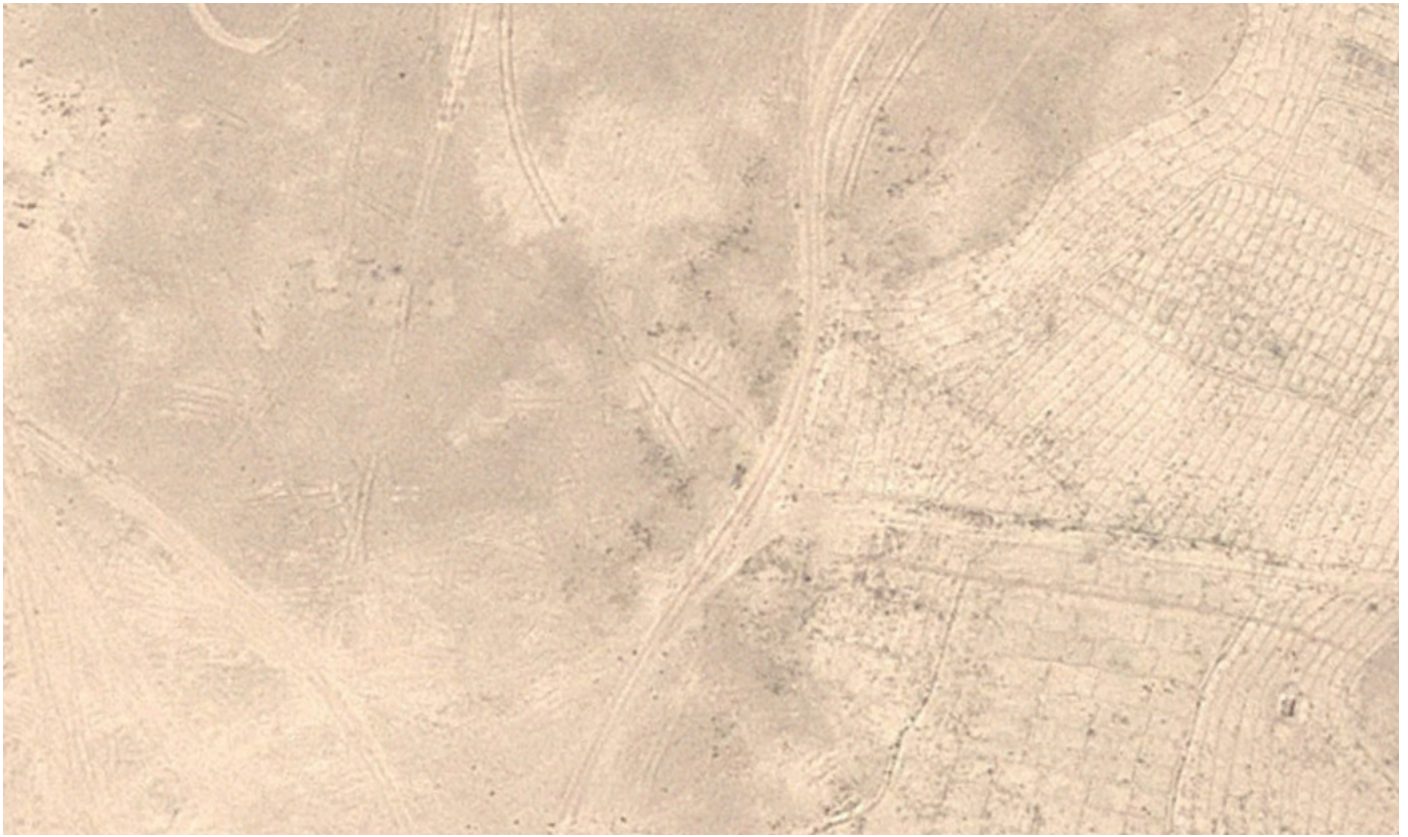
SE6\*\*31°31'31.61"N; 65°10'51.19"E

The site is located in a non agricultural area. it is situated approximately 130 meters north east of the previous site, in 2012, the site had not been identified yet, but as of 2019, it bares similar activity to the previous site with mechanic and manual looting traces.

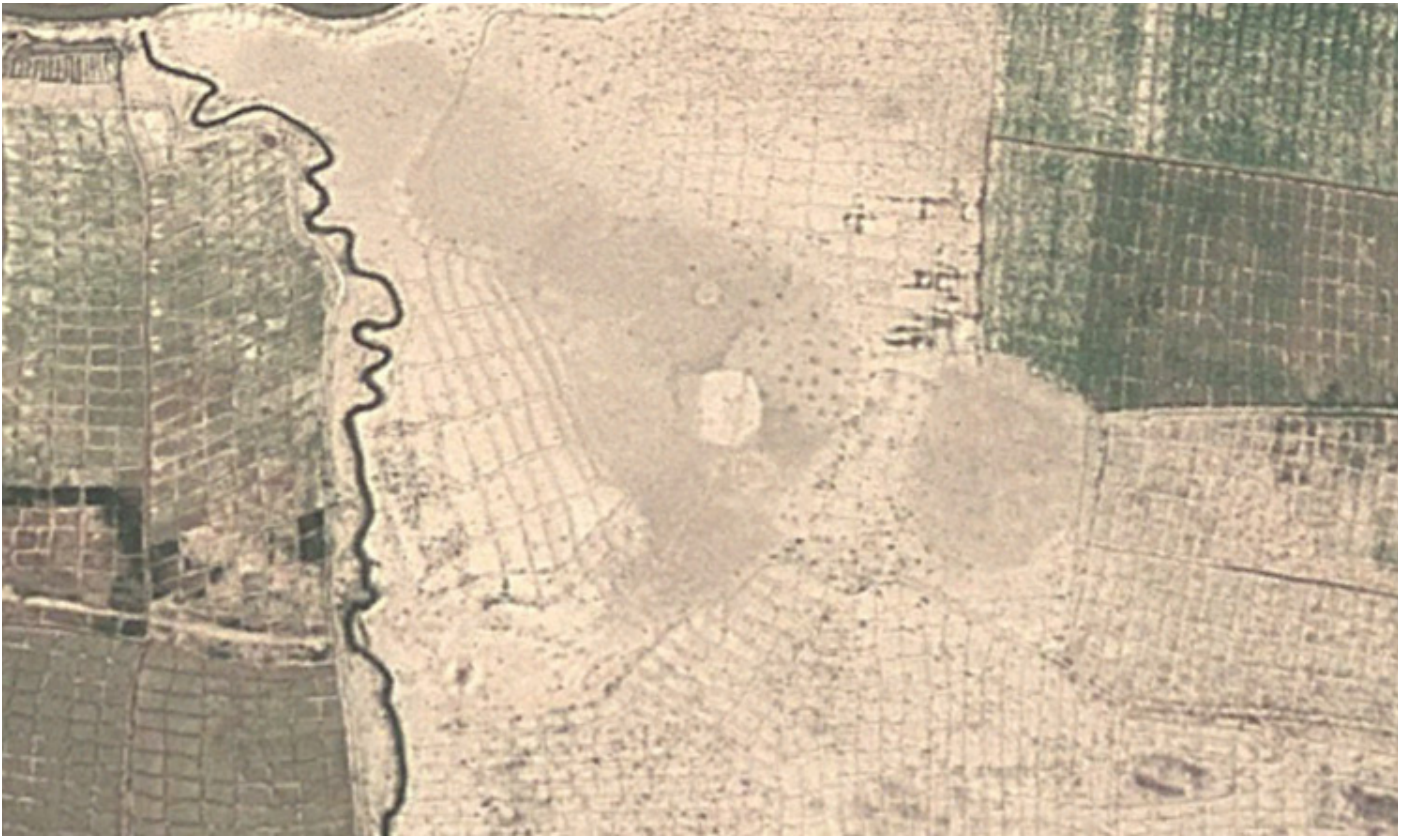
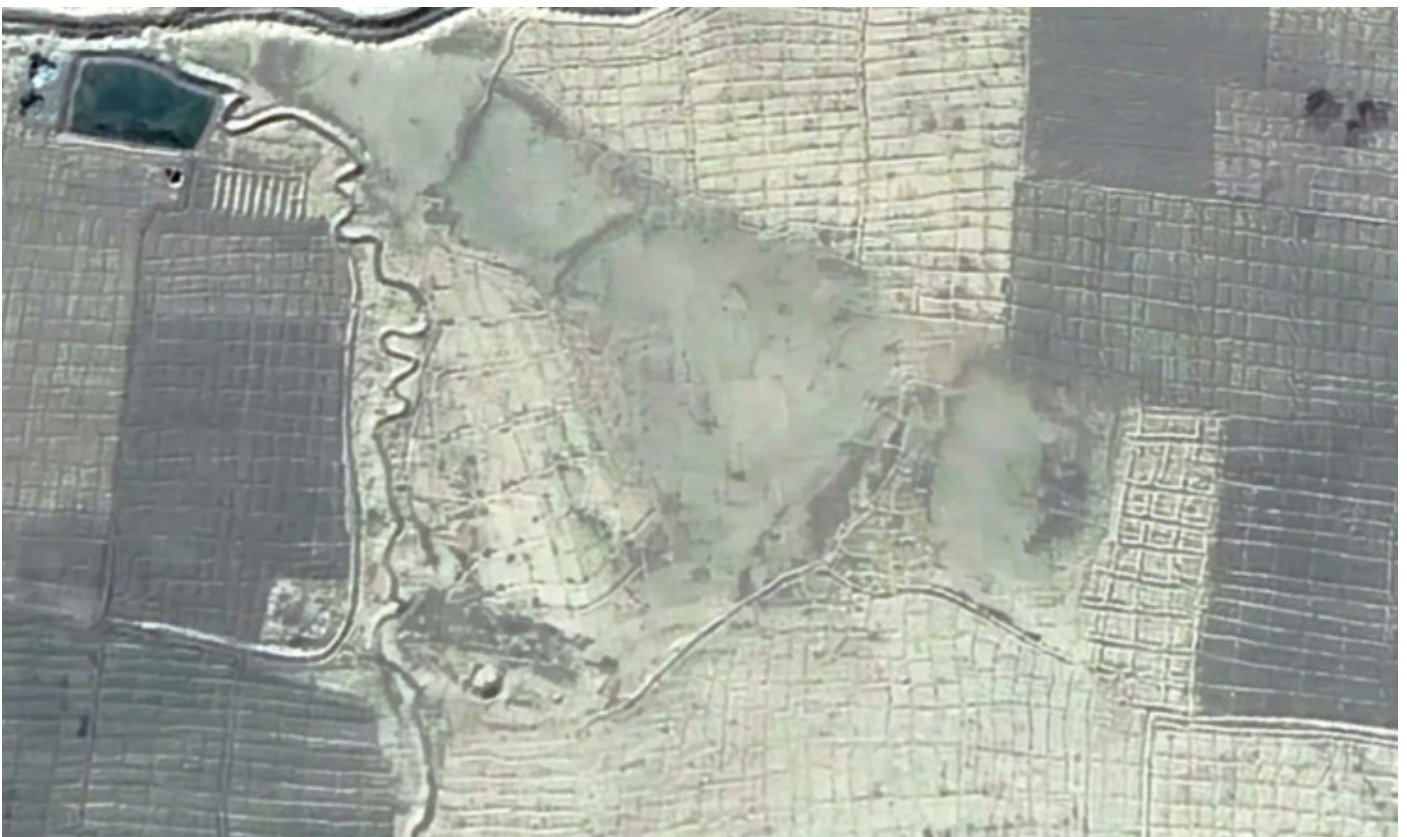
SE7 31°31'9.04''N; 65°10'45.08''E

The site is located in proximity to agricultural land and can be seen by 2012. There is little evidence suggesting looting or transformation to the site.

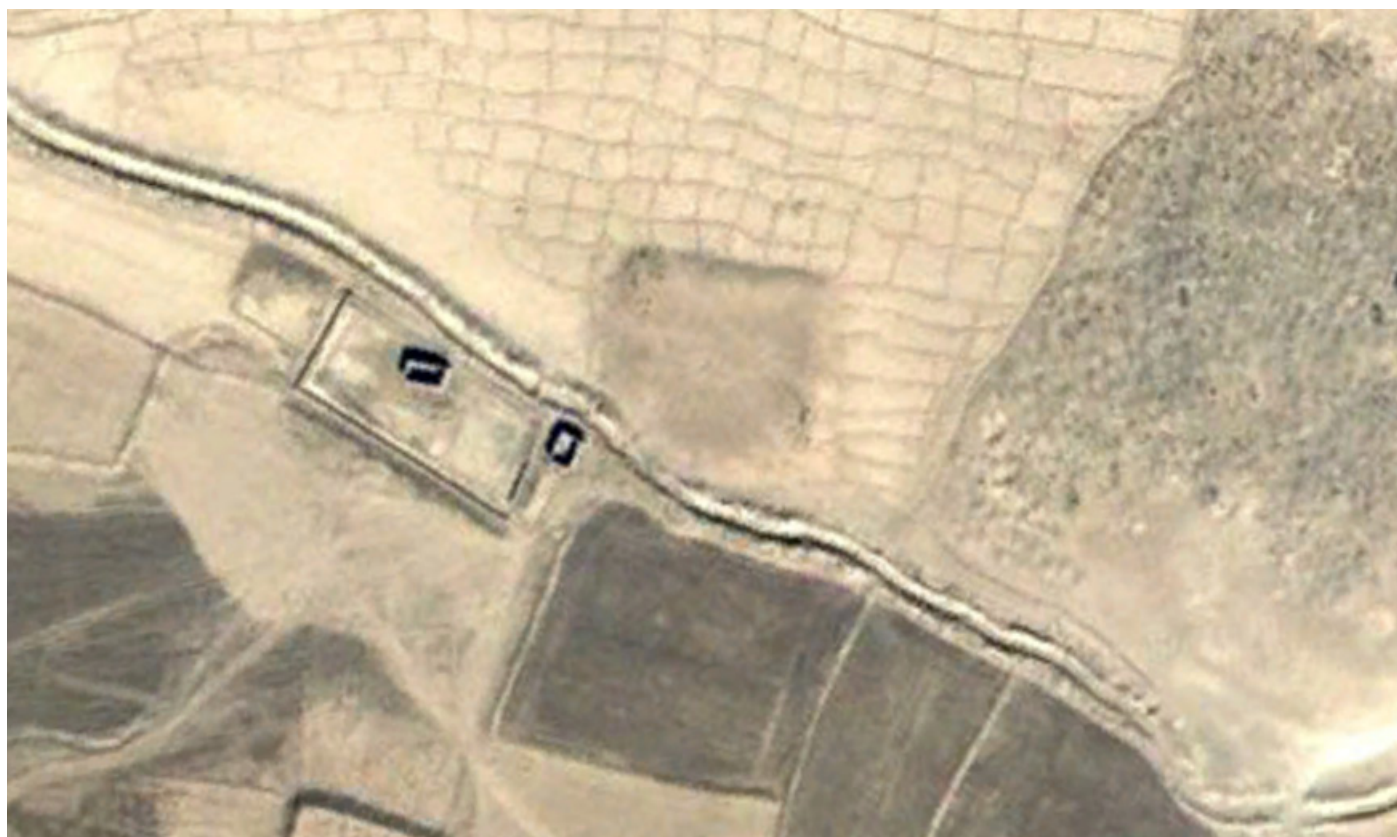
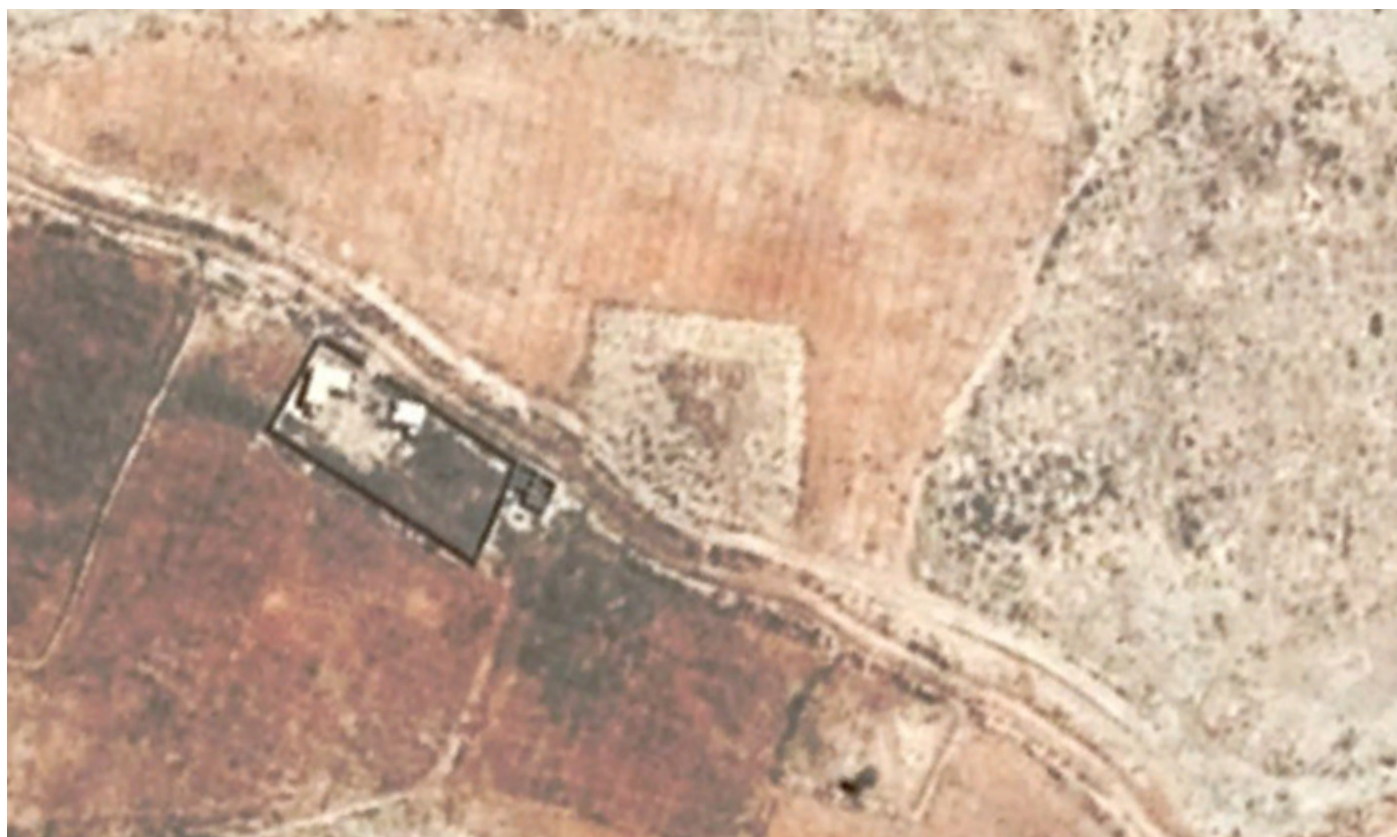
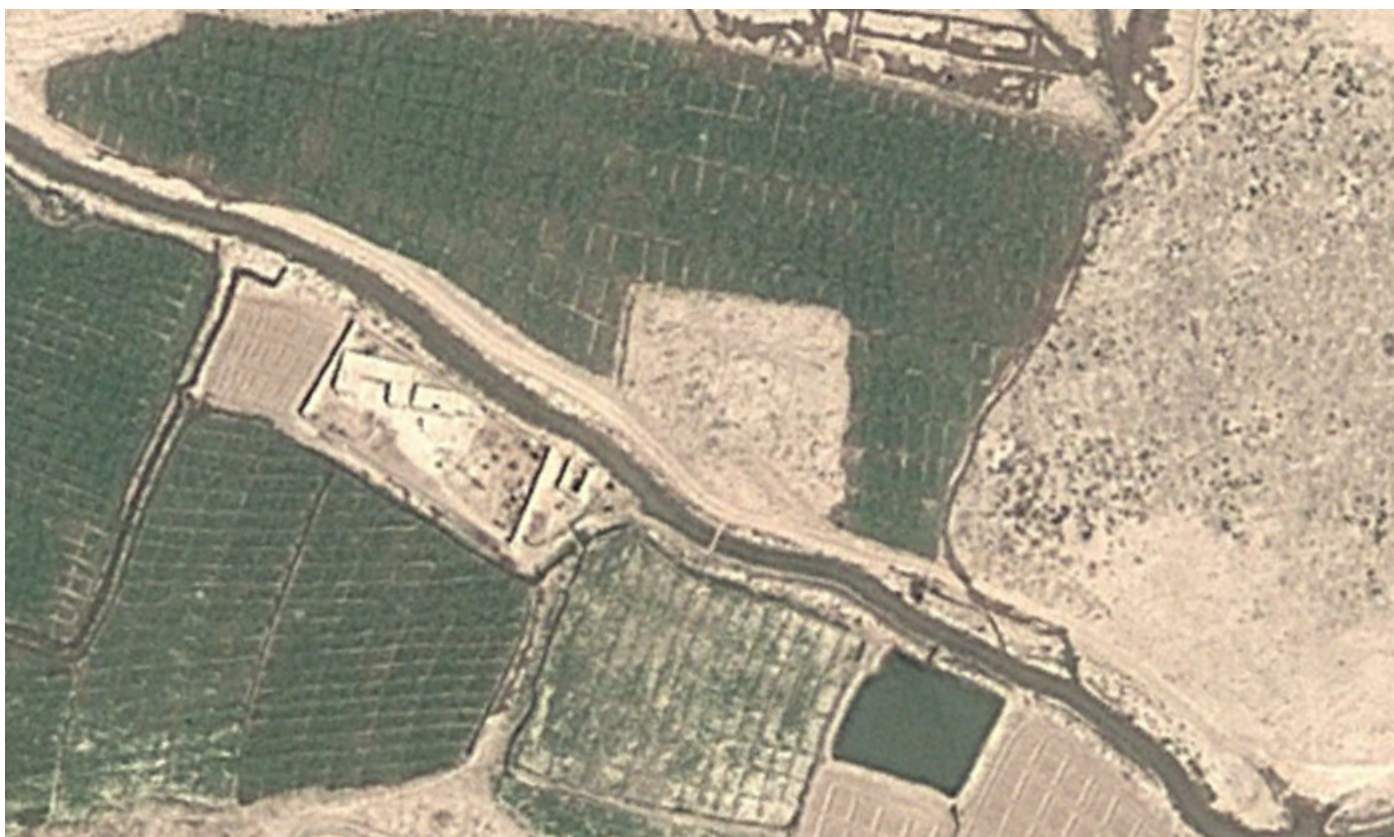
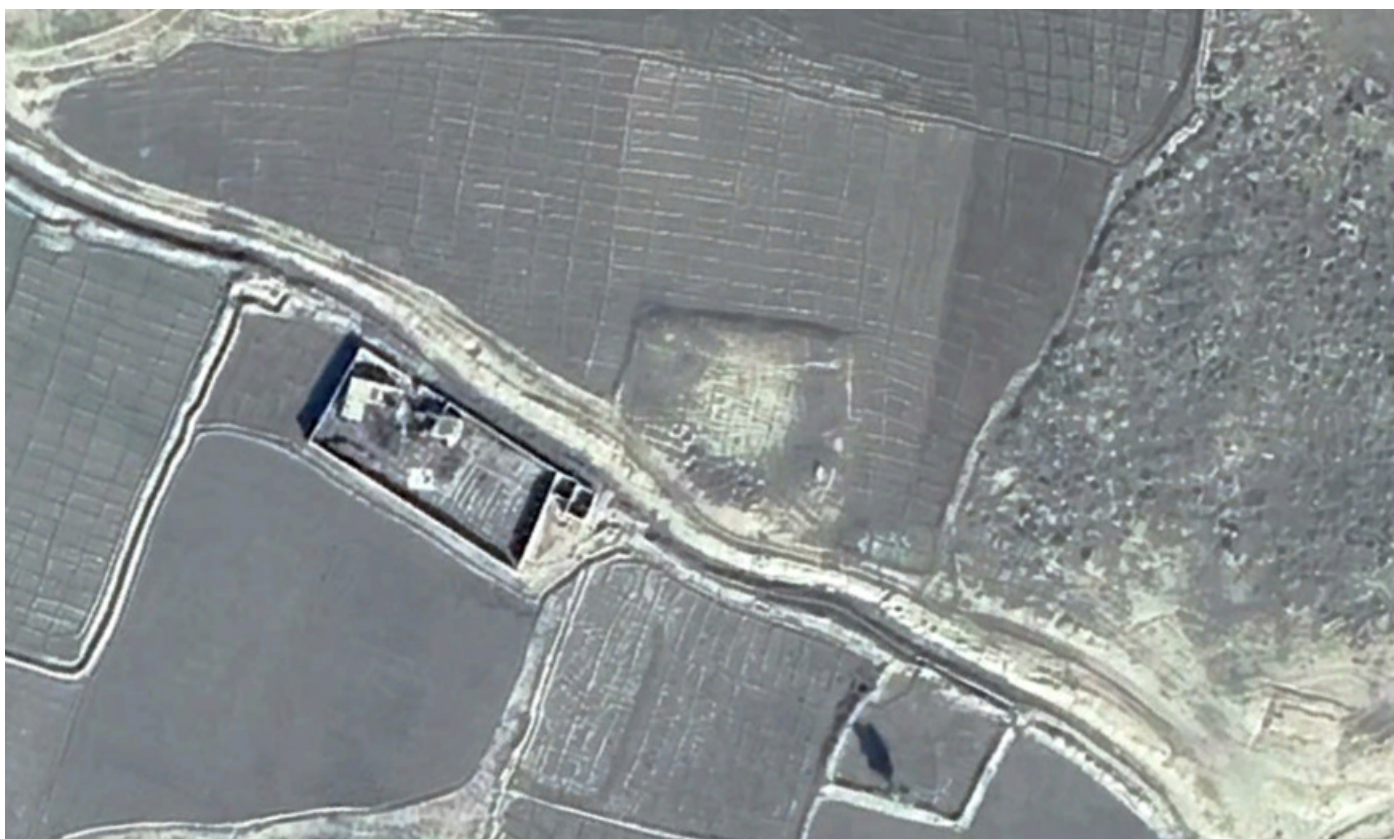
SO1 31°31'14.55"N; 65°10'32.81"E  
TYPOLOGY Mound/Tepe  
AREA (2004) 1255m<sup>2</sup>  
DIST FROM PIPELINE 1705m

The site is located in an agricultural field, next to a water stream. In 2012 a previously unrecorded road parallel to the stream can be seen, eating away a portion of the site. There is little evidence suggesting looting or transformation to the site.

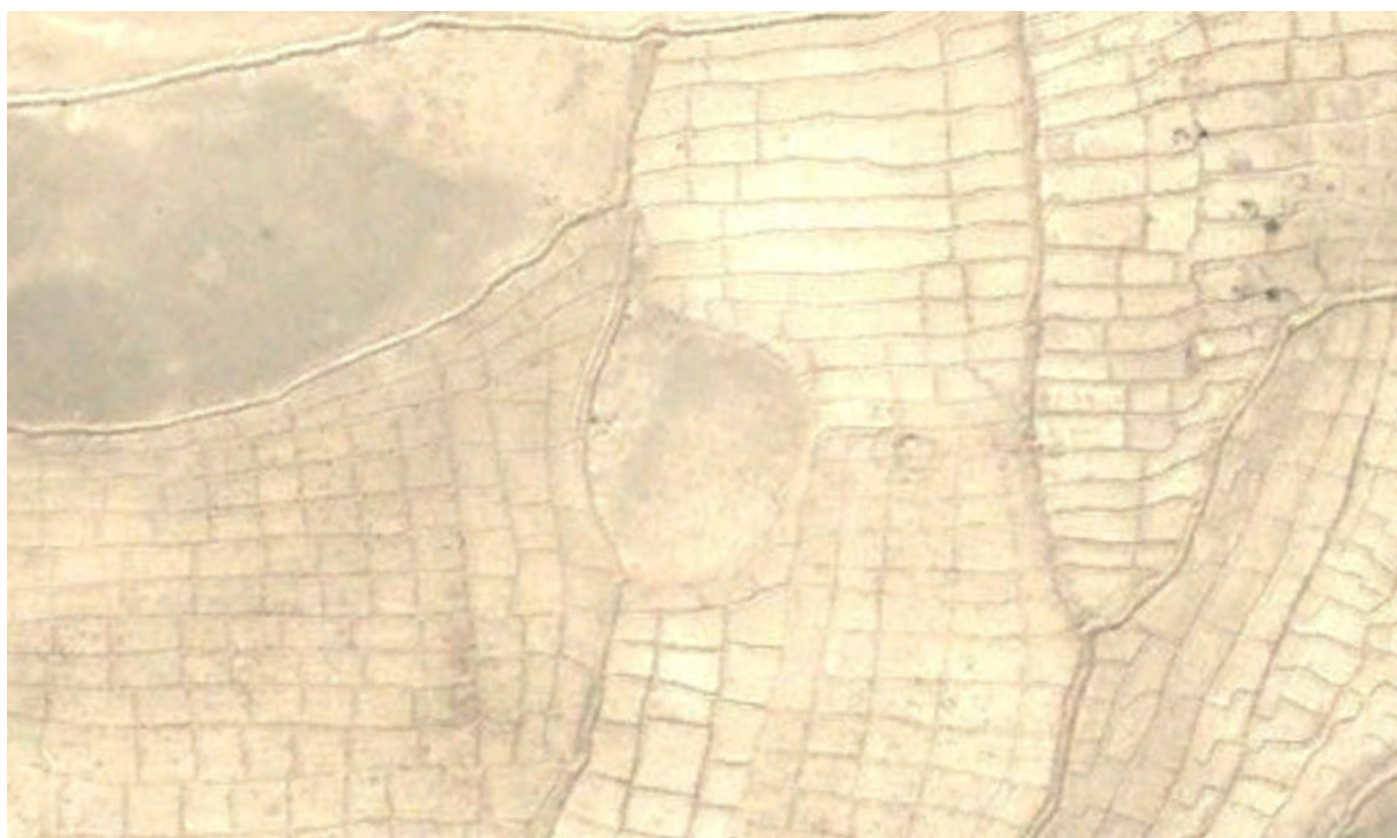
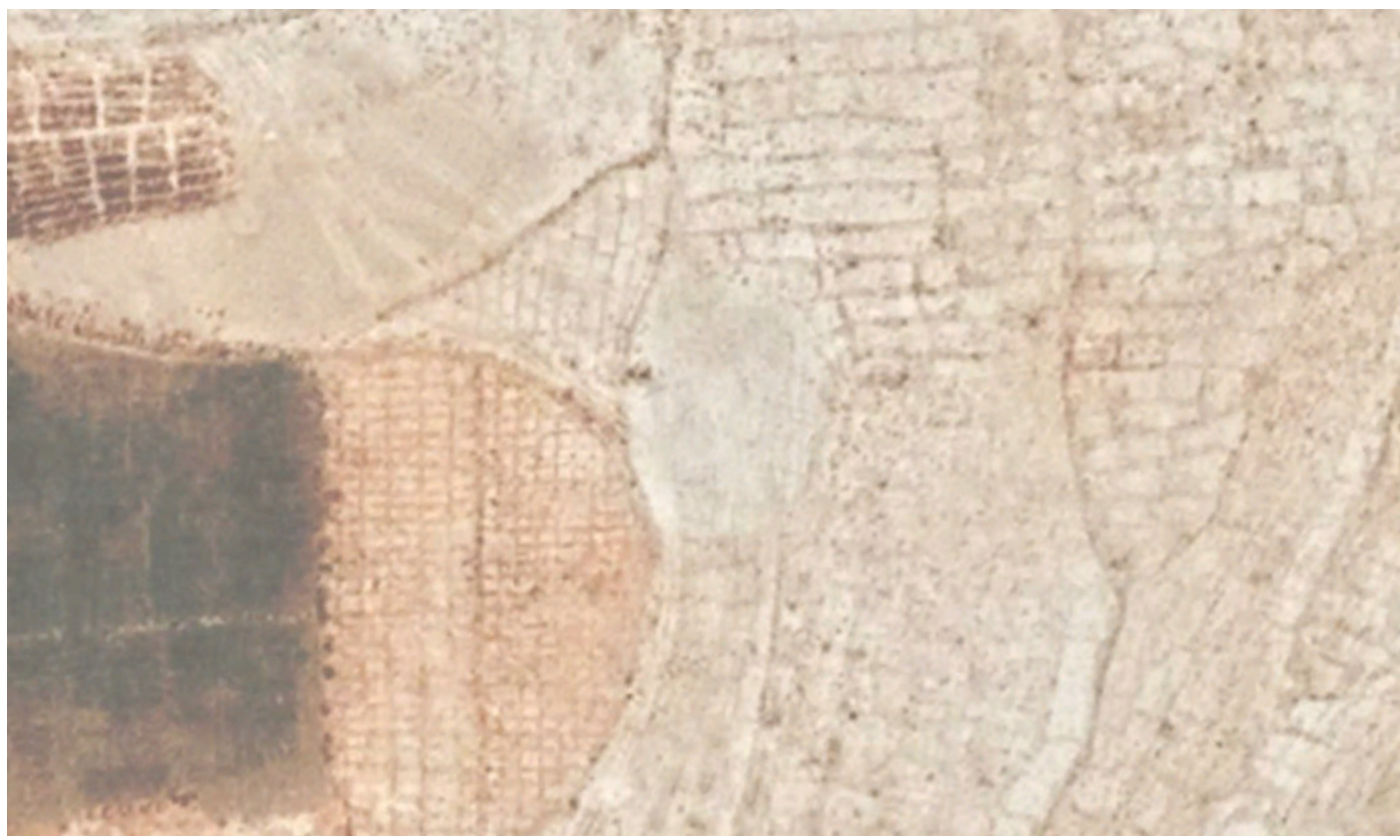
SO2 31°31'34.58"N; 65°10'28.69"E

The site is located in a non agricultural area & has an irregular shape. In 2012, we start observing the development of agricultural fields south west of the site, and by 2022, traces of vehicle tracks and construction can be seen.

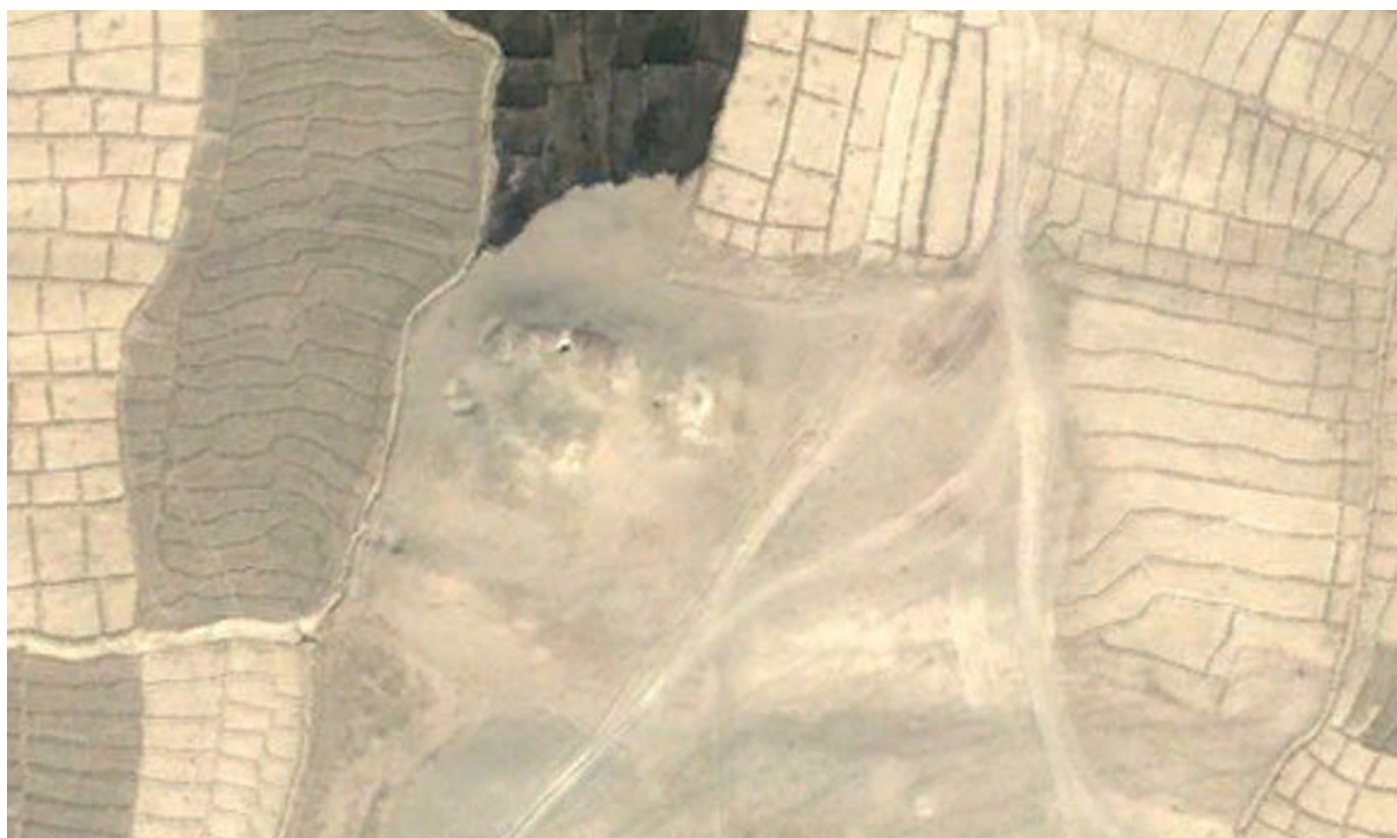
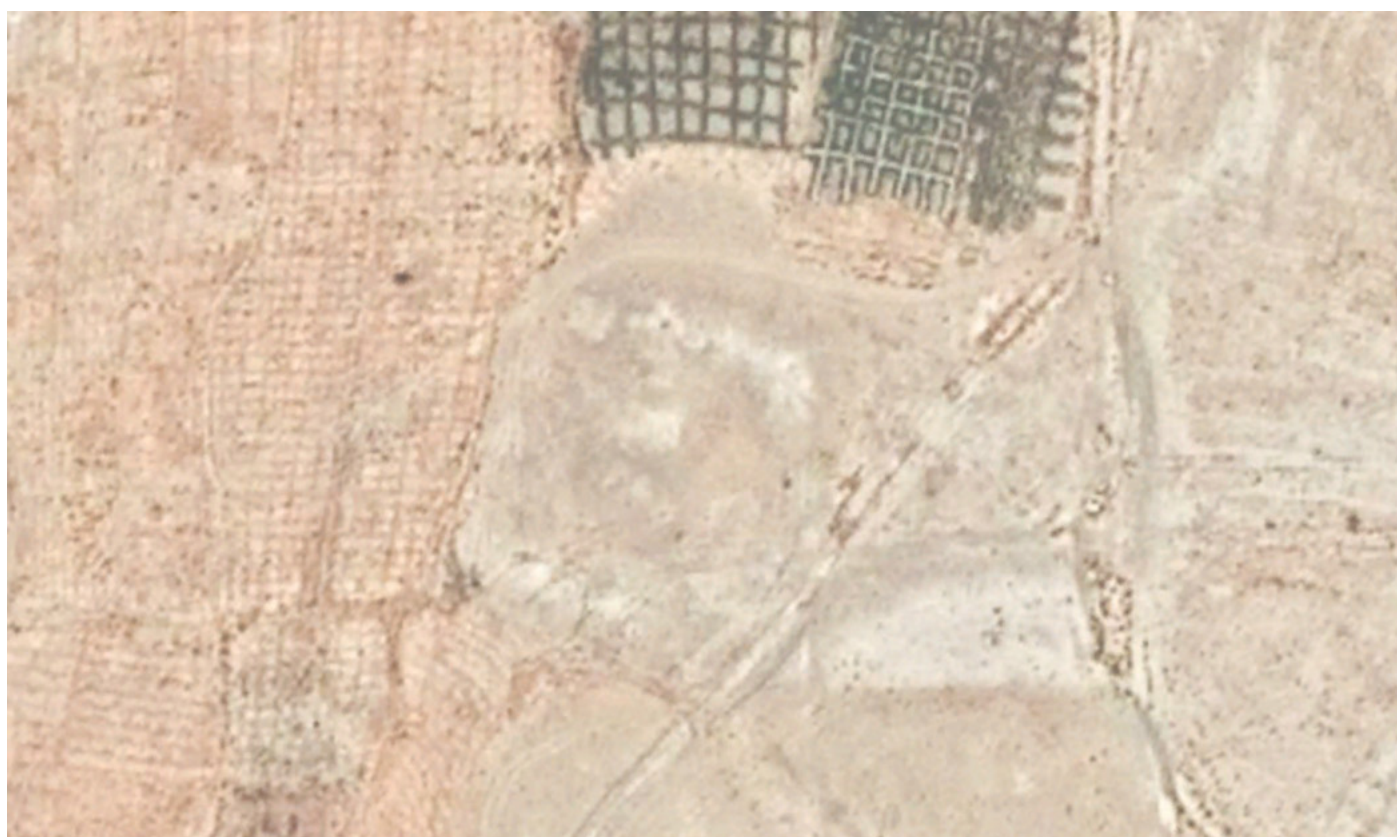
SO3 31°31'41.61"N; 65° 9'50.80"E

The site is located in proximity to agricultural fields. Irregular shapes seem to be emerging from the site, and vehicle tracks can be seen as early as 2012 but their number grows significantly in 2022. There is little indication to support looting or transformation to the site.

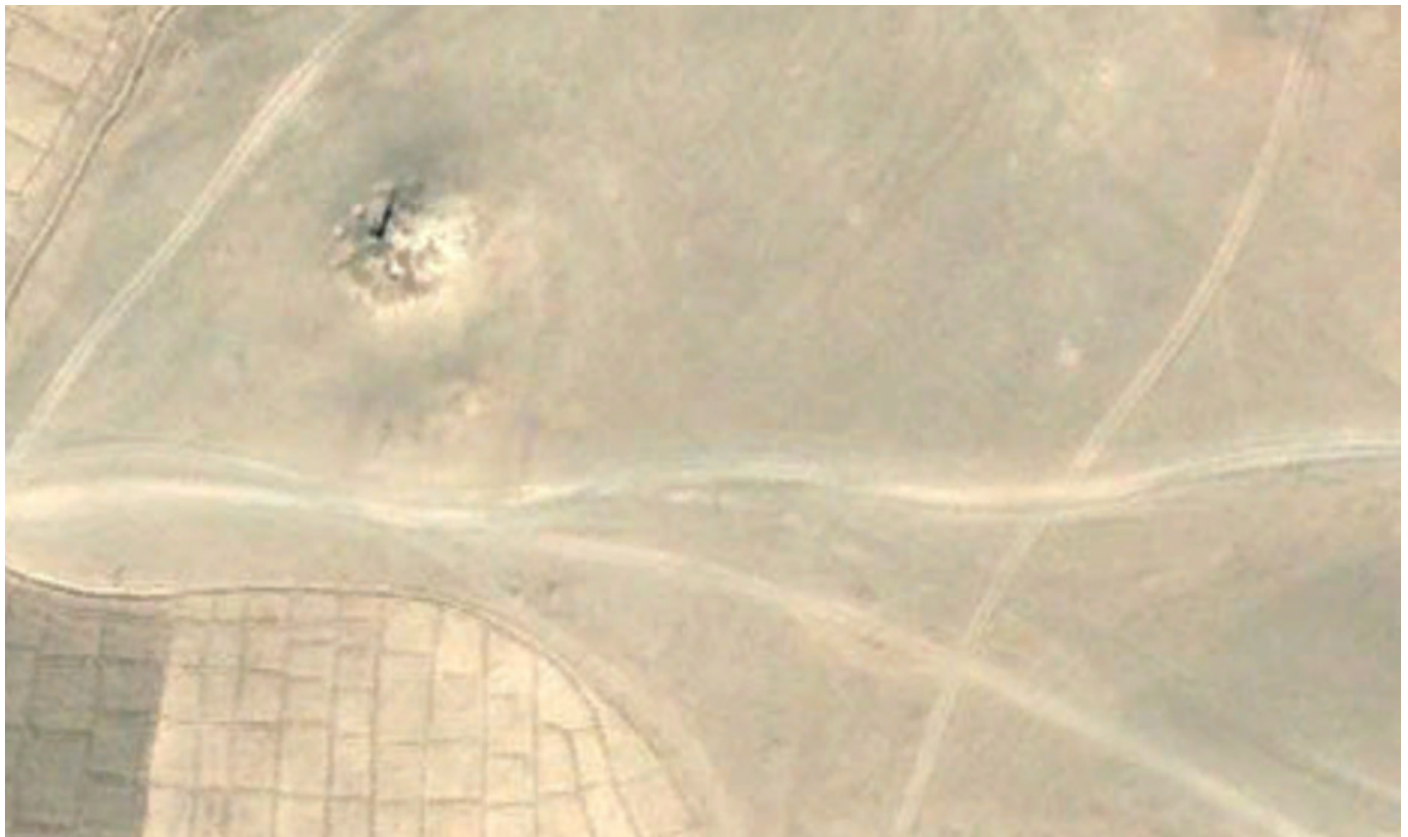
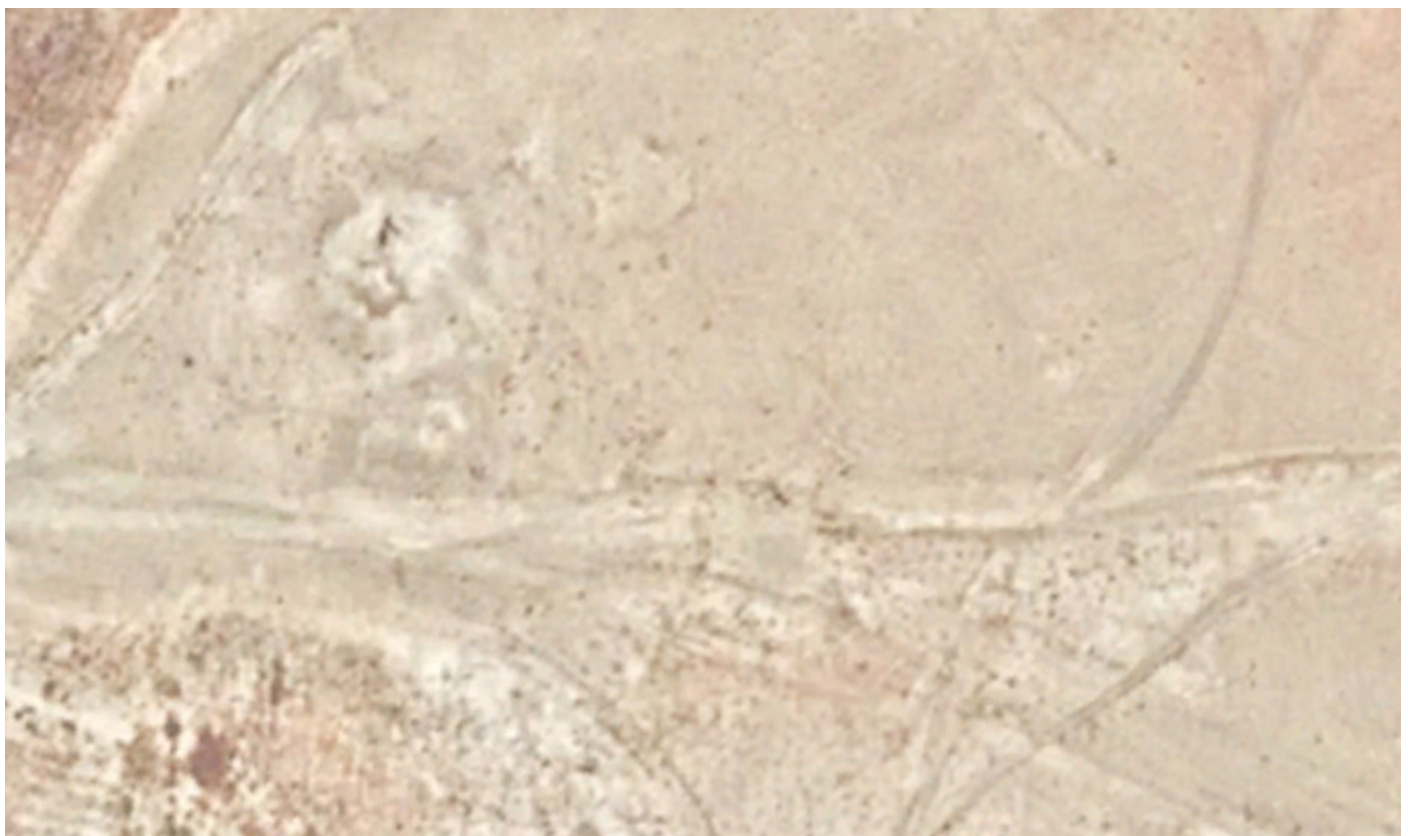
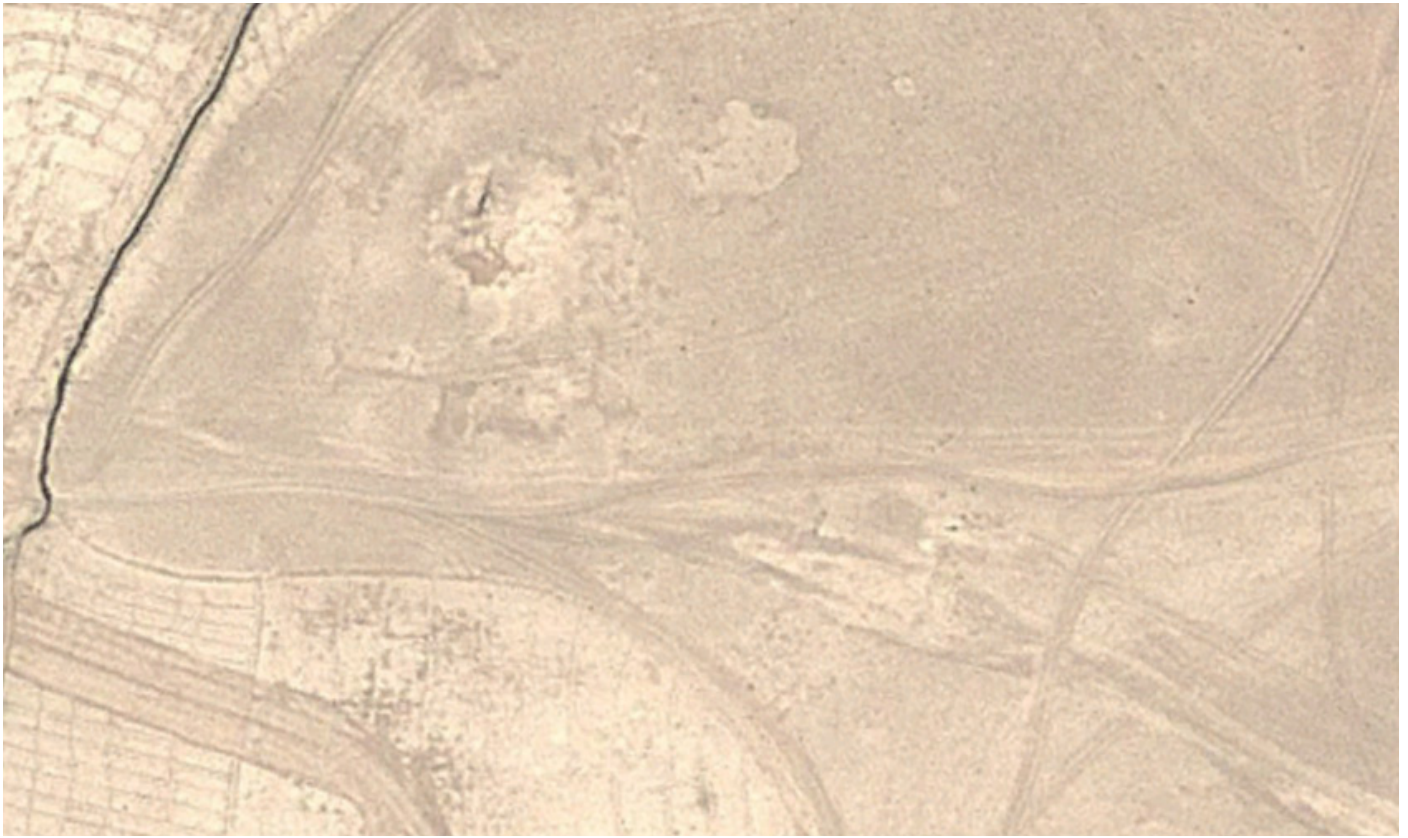
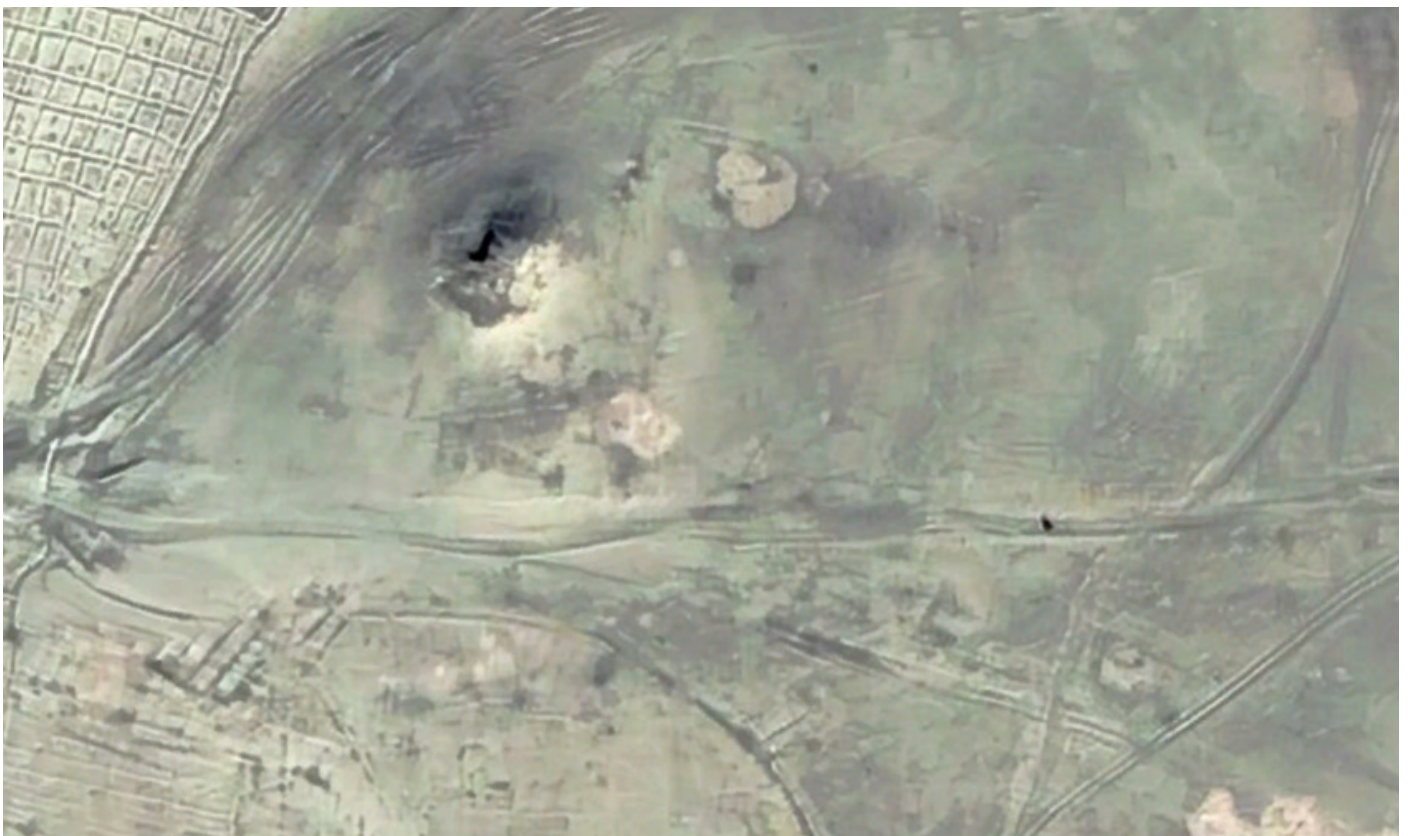
SO4 31°31'35.80"N; 65° 9'48.76"E

The site is located in proximity to agricultural fields close to the previous one. We can observe vehicle tracks as early as 2004 around the site and by 2022, they are greater in number.
