HERITAGE  
WATCH.AI

IMPACT OF TAPI PIPELINE PROJECT ON  
ARCHAEOLOGICAL SITES IN AFGHANISTAN

2 0 2 3

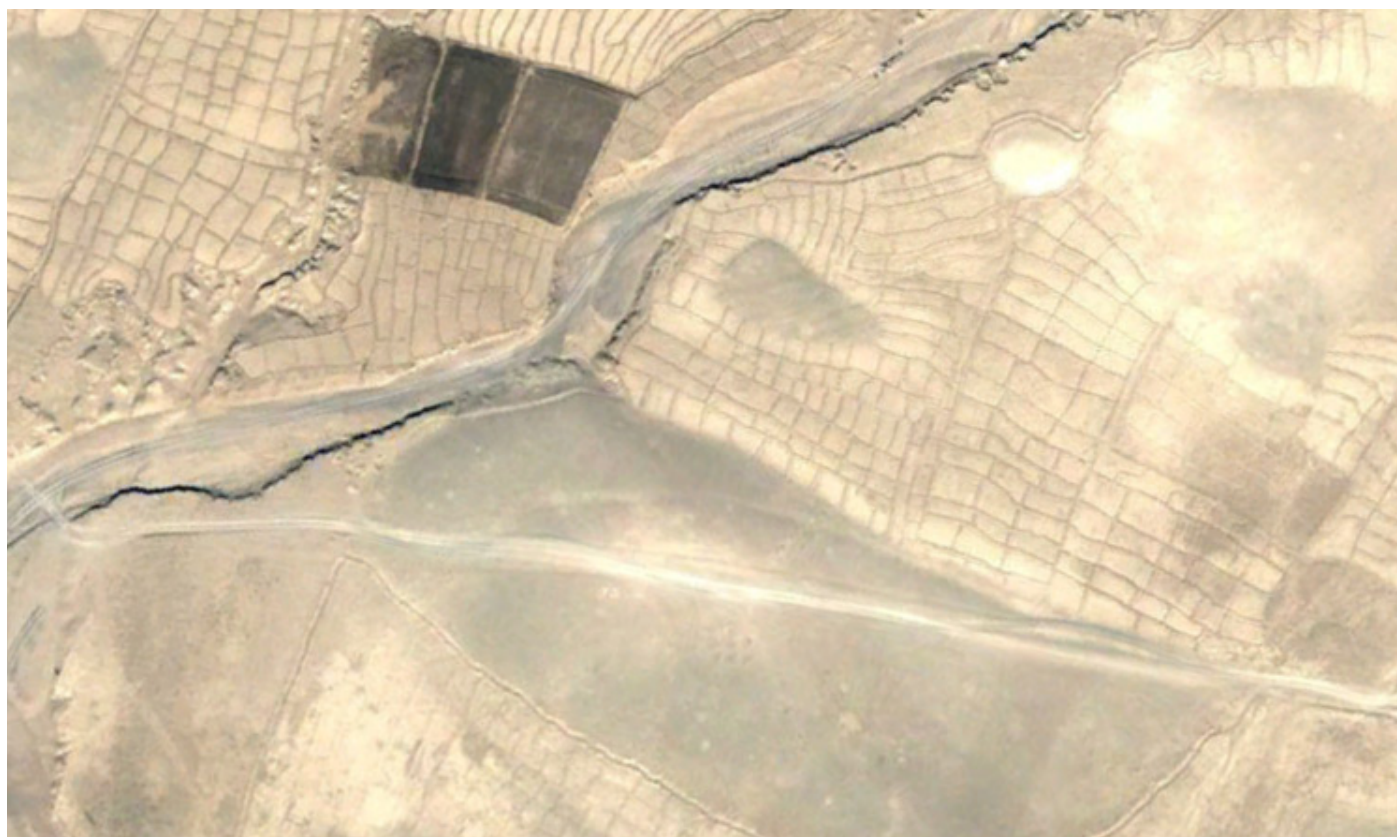
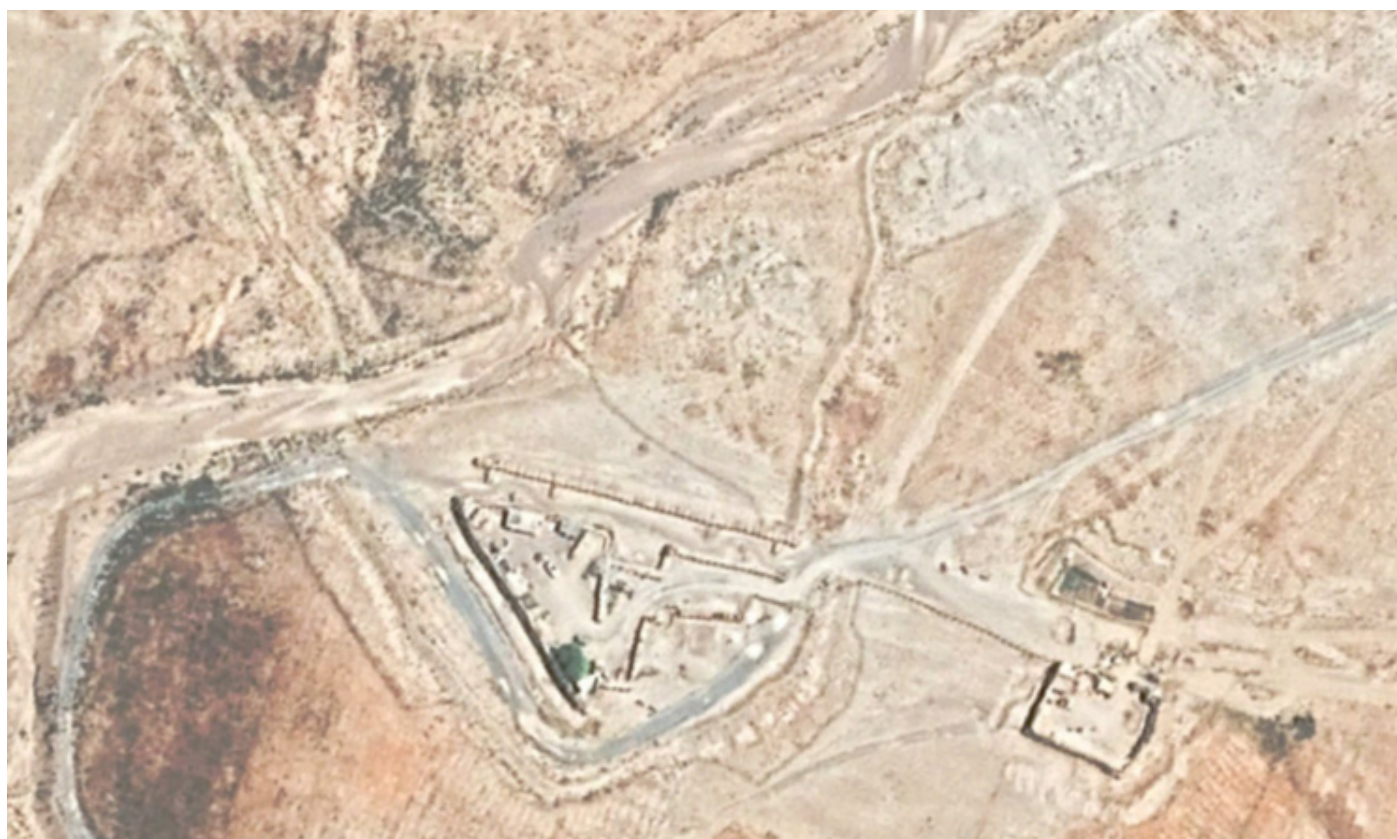
SO4\* 31°31'39.39''N; 65°10'6.14''E

The area seems to encompass several sites on each side of the watercourse. It is located in close proximity to the previous site. A large construction can be seen as of 2012 resembling a factory or a military complex. By 2022, extensive manual and mechanic excavation pits can be seen in the whole area.

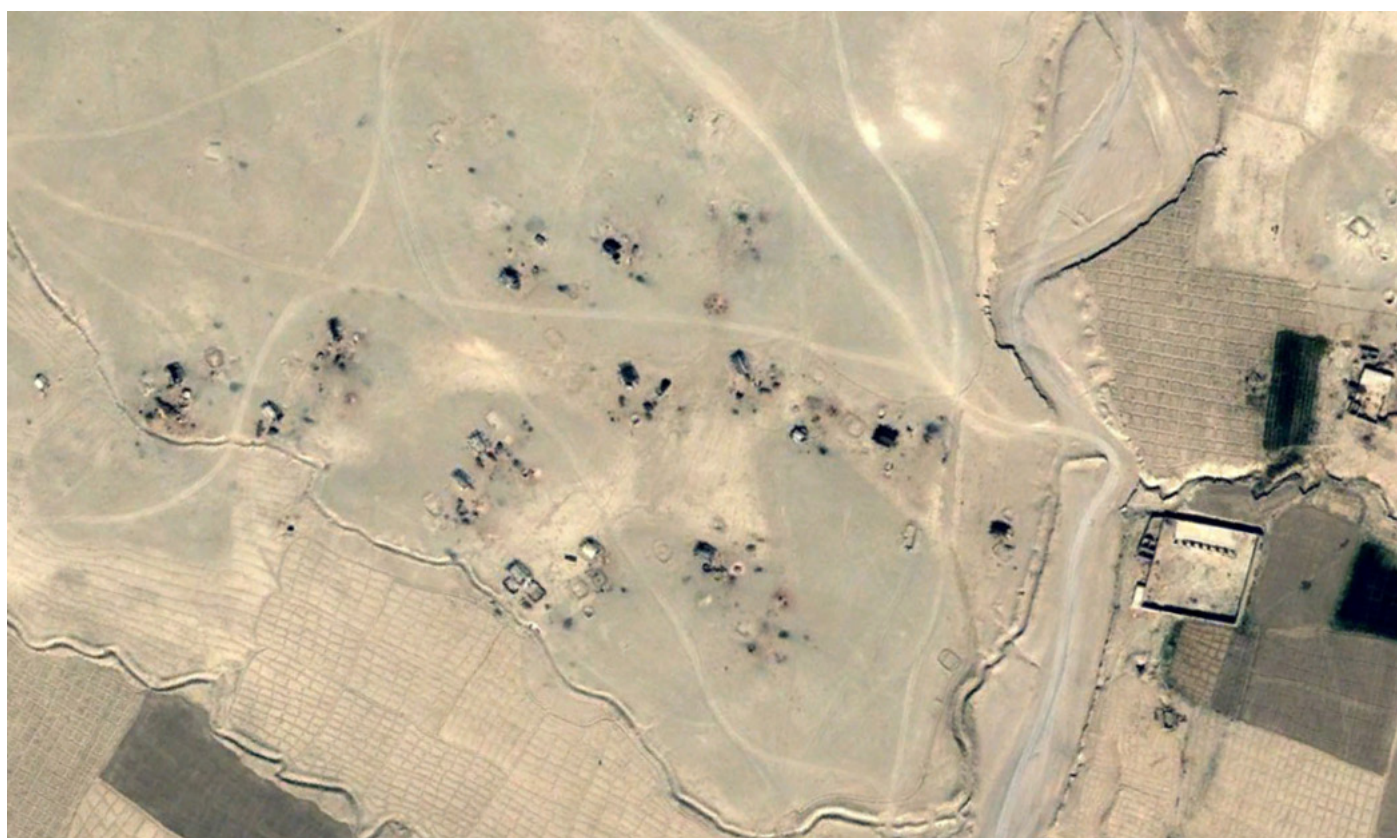
SO4\*\* 31°31'26.51''N; 65° 9'54.13''E

The area seems to encompass several sites expanding over 200 meters, and is also located in close proximity to the previous sites, suggesting the area is rich in historical sites. In 2004, we can observe several aggregated structures, implying the existence of settlements. Faint traces of vehicle tracks can also be seen as of 2004. Another structure east of the river bears traces of manual excavations.

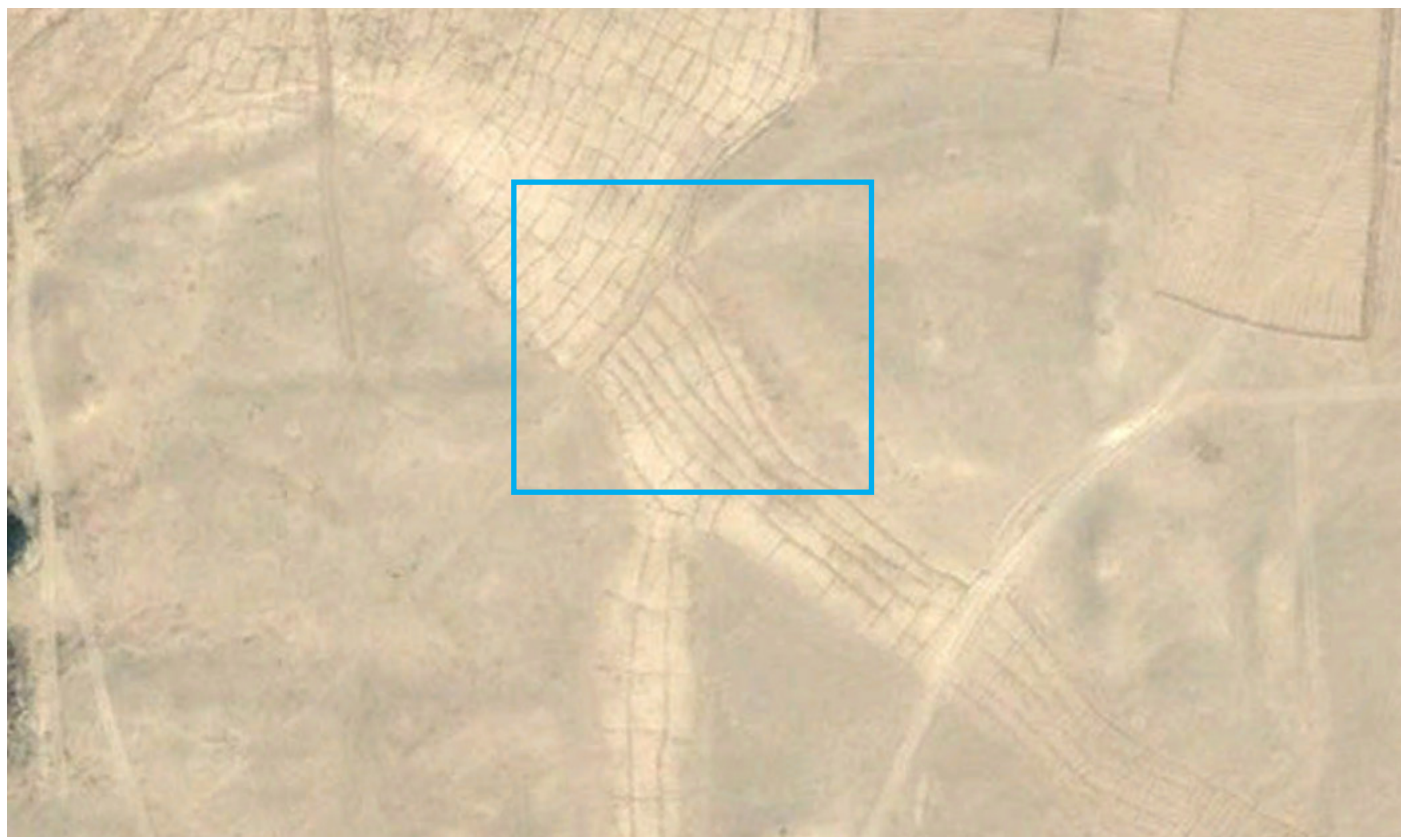
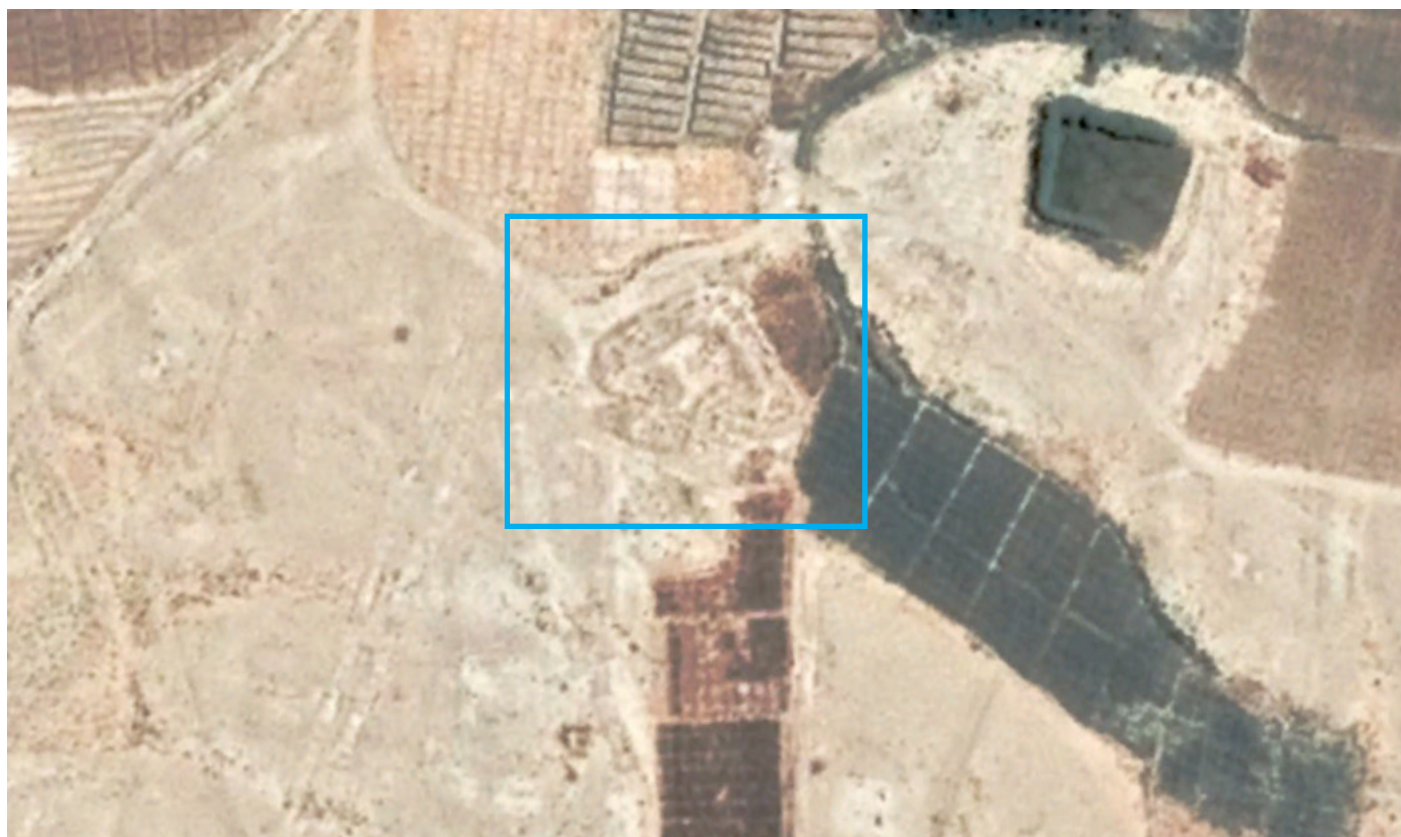
SO5 31°31'42.39"N; 65° 9'4.63"E

The site is located in an arid area transformed into agricultural land and becomes visible between 2012 and 2019. It has an irregular triangle shape. As of 2019, we can already observe traces of excavation pits. By 2022, an enclosed agricultural area appears north of the site.

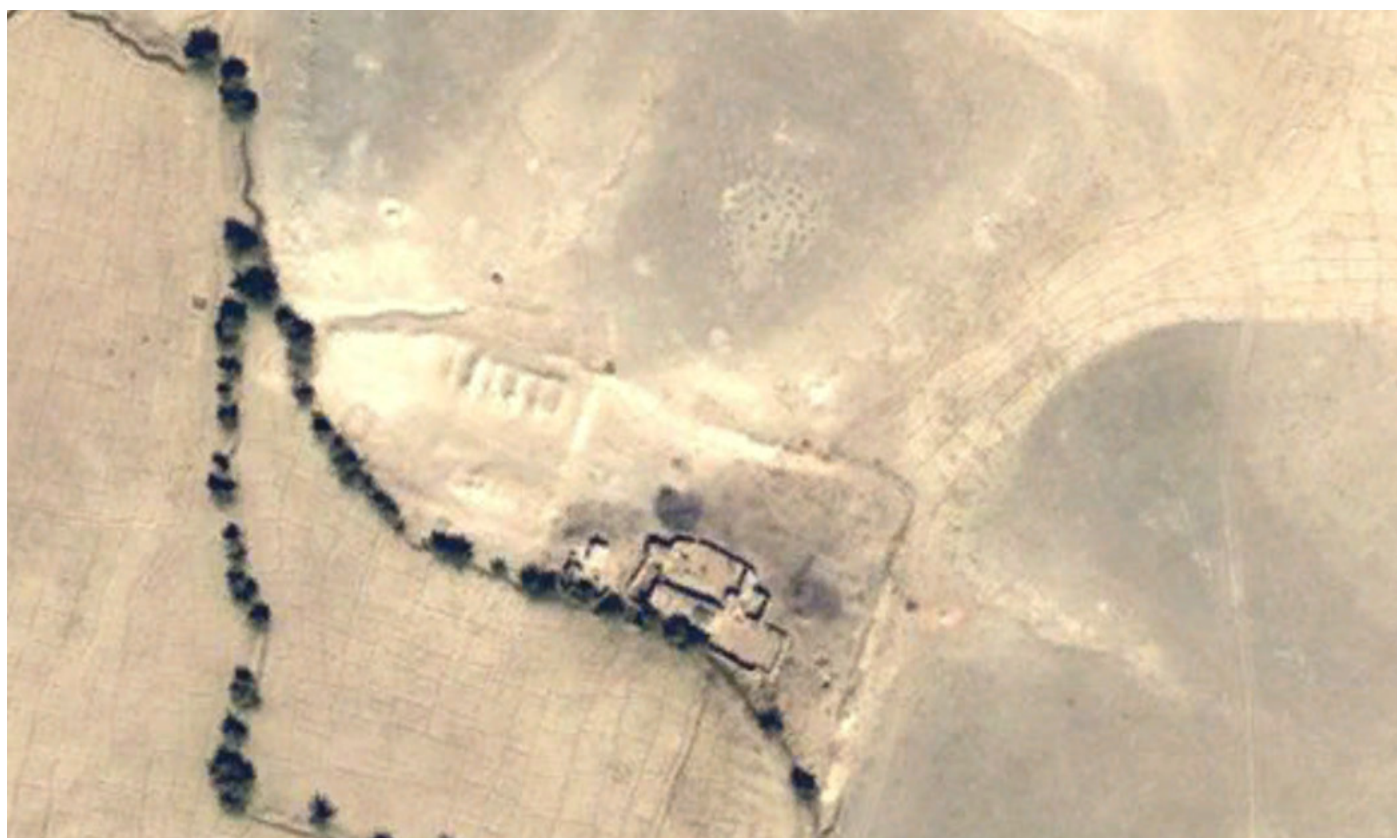
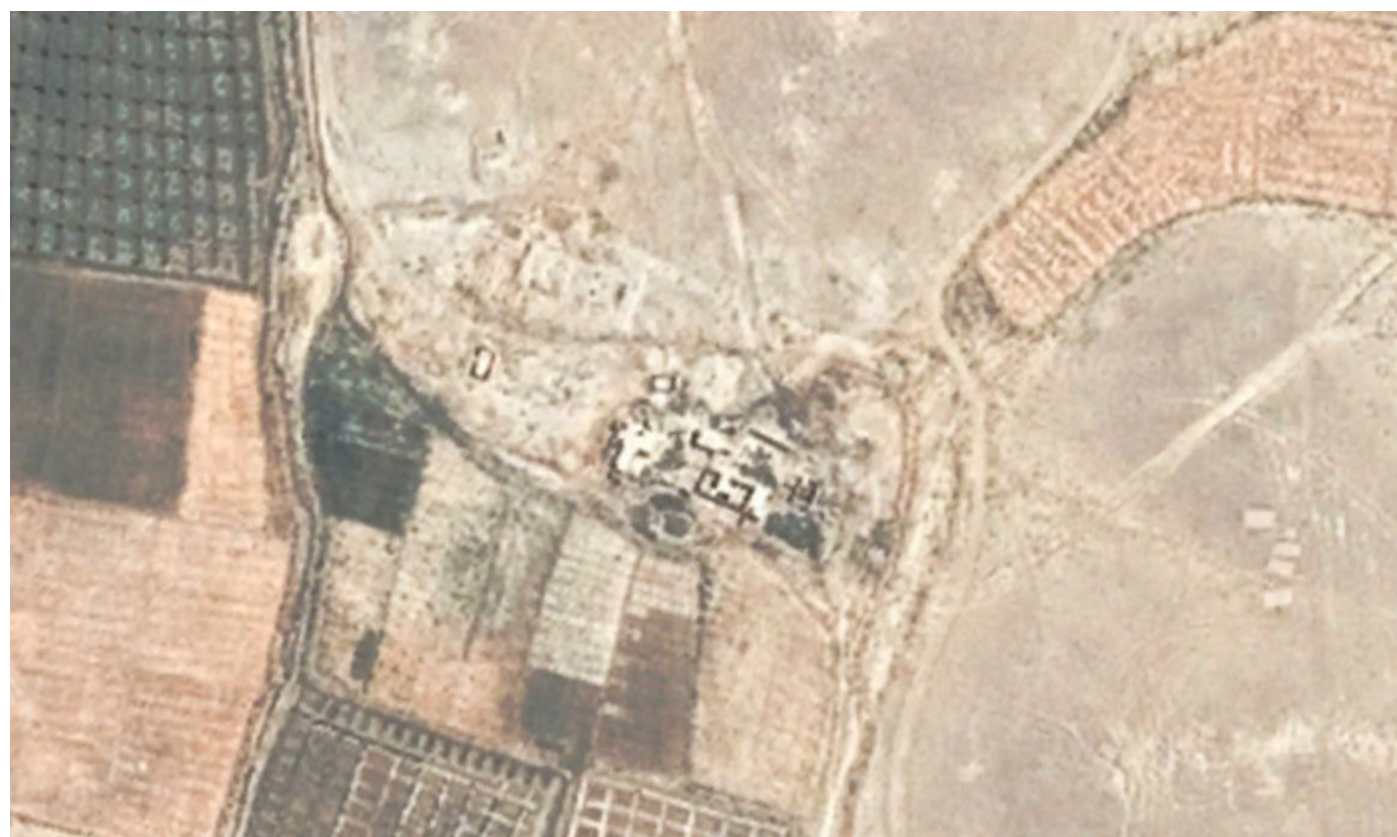
SO5\* 31°32'3.28''N; 65° 8'57.65''E

The site is located in proximity to agricultural fields. In 2004 we can observe traces of ruins as well as a construction in an enclosed space. In 2012, another ruin can be seen just outside the irrigation route. By 2022, we observe an evolution in the site: the apparent structure seems to have lost its roofs and more ruins can be defined. It is unclear whether this site has been looted or not.

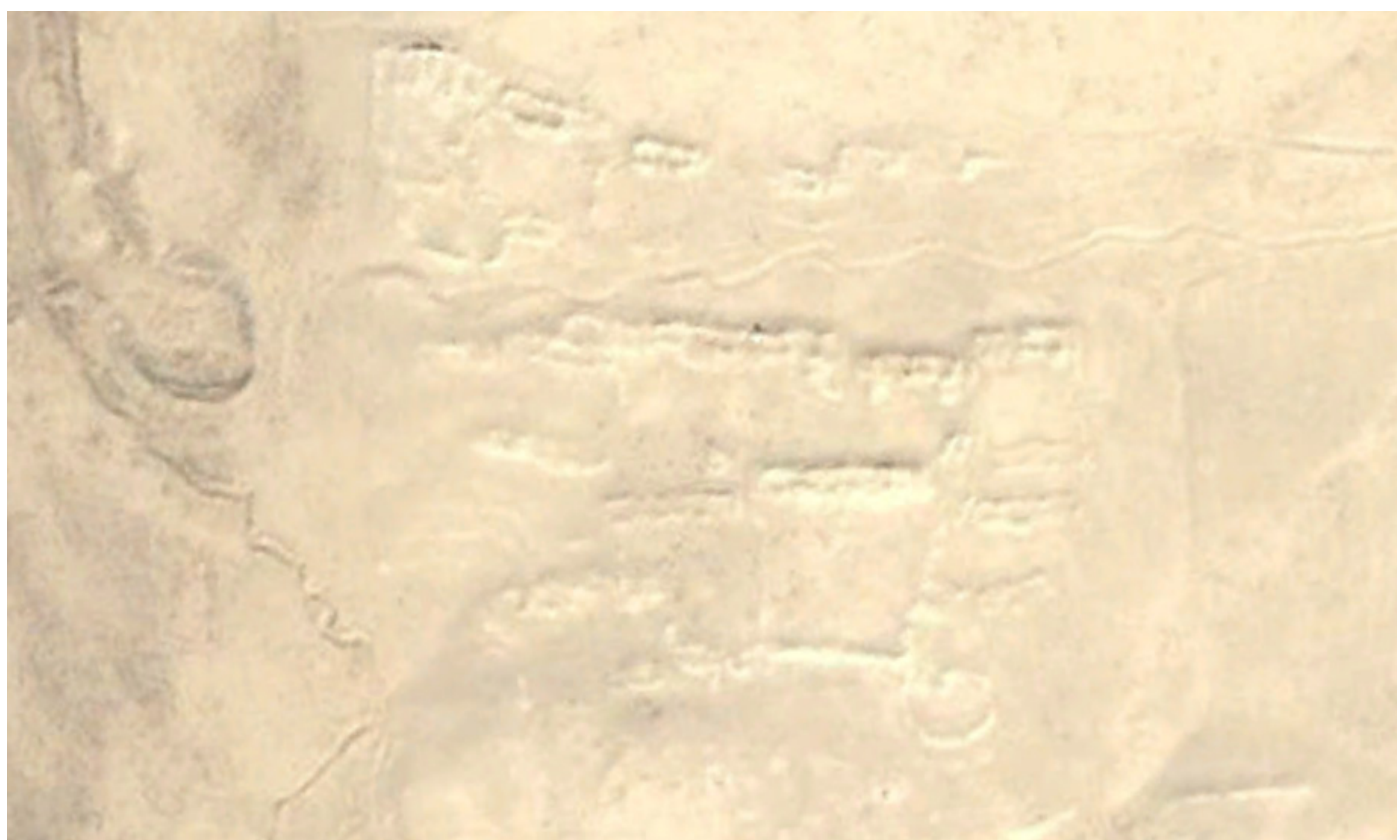
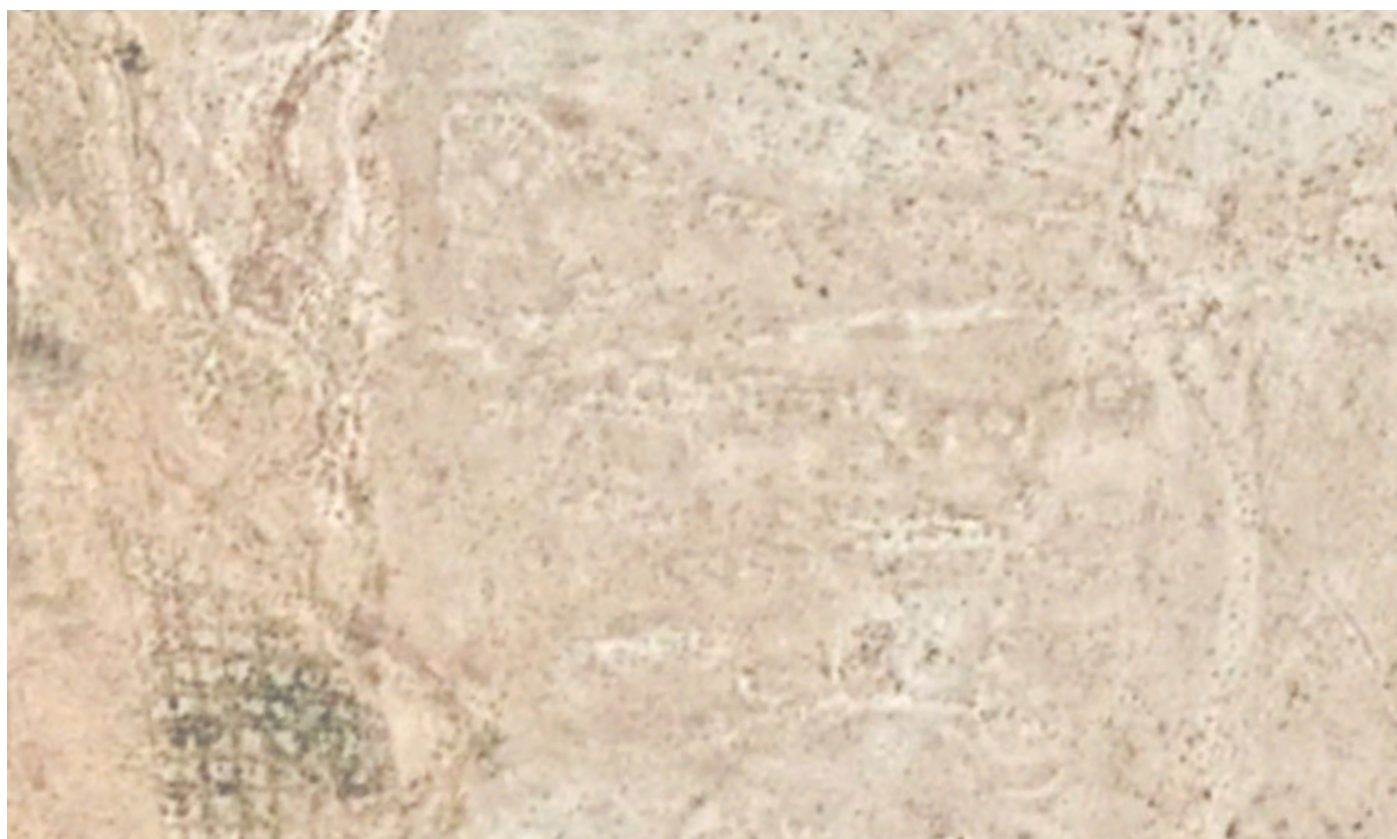
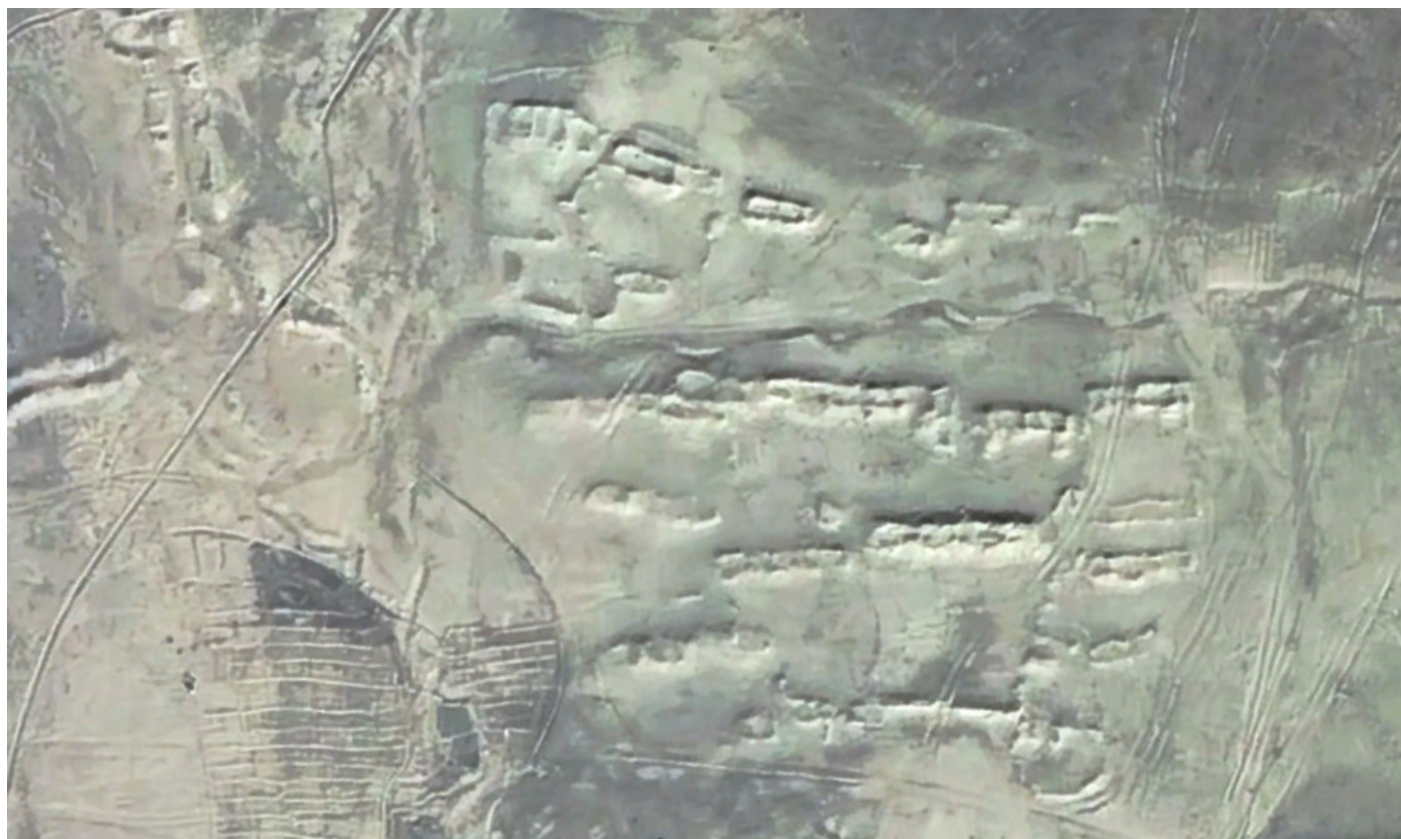
NO1 31°32'14.42"N; 65°10'29.88"E

The site is located in a non agricultural area. It is a multi structure complex distinguishable as of 2004 suggesting the presence of small settlements. There is little evidence suggesting looting or transformation.

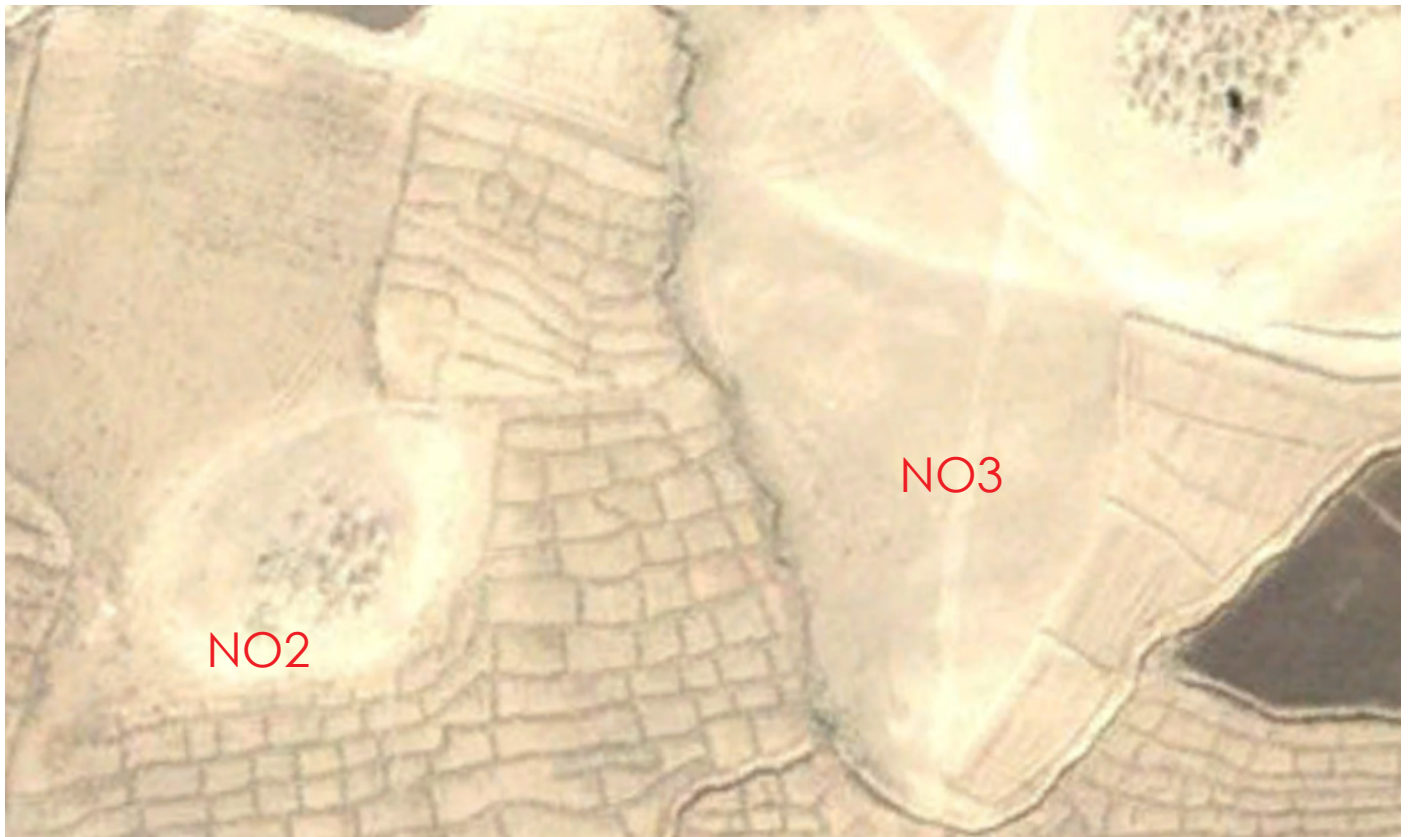
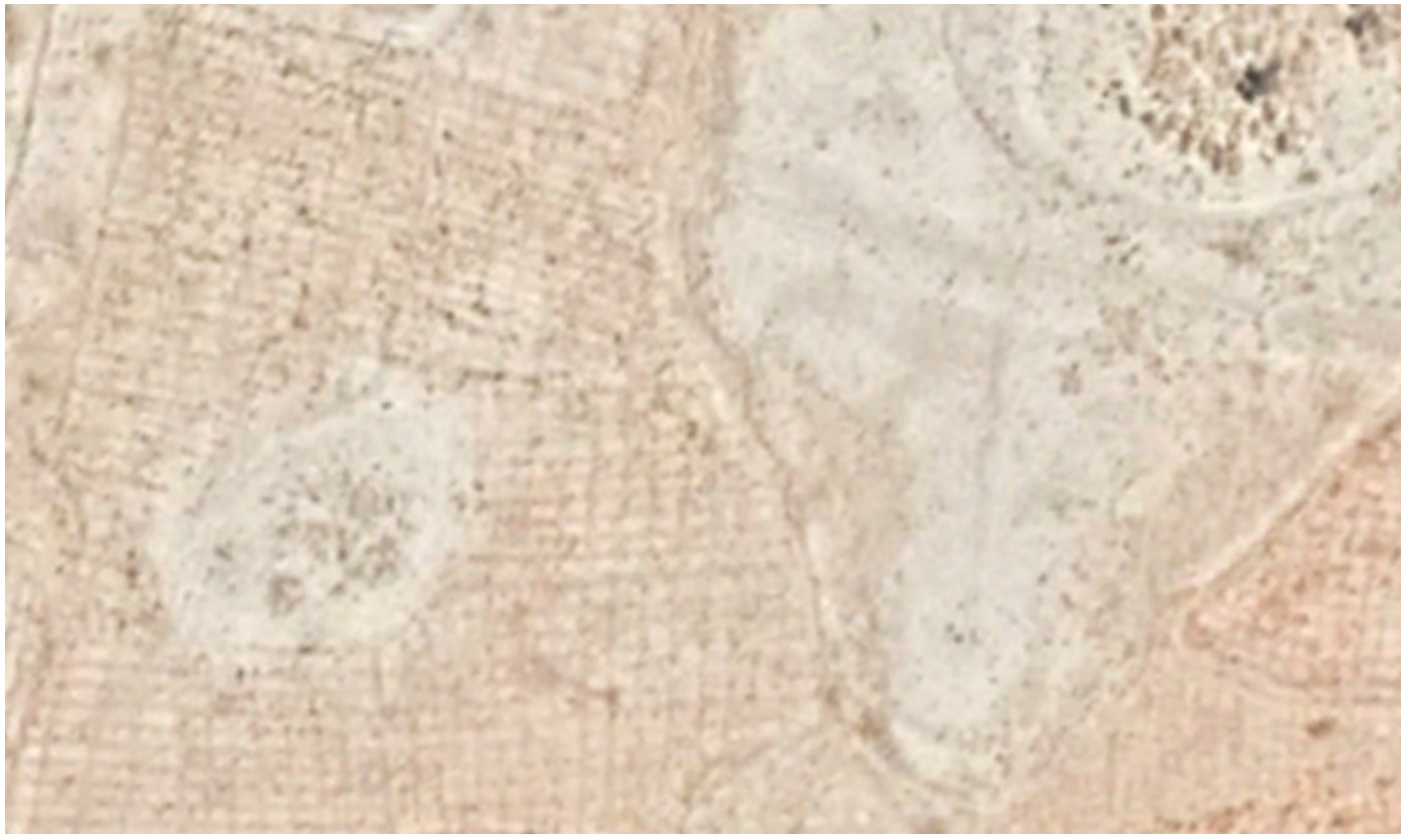
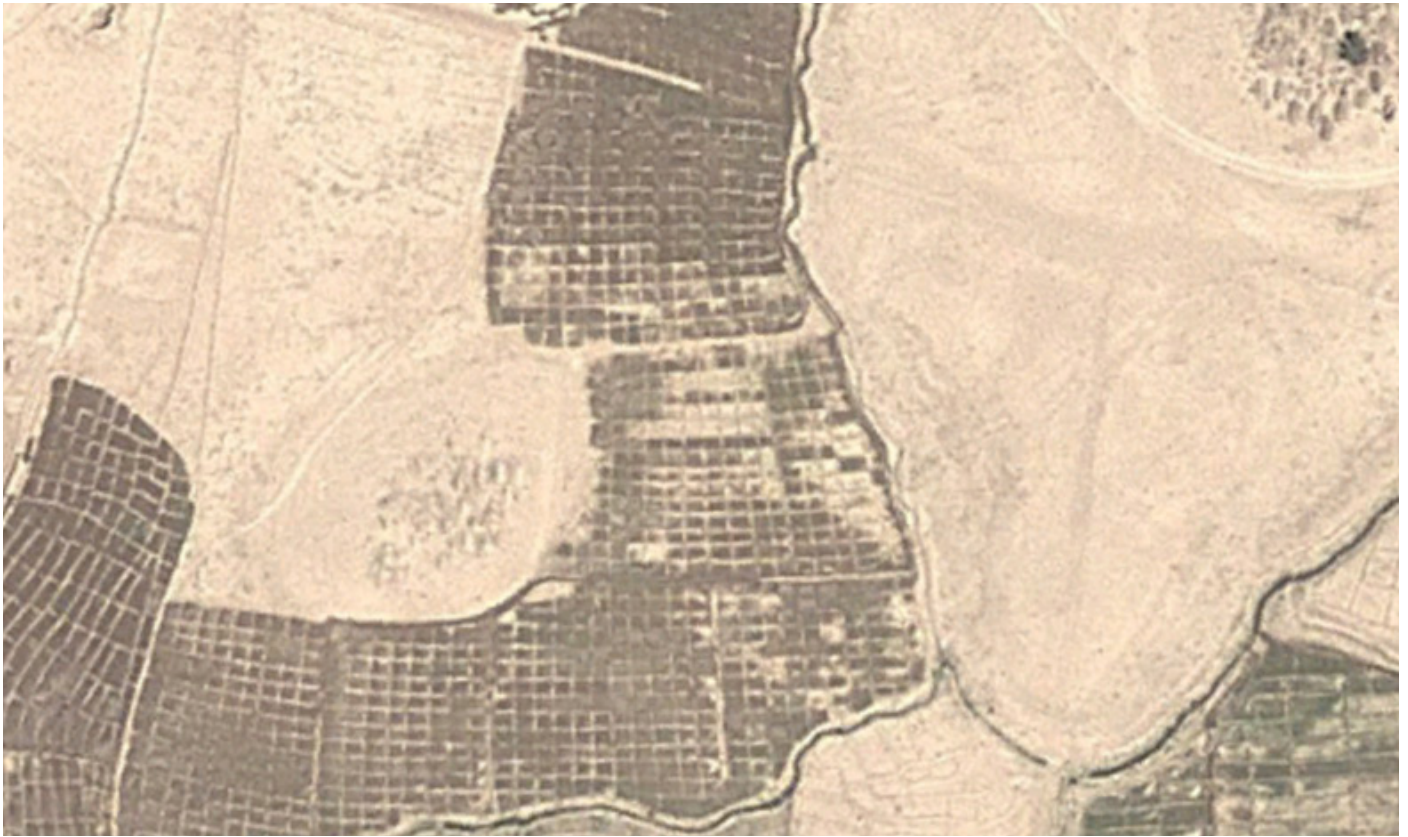
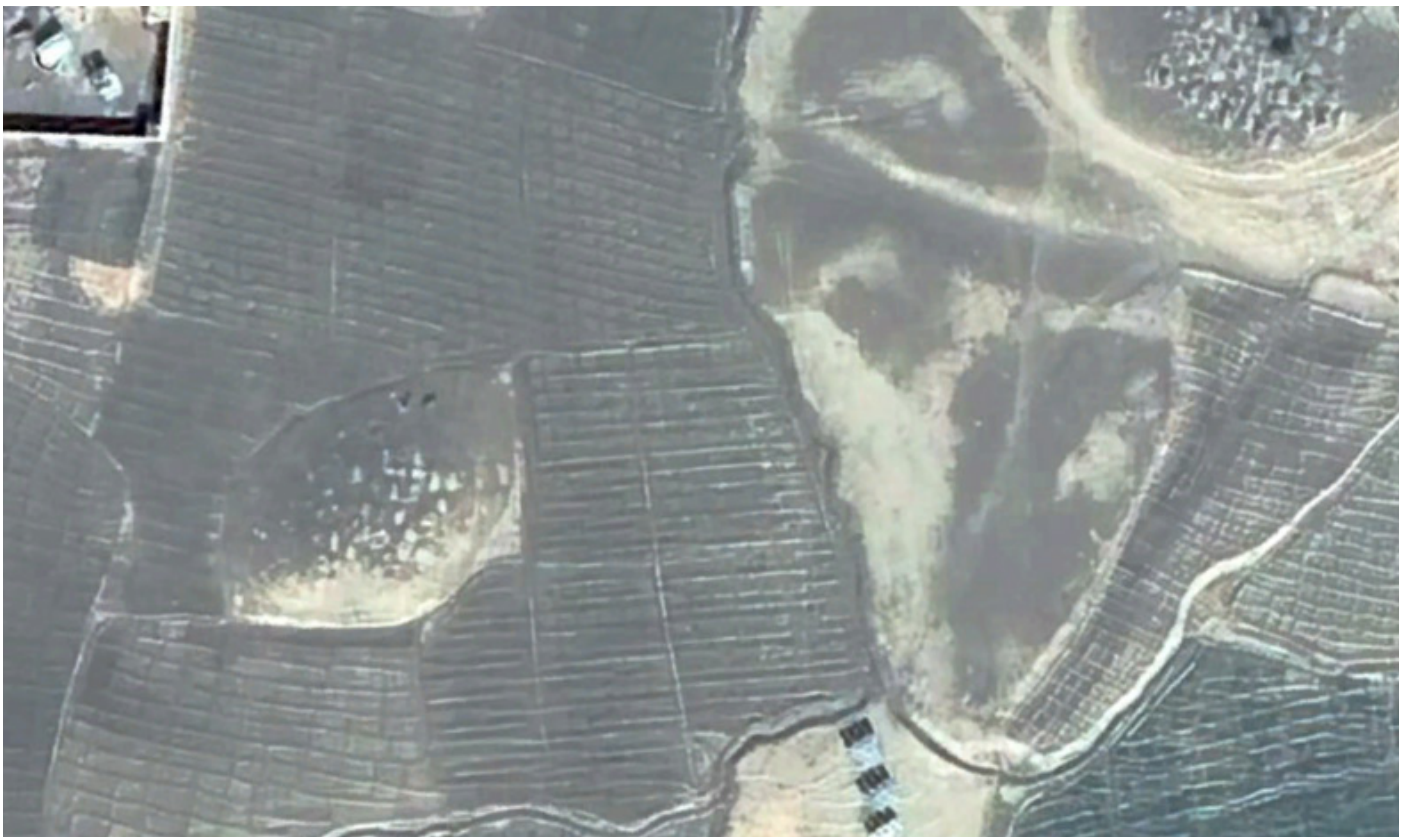
NO2	31°31'54.86"N; 65°10'9.47"E
NO3	31°31'54.15"N; 65°10'5.56"E
TYPOLOGY	Mound/Tepe + Unknown
AREA (2022)	1326m <sup>2</sup> + 5204m <sup>2</sup>
TYPOLOGY	1005m + 905m

The two sites are located in an agricultural area, with one mound and one undefined area. Small traces of activity can be seen as early as 2004 for the mound. There is little evidence suggesting looting or transformation.

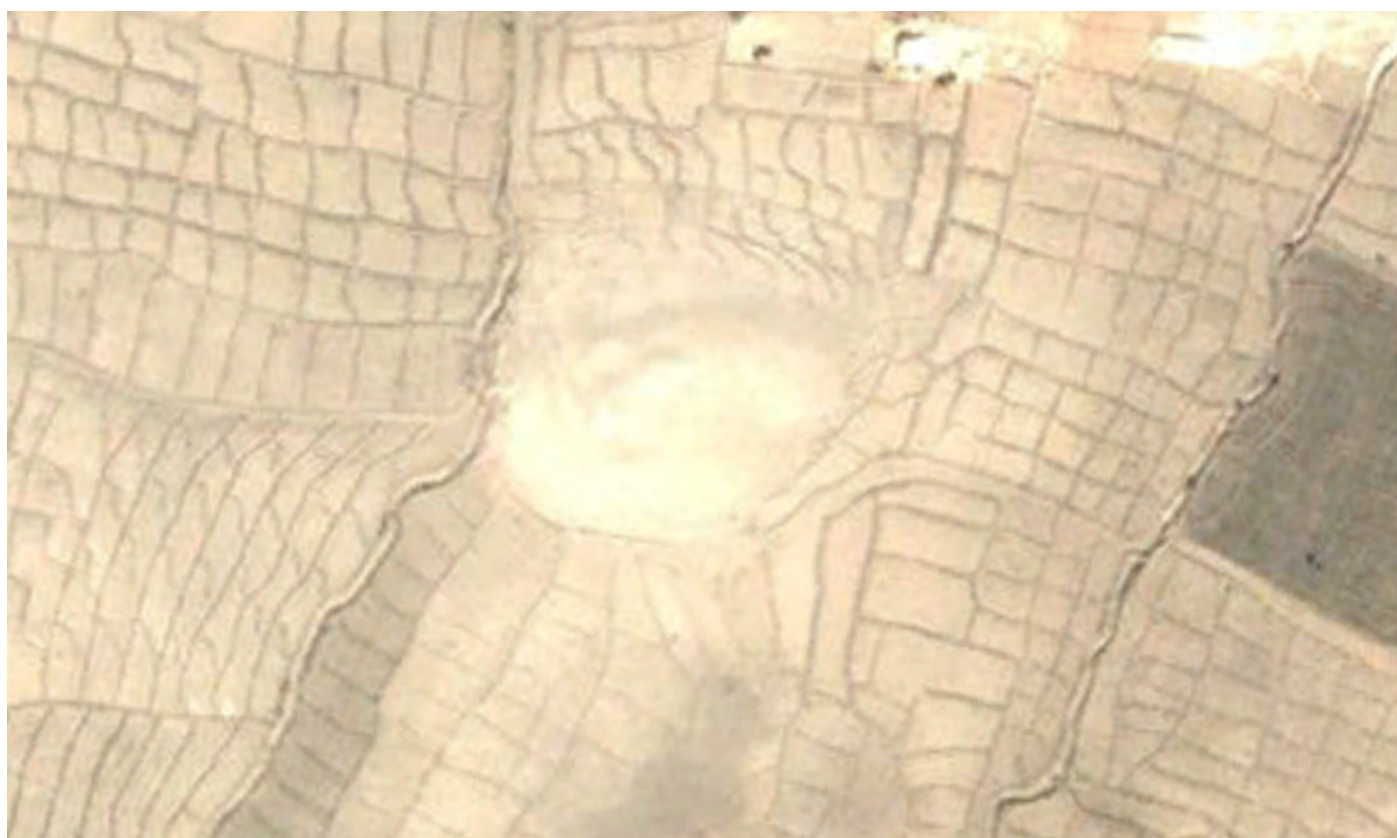
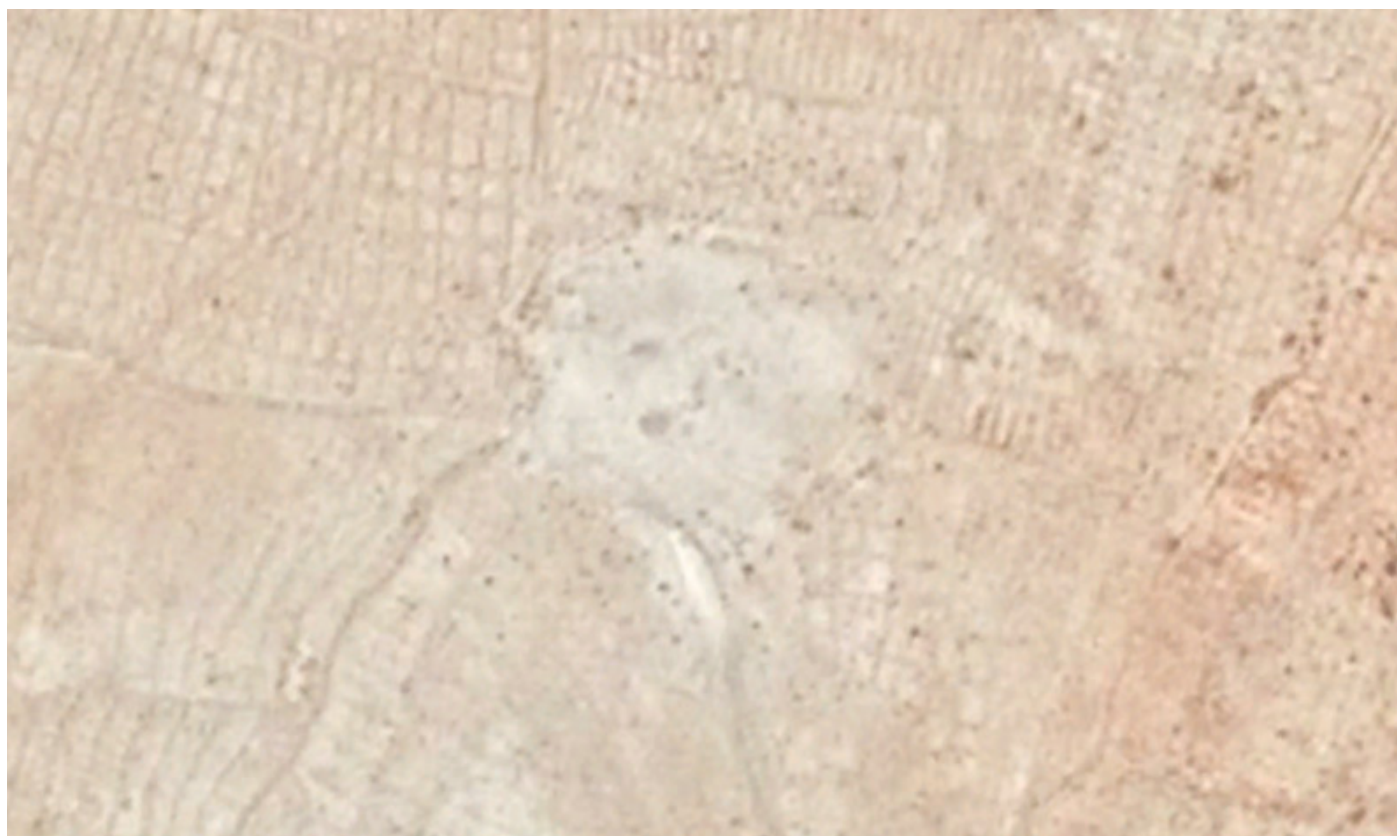
NO4 31°31'47.22''N; 65°10'2.36''E

The site is located in an agricultural area. There are no apparent structures showing. In 2012, we can observe subtle traces of pits in the southern and south-eastern parts of the site. In 2022, faint vehicle tracks can be seen across the mound. There is little evidence suggesting looting or transformation to the site.

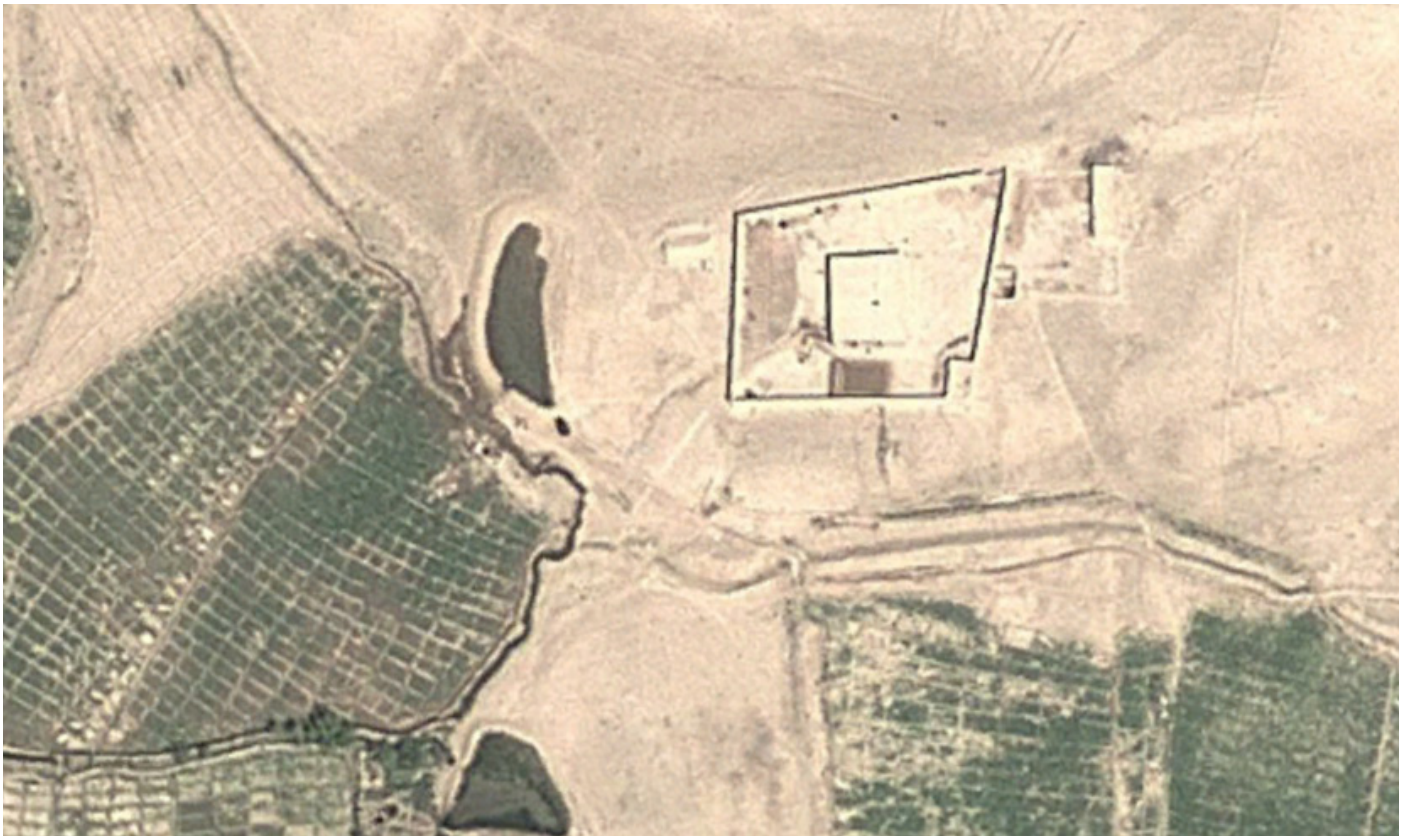
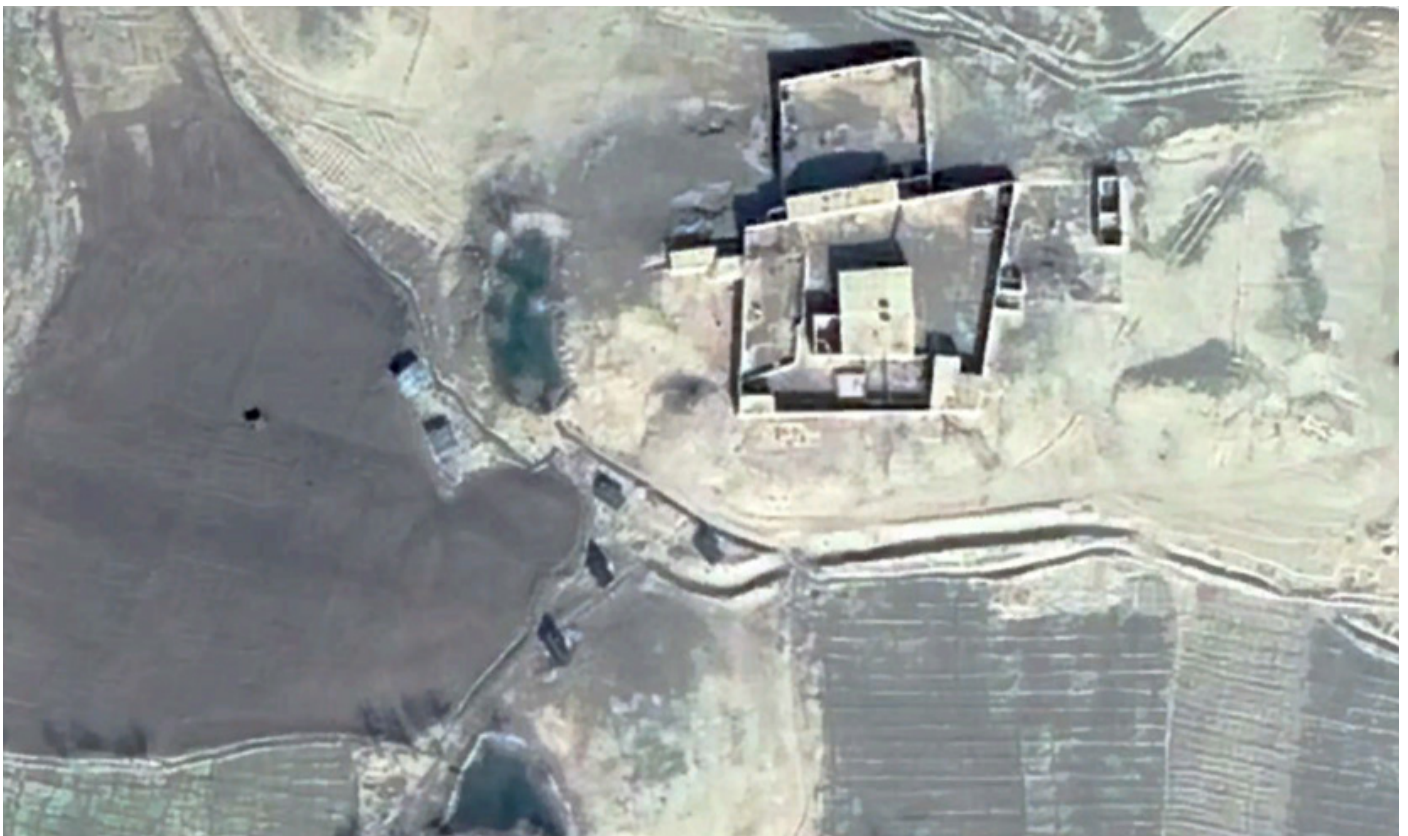
NO5 31°32'11.23''N; 65°10'4.56''E

The site is located in an agricultural area. Remains of a rectangular structure can be identified in 2004, with what appears to be an enclosure expanding to the east. As of 2012, a contemporary structure can be seen, expanding until 2022. A small mound can also be seen east of the structure. There is little evidence supporting looting of the area.
