HERITAGE  
WATCH.AI

IMPACT OF TAPI PIPELINE PROJECT ON  
ARCHAEOLOGICAL SITES IN AFGHANISTAN

2 0 2 3

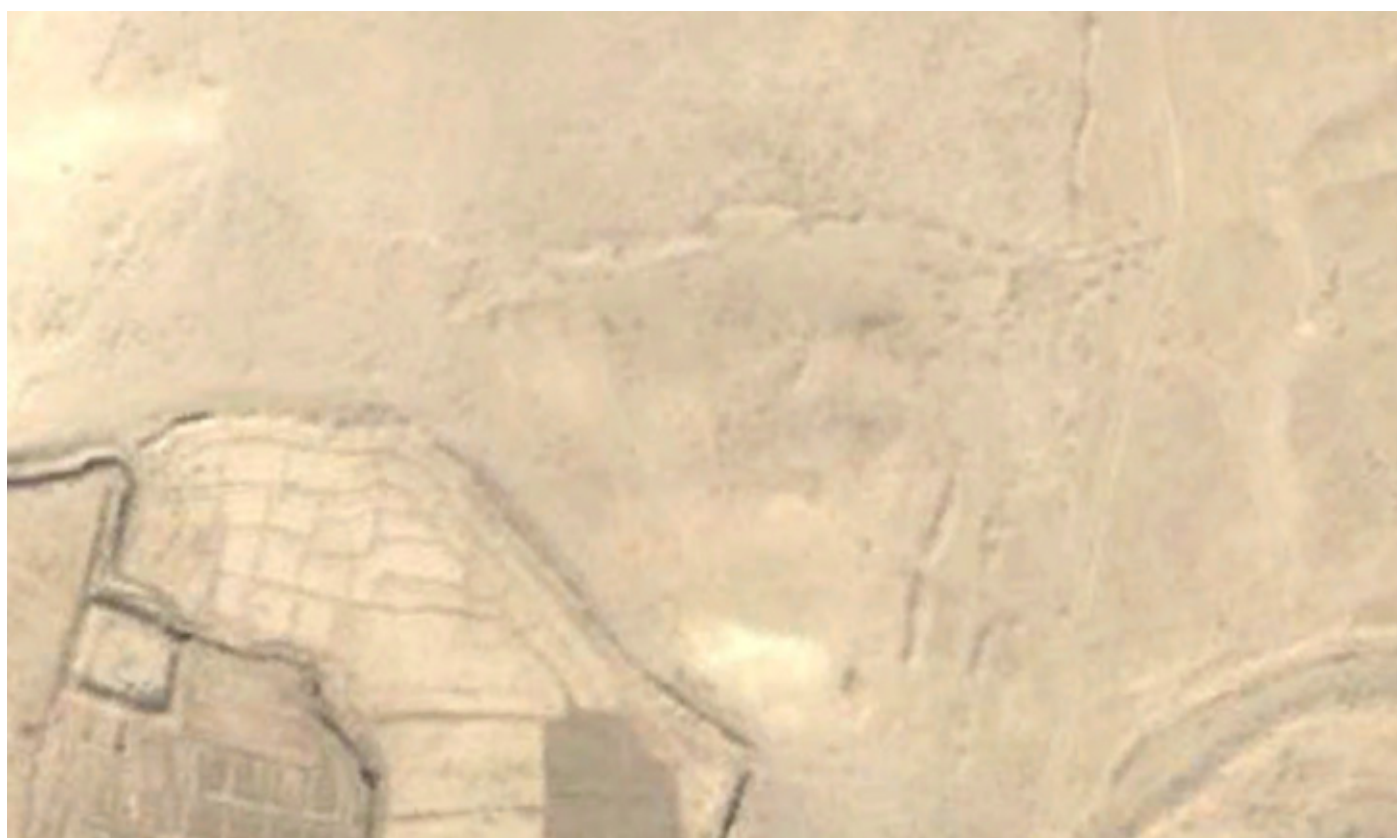
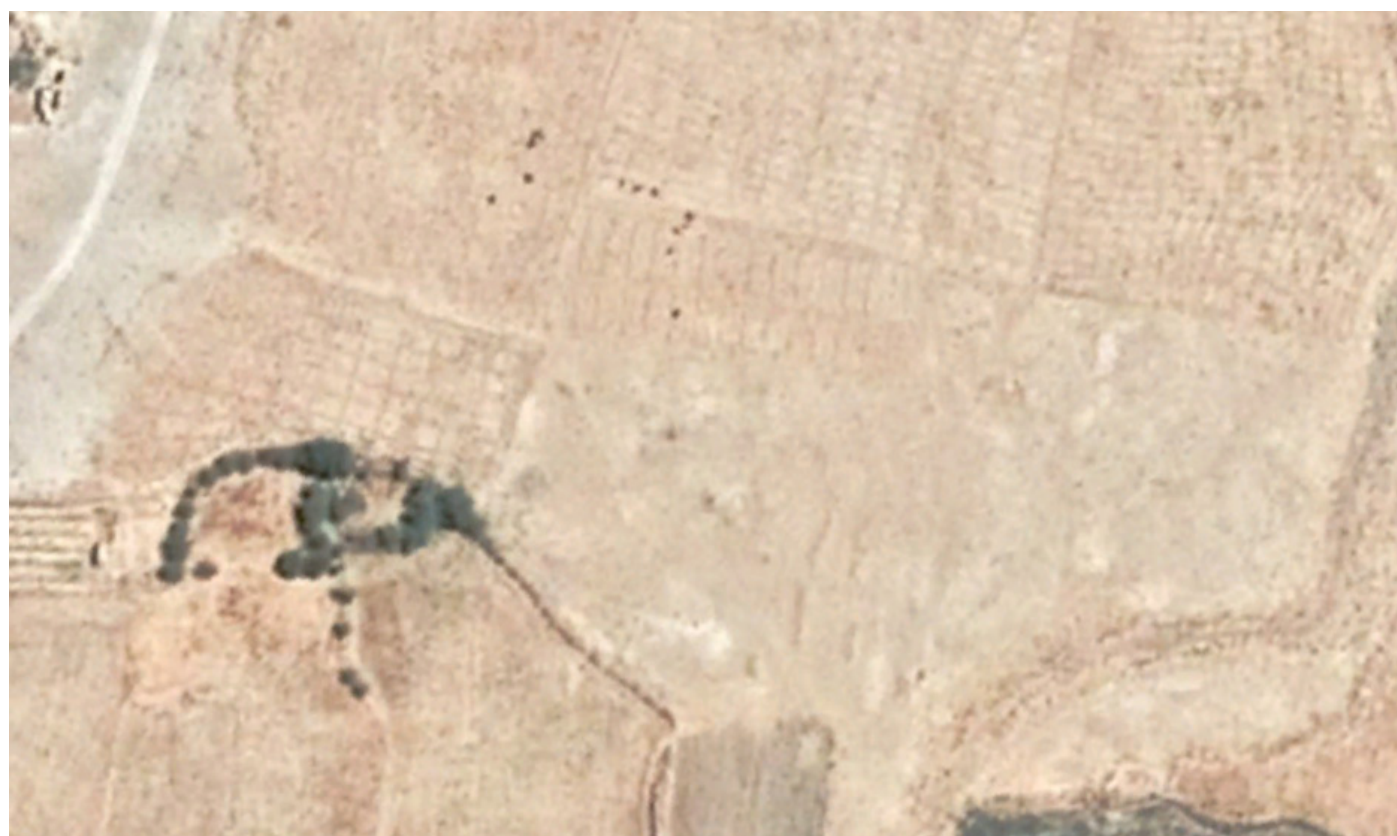
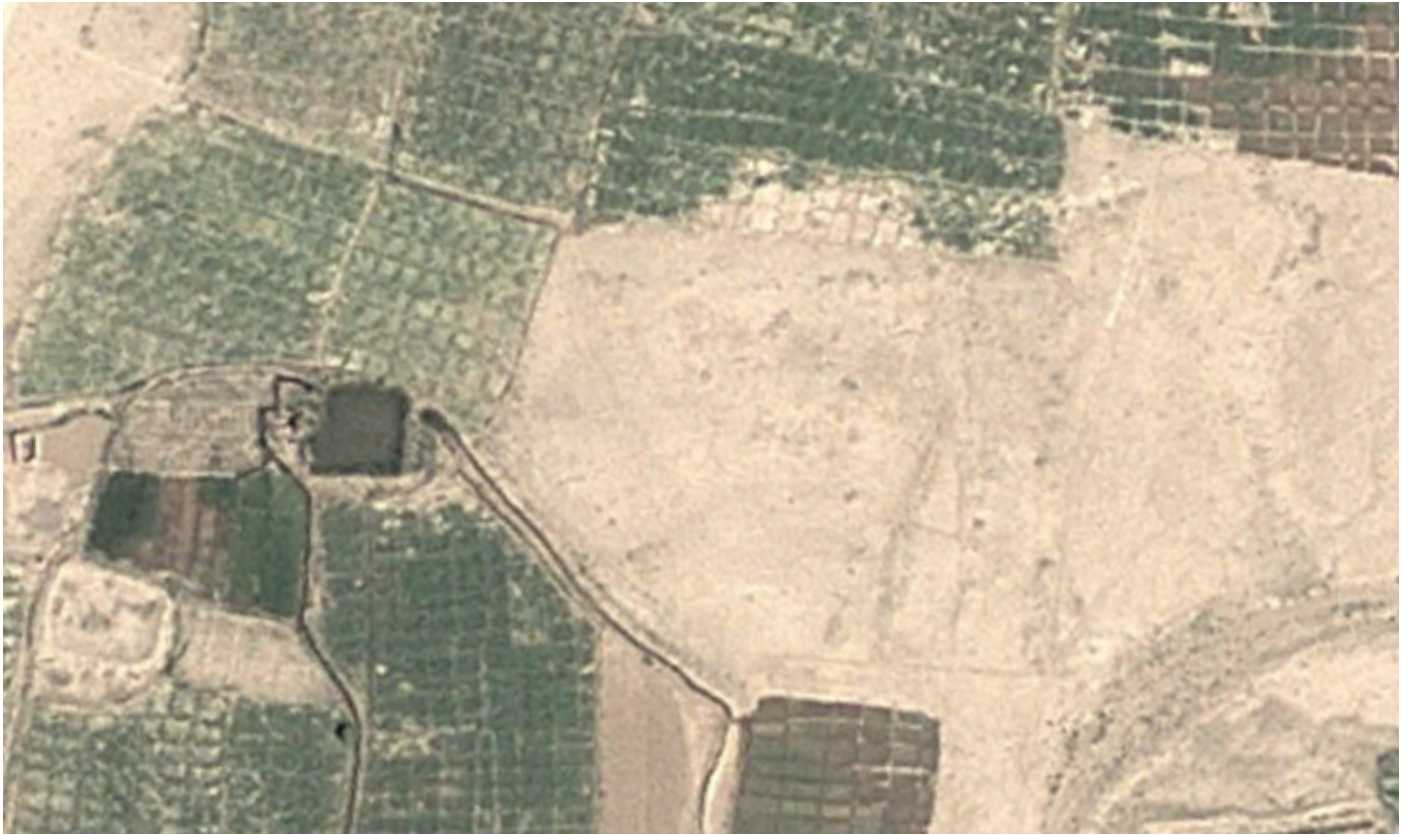
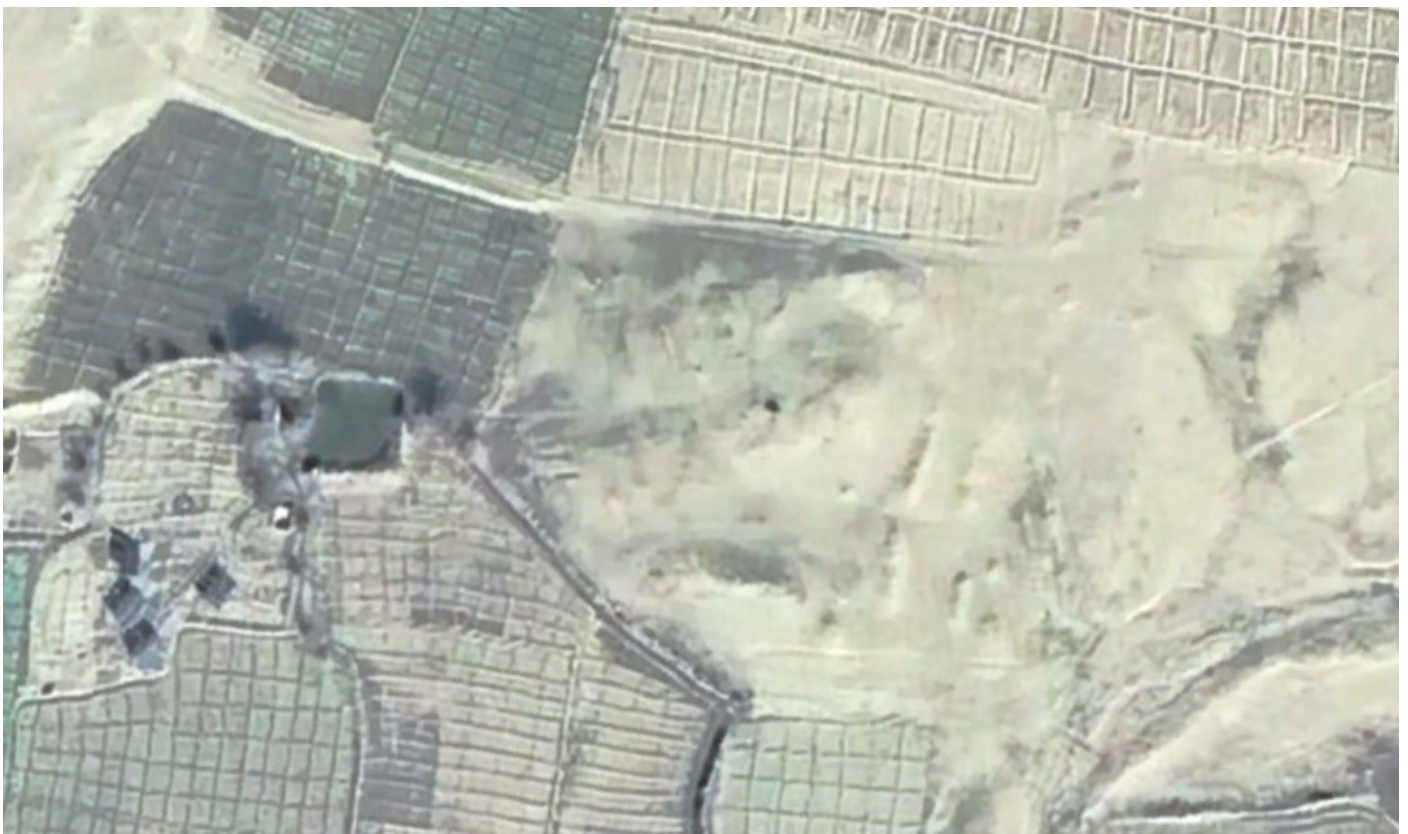
The site is located in an agricultural area. We can observe the presence of an irrigation system south east of the site. It is composed of several mounds. There is little evidence of looting or transformation to the site.

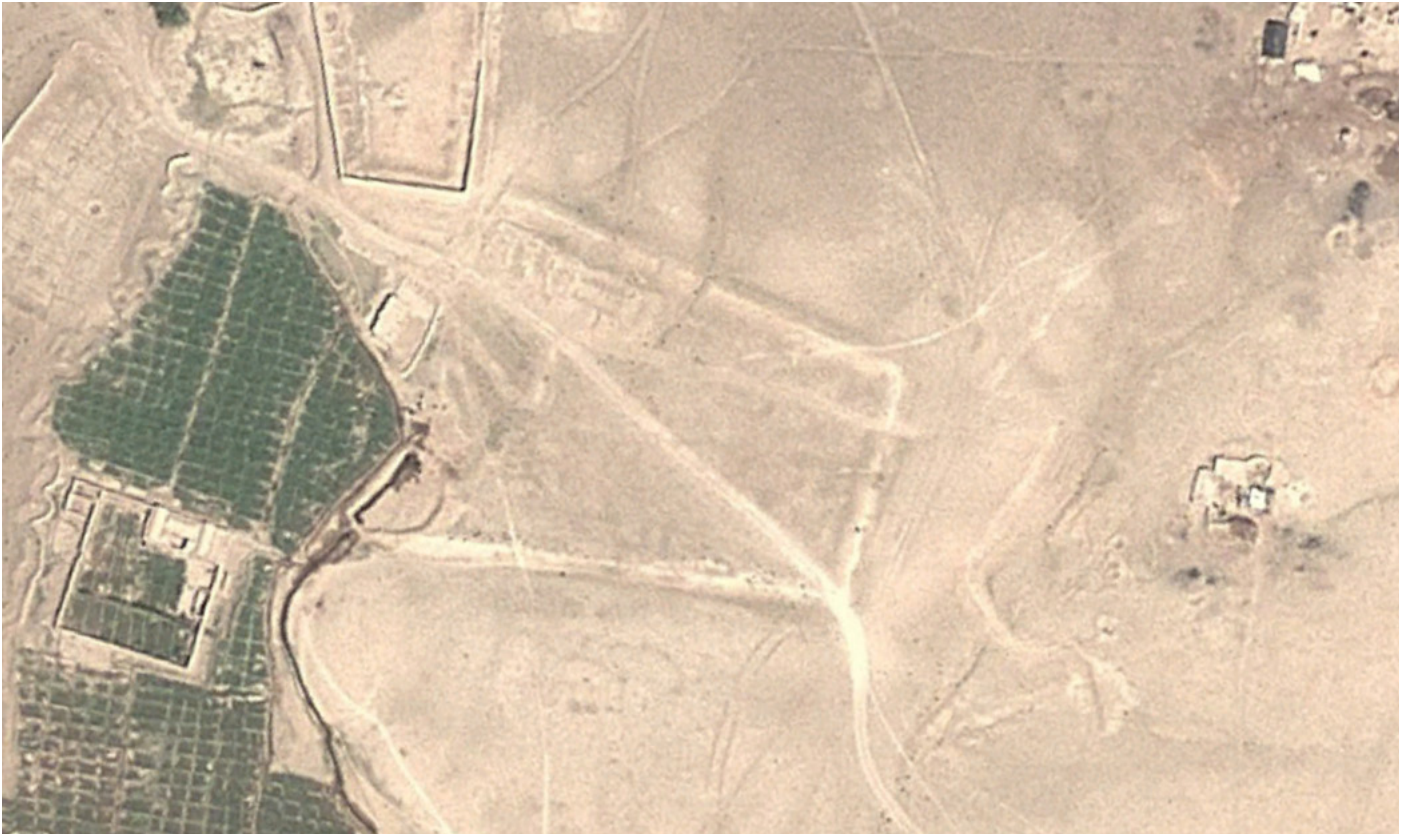
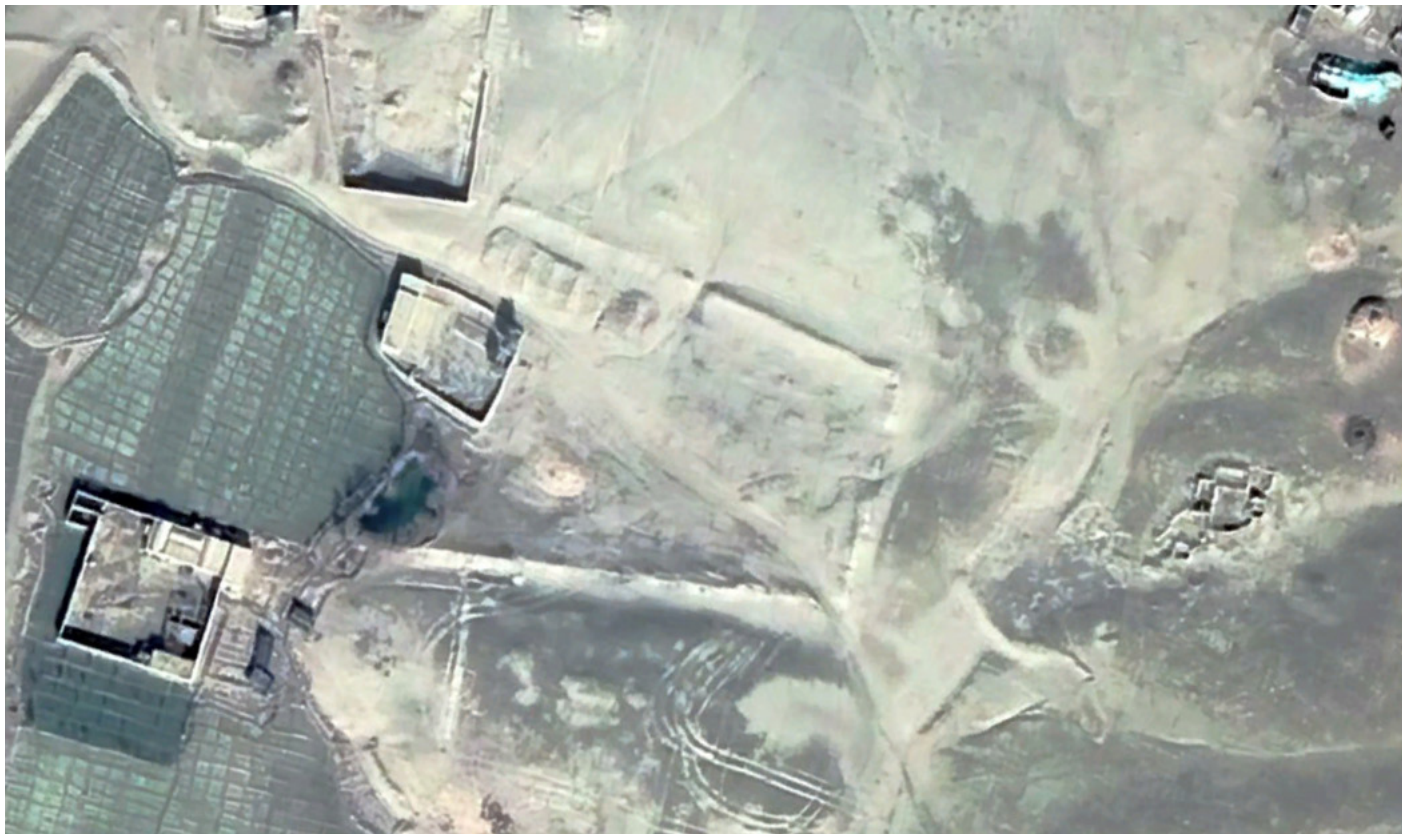
NO7 31°32'20.77''N; 65° 9'48.76''E

The site is located in proximity to agricultural land. It has an irregular rectangle shape. In 2004, we can observe a smaller site with manual excavation pits as well as lighter areas suggesting the existence of unexcavated ruins. In 2012, vehicle tracks are more defined, passing through the main site, the smaller site now bears a enclosure on the previously excavated ruins. There are no traces of heavy looting or transformation to the site.

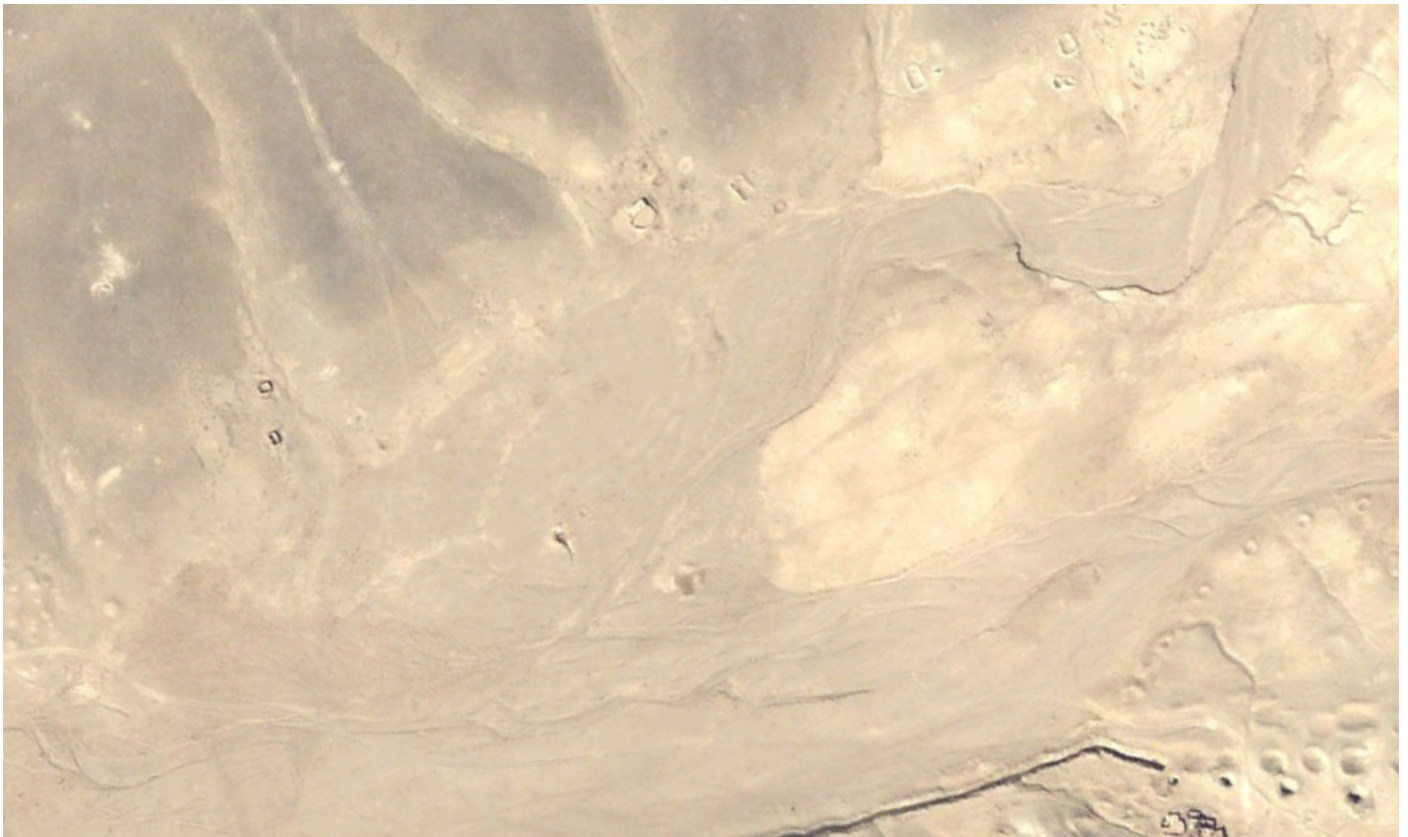
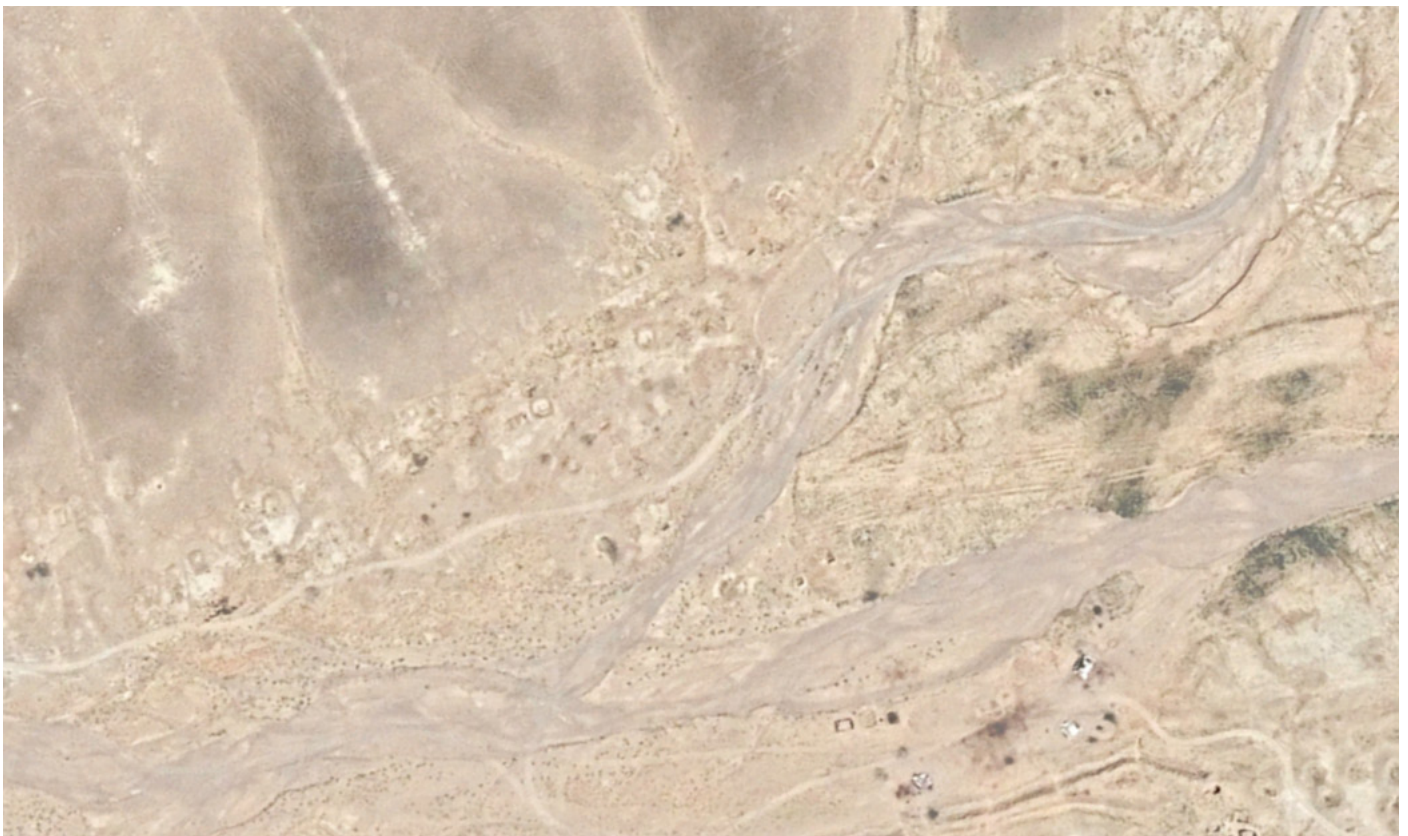
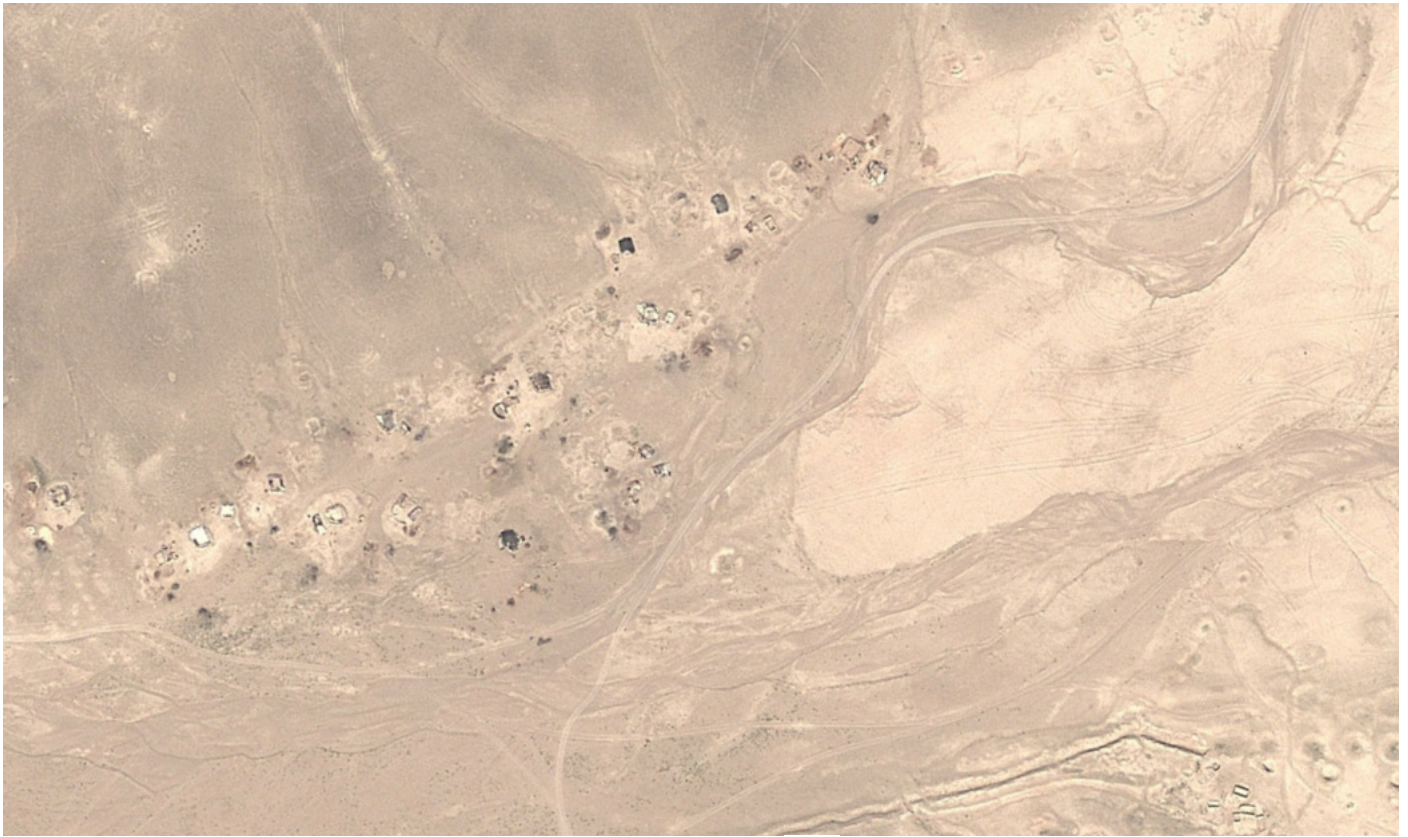
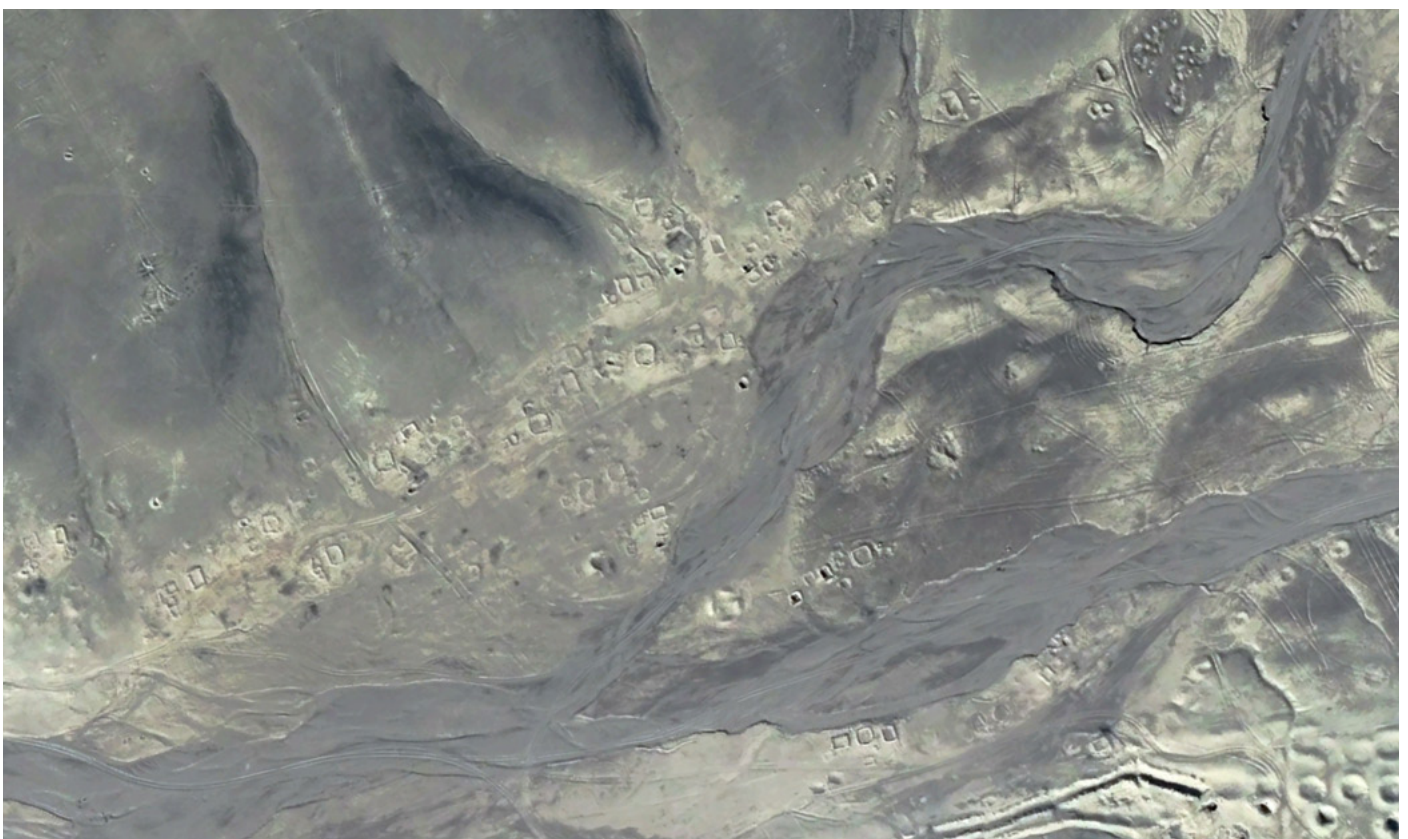
NO8 31°32'25.60''N; 65° 9'36.07''E

The site is located in proximity to a large watercourse, it extends over a large area and is composed of several small rectangular structures implying the presence of settlements. In 2012, the site appears to be inhabited. It is unclear to which extent the site has been looted.

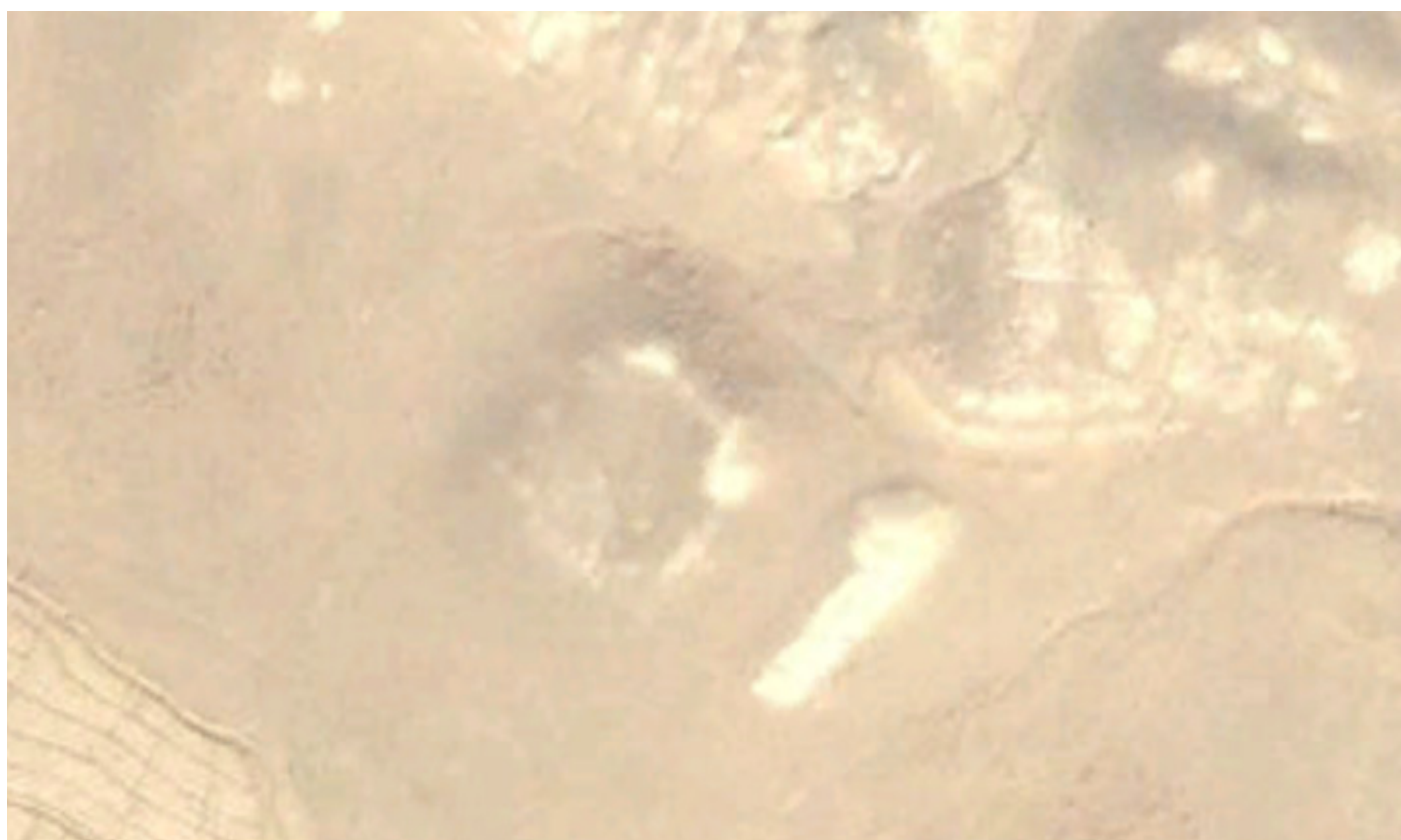
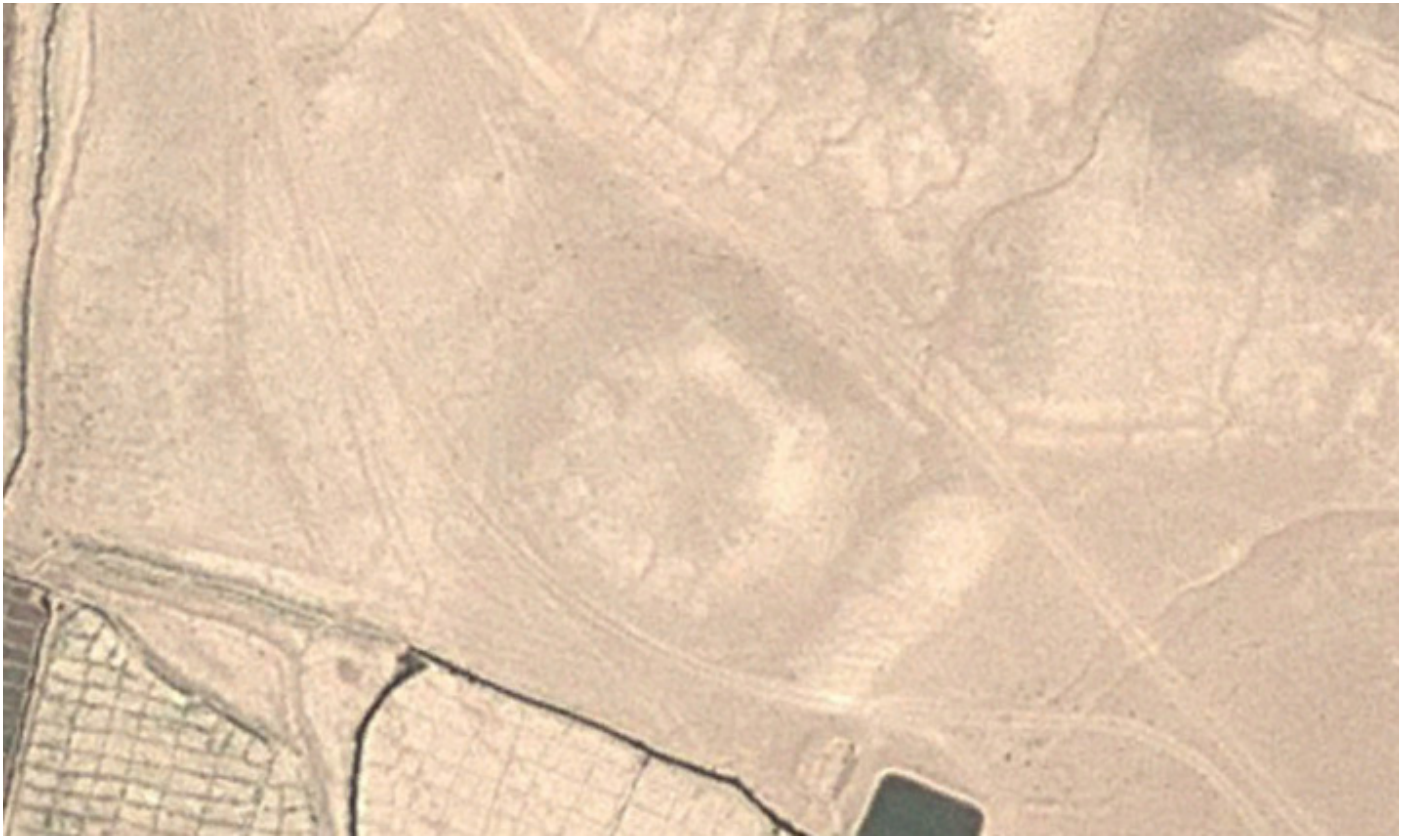
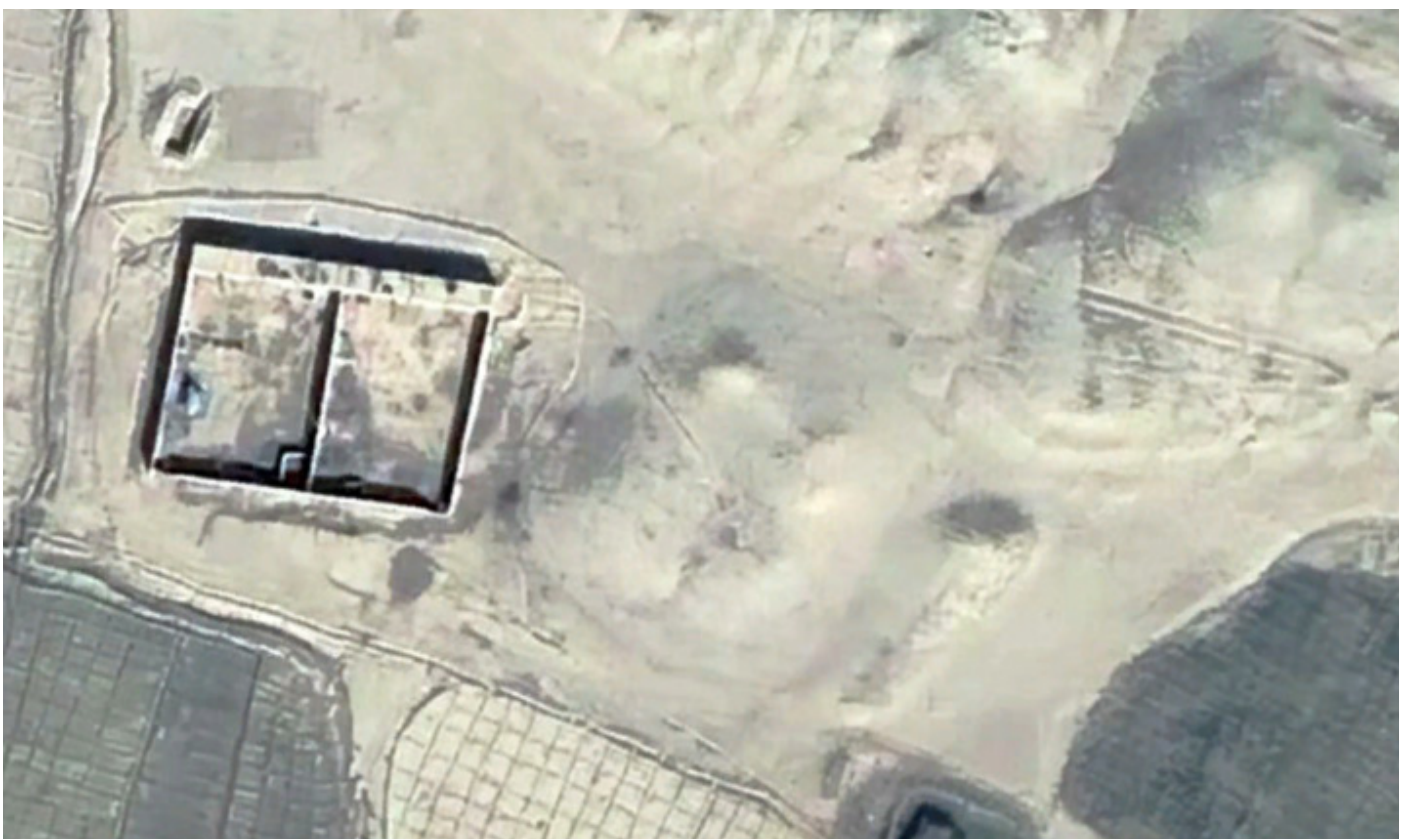
NO9 31°32'22.16"N; 65° 9'5.66"E

The site is located in proximity to agricultural land. In 2004, we can observe an unexcavated rectangular shaped structure alongside a longitudinal mound. By 2019, an enclosed structure appears very close to the site and an undetermined pit can be seen north west of the structure. Faint traces of vehicle tracks can also be observed as early as 2012. There is little evidence of looting or transformation of the site.

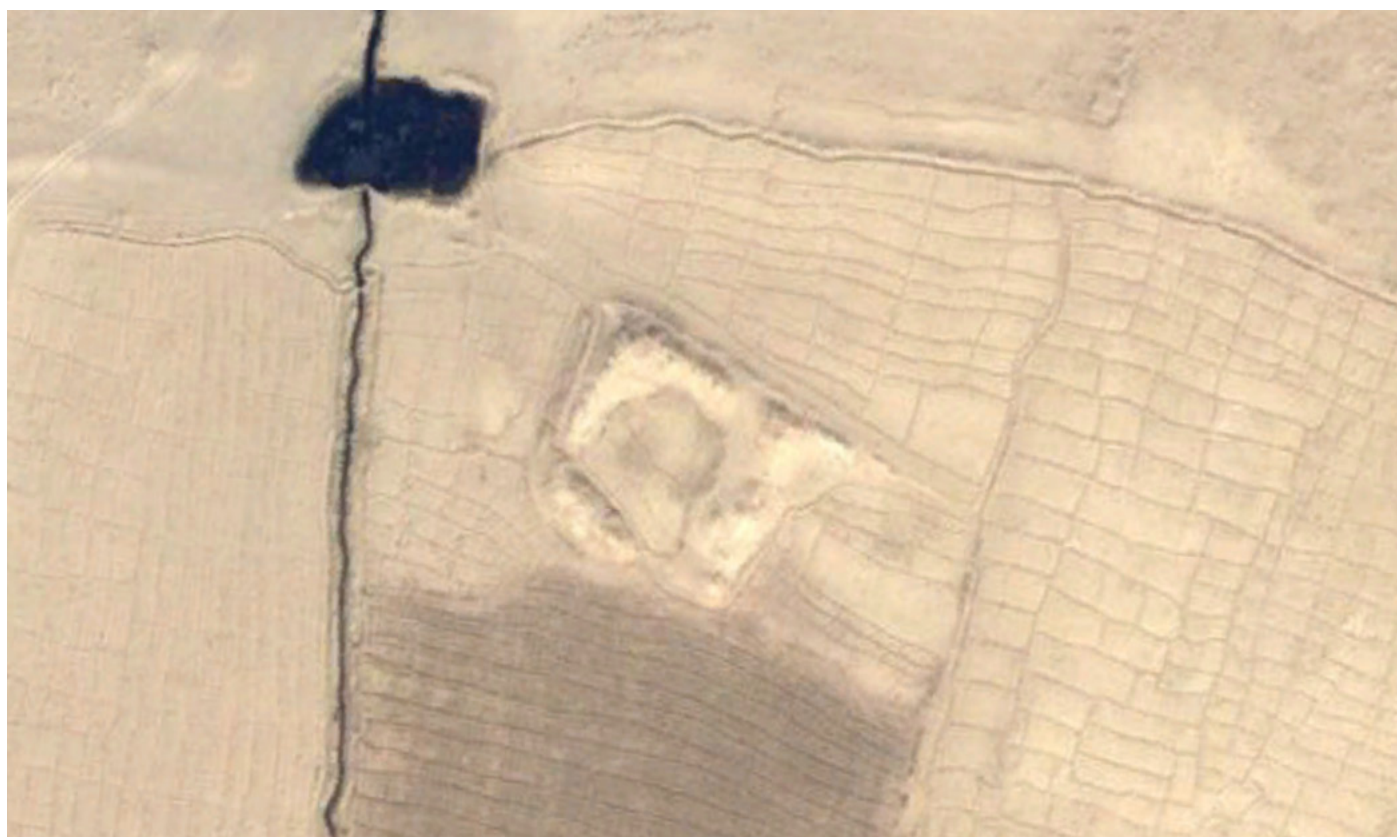
2004

The site is located in the middle of agricultural fields, in proximity to a small body of water. It has an irregular rerectangle shape with a lowered central portion which appears to have been transformed into a small field in 2019. By 2022, we can observe traces of mechanic excavations in the elevated parts of the site.

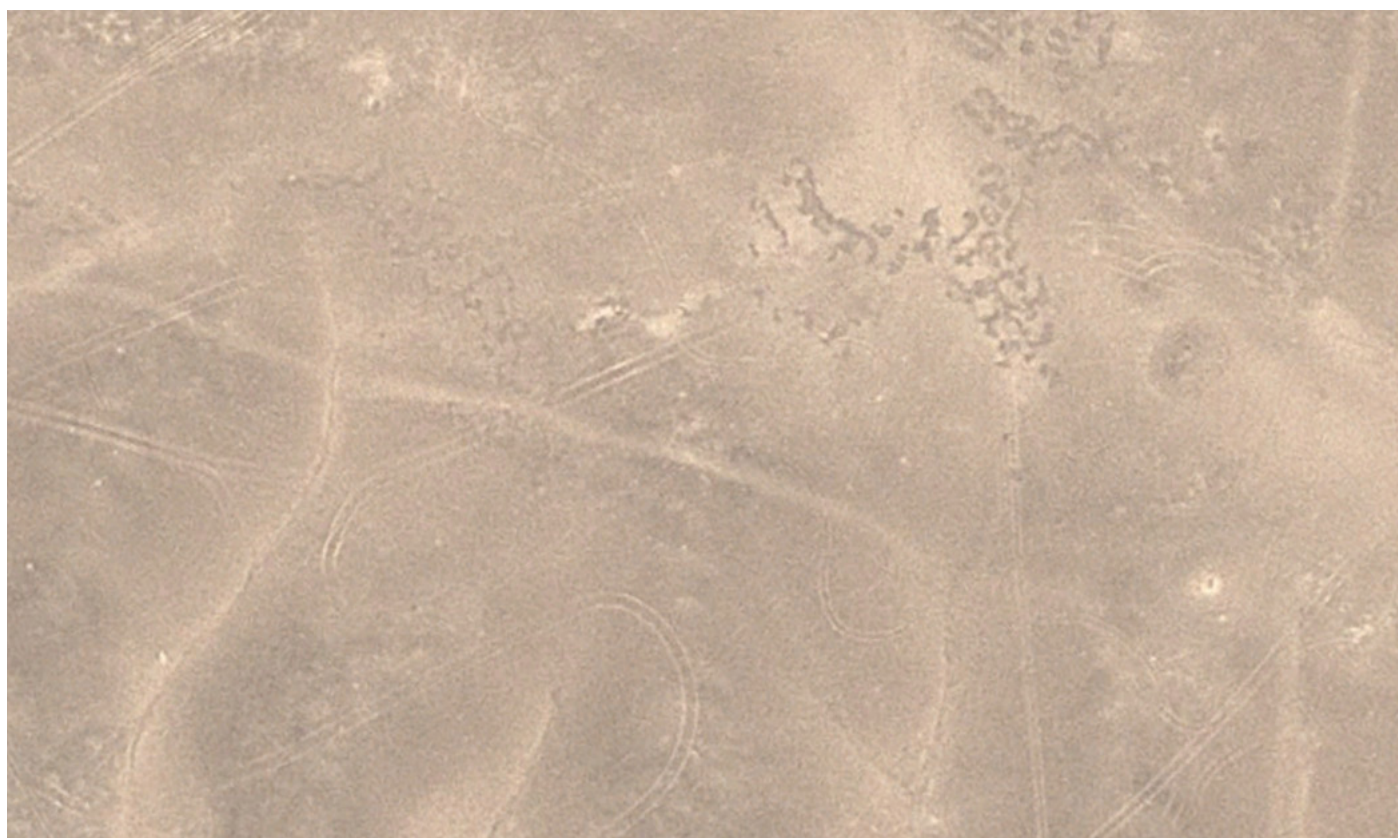
2004

The site is located less than 50 meters from the centreline of the pipeline. Up until 2019, the site does not appear to have been excavated, but by 2022 traces of manual and mechanic excavation can be clearly observed. It is not clear whether this site is ancient with a contemporary construction.
