IMPACT OF FLOODING ON THE LIBYAN HERITAGE

2 0 2 3

INTRODUCTION

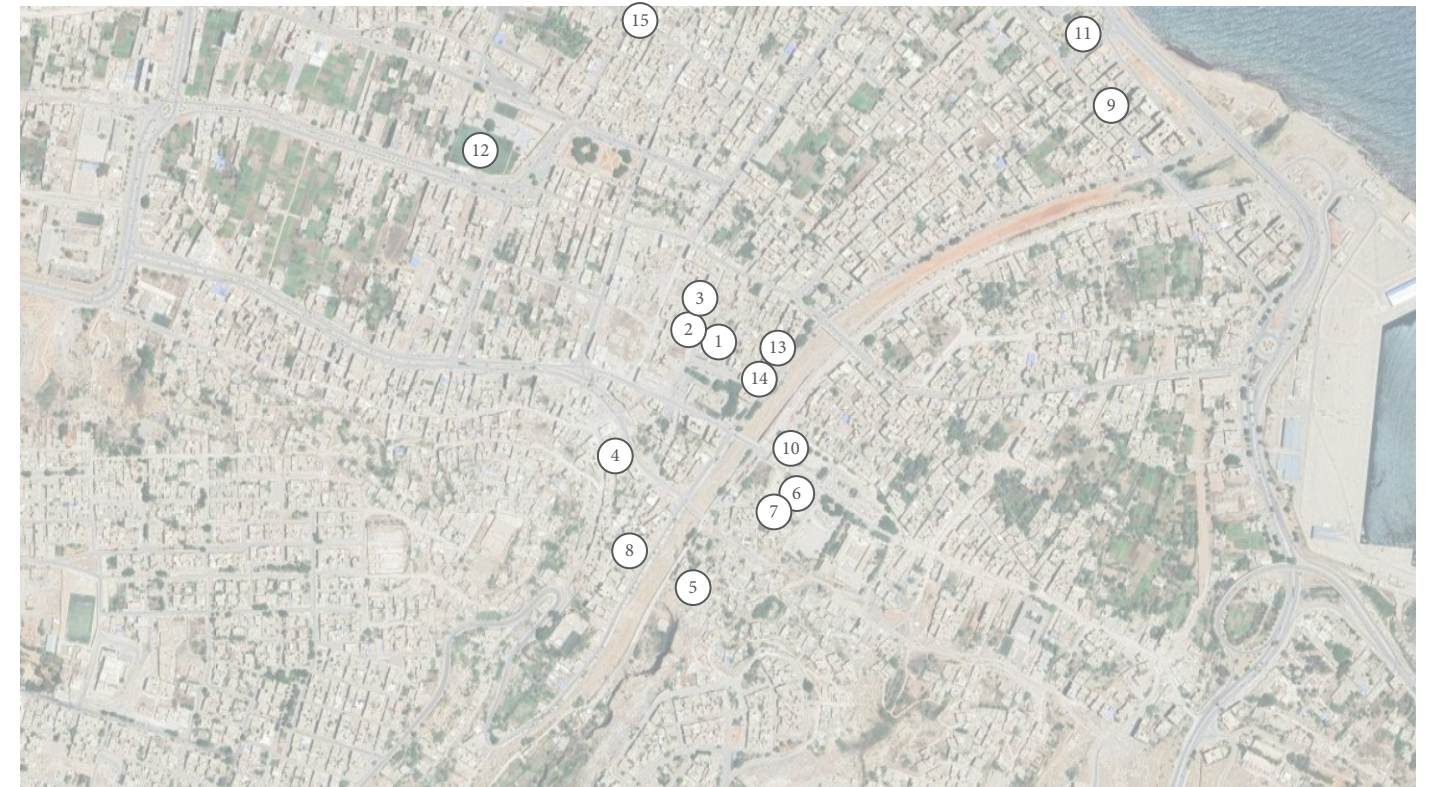
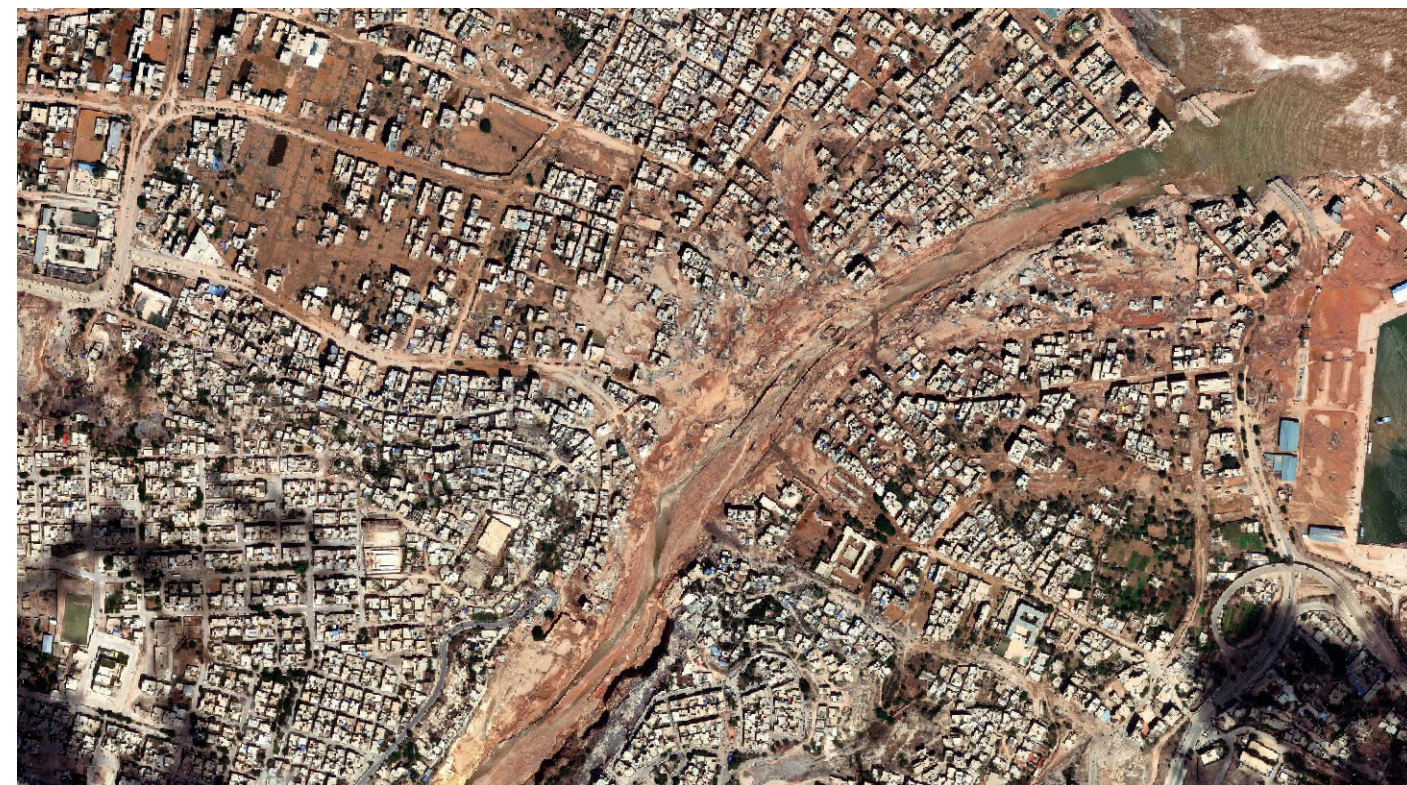
Derna - 13.09.2023, Maxar

- ① Al Atiq mosque
- ② Souk al Zalam
- ③ Piazza al Hamra
- ④ Al Rachid mosque
- ⑤ Al Senussia/ Al Zawiya mosque
- ⑥ Al Sahaba mosque
- ⑦ Shrine of Sahabi
- ⑧ Al Jaraba mosque
- ⑨ Al Fath mosque
- ⑩ Star café
- ⑪ King Idris Library
- ⑫ Darnis sports club
- ⑬ Derna Cultural centre
- ⑭ Mausoleum of Sidi Ali Al-Washish
- ⑮ Zawiya al Rifaiya
- ⓧ unidentified sites

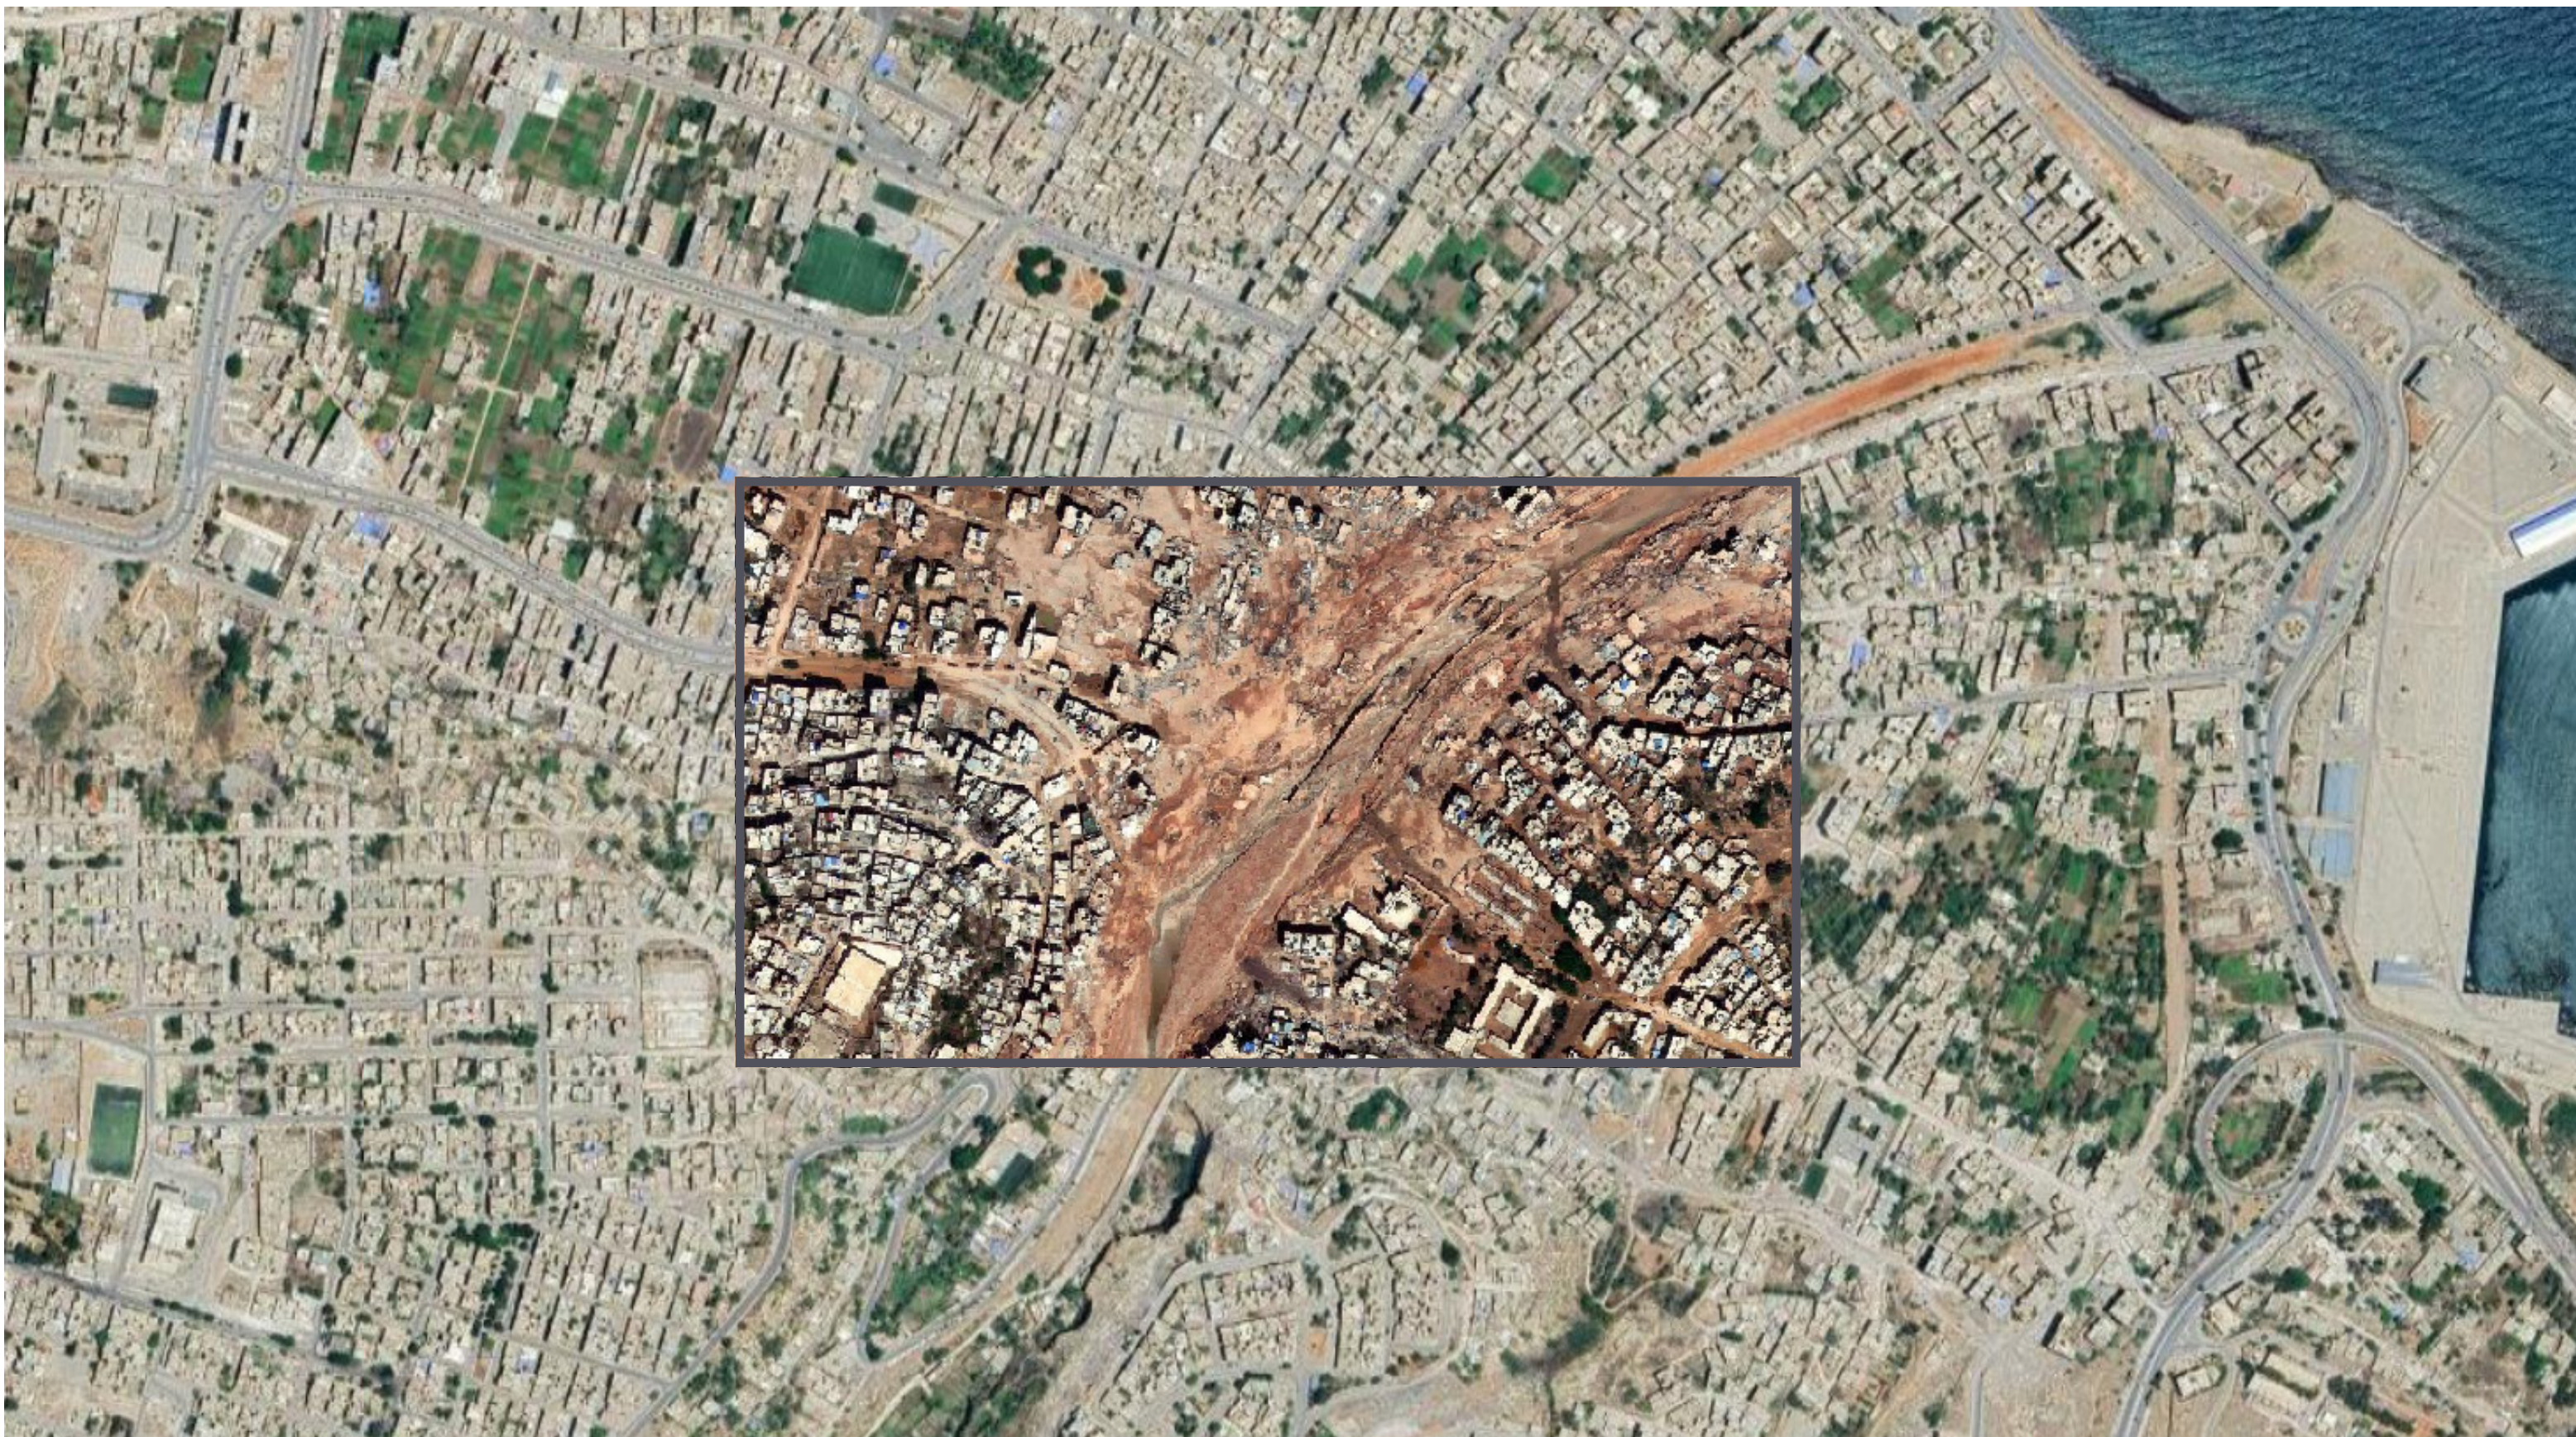
DERNA AL ATIQ MOSQUE

Date of construction 1670
 Current state 100% Destroyed
 Function Mosque

The Al Atiq mosque was built in 1670 during the Ottoman rule. The roof is typical of Ottoman architecture with 42 domes - the mosque is also called the mosque of a hundred domes -. Its interior is composed of 30 marble columns of approximately 5 meters with slightly different capitals from other buildings. The plan is divided into seven corridors and six vertical naves. The minaret is 15 meters high and is also typical of the Ottoman style with a square pulpit, an octagonal shaft, and a conical spire. The Al Atiq mosque had just been renovated after it was damaged during the Libyan war. It has been completely wiped by the floods.

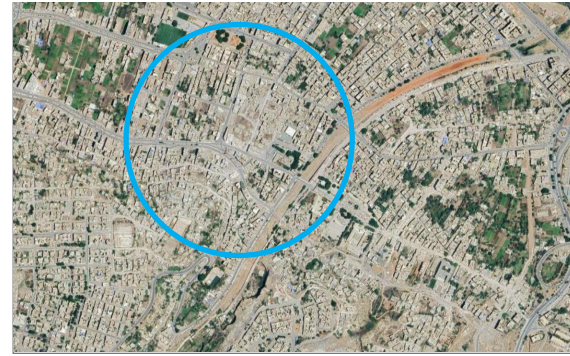
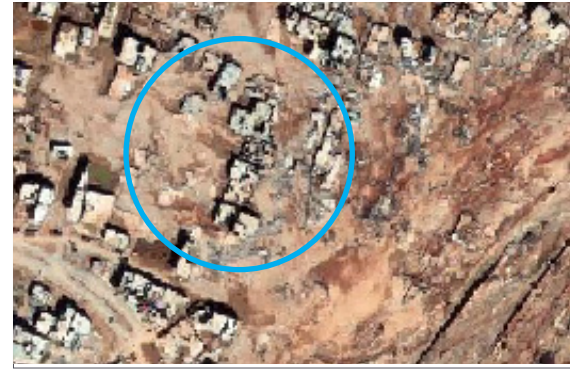
DERNA SOUK AL ZALAM

Date of construction XVII Century
 Current state 100% Destroyed
 Function Market

Souk Al Zalam is one of the oldest souks of Derna, the entrance is situated next to the Al Attiq mosque, one of the oldest souks in Derna dating back to the Ottoman rule, constructed in Andalusian style. It represented the artery of the city's economic and social life. Contained about 90 shops, and different branches and courtyards such as the trabelsi piazza. In 2022 began a restoration project for the souk which had been destroyed during the Libyan war.

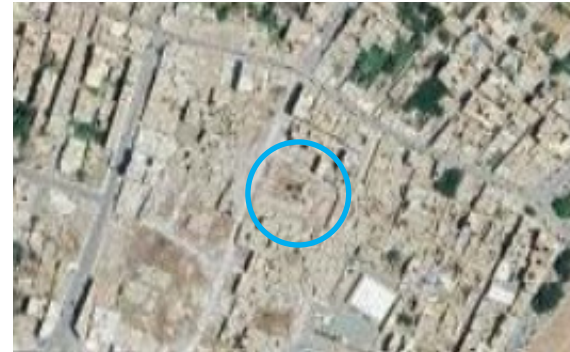
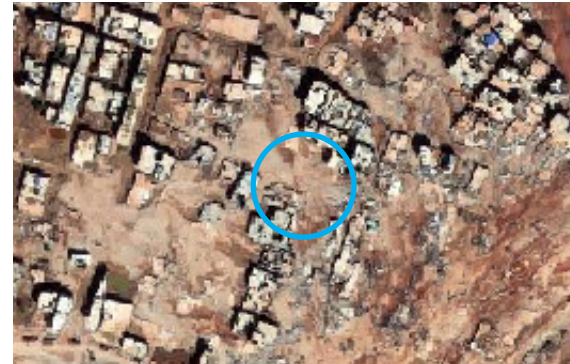
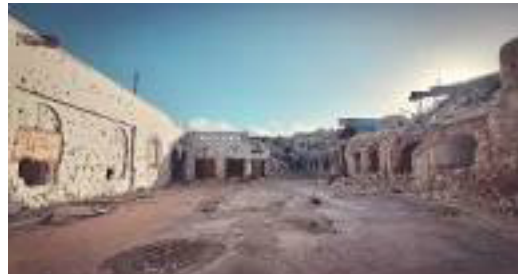
PIAZZA AL BAIDA AL HAMRA

Date of construction	1670
Current state	100% Destroyed
Function	Public Square

Al Baida al hamra, previously known as Piazza Regina Elena, was one of the courtyards adjacent to the city's souk. It was considered as the "rendez-vous" point for Derna's intellectuals and artists.

The piazza was severely impacted during the Libyan war, the central fountain and the archways were completely destroyed. In 2021, began a project of rehabilitation which was completed shortly before the floods.

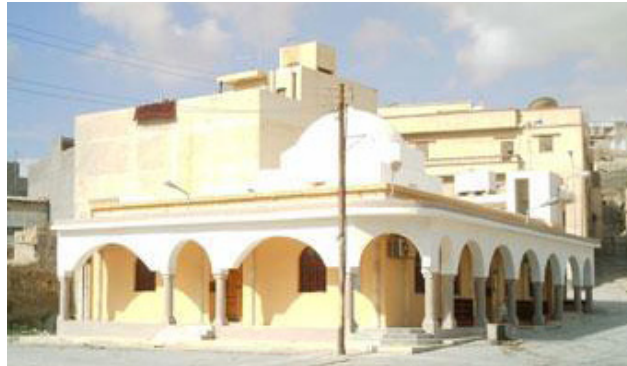
AL RACHID MOSQUE

Date of construction	XVII century
Current state	20% Destroyed
Function	Mosque

The Al Rachid mosque was originally called Bu Gharara mosque. it dates back 400 years but was rebuilt in 1887 under Ottoman rule. It was also one of the landmarks destroyed in the war in 2014. A restoration project was completed just a few weeks before the devastating floods, where the outer shape of the mosque was transformed. The mosque suffered water damage inside and degradation to its wooden components.

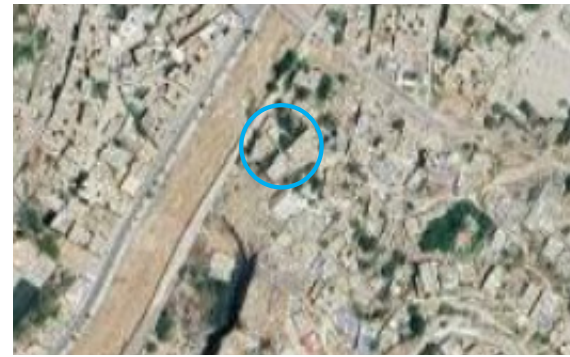
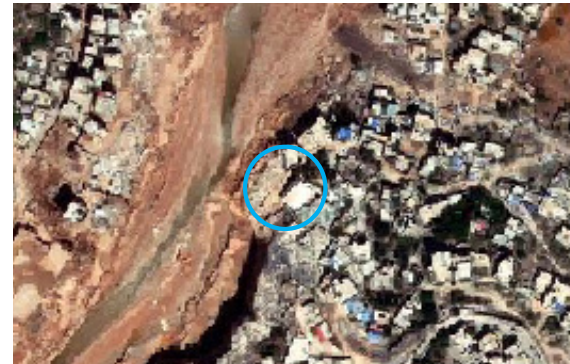
AL SENUSSIA/ AL ZAWIYA MOSQUE

Date of construction	1844
Current state	Unknown
Function	Mosque

The Senussia mosque was established in 1844 on the site of a roman well. It was built inside a cave. It is also called the 'kahf' mosque, the Zawya mosque or the Rock mosque. It is located on a plateau, south of the Sahaba mosque. The mosque is rectangular in shape and consists of five corridors. It is characteristic of Moroccan architecture with Corinthian capitals.

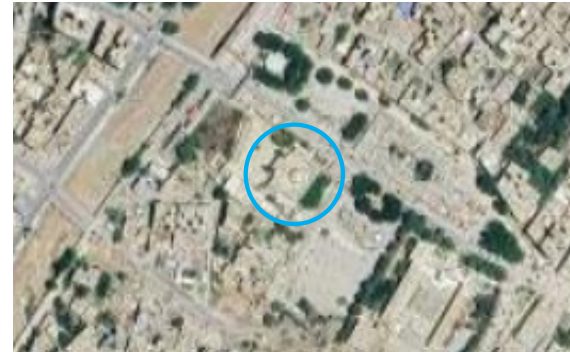
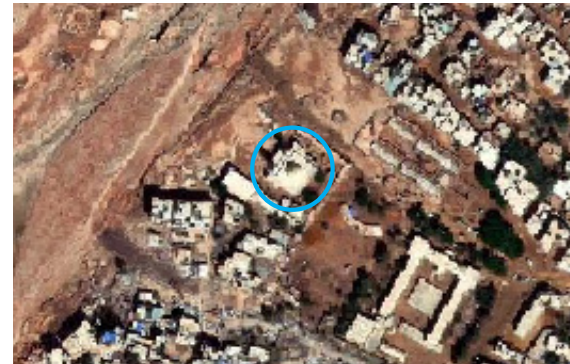
AL SAHABA MOSQUE

Date of construction	1975	
Current state	50%	Destroyed
Function	mosque and cemetery

Al Sahaba mosque was inaugurated in 1975 with a cemetery containing 70 of the prophet's companions. In addition to its religious role, the mosque is considered a meeting place for the people of the city on most national and social occasions.

The floods of September 10 caused major destruction to the surroundings of the building including its peristyle archway. The cemetery, which was a prominent historical landmark of the city, has been lost. There were also damages inside of the mosque.

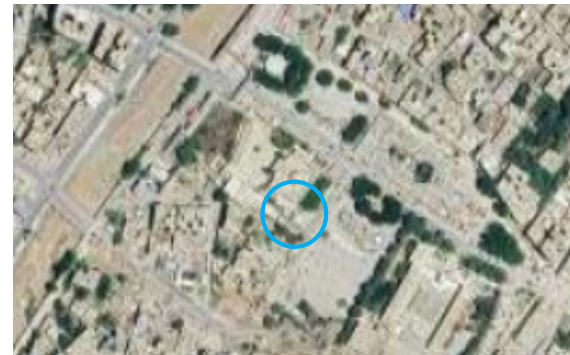
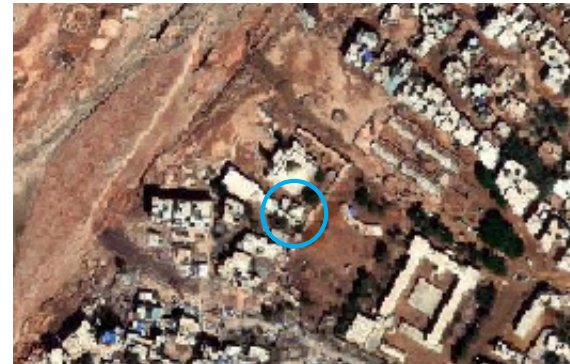
SHRINE OF ZUHAYR IBN QAYS

Date of construction	XVII
Current state	20% Damaged
Function	Shrine

The shrine of Zuhayr ibn Qays was built in the early XVII century on the south eastern side of the Al Sahaba mosque. It holds the body of the noble companion Zuhayr Ibn Qays and was destroyed during the Libyan war in 2012. The flood severely damaged the shrine and wiped away the cemetery which dates to the 17th century

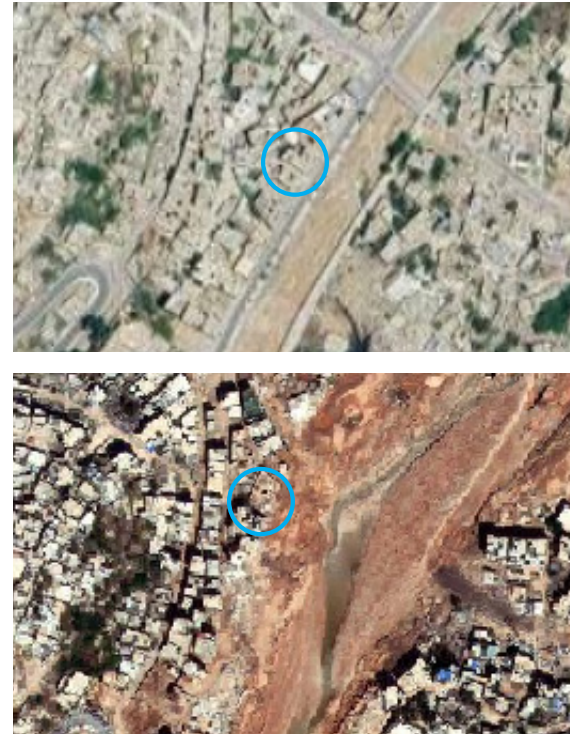
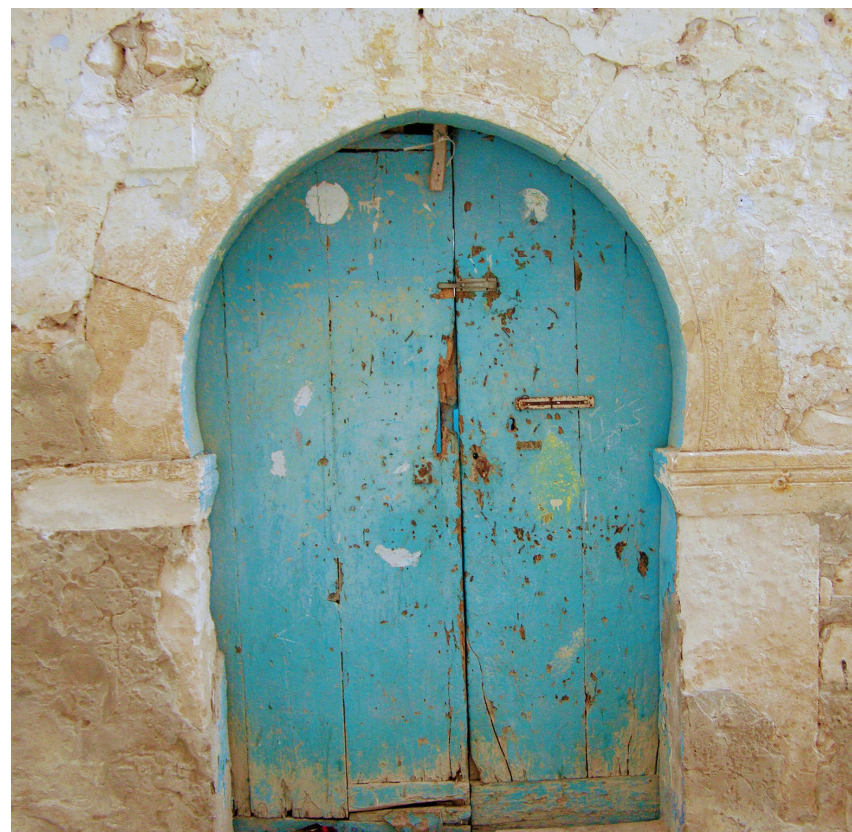
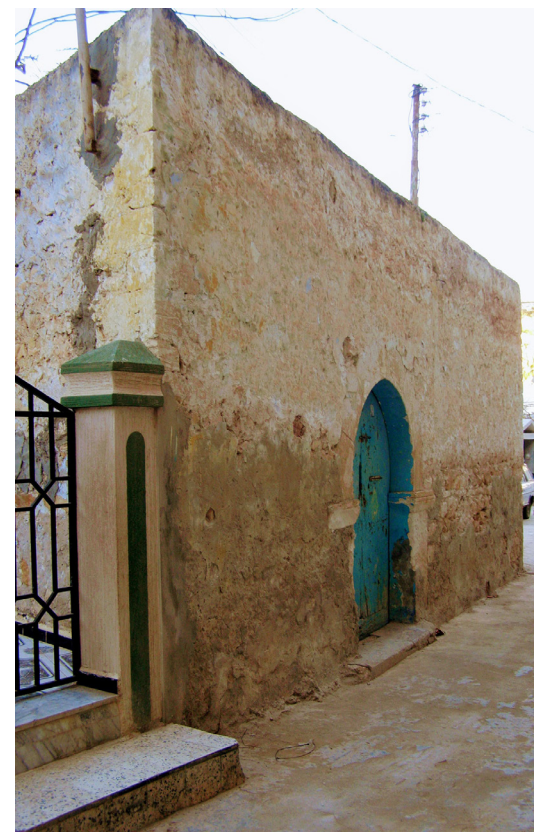
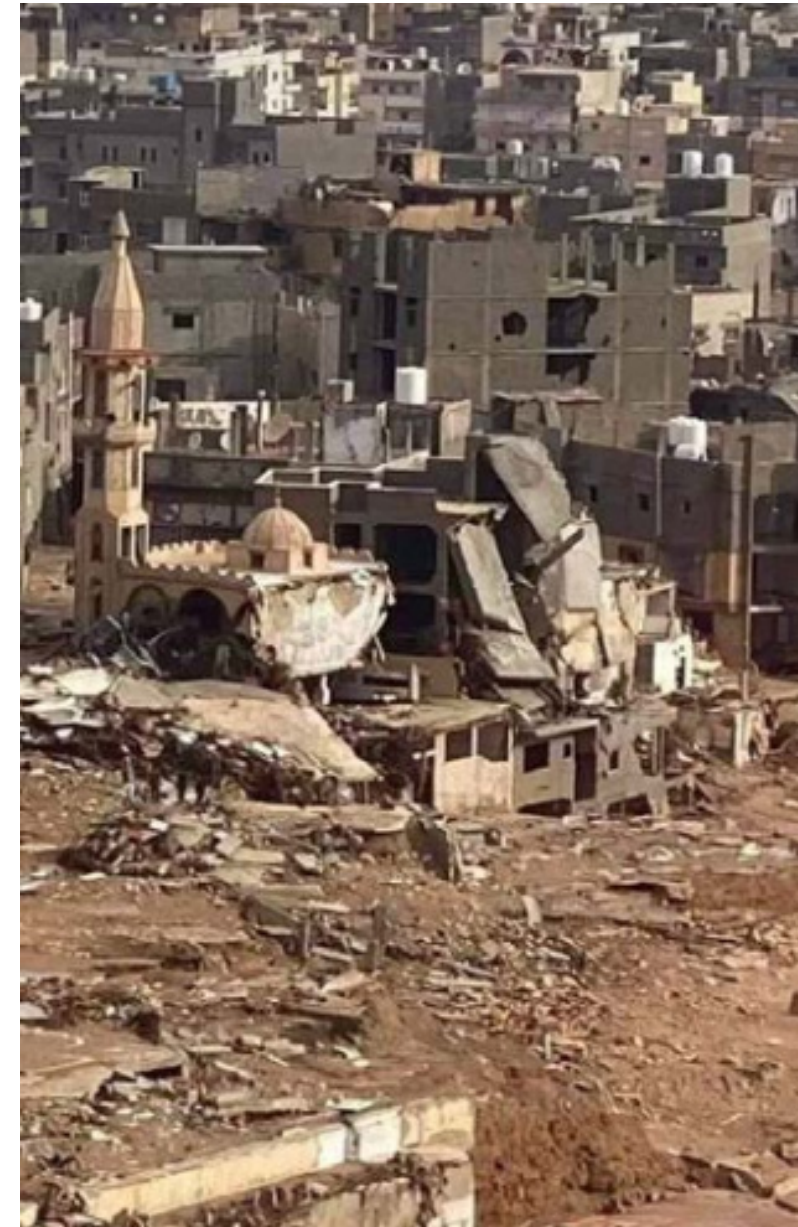
DERNA
AL JARABA MOSQUE

The Jaraba mosque is situated in the Maghar neighborhood, and was built in 1558 in the first Ottoman era by a family from Djerba. It was not built in Ottoman style but is characteristic of local architecture with horseshoe arches and short columns. The plan is irregular to fit in the urban context. Even before the floods, the structure was in a bad state of conservation, but the storm led to its partial destruction before it was torn down for safety measures.

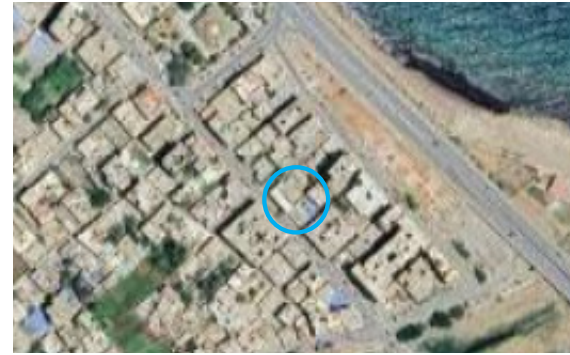
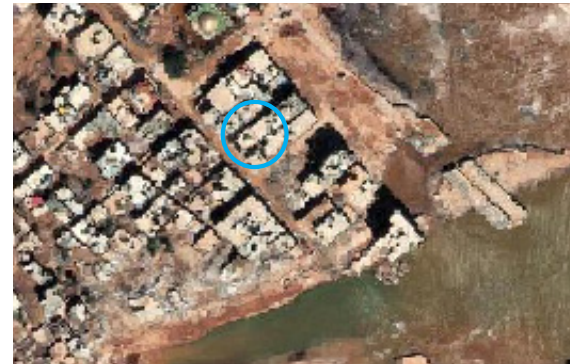
AL FATH MOSQUE

Date of construction	XX century
Current state	40% Destroyed
Function	Mosque

Al Fath mosque is situated on the western side of the river, at 500 meters from the beach. The floods have severely damaged the facades of the mosque, destroying its columns, posing a structural threat to the building. Inside, the damages appear to be minor with no apparent structural damage.

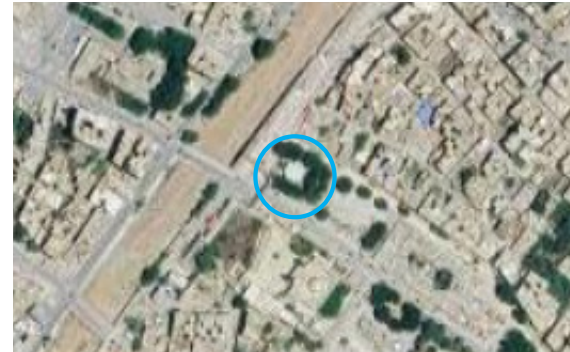
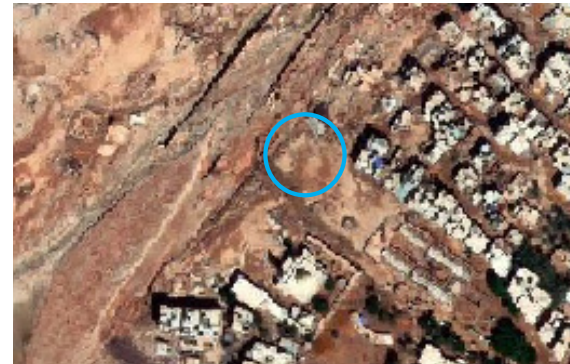
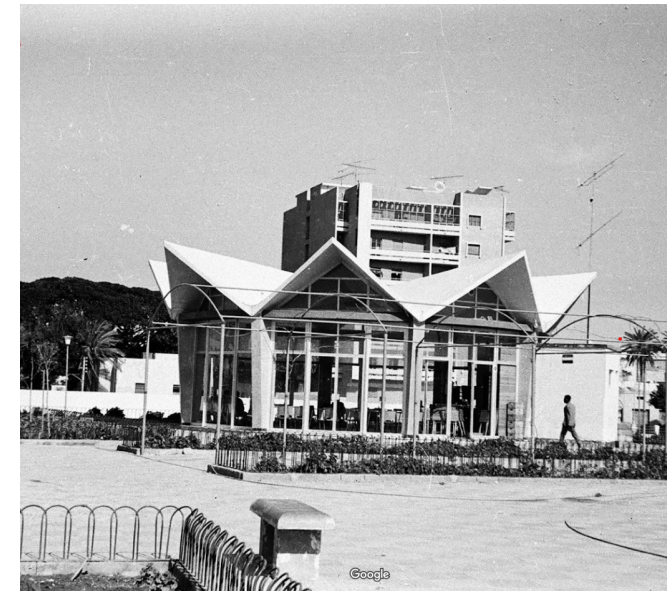
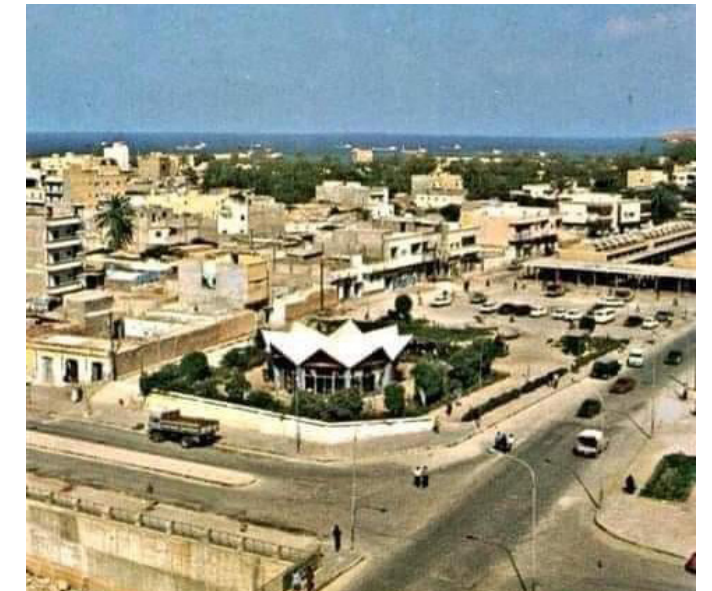
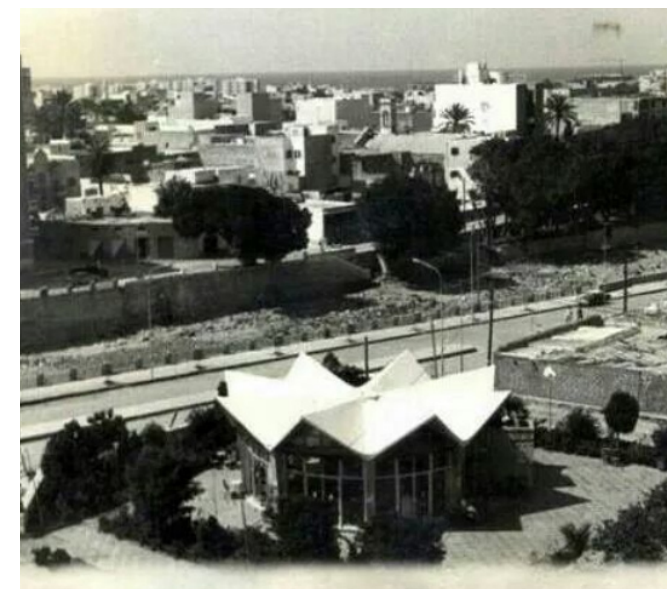
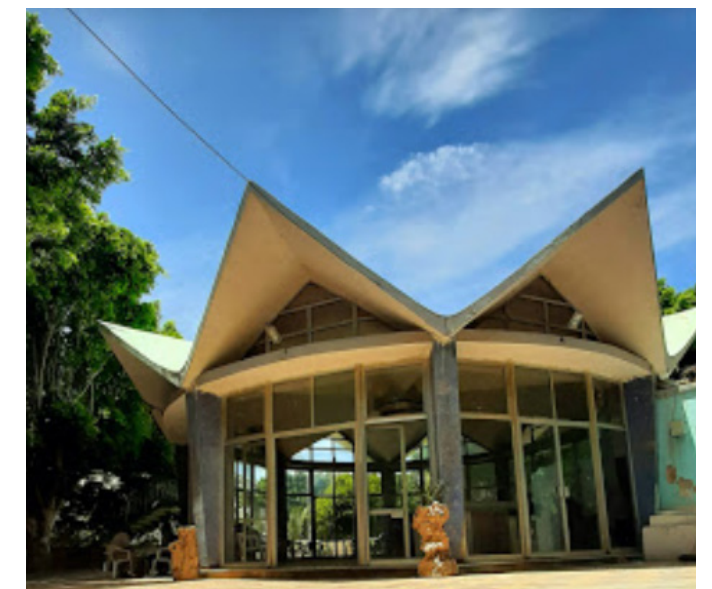
DERNA
STAR CAFÉ

Star Café is a rationalist structure probably dating back to the 1930's when Derna was under Italian rule. It is located next to the Sahaba mosque and the city's main vegetable market. The structure is made of concrete, glass and metal. It was a "rendez-vous" point for locals. It has been completely wiped by the floods.

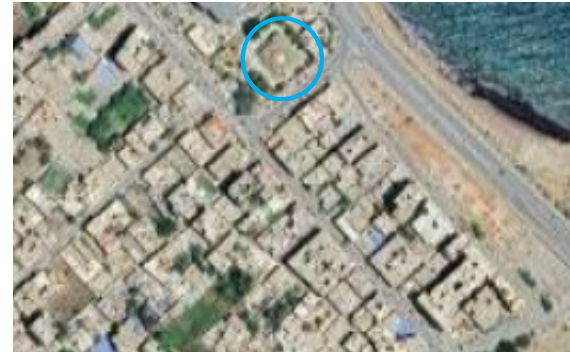
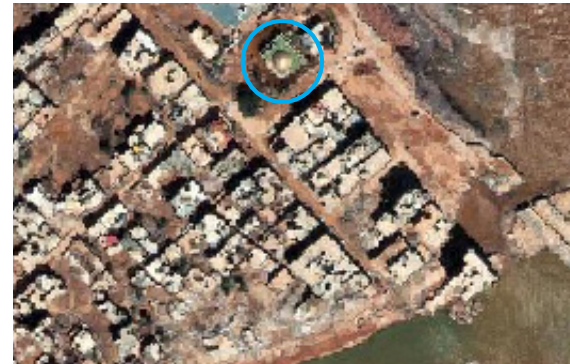
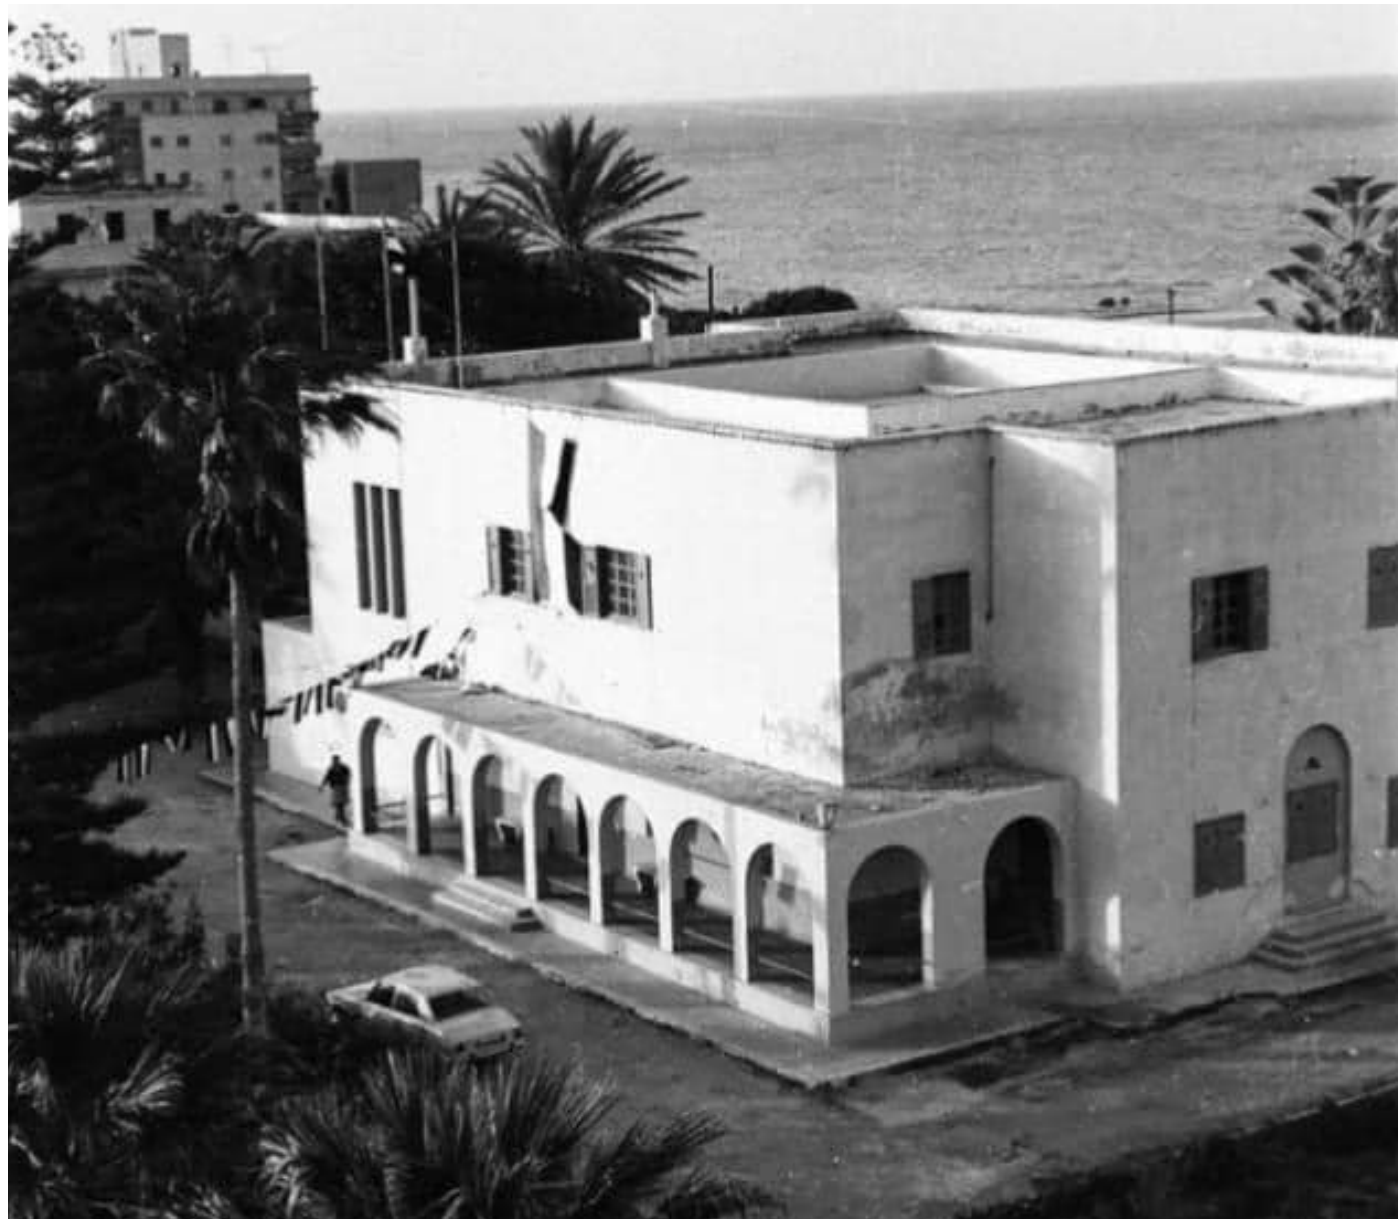
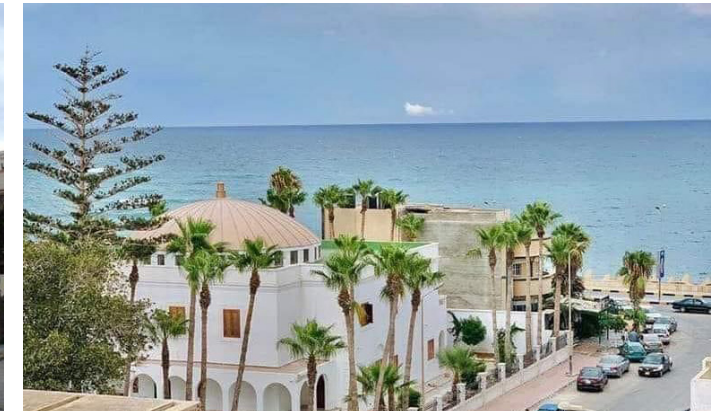
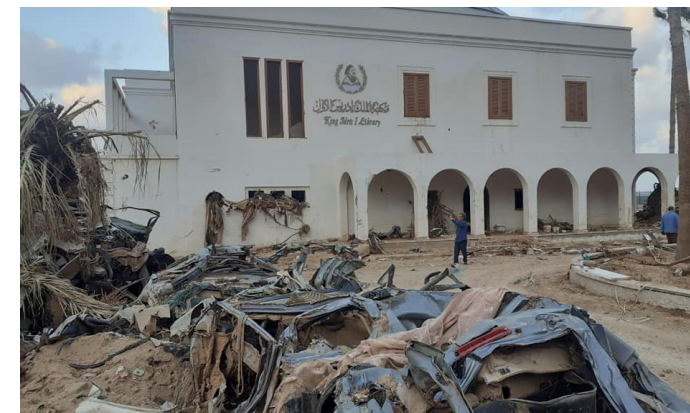
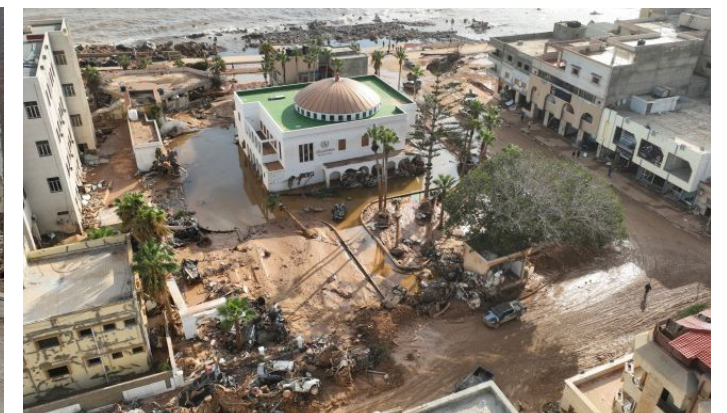
DERNA
KING IDRIS LIBRARY

King Idris Library, also known as Al Zuhur Palace was built in 1920 to be the headquarters of the Italian ruler. In 1956, after the liberation, it was turned into a royal palace, then into the city's Education directorate in 1964. In 2011, during the Libyan revolution, the building was damaged and became a private residence for armed forces and their families. It was finally transformed into a public library, set to open in December 2023.

The floods caused significant damage to the ground floor, in addition to complete damage to all garden works, piazza arches, fences, gates, external floors, air conditioning works, carpentry, electricity, painting...

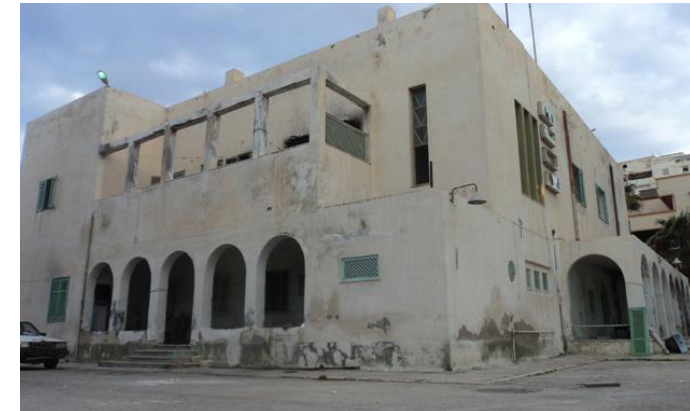
Date of construction 1920
 Current state 40% Destroyed
 Function Public Library

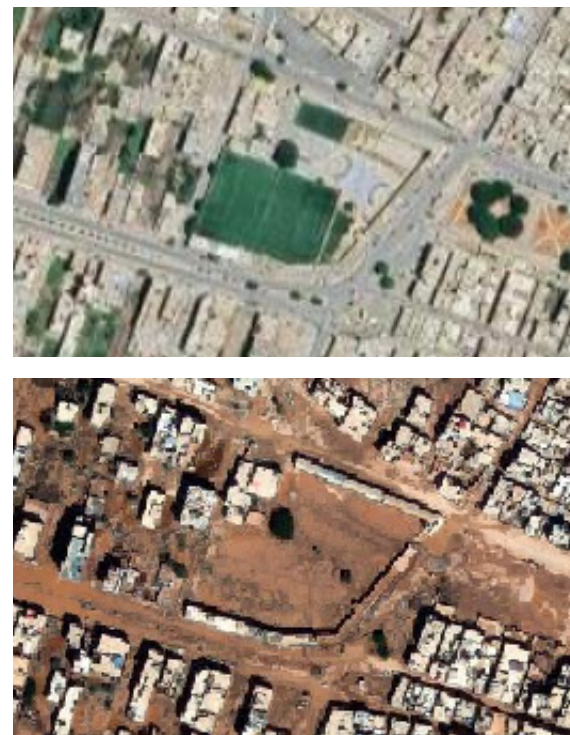
DERNA
DARNES SPORTS CLUB

Date of construction XX Century
 Current state 50% Destroyed
 Function Sports and cultural complex

The Darnes Sports, Culture and Socials Club was founded in 1958 and named after the ancient name of the city of Derna.

The floods caused devastating damages to the stadiums, facilities, administrative building as well as the shops, restaurants and hotel surrounding the complex. The costs of building a new stadium are valued at 10 million dollars.

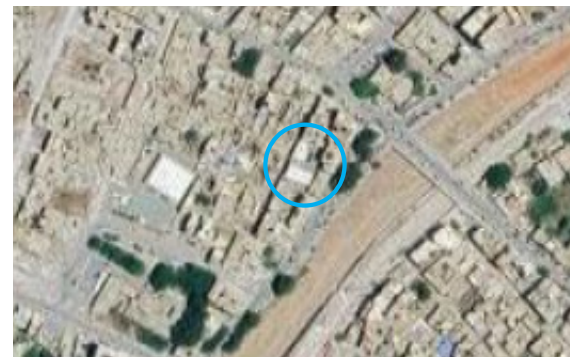
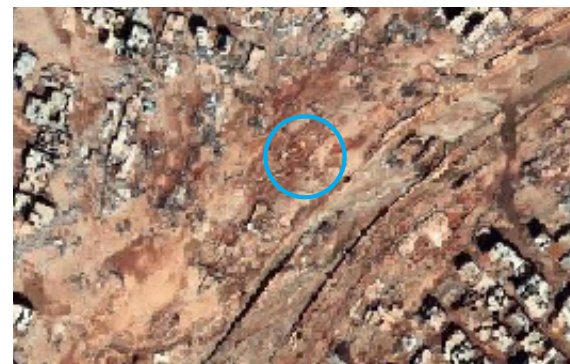
DERNA DERNA CULTURAL CENTER

Date of construction Unknown
 Current state 90% Destroyed
 Function Cultural center

The Derna Cultural center was founded in 1977 in a former church. It welcomed literary and artistic fairs, as well as local film and music festivals. The church was destroyed during the Libyan war but was restored and brought to its former glory. The floods completely wiped the structure which was renovated in 2021.

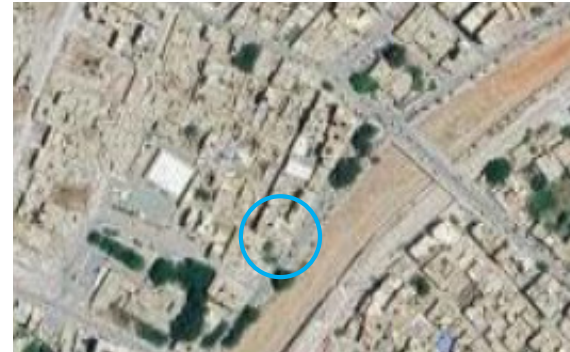
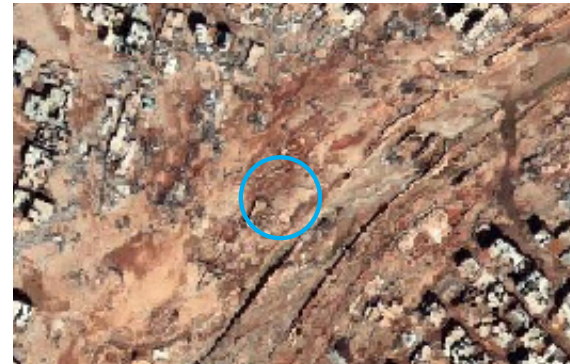
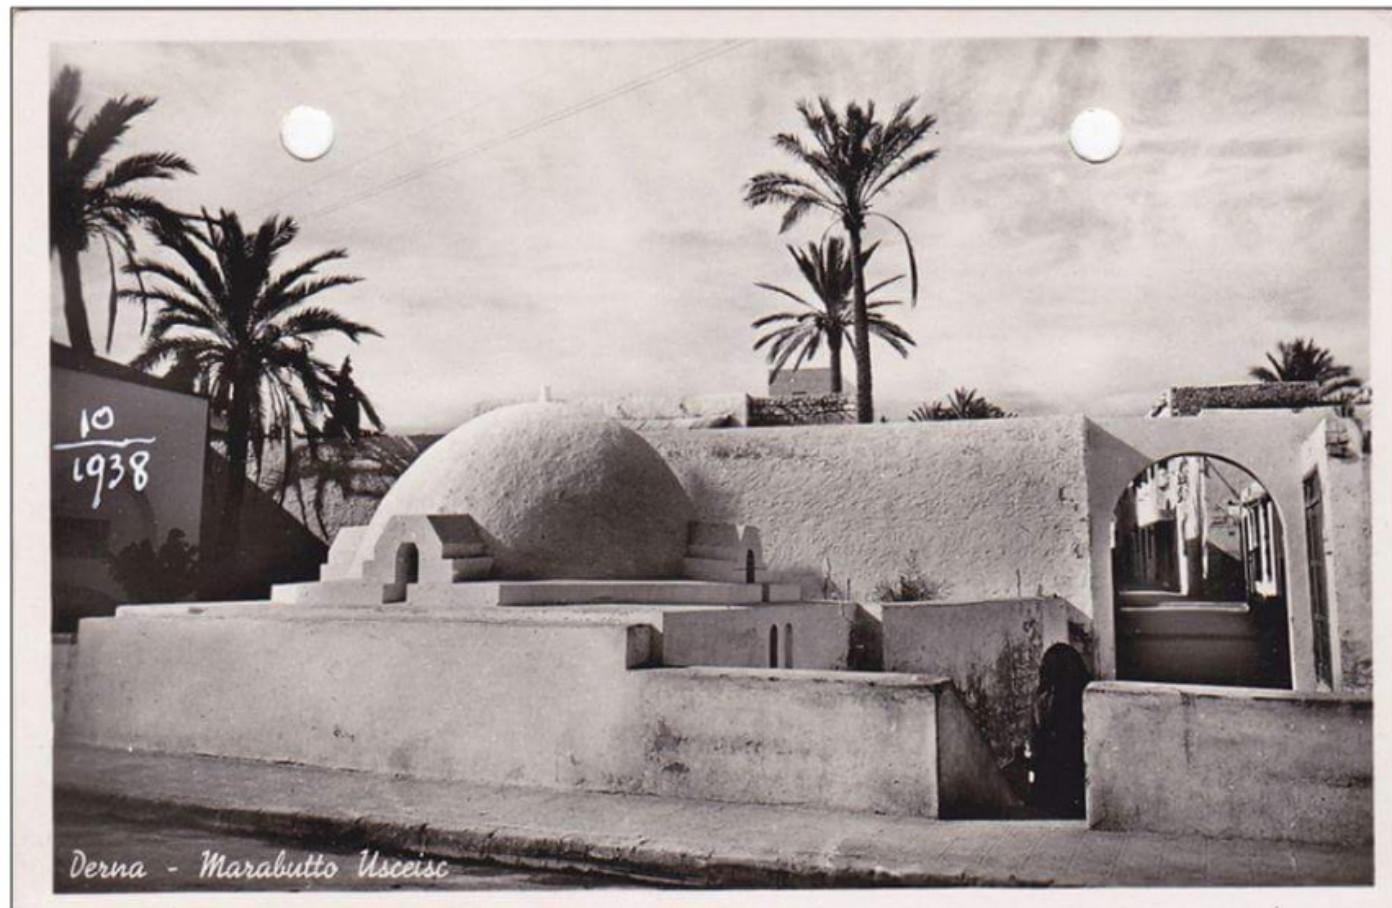
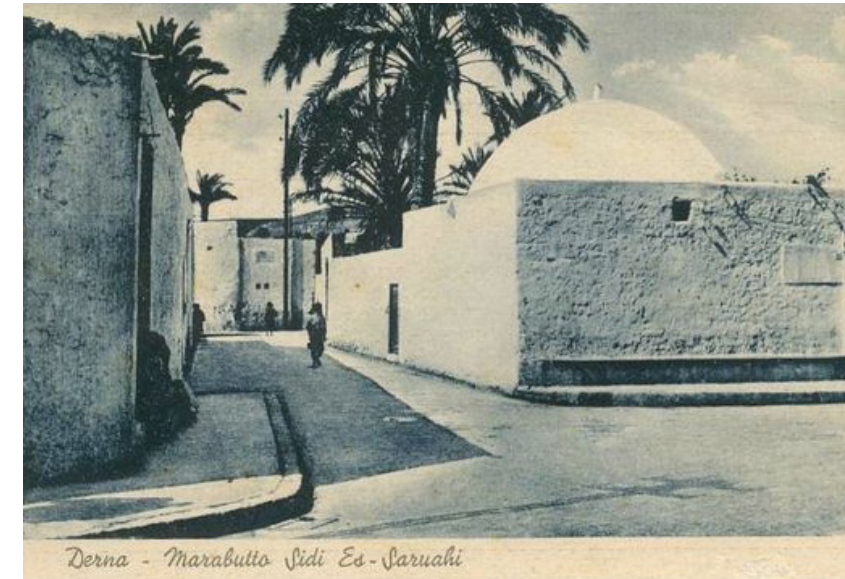
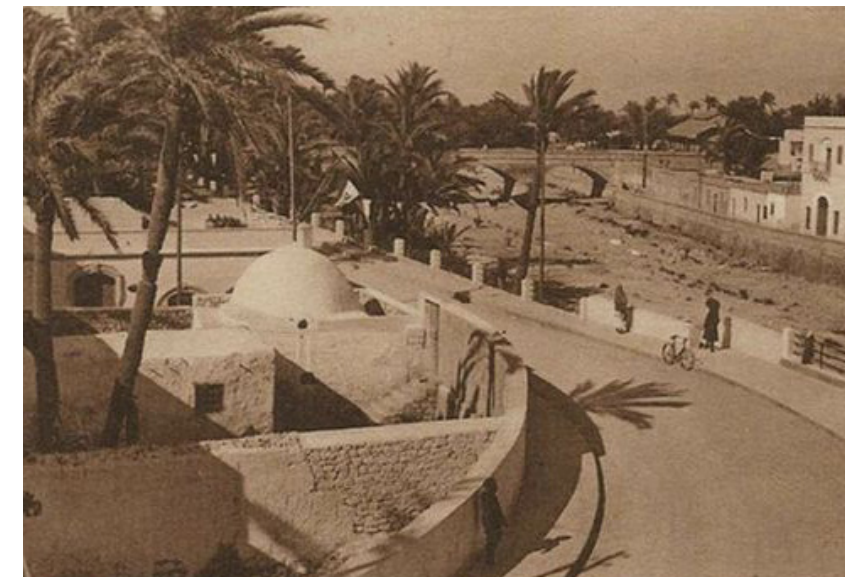
The Mausoleum of Sidi Ali Al Washish was one of the oldest shrines in the city. In May 2014, the shrine was blown up and leveled to the ground. The floods wiped all traces that remained of this shrine.

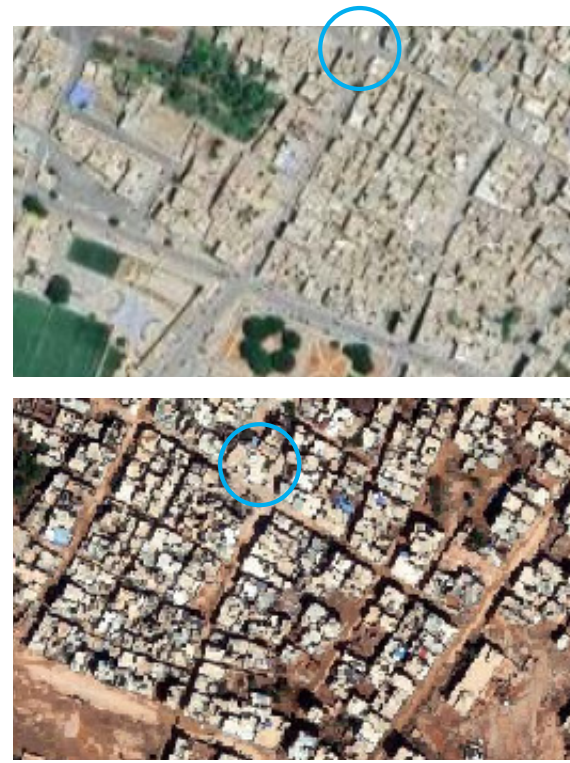
ZAWIYA AL RIFAIYA

Date of construction	Unknown
Current state	Undamaged
Function	Mosque

The Zawiya Al Rifiya is located on the western bank of the Derna river. The decorative elements are characteristic of local architecture with horseshoe arches and limestone wash facade. From the satellite imagery, the site does not seem impacted from the flood.
