IMPACT OF FLOODING ON THE LIBYAN HERITAGE

2 0 2 3

INTRODUCTION

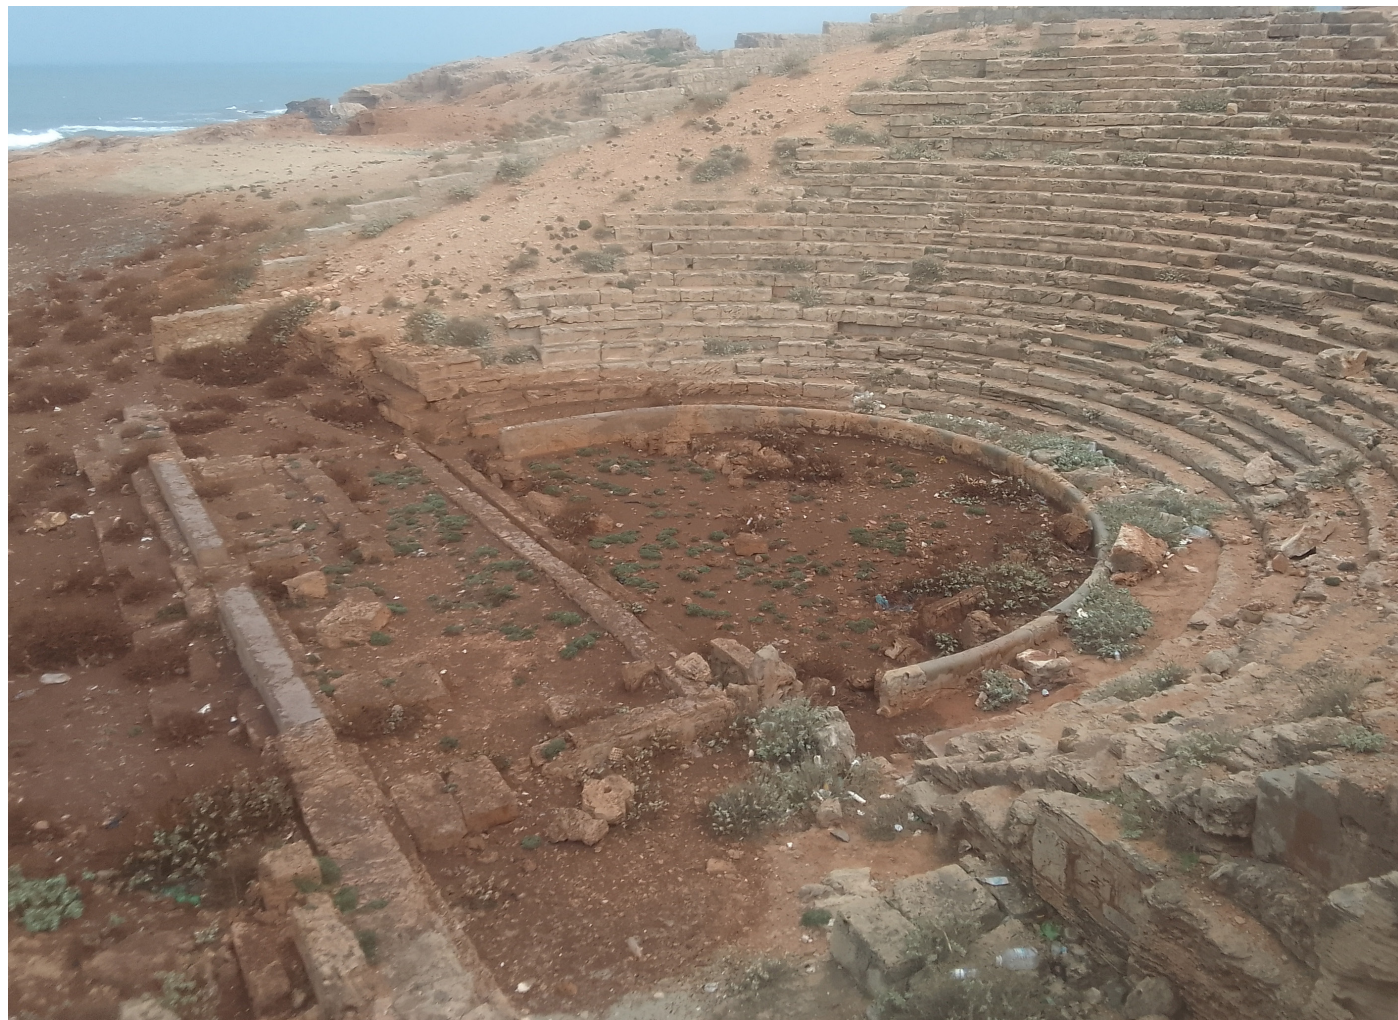
Amphitheatre - Apollonia , 09-10-2023 Iconem

SOAKED SOIL AND CAPILLARY RISE

The ancient site of Apollonia in Libya, nestled by the seaside, is under intensified threat not only from the persistent dangers of capillary action but also from a recent flood that struck just two months ago.

This coastal location inherently draws saline water from the sea into its subterranean layers due to capillary forces.

As this saline moisture permeates the porous structures of Apollonia's historic relics, salts can crystallize within, leading to potential expansion and fracturing of invaluable artifacts and remnants of ancient architecture.

Moreover, the continuous moisture, intensified by the recent flood, exacerbates the soil's anoxic conditions. Such conditions are conducive to the proliferation of microorganisms which may precipitate the degradation of organic archaeological materials. The flooding, by saturating the site even more extensively, has potentially expedited the already existing threats, making imme-

diate preservation actions even more imperative. In the face of these challenges, it's crucial to take swift measures to safeguard the rich cultural legacy of Apollonia.

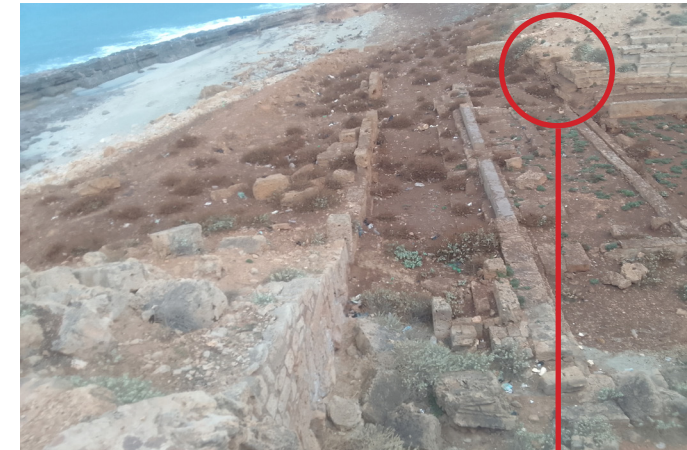
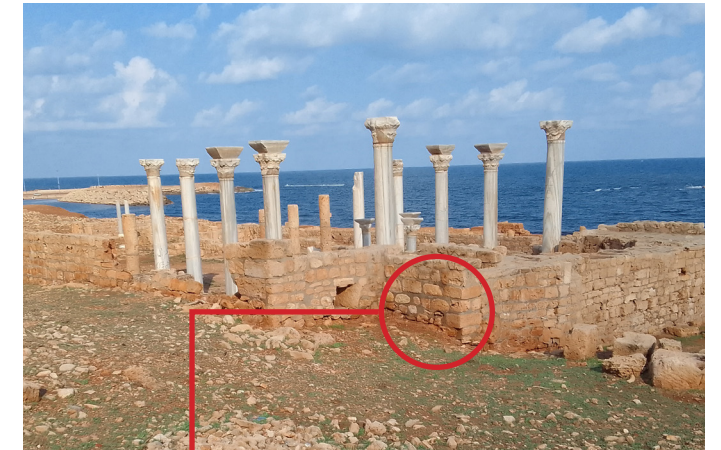
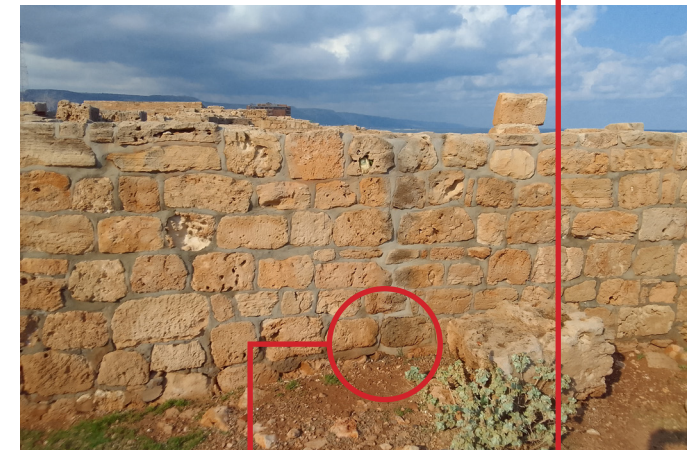
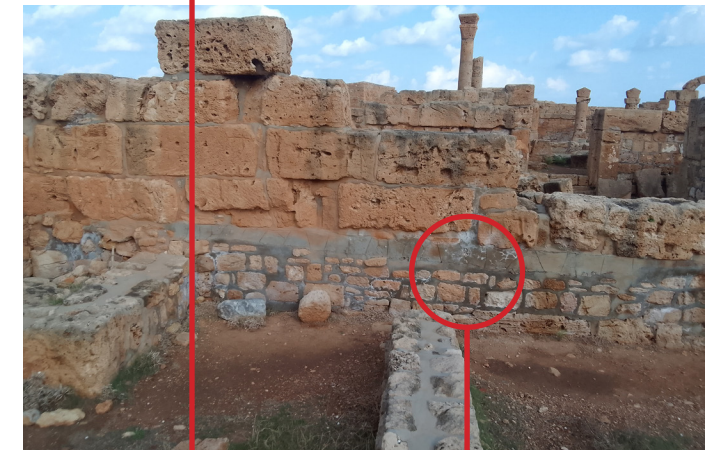
Capillary rise in concrete joints poses a distinct issue. Unlike stone, these joints have different characteristics. They trap water, which in turn undermines the very equipment they are meant to strengthen.

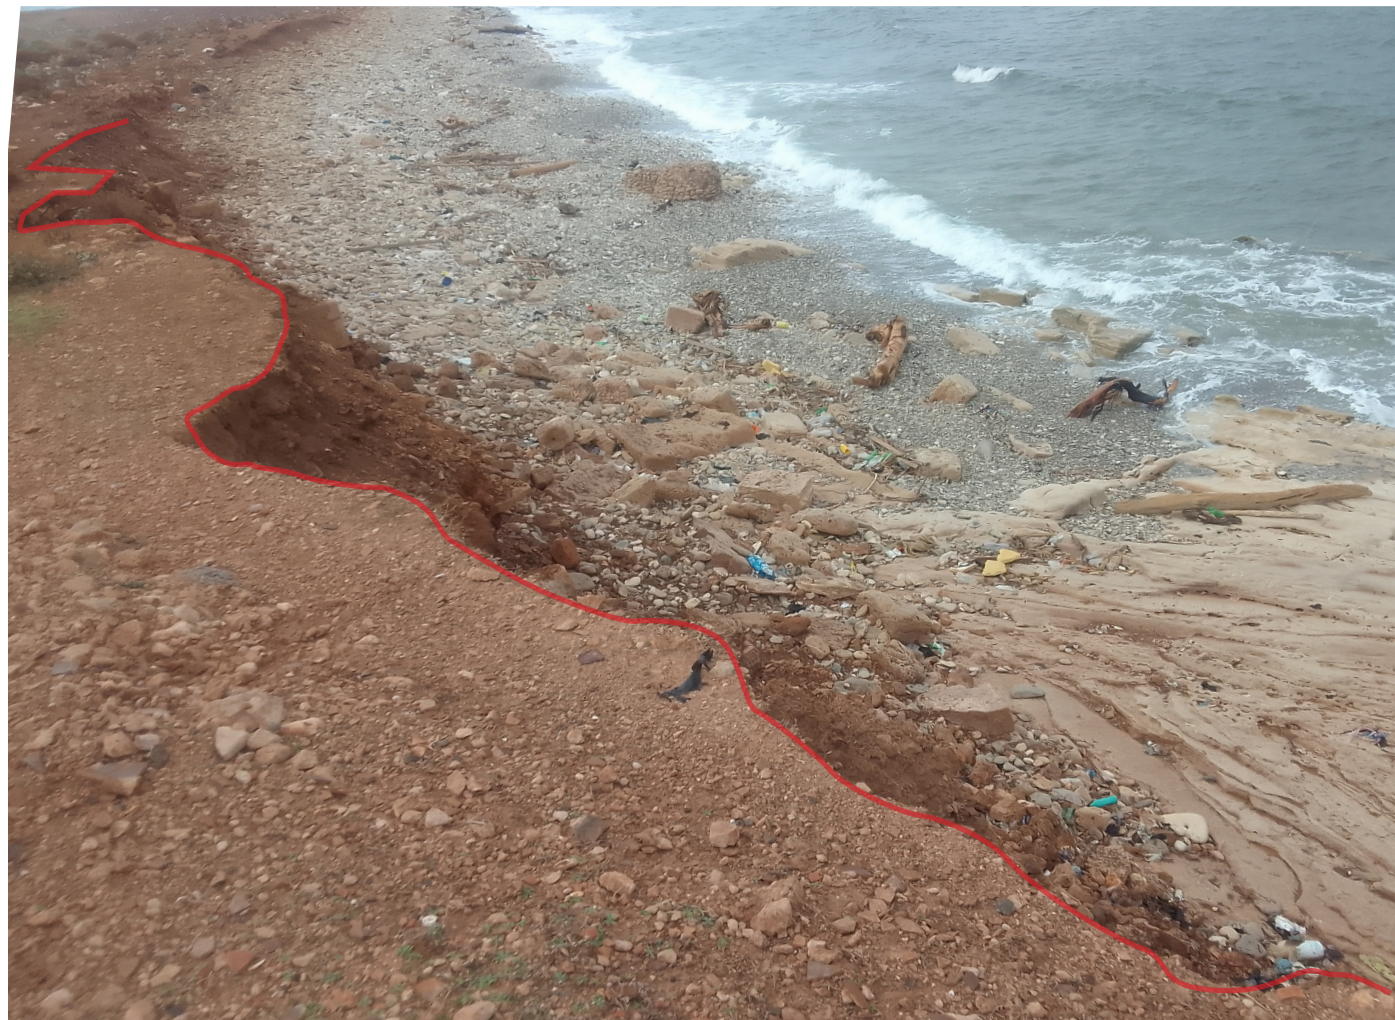
Apollonia , 09-10-2023 Iconem

LANDSLIDE

The site of Apollonia in Libya, perched near the coastline, faces not only the challenges associated with its seaside location but also the looming threat of landslides. While coastal factors like capillary action expose the archaeological treasures to moisture and salt intrusion, the recent flood two months ago has brought an added risk: destabilizing the soil structure and making the site more vulnerable to landslides.

These sudden and downward movements of a mass of rock, earth, or debris can be catastrophic, potentially burying or displacing invaluable artifacts and remnants of Apollonia's storied past.

Such landslides can irreparably damage the site's structural integrity and the delicate stratigraphy that archaeologists rely upon for their research. The combination of saturated soil from the recent flood and the inherent instability

of the coastal terrain makes Apollonia particularly susceptible. To ensure the preservation of this invaluable heritage site, proactive measures against landslide risks are important.

While the traces of the landslide are not significant at the moment (compared to the 2019 orthomosaic), it is crucial to monitor them closely.

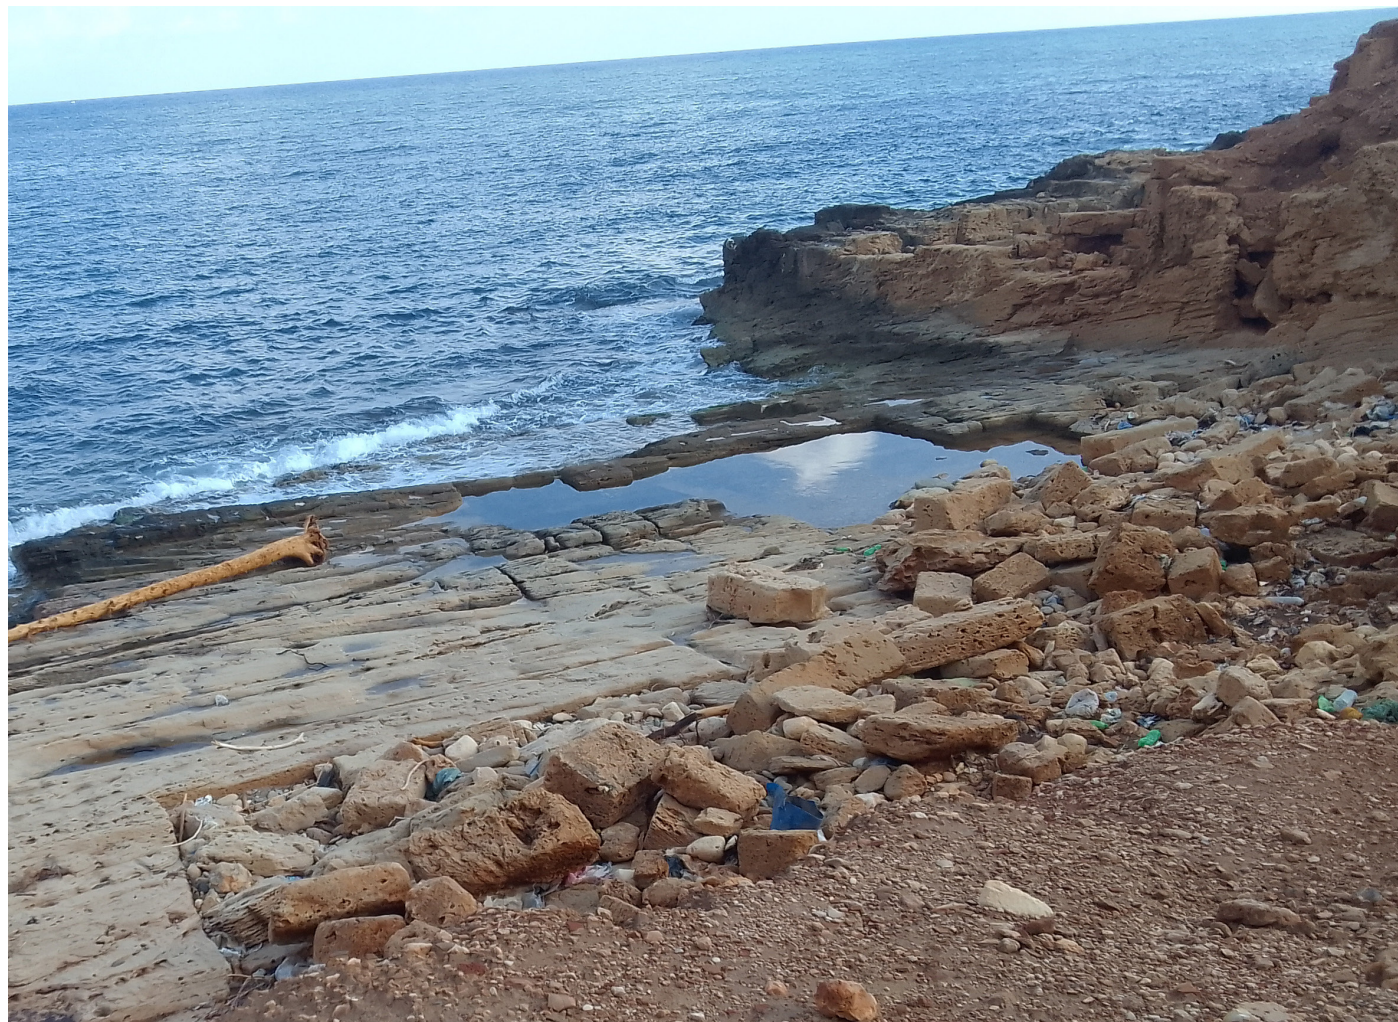
Apollonia , 09-10-2023 Iconem

WATER STAGNATION

The site confronts a pressing conservation challenge in the form of water stagnation. While factors like its seaside location and recent flooding events contribute to heightened moisture levels, the retention of water within the site's buildings and substructures poses a threat.

Stagnant water can lead to the degradation of ancient masonry, eroding the very foundations of these historical edifices. Moreover, pools of stagnant water become breeding grounds for harmful microorganisms and pests, which can further deteriorate both organic and inorganic archaeological materials.

The humidity created by trapped water can also promote the growth of molds on organic relics. For Apollonia, where each structure holds invaluable insights

into civilizations past, addressing water stagnation is crucial to ensure the longevity of its archaeological legacy.

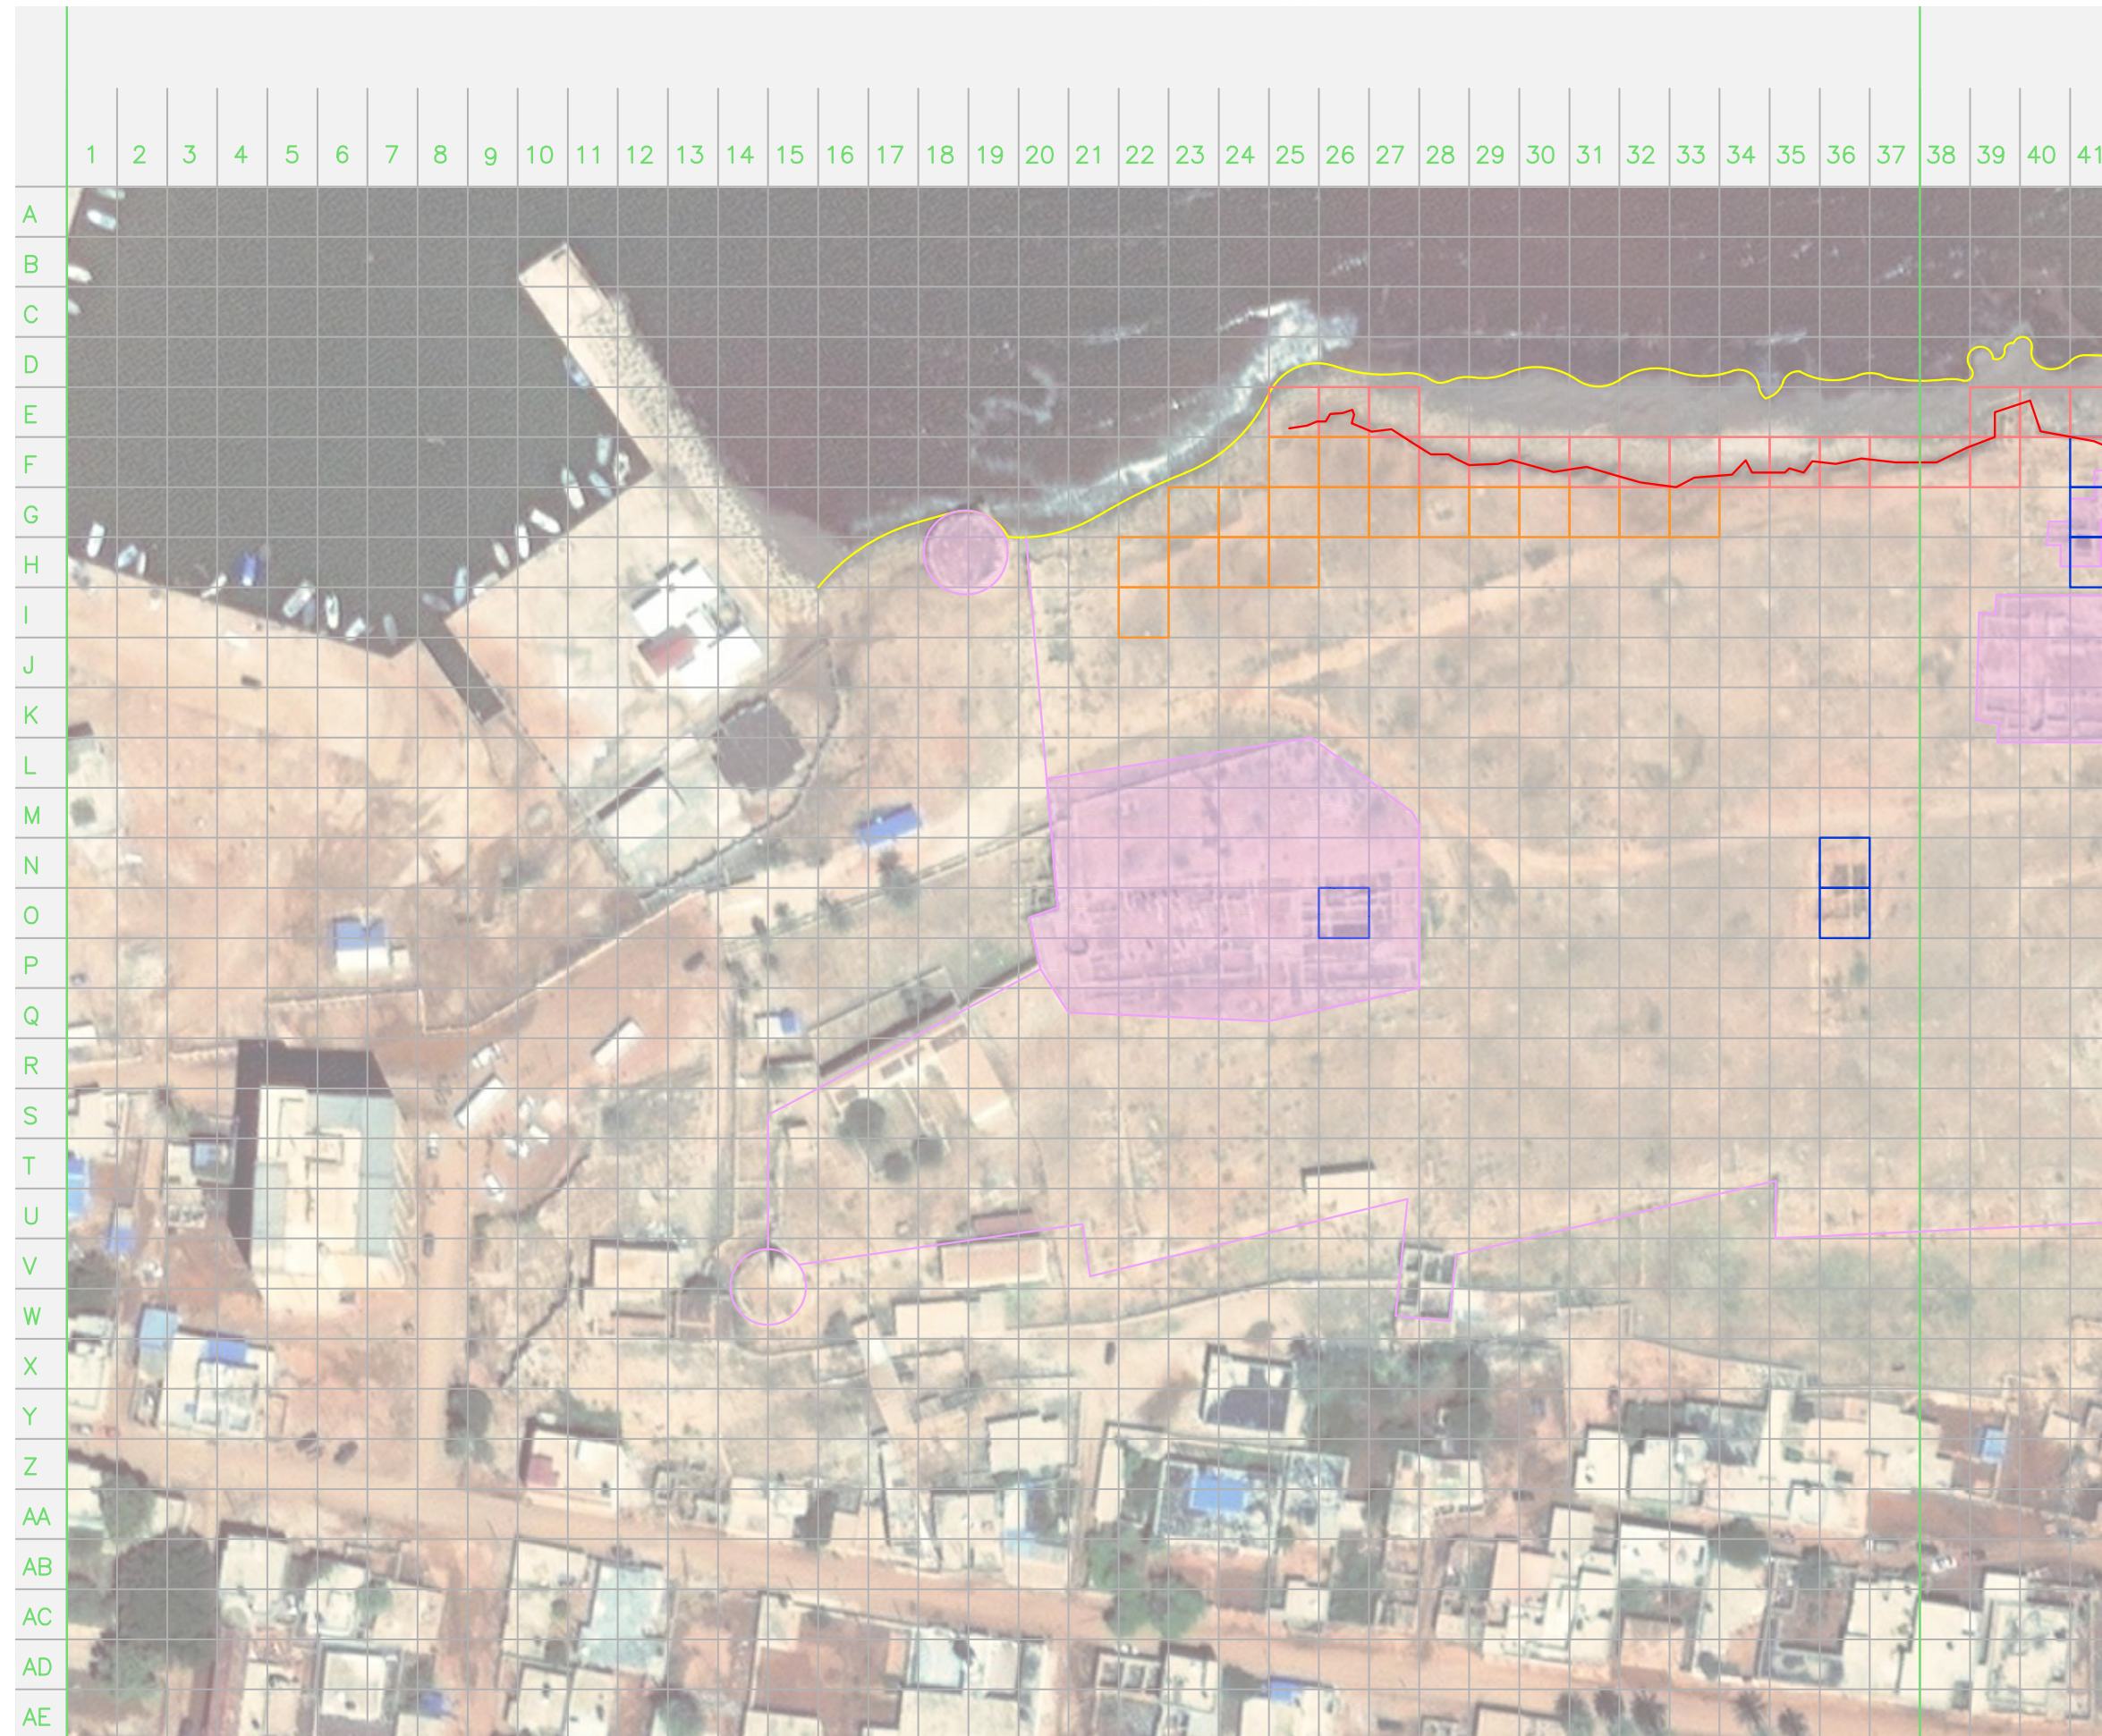
- Soaked soil
1800M2
- Water stagnation
300M2
- Landslide impact
1300M2
- Coastline
- Landslide path
138M
- Archaeological structures
- 10mx10m location grid

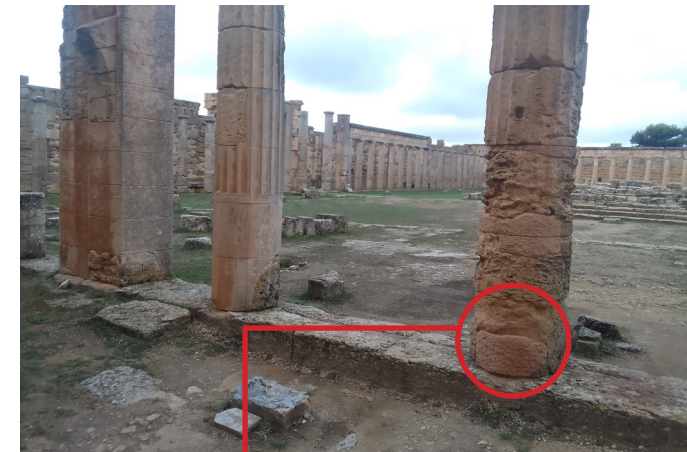
It's essential to note that while the nature of the damages is similar, the location of the Cyrene site differs from that of Apollonia, being directly open to the sea. Therefore, a more in-depth exploration of the details becomes crucial for effectively guiding emergency interventions.

Cyrène , 09-10-2023 Iconem - soaked soil and capillary rise

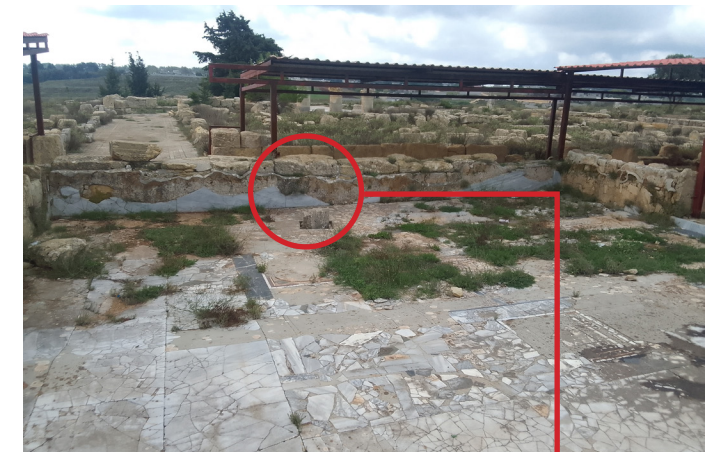
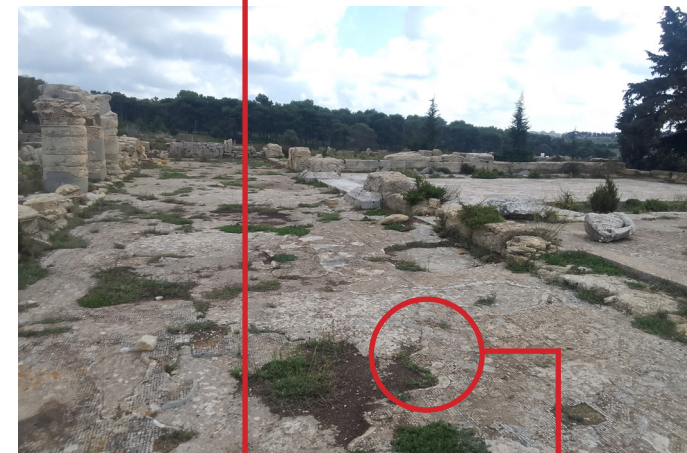
Cyrène , 09-10-2023 Iconem - soaked soil and capillary rise

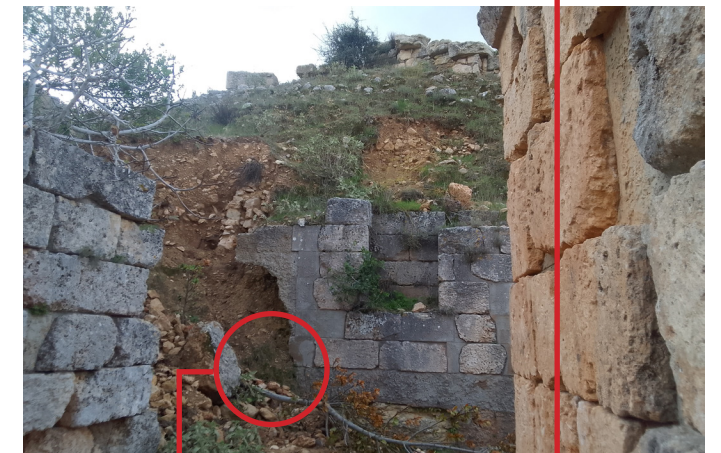
Cyrène, 09-10-2023 Iconem - Landslide

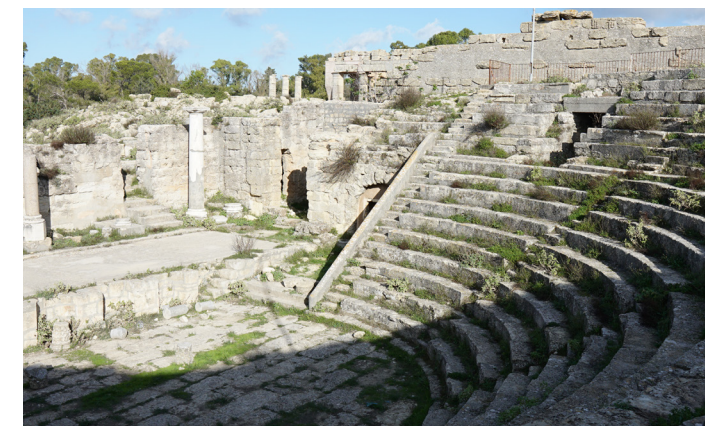
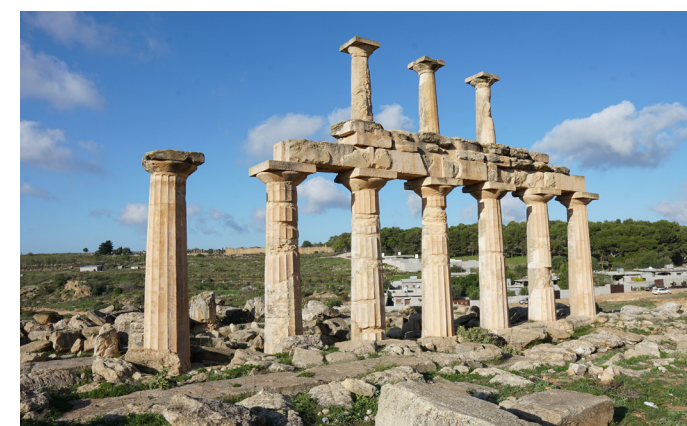
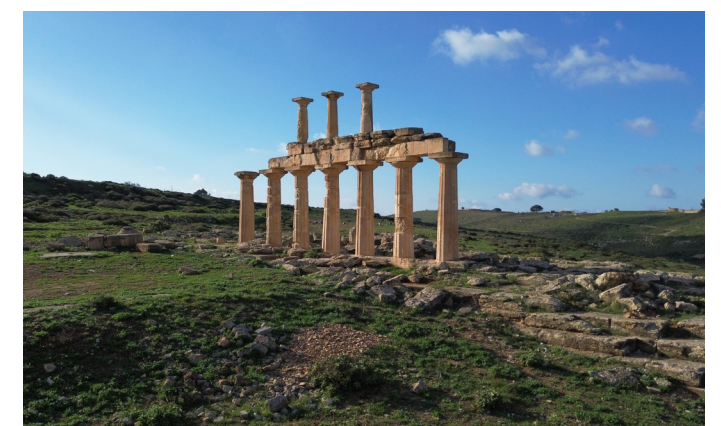
The site photos provided clarity in identifying various types of damages in certain zones. The images within the report offer insight into the nature of the damages, akin to those observed at the Apollonia site: soaked soil and capillary rise, landslide, and water stagnation.

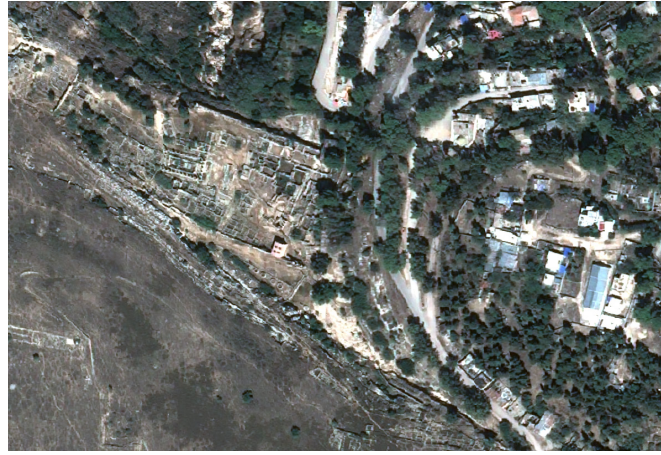
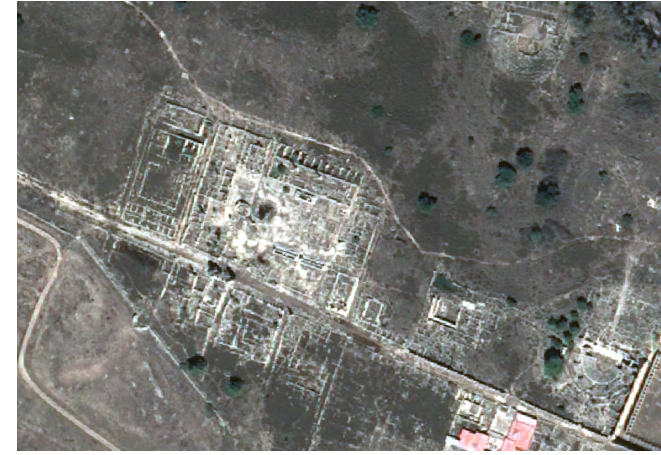
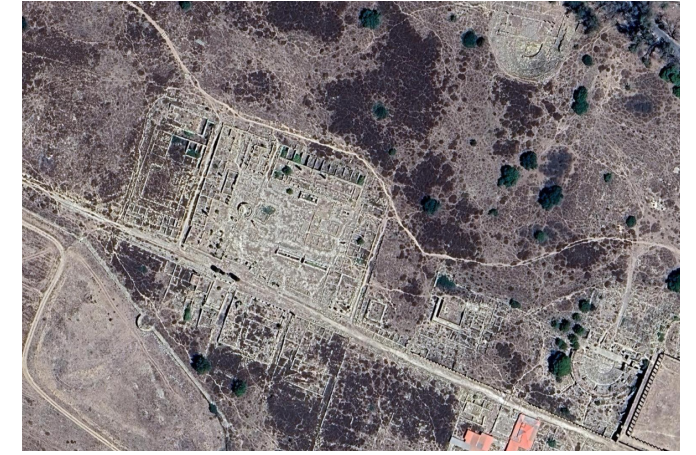
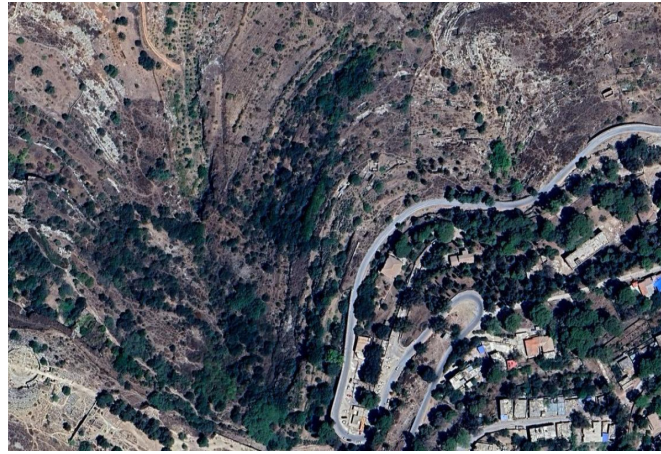
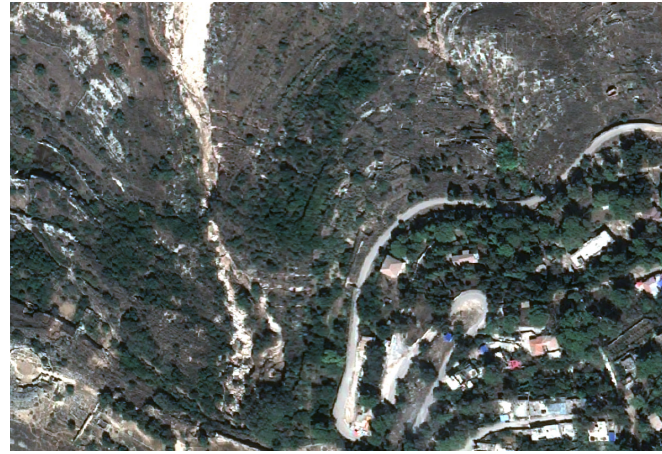
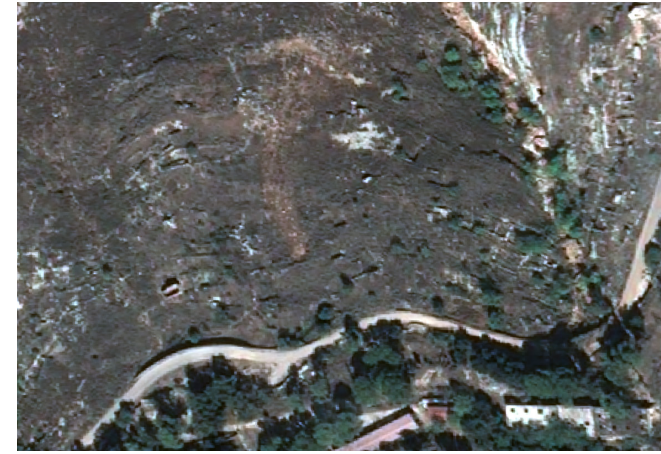
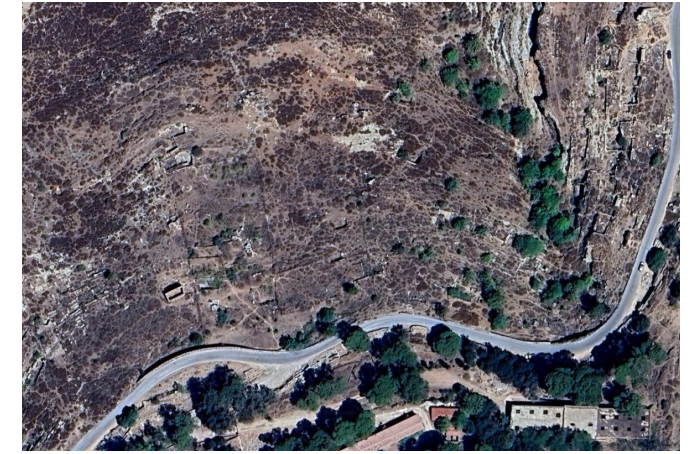
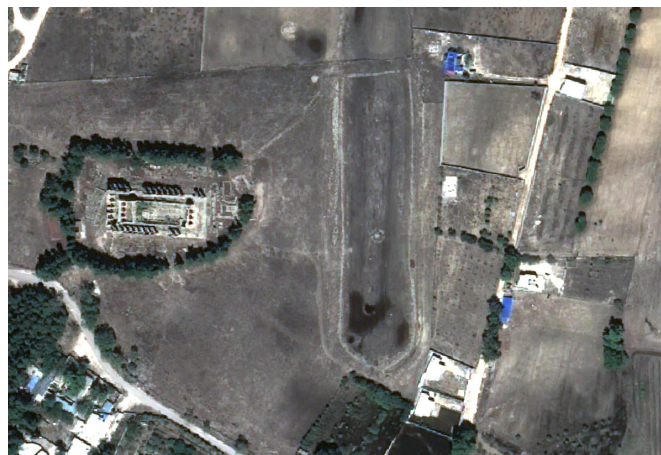
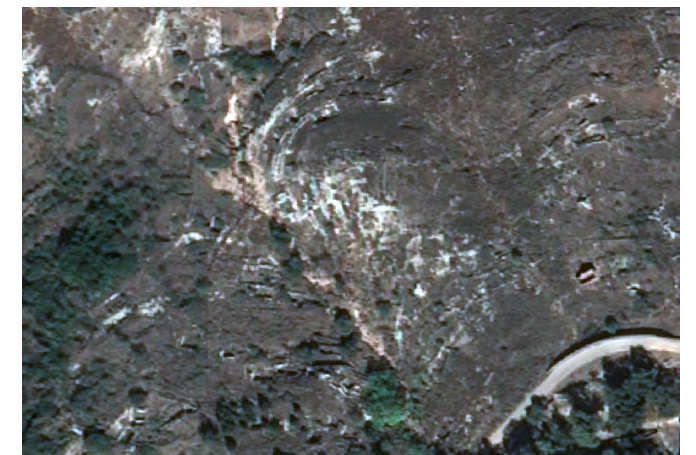
The archaeological site of Cyrene also fell victim to the floods. The observation and analysis of satellite data proved to be limited, failing to precisely pinpoint damages. Nonetheless, notable modifications were observed. Consequently, we opted to compare satellite photos taken before and after the catastrophe in specific areas.

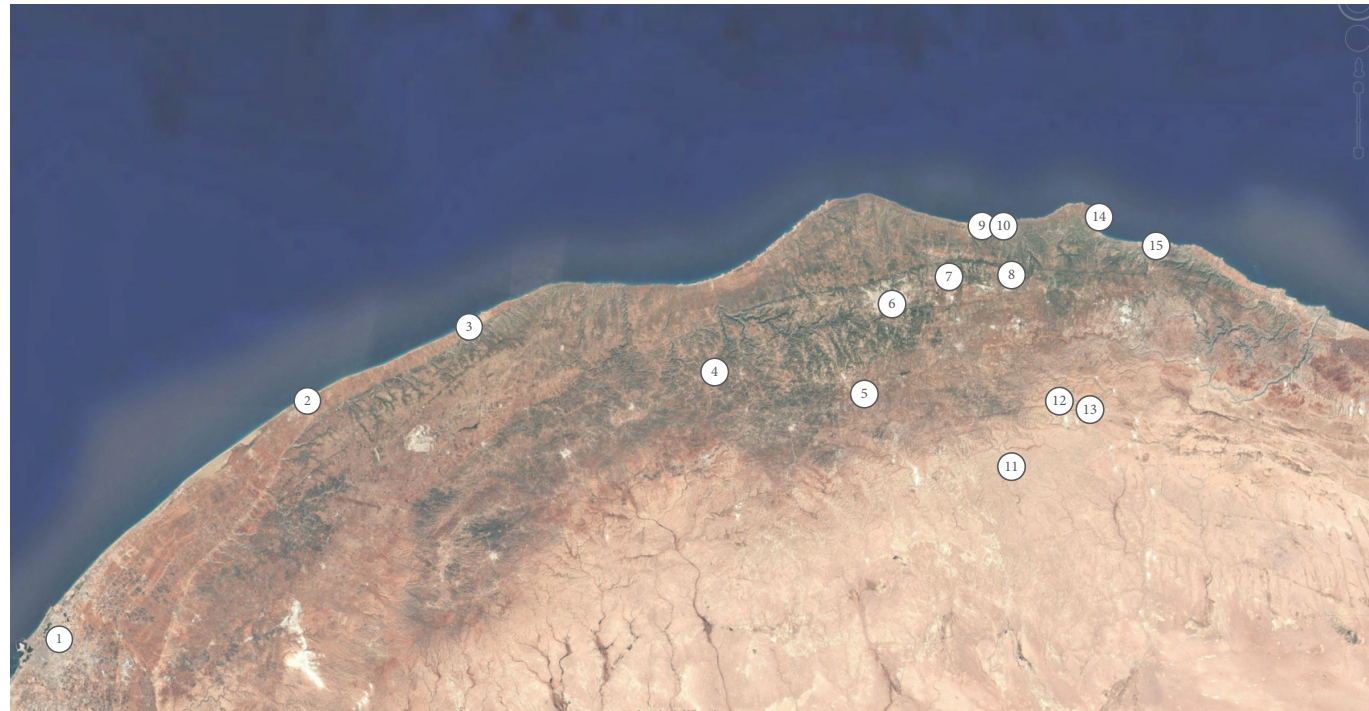
- ① ROMAN RUINS OF BENGHAZI
- ② TAUCHEIRA
- ③ PTOLEMAIS
- ④ QASR LIBYA/ THEODOREAS
- ⑤ PRE HELLENISTIC TEMPLE OF SULUNTAH
- ⑥ ROMAN RUINS OF AL BAIDA
- ⑦ CYRENE
- ⑧ ANCIENT MACAREUS CITY
- ⑨ RUINS WEST OF APOLLONIA
- ⑩ APPOLONIA
- ⑪ QASR AL MARAGH
- ⑫ KHAWLAN CASTLE
- ⑬ QASR WARTIJ
- ⑭ BYZANTINE CHURCH
- ⑮ AL ATHRUN/ ERYTHRON
