# ENCROACHING SEAS AND HERITAGE AT RISK IN AFRICAN COAST

Encroaching Seas and Heritage at Risk in African coast  
With Case Studies from Senegal, Mozambique, Kenya,  
Tanzania.

Prepared by Heritage Watch AI

Date of Publication: February 2026

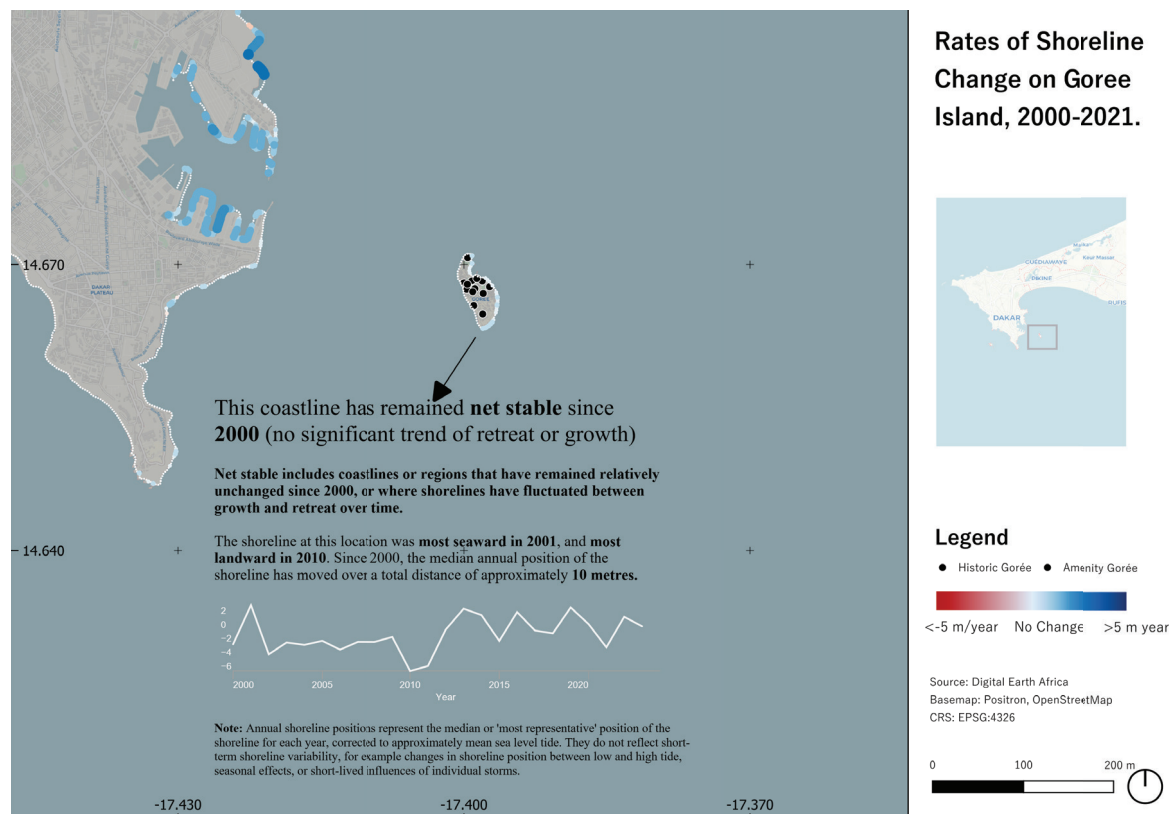
Figure 19. Rates of shoreline change at Gorée Island, 2000–2021.  
Source: Digital Earth Africa.

For Gorée's coral stone masonry and lime-based plasters, the principal heritage risk arises not from shoreline displacement, but from long-term marine influence under stable coastal geometry, which sustains salt accumulation and material fatigue over time. Shoreline change therefore functions as a modulating factor, shaping the persistence of environmental stress rather than driving damage directly.
